Happisburgh: Assessment of Rock Bund and Beach Access

Document no: B2491800-JAC-RPT-001 [P03]

North Norfolk District Council
Coastwise- Happisburgh
8 May 2025

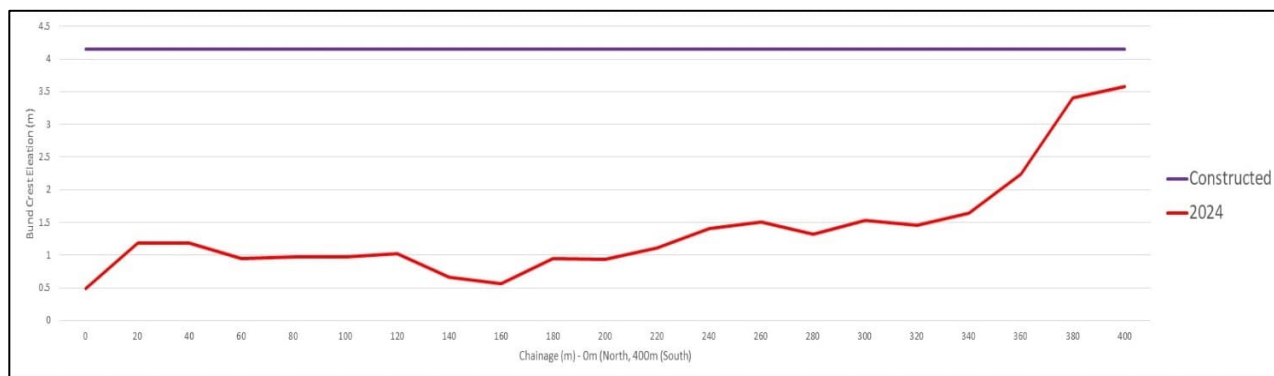
It is understood that the 2019 reconfiguration of the bund was all built to an approximate consistent elevation along its length (estimated to be approximately +4.0mOD). However, as can be seen from LiDAR data below in Figure 3-5, the bund elevation since reduced dramatically along all of the length with the exception of the southern-most end adjacent to the beach access ramp.

Figure 3-5. Reduction in Present Bund Crest Elevation (Note – left to right, chainage 0 is at north end of the bund, chainage 400 is the southern end where the beach access ramp is located)

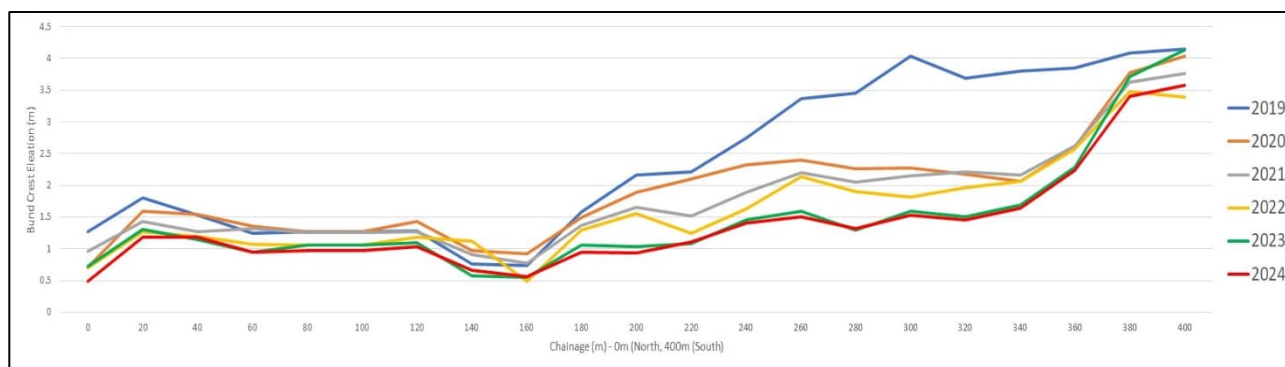
What is particularly notable is how soon the bund elevation dropped. As Figure 3-6 shows, this reduction in elevation occurred in the most part within the first few months (the 2019 LiDAR was conducted in November while the construction of the bund had been completed in January/February). Along the southern half, there was over 2m lowering within just the first few months.

Figure 3-6. Rock Bund Crest Elevation 2019-2024 (present configuration)

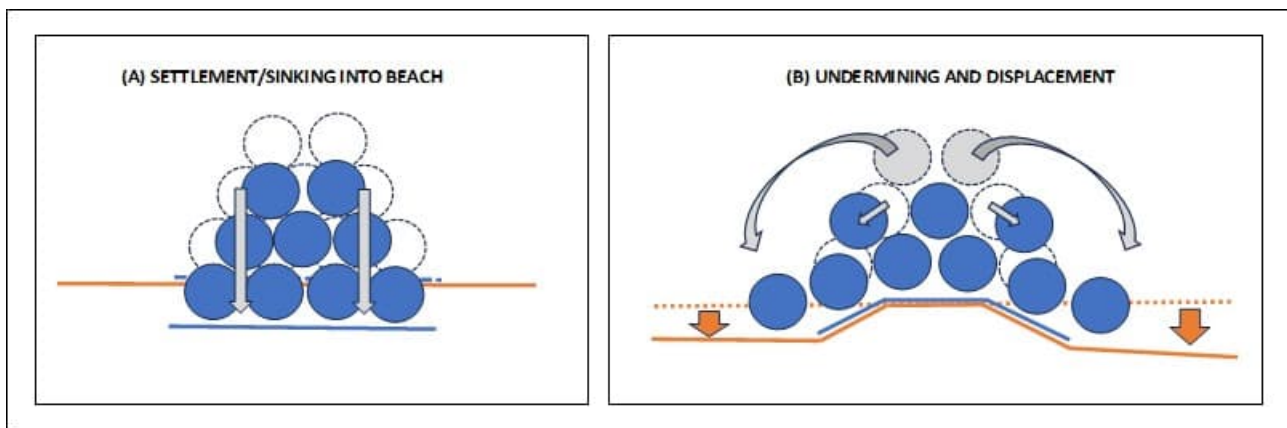
Due to the geotextile beneath the rocks, it is unlikely that the structure simply settled, as illustrated in Figure 3-8 (a) below. Indeed had that been the case then the time for that to occur to the extent shown in Figure 3-7 above would have been much slower than just a few months. What is likely is that, because the bund had to be placed on sand rather than the underlying clay, scouring of the sand at the edges has led to the structure being undermined. As the sand lowered, the edge rocks will have been displaced, leading to those above also becoming destabilised and falling away from the crest, as illustrated in Figure 3-8 (b).

Figure 3-8. Mechanism for reduction in elevation of the Rock Bund

The rock would be best placed directly on the wave cut clay platform (over geotextile) rather than on the unconsolidated sand veneer to restrict or at least slow the rate to which the structure lost. However, the reasons this was not done for parts of the existing (and previous) bunds is recognised. This was due to depth at which the wave cut clay platform is found, which would have therefore required excavating deeper to locate this. This would have also resulted in a lower elevation (or shorter) bund from the outset due to the finite quantities available. Placing the rock directly on the clay would have also been contrary to restrictions that exist due to archaeological/heritage interests (discussed later in Section 5.1.6).

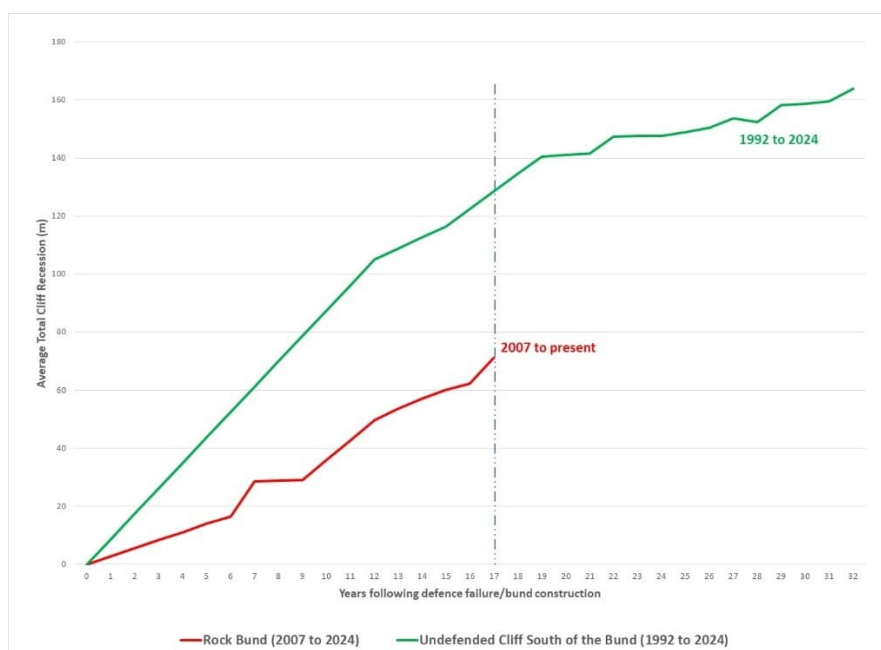
In Figure 4-1 below, the year-on-year recession of the cliffs following failure of the timber revetment to the south of Happisburgh from 1992 onward is shown by the blue line. This indicates an average recession of approx. 9m/year over the initial ten years, falling to an average of approx. 5m/year over the following ten years, and reducing to approx. 2m/year over the next ten years. If the rock berm had not been constructed, then it is reasonable to assume that similar rates of recession would have also occurred along the village frontage following failure of the timber revetment there too. However, the actual recession that has taken place in the 17 years since installation of the full rock bund in 2007, is shown by the red line on the same figure. What this shows is that the rock bund has provided a reduction in recession of up to 50% compared to that which might have been otherwise expected.

Figure 4-1. Comparison of the recession rates of the undefended cliff line and the rock bund defended cliff line (rates averaged over full lengths).

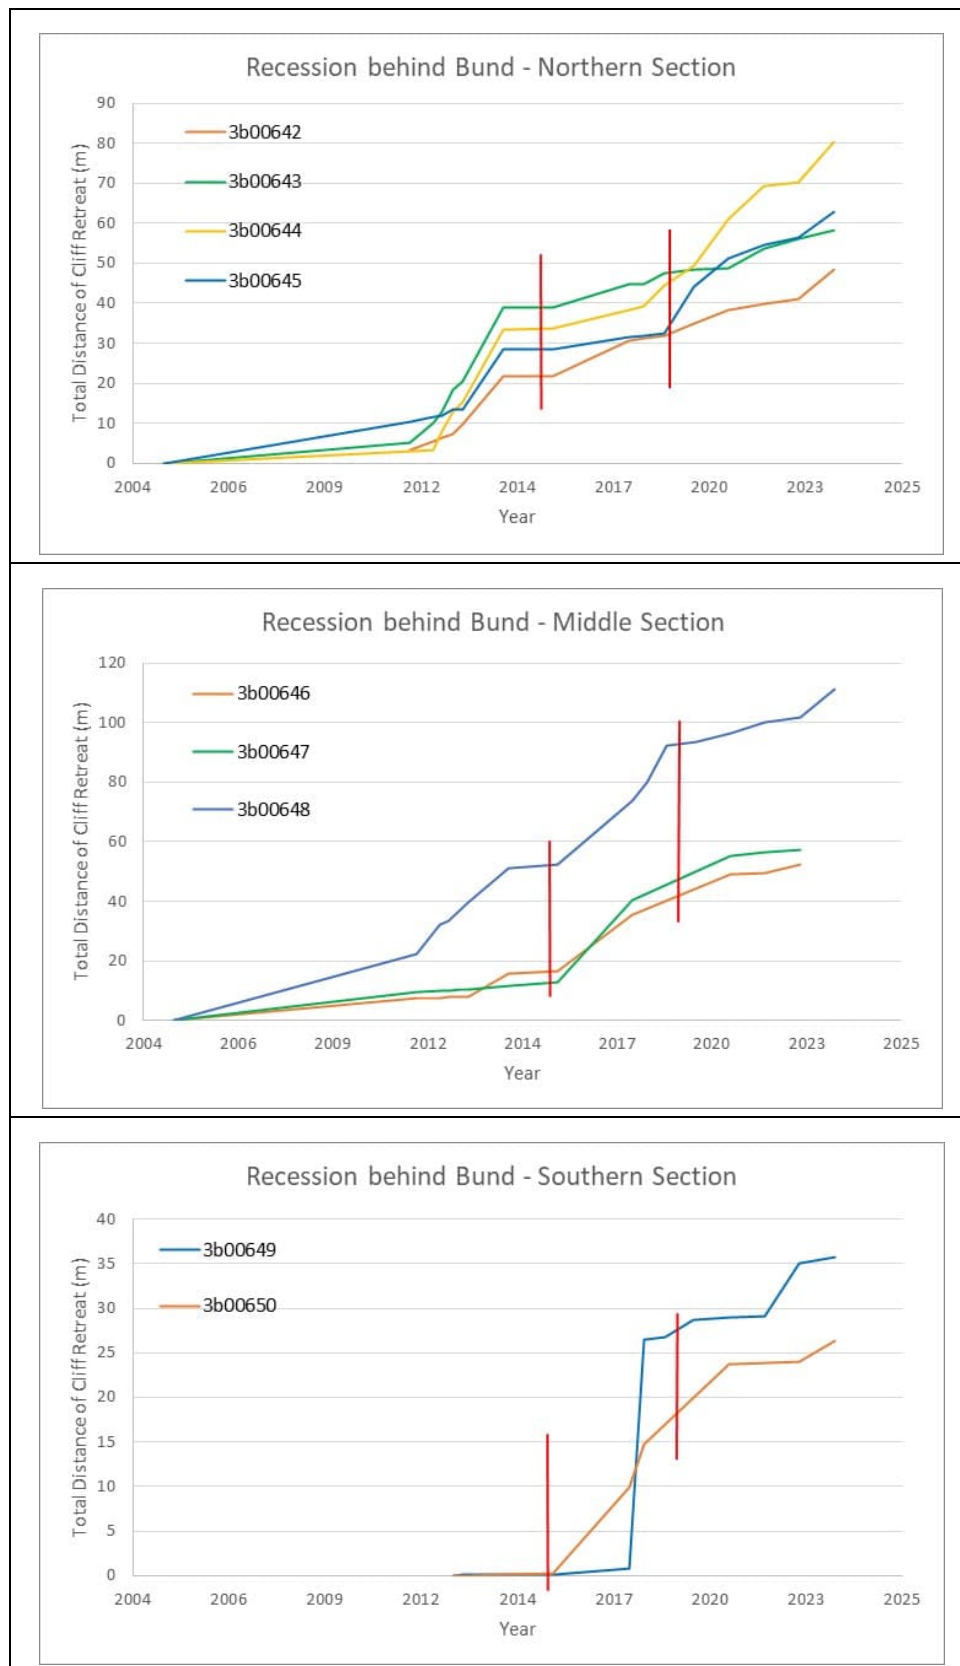
Figure 4-3. Cliff recession behind the rock bund (red lines indicate times of bund reconfigurations in 2015 and 2019, and extension of bund at southern end in 2013)

However on inspection of the recession profiles (Figure 4-3) it can be seen that the erosion patterns are also different through time, which may provide some other indication of bund effectiveness. Irrespective of the differences in total recession extent, along the southern section (transects 642 to 645) there was a marked erosion of the cliffs in 2013, ranging between 12m and 18m. This is where the bund elevation was lowest, typically around +1.0mOD. This is also noted at transect 648 (11m erosion), where the bund was also at a similar level, but not so noticeable in those areas where the bund was at an elevation of +2.0mOD and above. Notably, this significant erosion event coincides with the major storm surge event of December 2013.

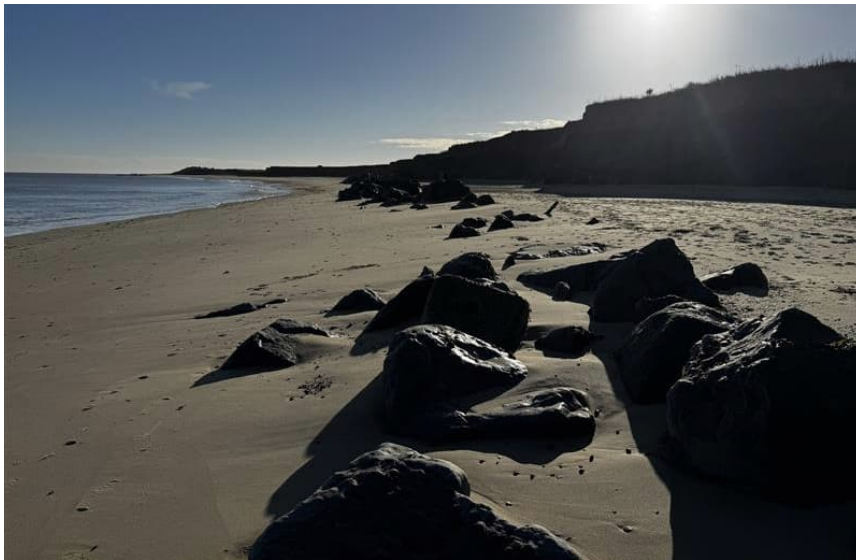
The timeframe for more of that material reaching Happisburgh is not certain, however at the time of the LiDAR being flown (March 2024) and the site inspection (November 2024), beach levels here were certainly higher than had been observed in previous years – see Figure 4-4 (lower) and Figure 5-3 respectively.

Figure 5-3. Southern section of Rock Bund, November 2024.

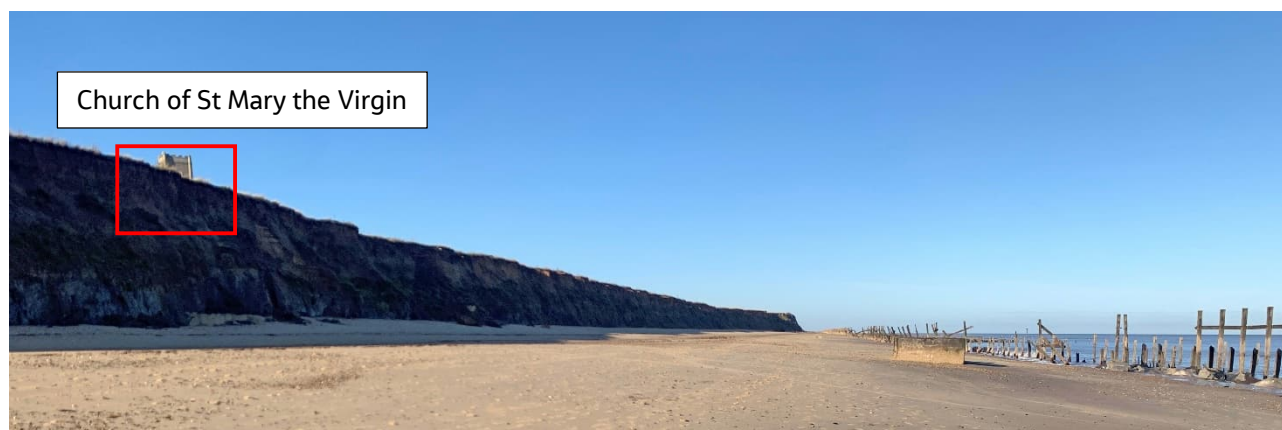
Figure 5-5. Happisburgh Cliffs SSSI (Photo: November 2024)

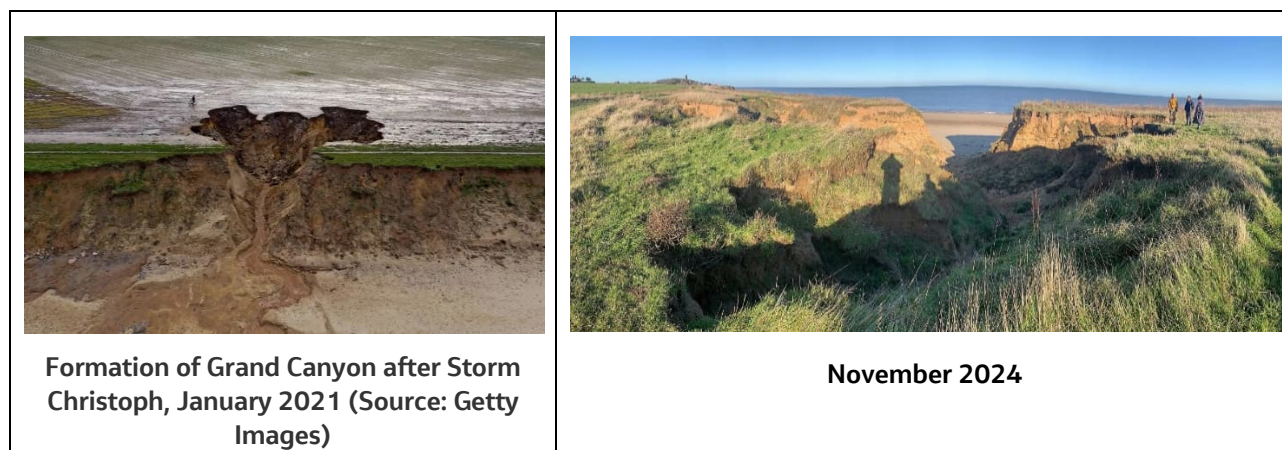
The 'Grand Canyon' now extends approximately 40m inland from the main cliff frontage and spans approximately 50m at its widest point after just four years. It is thought that this was initially triggered by Storm Christoph in the January of 2021, and resulted from an erosion induced 'landslide' (Petley, 2021), which formed a small but ever growing 'gully' feature (Figure 7-4). Certainly surface water runoff has contributed to its development, this being a noticeable low spot in the surrounding field, and there also appears to be sub-surface groundwater running off through this location too.

Figure 7-4 Photographs of 'Grand Canyon' site
