Trafalgar Court Beach Access

Cliff Assessment and Options Appraisal

Prepared for
North Norfolk District Council

Date
September 2014

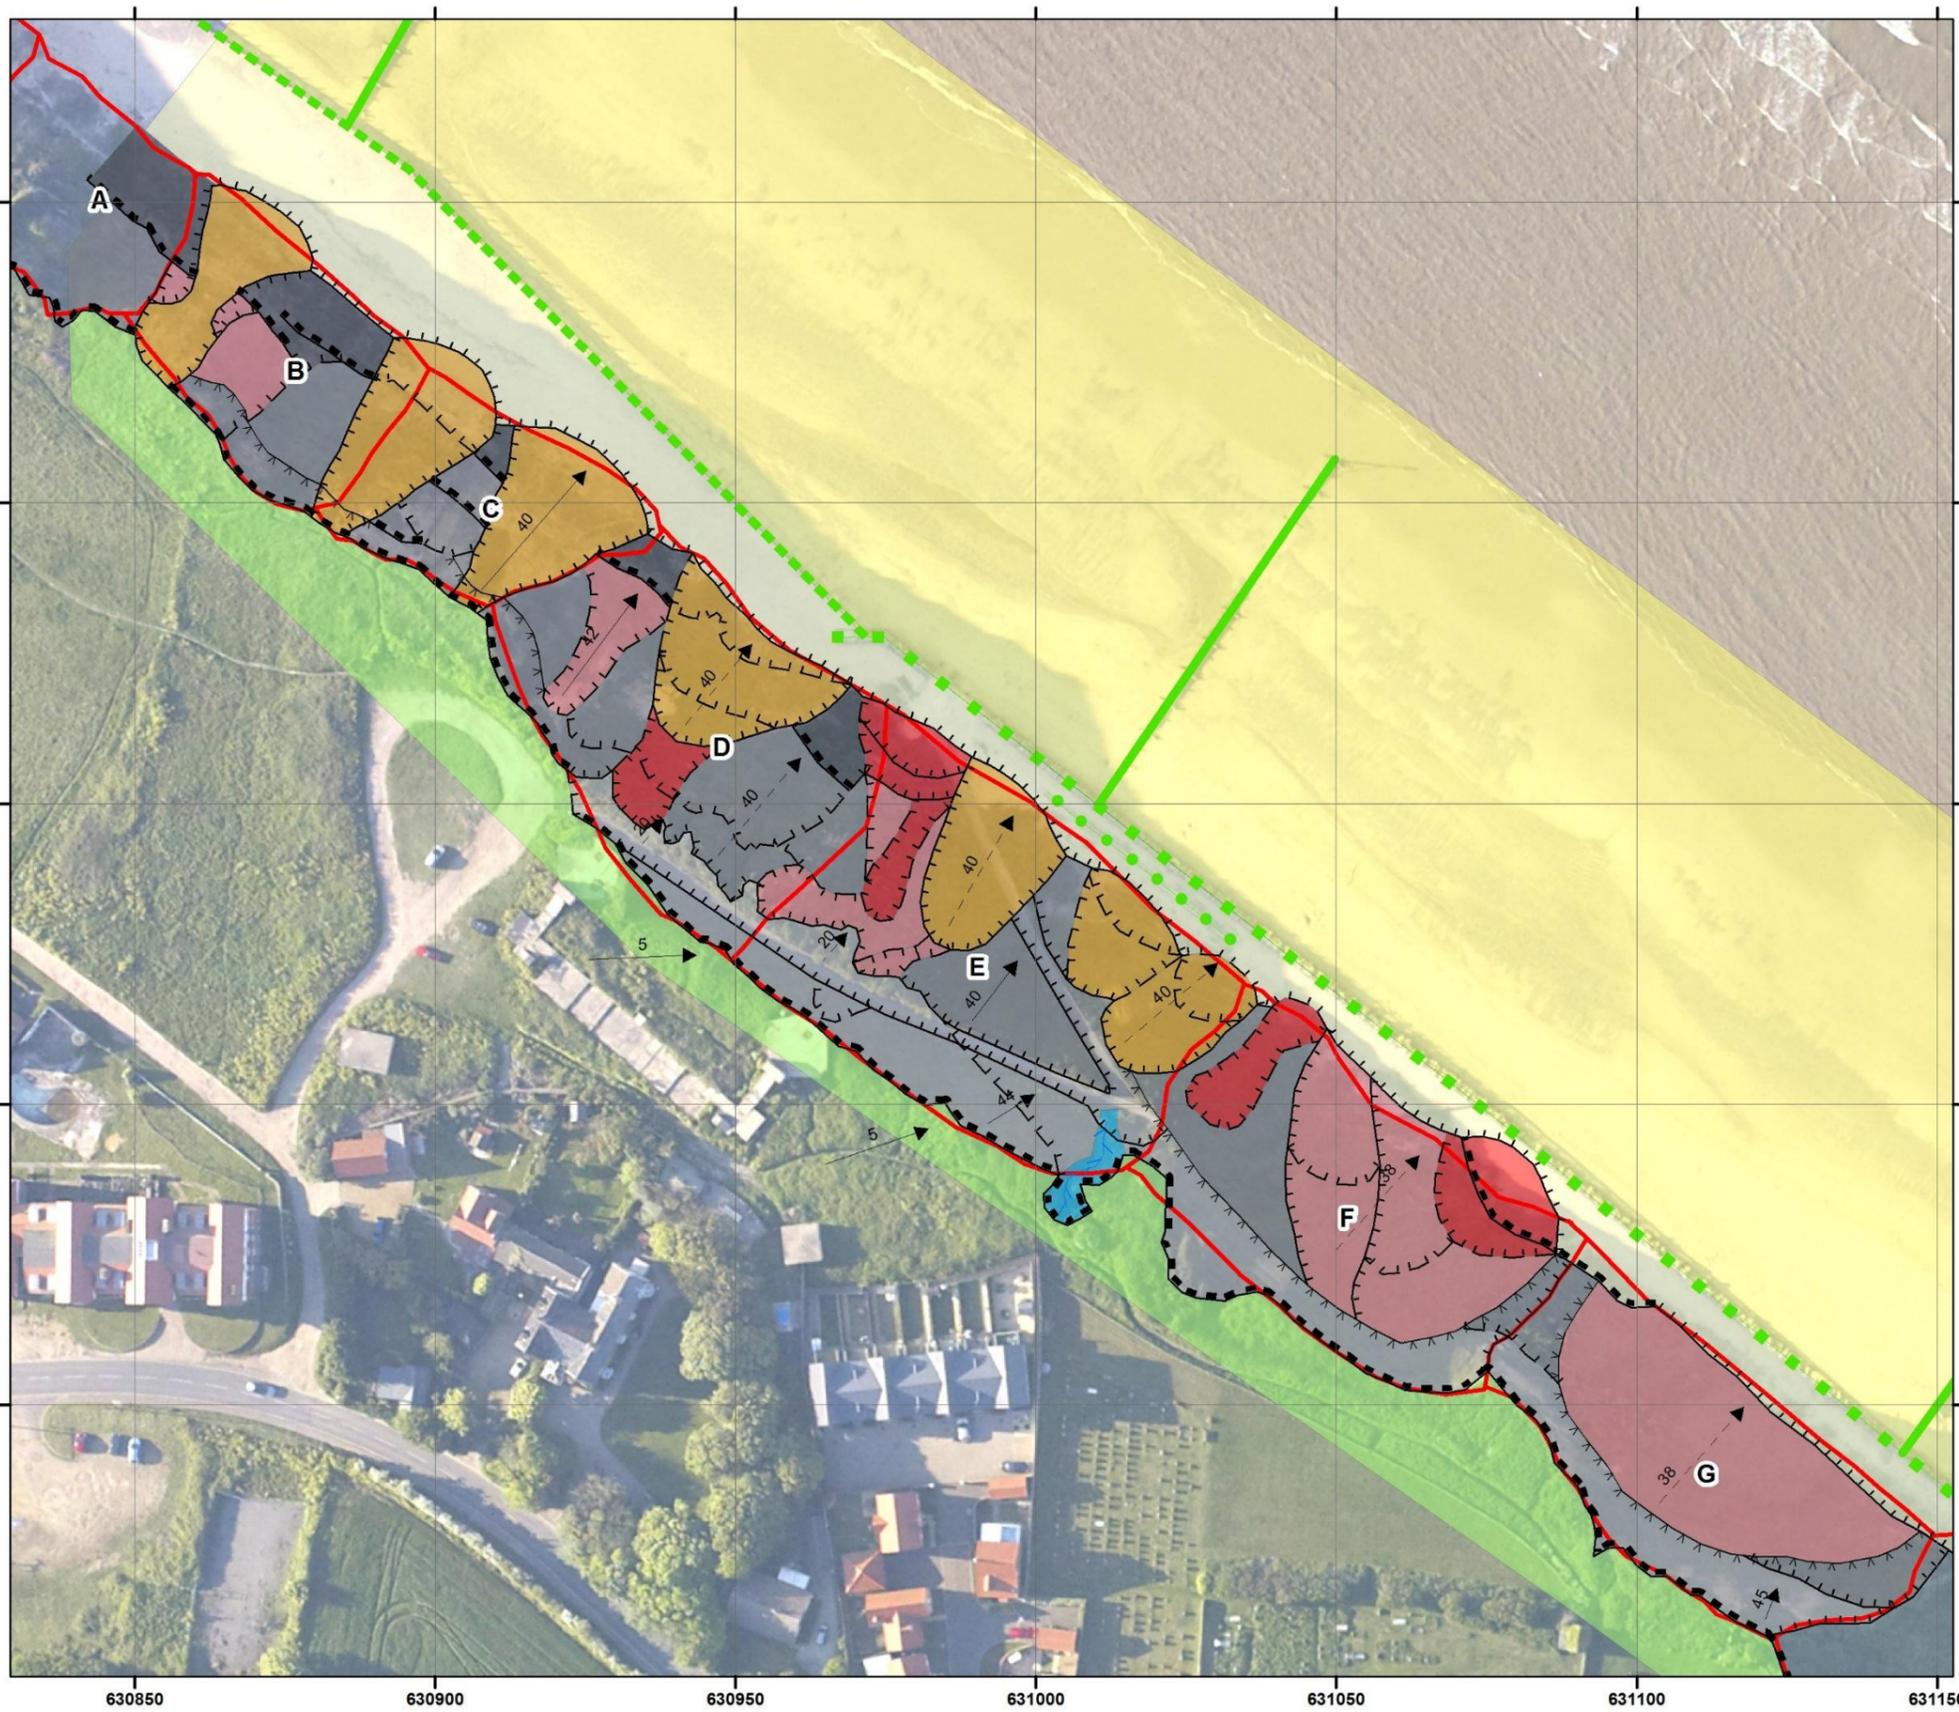
Figure 1 Slope geomorphology

The data highlight that CBU E (Figure 1), which includes the beach access ramp and steps, was marginally active in 1988 but shows inactivity in other time periods. The activity in 2008 that damaged the lower section of the path is not indicated in the closest subsequent imagery from 2010. In contrast, CBU D has consistently shown activity. CBU F does not show any activity in the period 1988 to 2012, but the site visit highlighted widespread evidence for instability (Figure 1 and Table 1).

A site visit to map the cliff geomorphology was undertaken on 31 July 2014. The slope characteristics were measured with a tape and clinometer and were recorded on a 1:500 basemap. The results are shown in Figure 1.

The cliffs northeast of the access ramp, including CBUs A, B, C and D comprise three stratigraphical units with corresponding slope morphology and instability features. The base of the slope is formed of a near-vertical cliff up to 5m high formed of a matrix-supported dark grey sandy clay diamicton containing gravel of flint, chalk and crystalline minerals that is interpreted as Walcott Till. This cliff is failing through debris fall processes and blocks of fallen material are evident on the beach. The main body of the cliff is formed of a yellowish orange sand that is laminated near its basal contact. This is interpreted as Mundesley Sand. It forms slopes up to 40 degrees and is subject to widespread failure through sand falls with well-developed talus cones that extend across the back of the beach and obscure the lower cliff. The upper part of the slope comprises a near-vertical cliff that is c. 2m high and formed in sand and gravel that is susceptible to localised failure by falls and topples. This upper unit was not clearly exposed due to vegetation and instability, and may be either the Bacton Green Till or the Briton's Lane Sand and Gravel.

The cliffs of the Trafalgar Court access ramp (CBU E) comprise two stratigraphical units with corresponding slope morphology. The Walcott Till was not observed here and is assumed to be below beach level and/or obscured by talus. The majority of CBU E is formed in Mundesley Sand that forms steep slopes of 35 to 40 degrees. The lower half of Mundesley Sand slope is affected by debris falls that are typically 20m wide, up to 30m long but rarely more than 1m deep. These features are likely to have been triggered by toe erosion during the storm surge and have undermined the lowest section of the footpath and threaten other parts of the path. The upper part of the slope is well-vegetated, but shows evidence for former mudslide activity in the form of linear tracks and relict mudslide embayments. The upper slope unit is cut in sands and gravels (Britons Lane Sand and Gravel or Bacton Green Till).

Where this slope appears below the footpath, it lies at an angle of less than 25 degrees and is indented by a series of gully heads that were dry during the visit. One of the gullies that lies at the apex of the path is up to 1m deep and cuts to the top of the cliff. Above the footpath the slope is very smooth with an angle of over 40 degrees. This section is likely to be a cut slope dating from path construction after World War 2.

The cliffs to the southeast, comprising CBUs F and G, comprise c. 60 m wide mudslide embayments that have 35 to 40 degree slopes, and a c. 45 degree upper cliff up to 2m high. The mudslides have formed in till and sand and the cliff shows widespread evidence of instability including active and relict mudslide and recent toe erosion to form near-vertical cliffs fronted by recent debris accumulations.

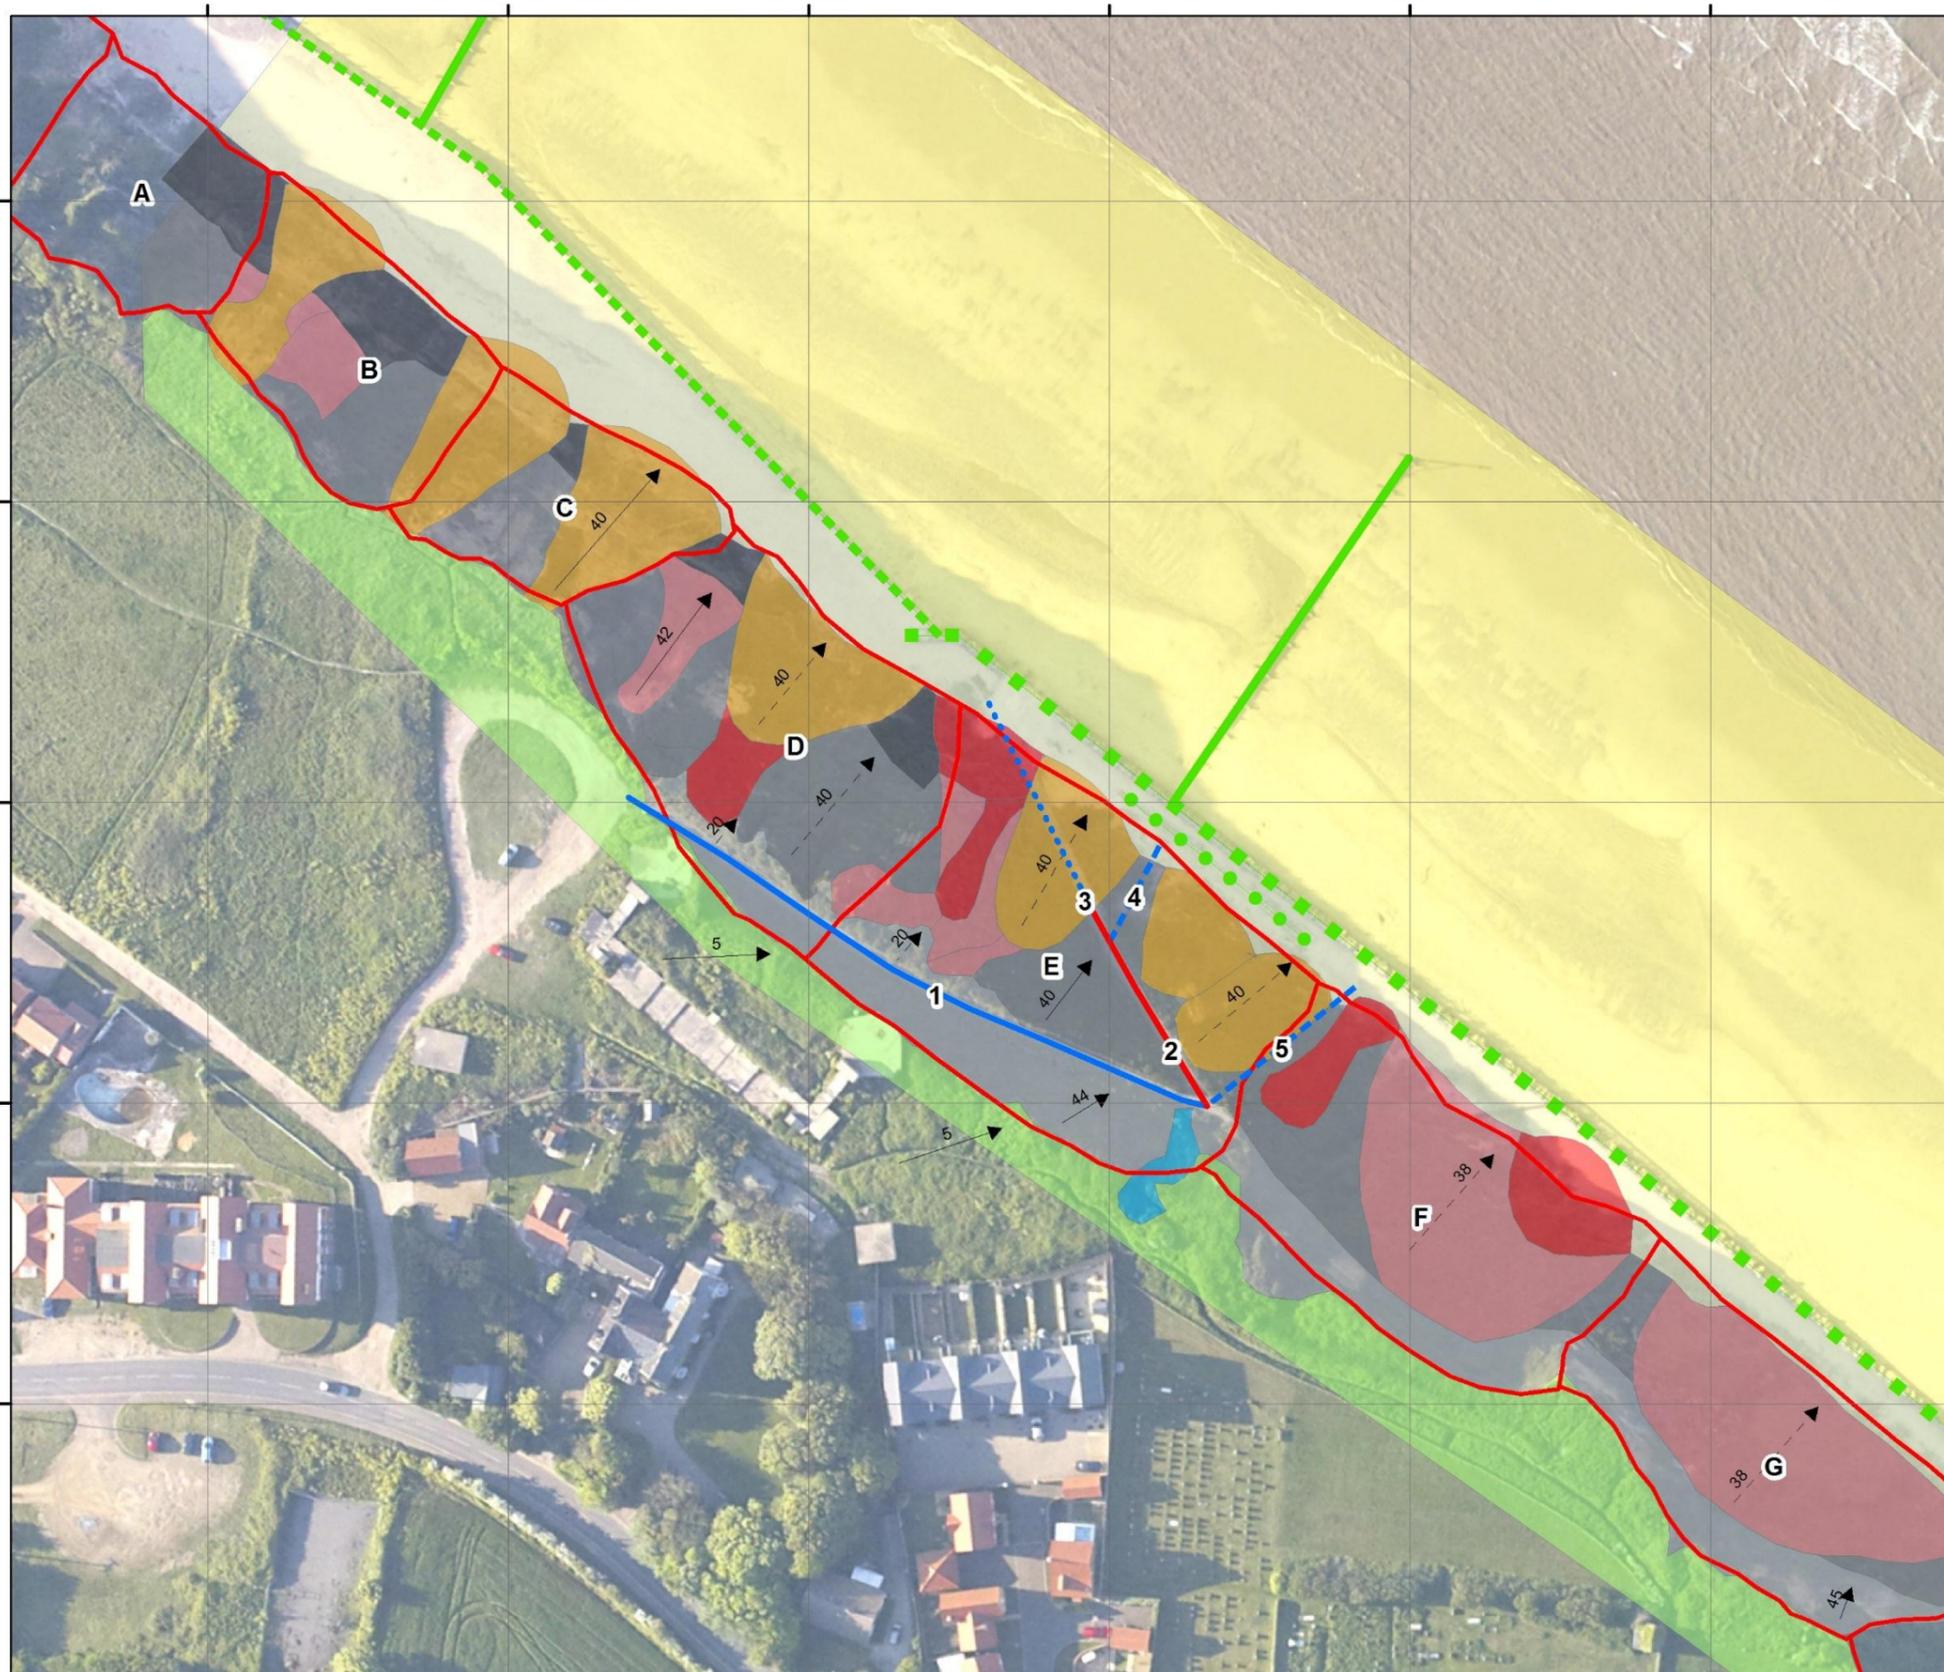
Figure 2 New pathway options

The upper section of the existing path, labelled 1 on Figure 2, is considered to be sound, and is likely to have a lifespan of at least 20 years with minor maintenance and with repair of the lower slope. It is therefore recommended that this 110m long section be retained. The remaining 38m long section of the lower path that has not been lost to erosion (labelled 2) is at risk due to loss of support from the underlying slope and therefore its lifespan cannot be guaranteed in the short-term. However, this section of path can be stabilised by reinstating the lower slope and need not be abandoned.

The options are presented on Figure 2 and comprise the following:

- Option 1 – remediate existing lower section of path
- Option 2 – remediate part of the existing lower section of path with a short stair to the beach
- Option 3 – abandon the lower section of path and construct a long stair to the beach

Option 1 comprises construction of a gravity structure to support a replacement section of footpath to beach level (1a) and reinforcement of the existing section of path that is affected by undermining (1b). The gravity structure may comprise a gabion basket wall, or a crib-lock wall that comprises a timber lattice with stone infill similar to that shown in the photograph. Depending on the precise design requirements, the structure could be founded on a concrete foundation to accommodate any projected beach lowering. The structure would enable the reconstruction of the footpath along the same the alignment and also provide additional erosion protection. It is presumed that the structure will need to support the new backfill and footpath but not the cliff, which does not include deep-seated instability features, and therefore its construction should be relatively slender. Reinforcing the existing, undermined section of path could involve use of short soil nails with localised hard facing and granular fill, or additional gabion baskets. Both options would include soil netting and seeding to limit erosion by surface water runoff. While the principal method of toe erosion protection would be the existing gabions, but both gravity structure options would afford some protection against storm surges, particularly if soil netting was used and vegetation became well-established.

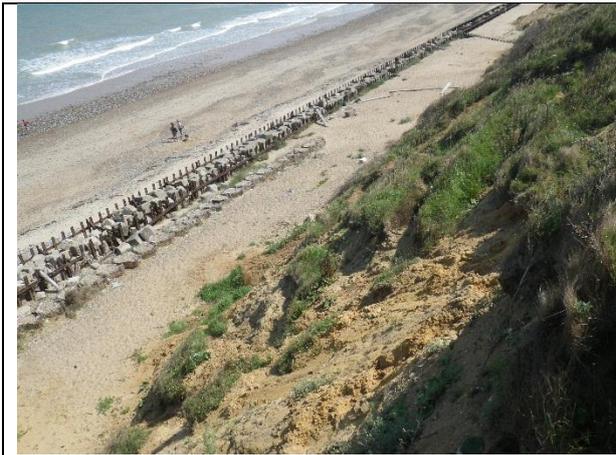
Boulder-fill baskets protecting the cliff toe at Trafalgar Court access

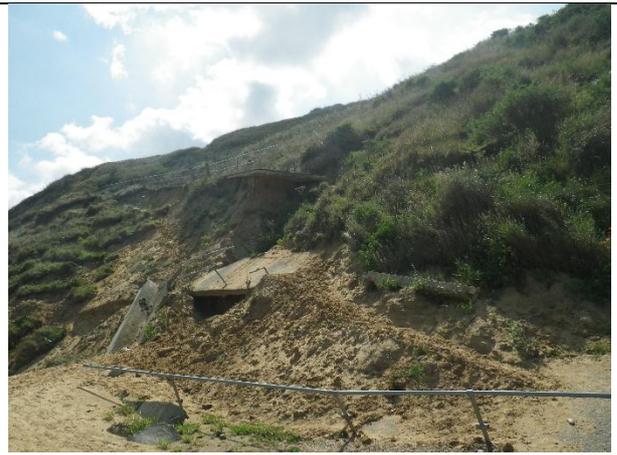
Details of the lowermost section of footpath lost in the December 2013 storm surge. Note the geology here is Mundesley Sand

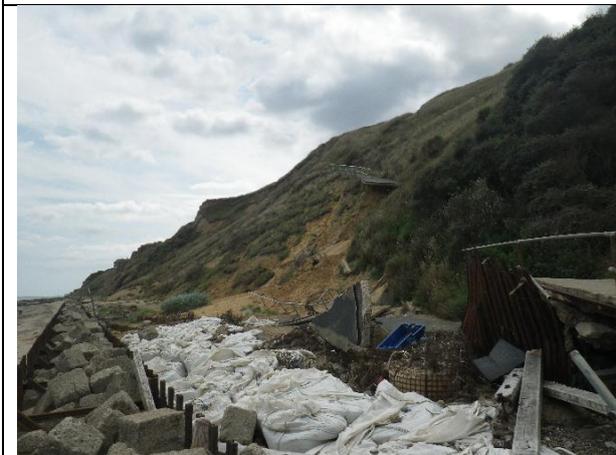
Overview of the lowermost section of path showing undermining of remaining section and toe defences of gravel-filled bags

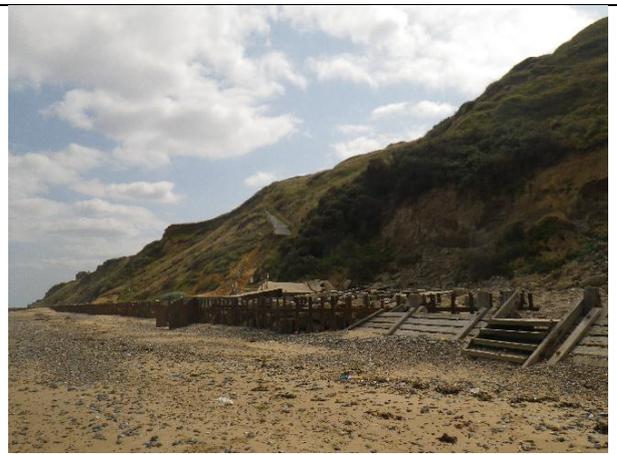
Overview of the northern section of the site showing transition from boulder-filled gabions to detached palisade fence

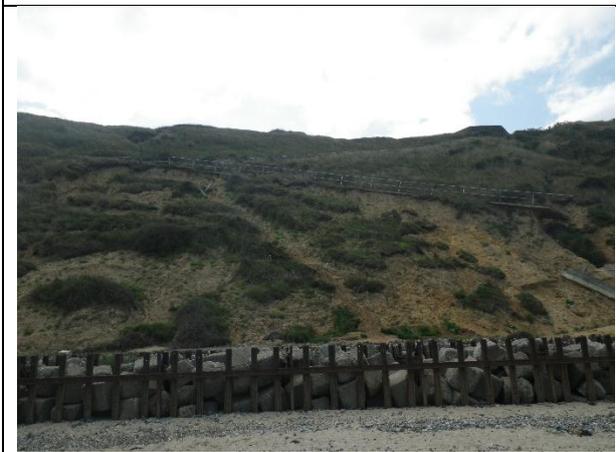
Shallow instability features triggered by toe erosion that are undermining of the lower path.

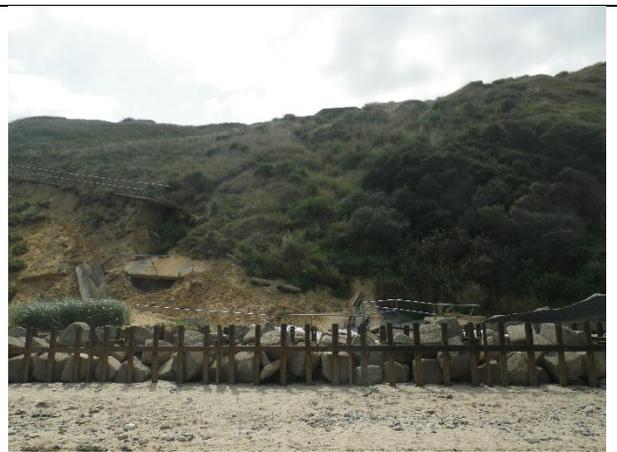
Detail of the lost section fo path caused by toe erosion of Mundesley Sand

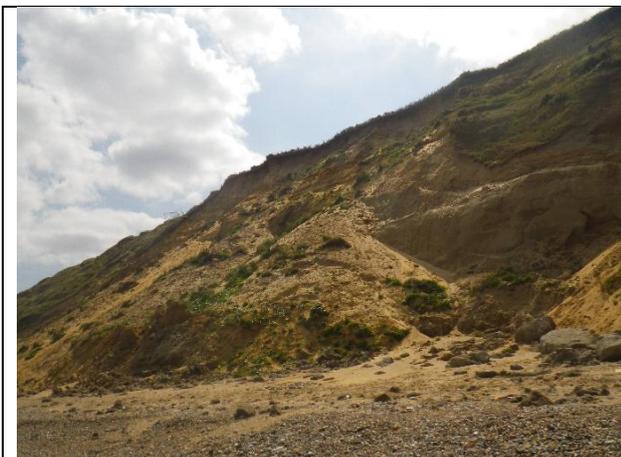
CBU north of the access ramp showing steep cliff and debris falls.

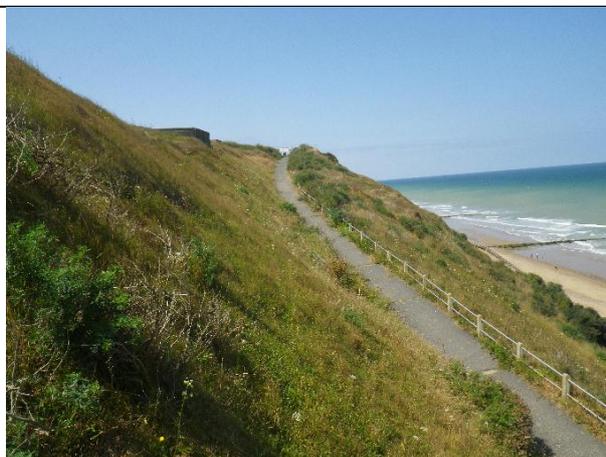
The upper section of path is in a good state of repair. It shows some evidence for settlement, but cracks are minor and easily repairable. The adjacent slopes are steep, but show no evidence of instability. With minor maintenance to the pavement, this section of path is considered to have a life of at least 20 years.

Overview of the upper section of path showing stable slope and footpath in good condition.

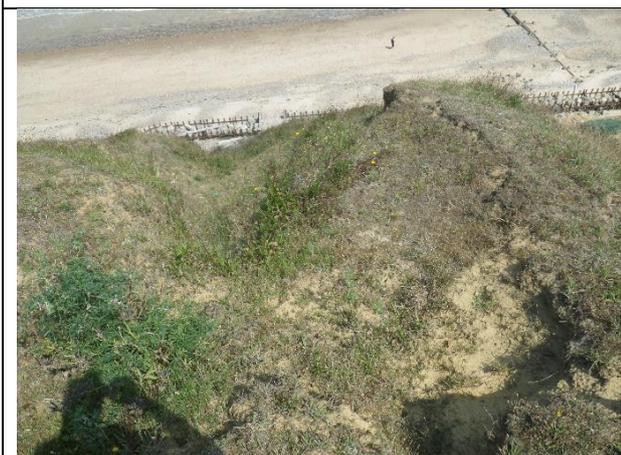
Detail of relict mudslide embayment between the upper and lower sections of path.

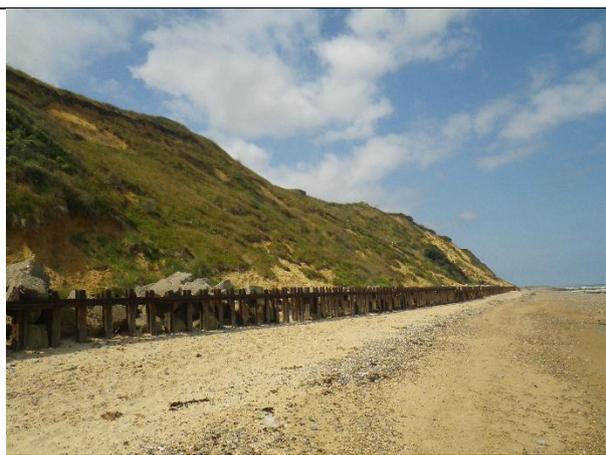
CBU south of the access ramp showing steep slope and localised reactivation of mudslide debris

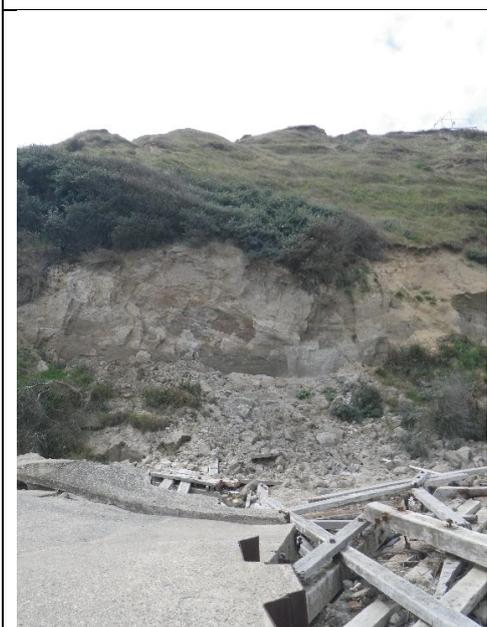
Walcott Till below the Mundesley Sand where the path formerly reached beach level. This unit crops out below beach level in the vicinity of the path

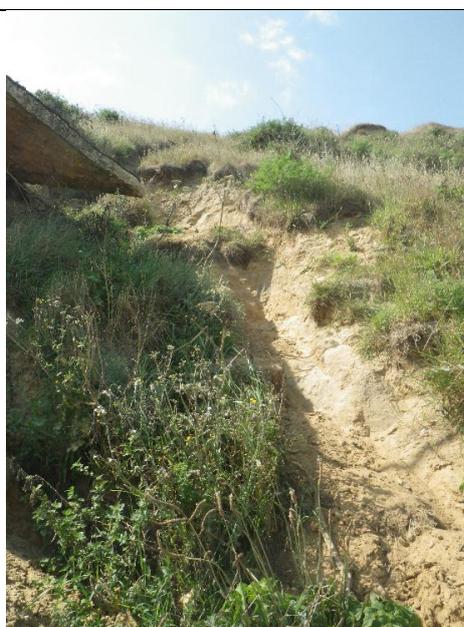
Mudslide embayment that led to loss of the lower-most section of footpath
