## **Document 8 – Clifton Way, Overstrand Coast Protection Scheme**

# **GEOTECHNICAL AND OTHER ASPECTS OF THE OVERSTRAND COAST PROTECTION SCHEME**

**PETER FREW, CEng MICE**  
**North Norfolk District Council**  
**STEVE GUEST, CEng MICE**  
**Rendel Geotechnics**

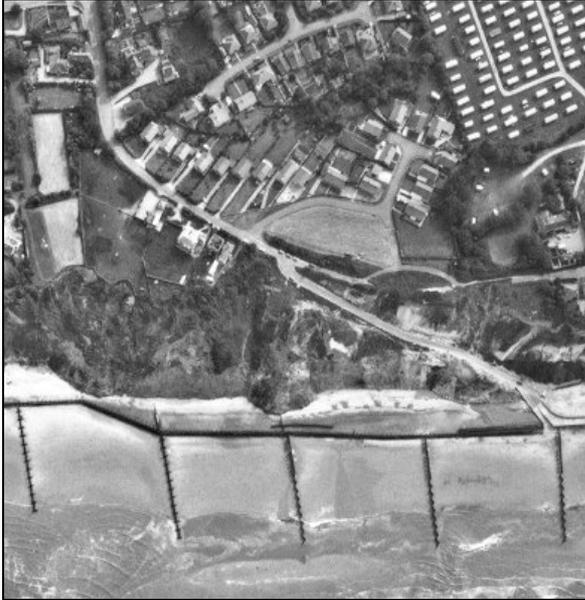
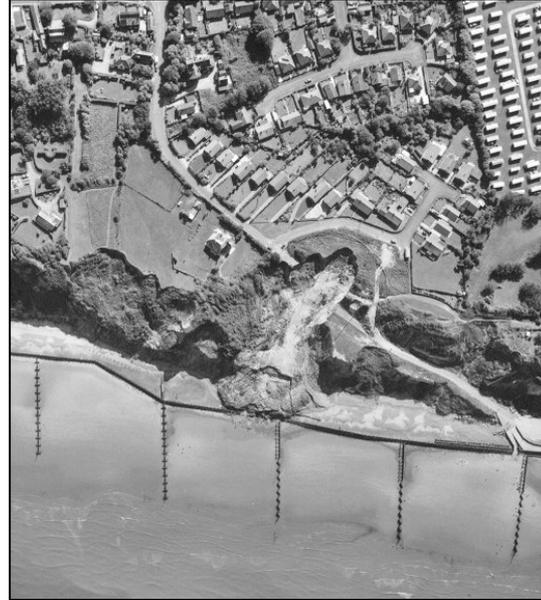
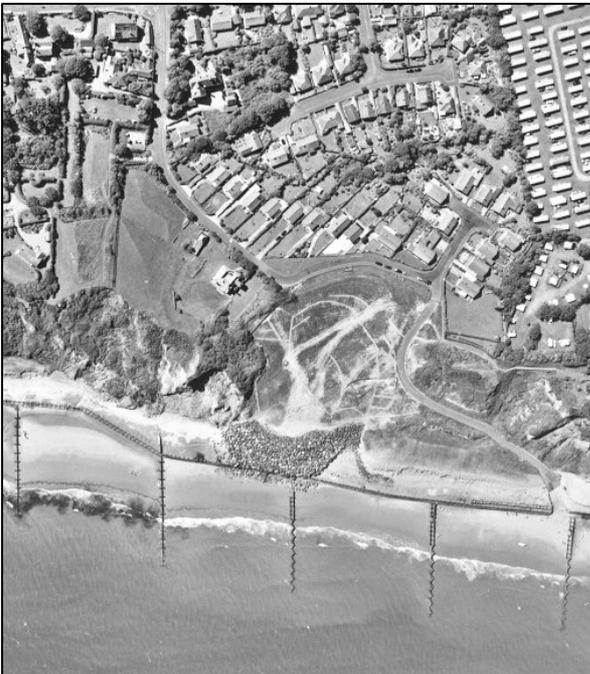
The top left photograph shows Clifton way in 1986 before the major failure occurred. The top right photo is from 1994 and shows the extent of the failure at that time. The photo on the left was taken in 2000, approximately 5 years after the site was stabilised. The rock armour is clearly visible at the toe of the slide and many of the surface drains can also be seen.

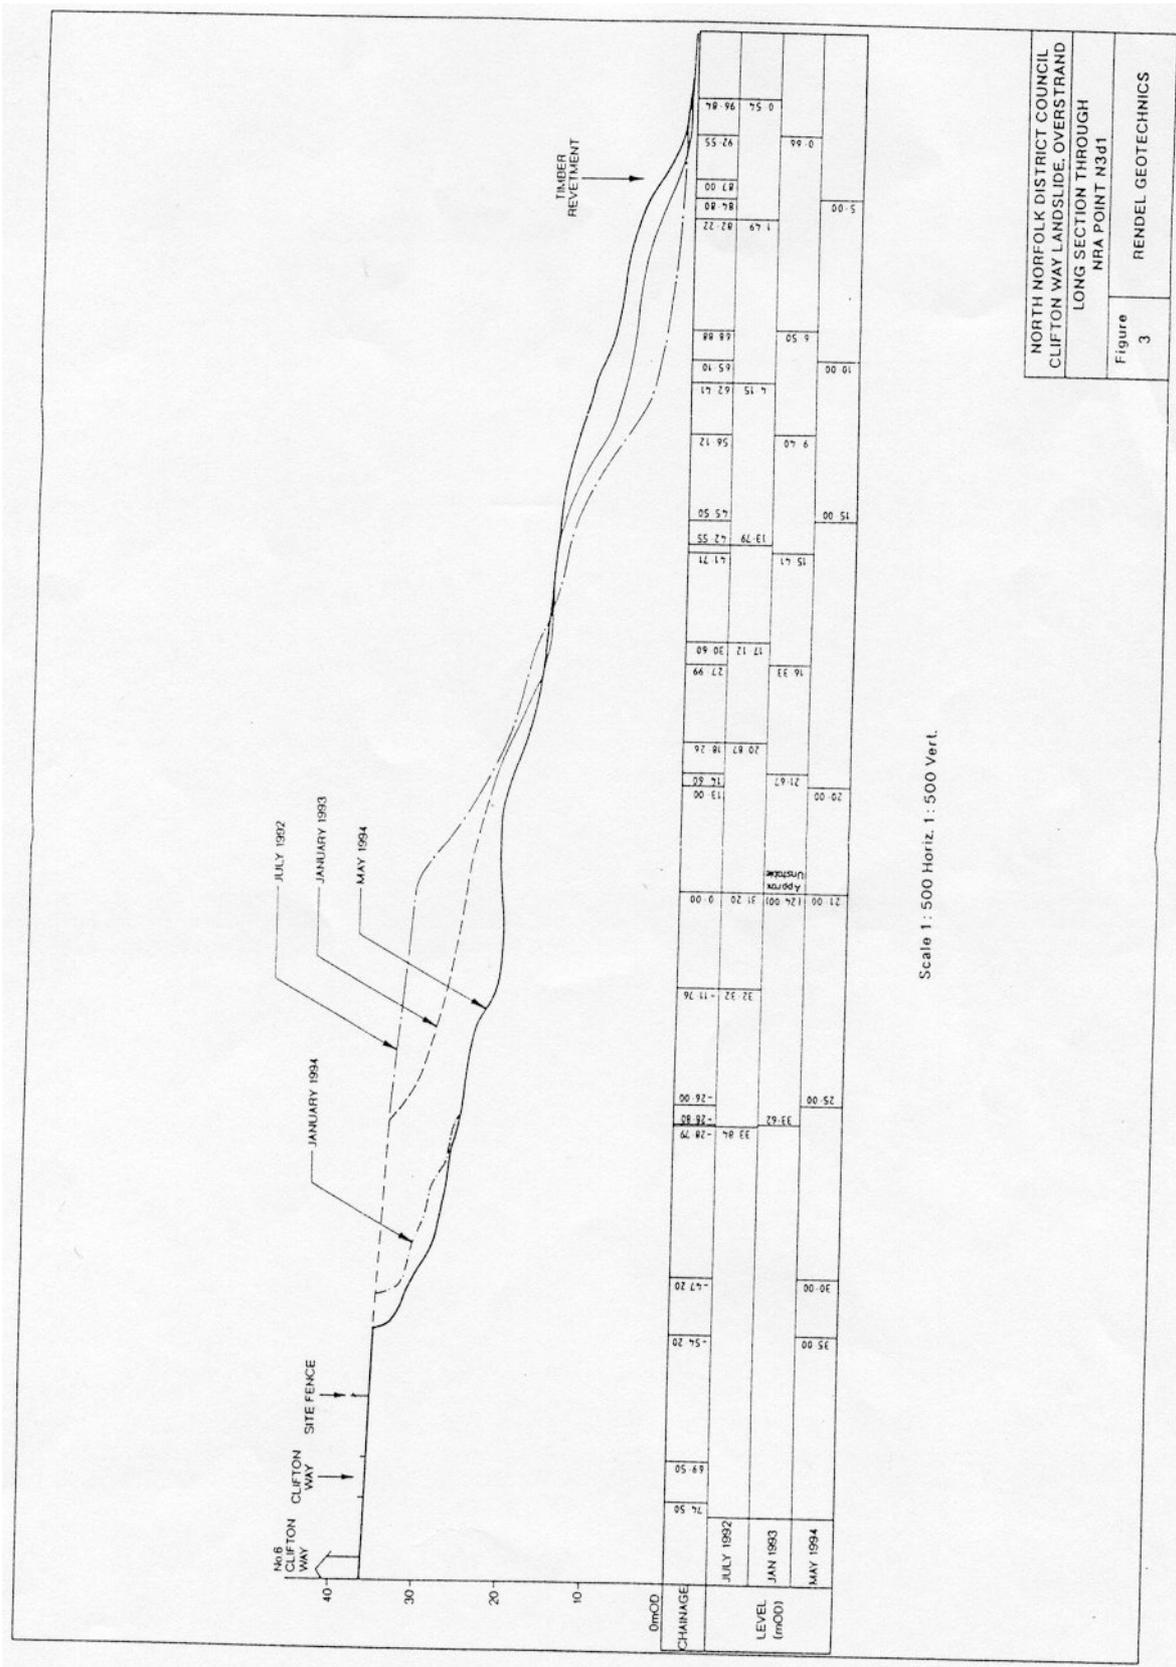
Figure 3 - Cross Section Through Slip

Overstrand is a village of 1100 people situated on 35 metre high cliffs on the North Norfolk coast (**Figures 1 & 2**). There is a long history of cliff failure and coastal erosion, not just at Overstrand, but all along the 34km section of coast for which the Council has responsibility. The need for a coast protection scheme at Clifton Way followed a series of cliff failures. The first occurred in May 1990 and was followed by further failures in November 1992 and January 1994. This last failure severed the 225mm diameter public sewer serving 60 houses and a school. Anglian Water installed a temporary pumping station and main. Approximately 85-90 metres of land was lost as a result of the failures and further failures were expected if no works were implemented. Indeed another 20 metres were lost immediately prior to works starting in March 1995. By this stage the eroding cliff edge was only 5 metres away from the roadway and another failure would have led to the loss of the road and services and the properties they served would have been declared unsuitable for habitation (**Figure 3**)

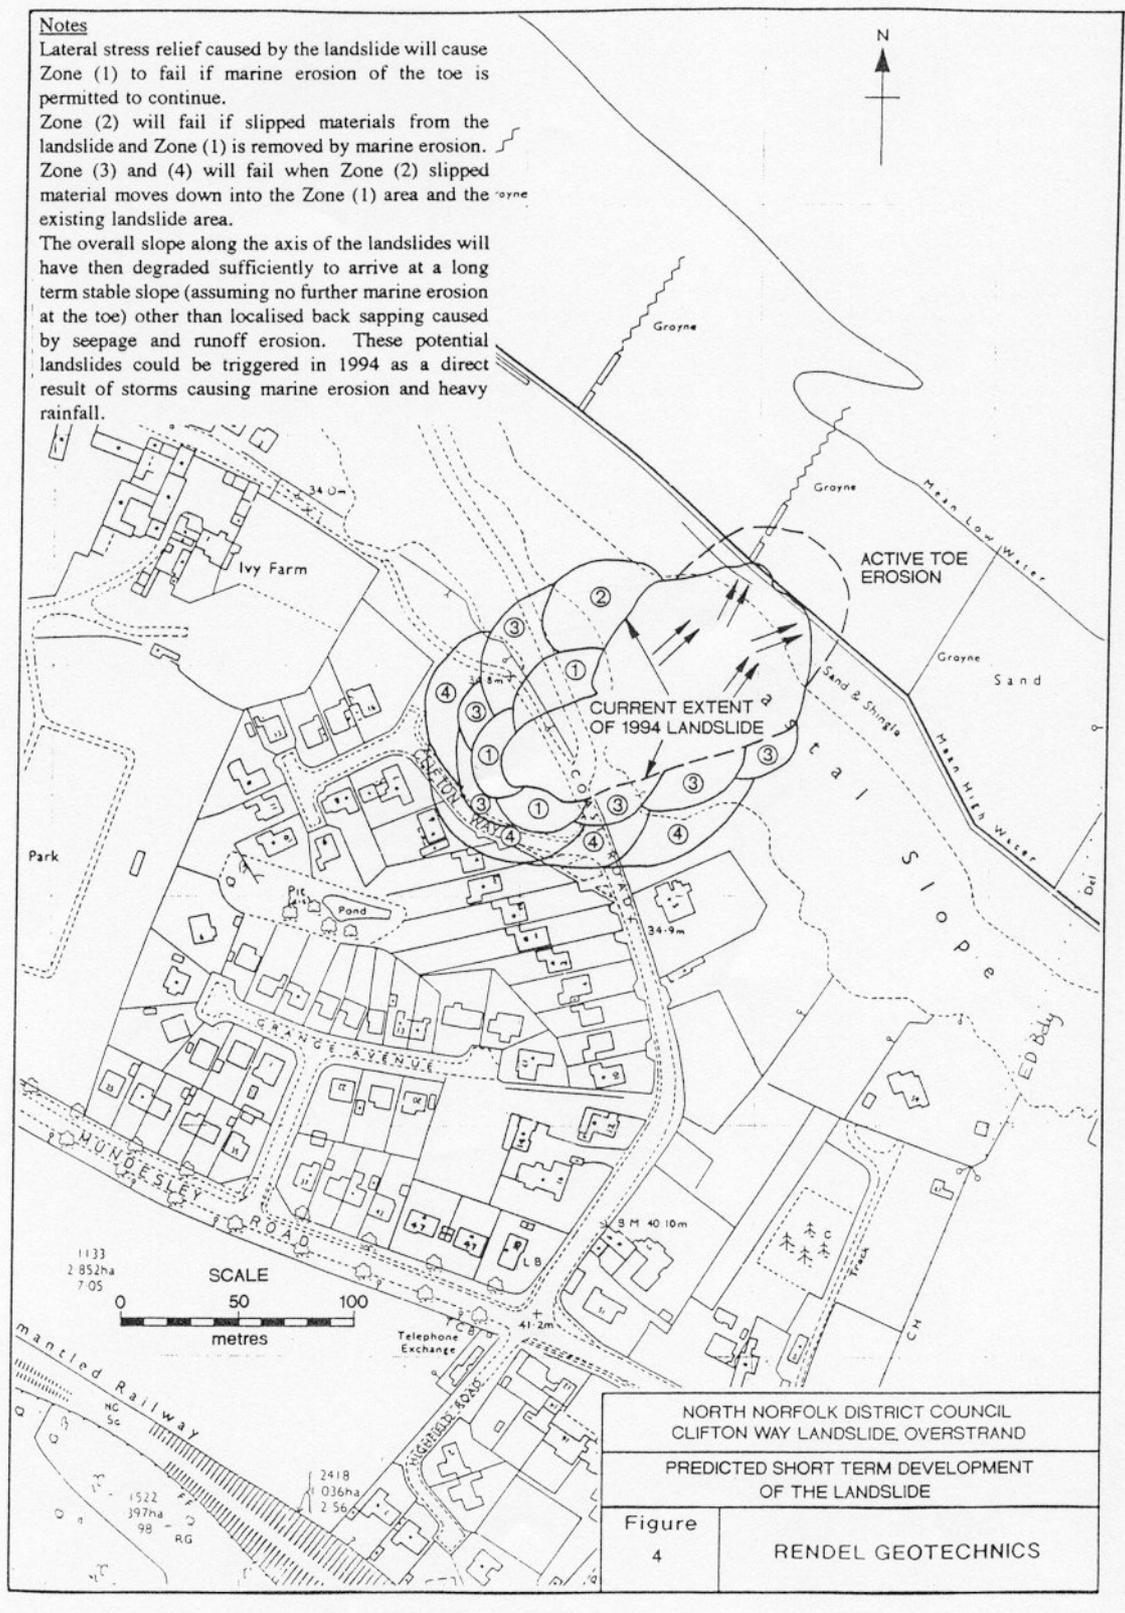
Figure 4 - Projected Development of Landslide

Unusually, at the Overstrand site, there were three separate failures in three and a half years with an overall recession of the cliff top of about 90m. While the first in May 1992 only led to the temporary loss of a maintenance access road, the third, in January 1994, posed a serious threat to domestic property on the cliff top. The failures appeared to have been initiated by a combination of localised high groundwater and the presence of large irregular blocks of laminated clay in a silty clayey sand matrix and led to the slipped material flowing out over the beach. The autumn and winter of 1993/4 had been characterised periods of heavy rain with considerable flooding. By mid 1994 a small section of the access road from the cliff top had moved over 100m and been deposited on the beach having been first displaced in a failure in November 1992. The failure exhibited many features strikingly similar to the Holbeck landslide at Scarborough in 1993. Further substantial failures were predicted if no action was taken (**Figure 4**).

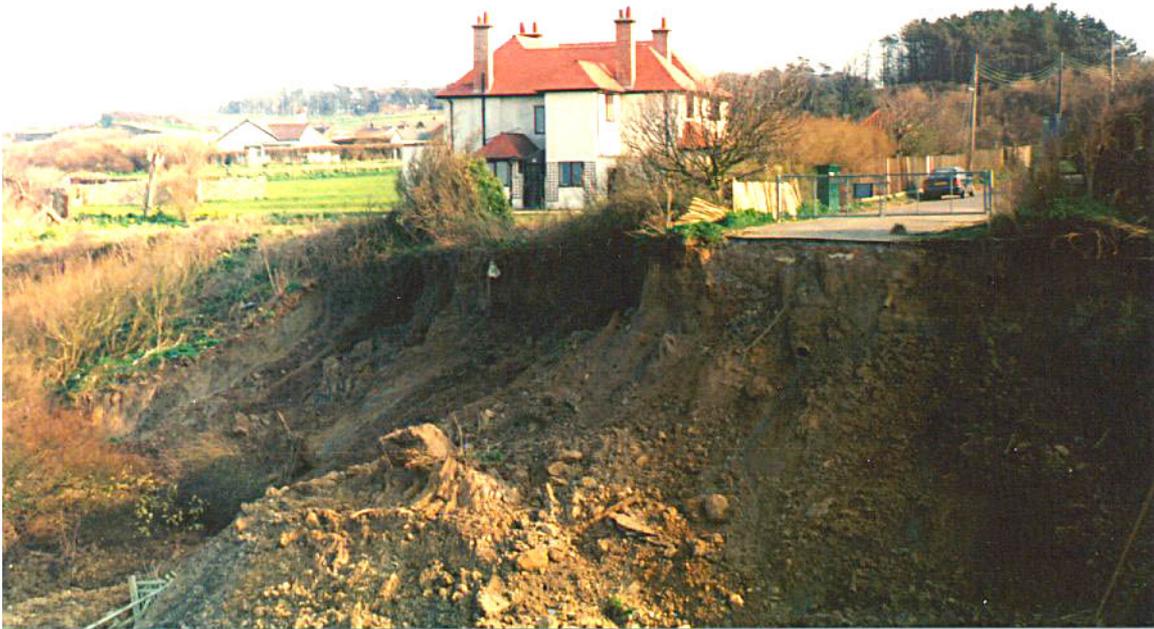
**Figure 7** - The Old Coast Road Before Works Commenced

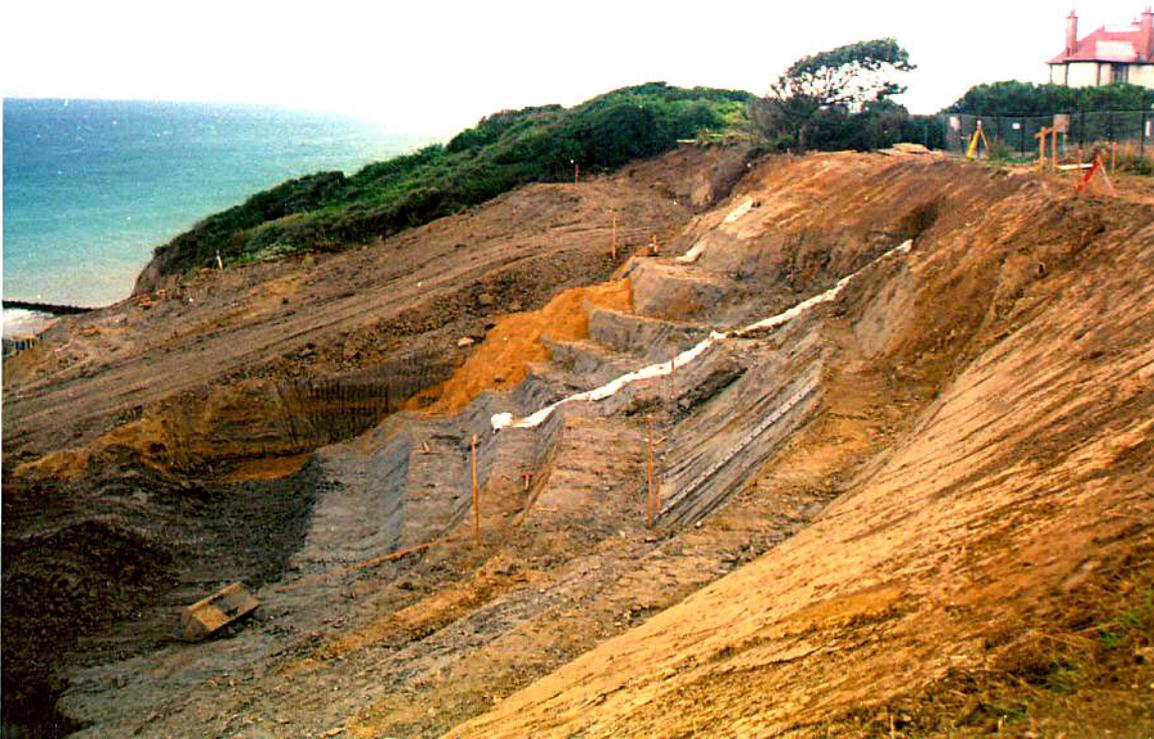
**Figure 8** - Benching of Earthworks and Installation of Under Drainage

Within the main body of the slip, excavation of the debris to below the level of the slip plane commenced at the same time as the toe works. The general sequence adopted by the Contractor was to excavate material working down from the top of the slope, cutting benches into the intact soil below the level of the slip plane as the excavation proceeded down the slope. Upon completing the excavation in a given area a drainage blanket was placed and filling operations commenced. Where potentially more permeable horizons were exposed in the formation, i.e. sand layers, unpiped french drains were installed beneath the drainage blanket to provide additional flow capacity. The earthworks operations progressed in sections across the site from east to west.

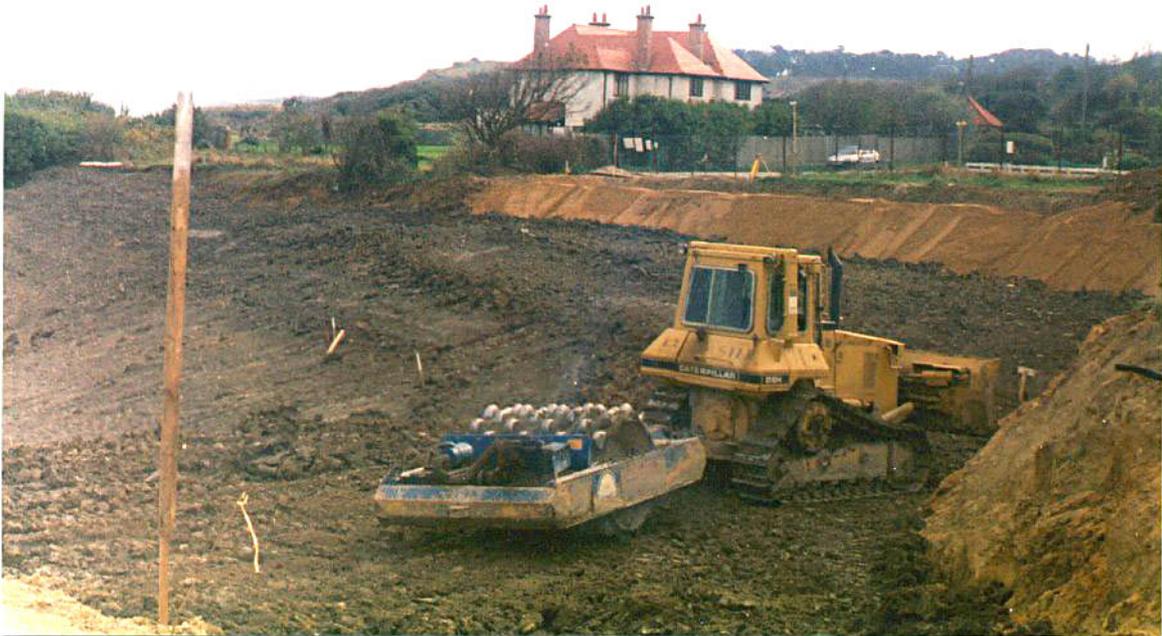
**Figure 9 - Earthworks Nearing Completion**

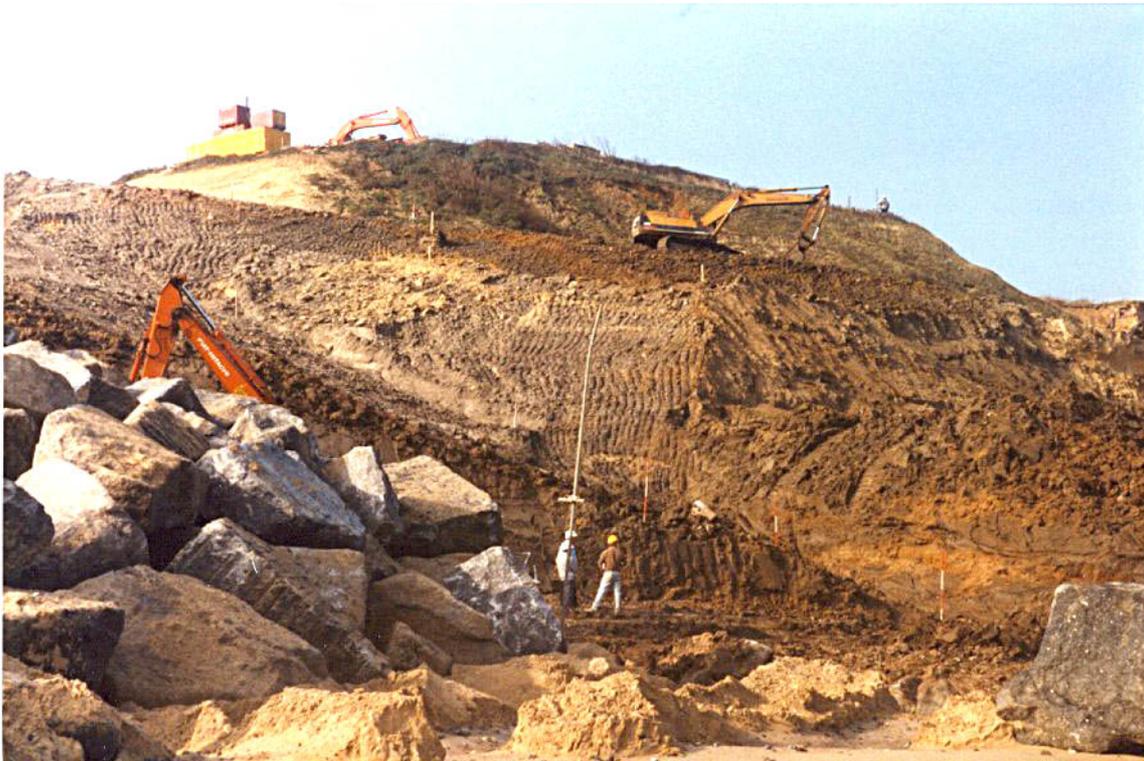
**Figure 10 - Rock Armour Toe Protection Works**

Removal of the slip debris was carried out in stages. The surplus material was placed along the cliff toe to east and west of the site. Excavation was extended downwards through the slip material and the underlying beach in to the stable beach material about 1.5 metre below beach level. As each panel of material was removed it was replaced with the rock armour. This incremental approach meant that the normally routine activity of placing the armour took 3 months to complete.
