Overstrand to Walcott

Defence Condition Survey

**Interim Report
October 2003**

This report describes work commissioned by North Norfolk District Council whose representative was Mr Peter Frew. The HR Wallingford job numbers were CDR3212 and CDR3214. The work was carried out by Mr Peter Lawton of St La Haye Consulting Engineers. The HR Wallingford project manager was Mr Paul Sayers.

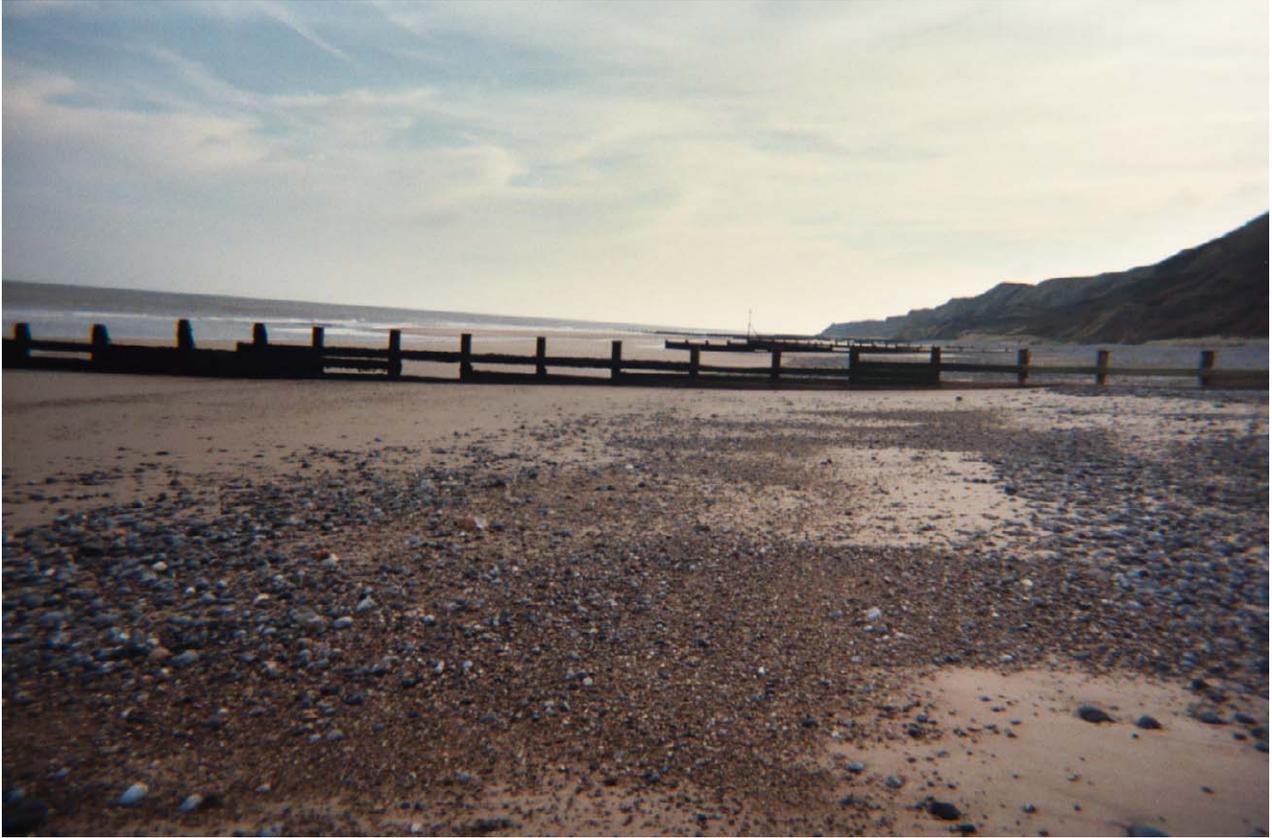
Plate 2.1 Photo P22 View along beach to east showing groynes D2, D3, D4

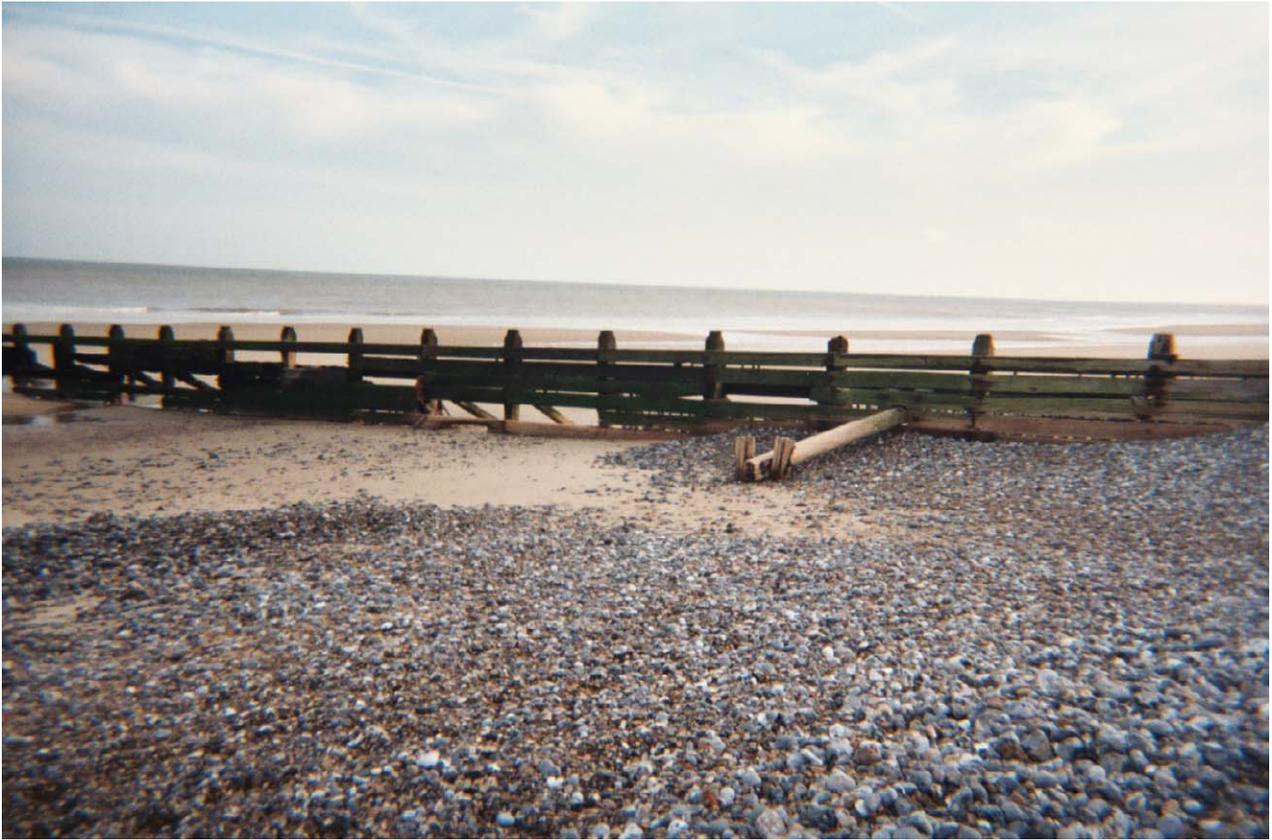
Plate 2.2 Photo P21 Groyne D5 (0)

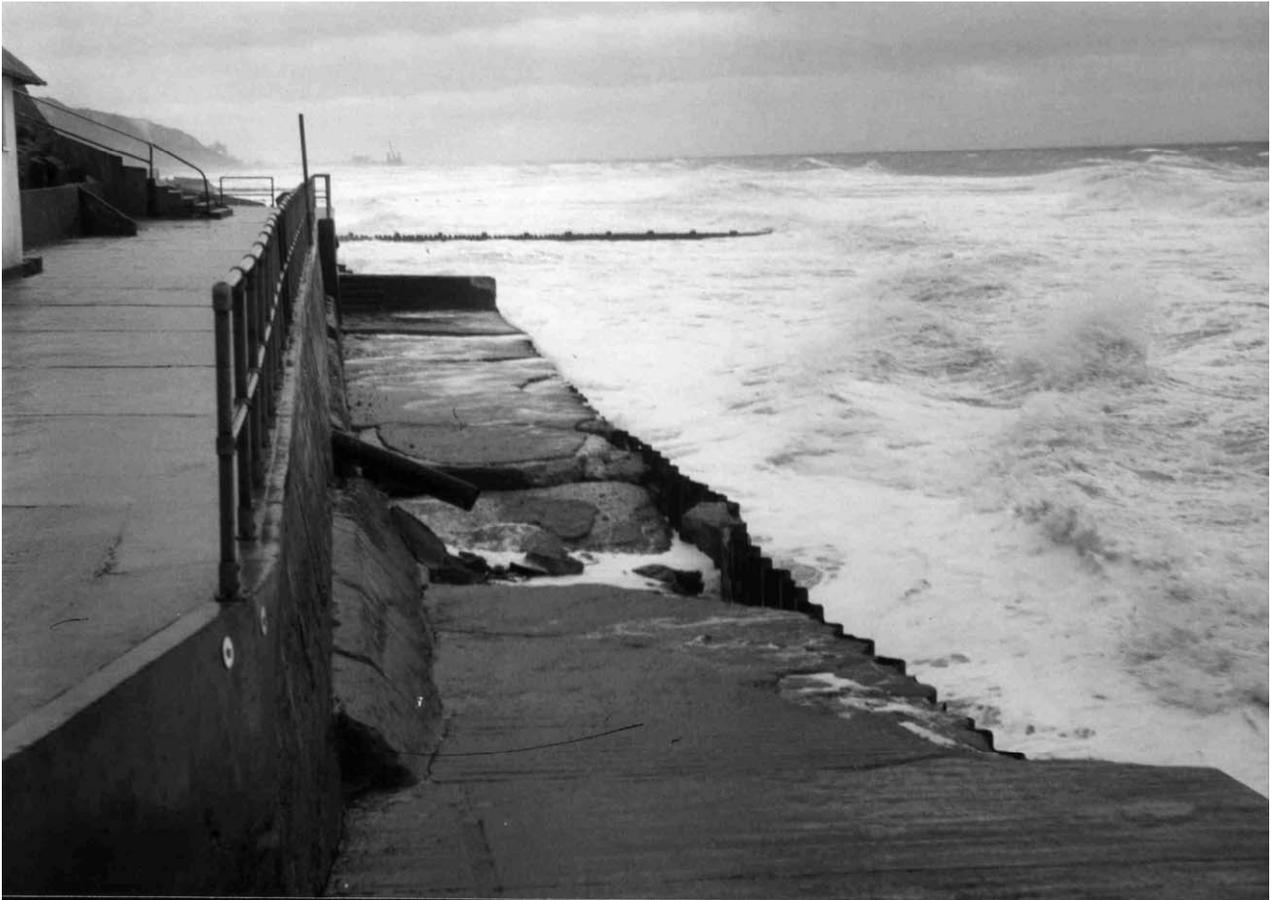
Figure 3.3 Failure of the apron and steel pile toe in December 1997 at Overstrand

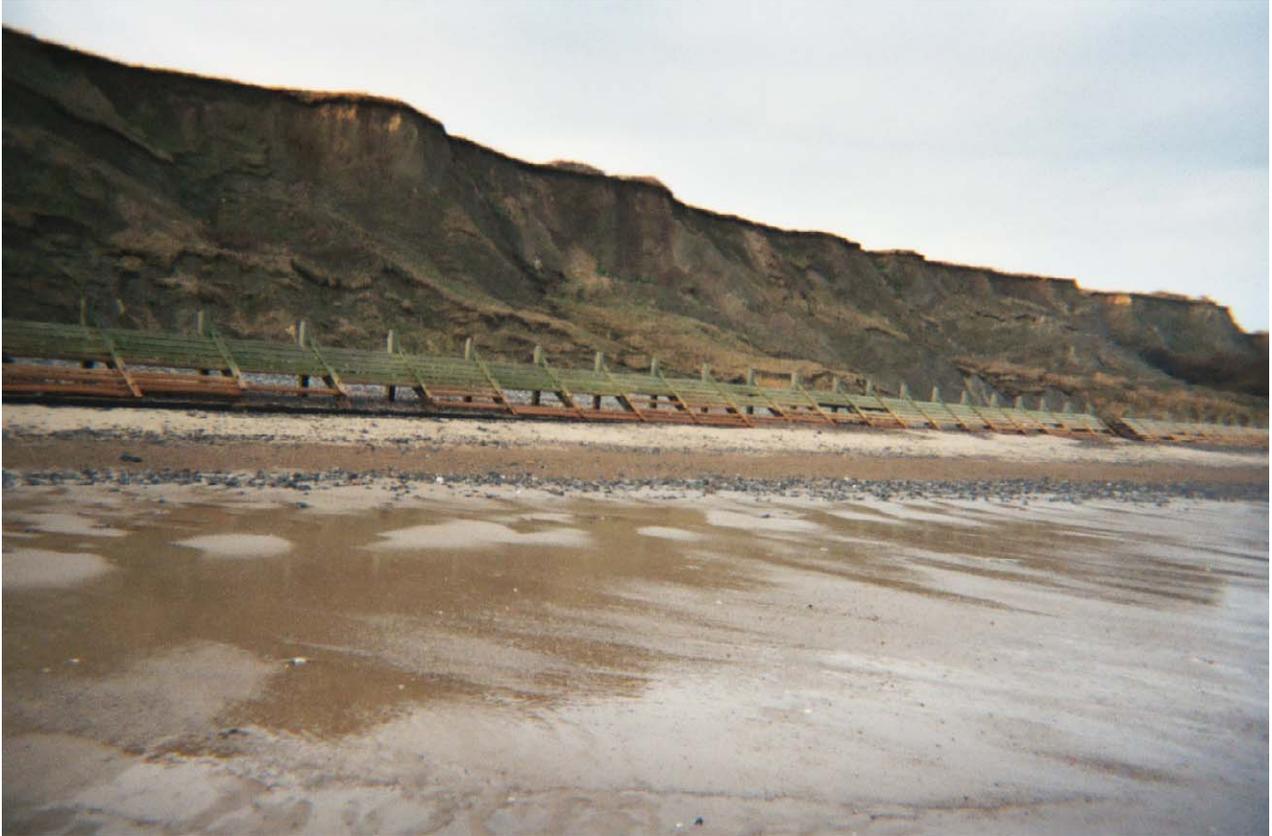
Plate 3.1 Photo P15 General revetment view

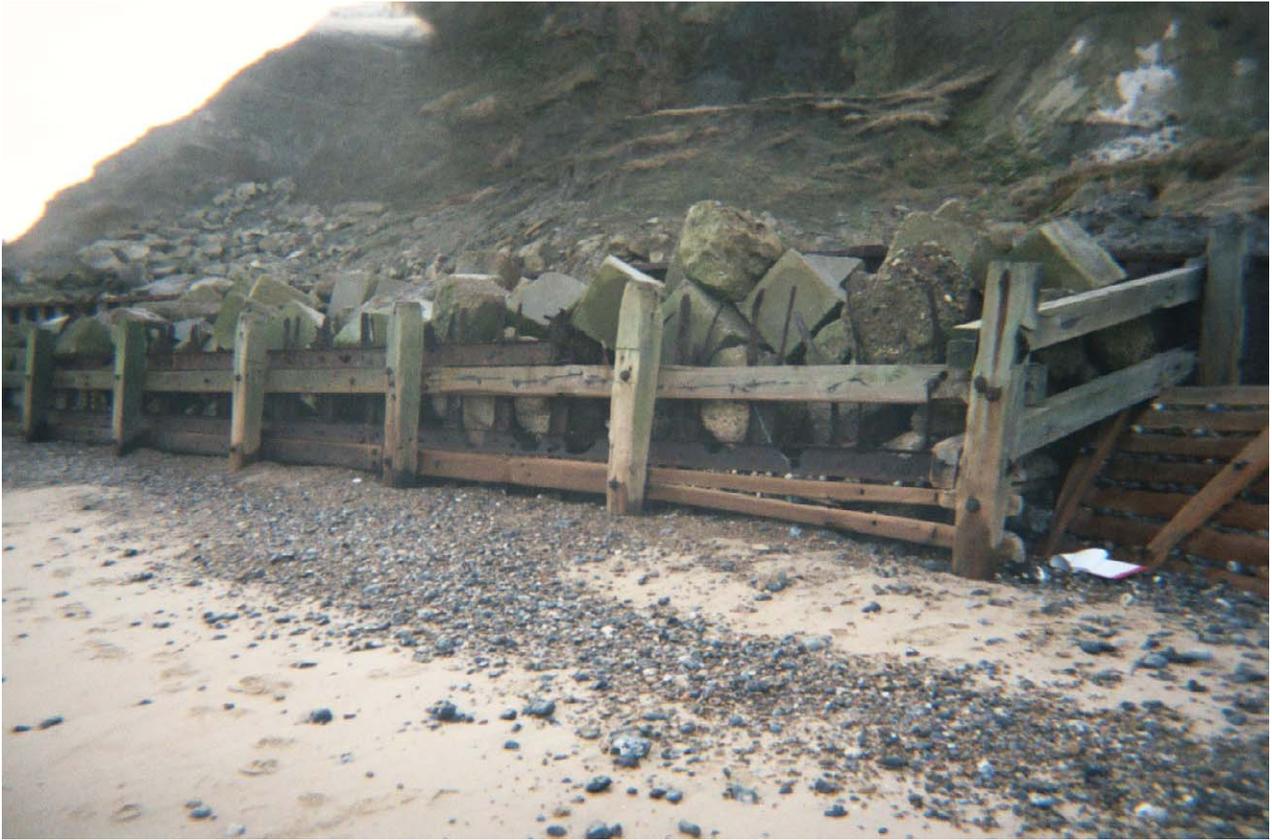
Plate 3.3 Photo P14 Blockwork revetment

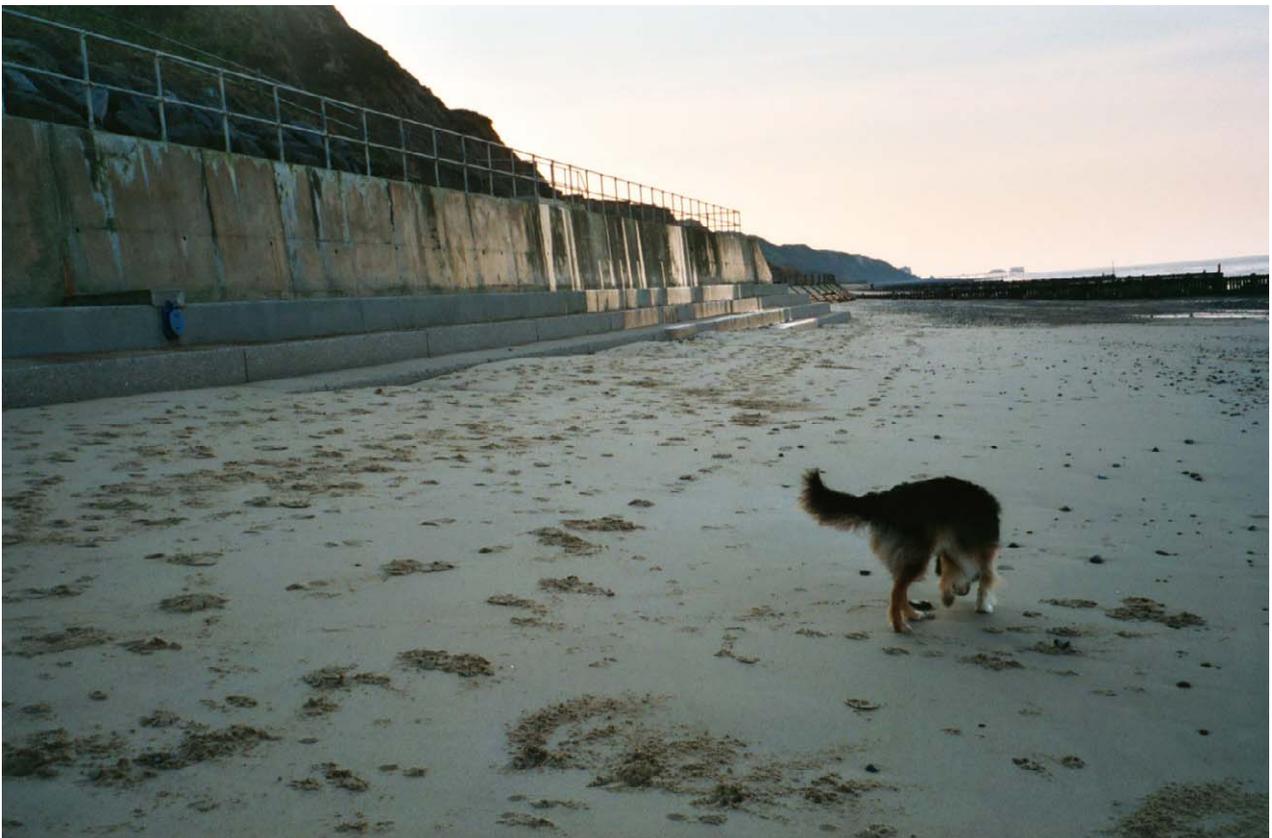
Plate 3.5 Photo OP53 View along the base of the Sea Wall from the West

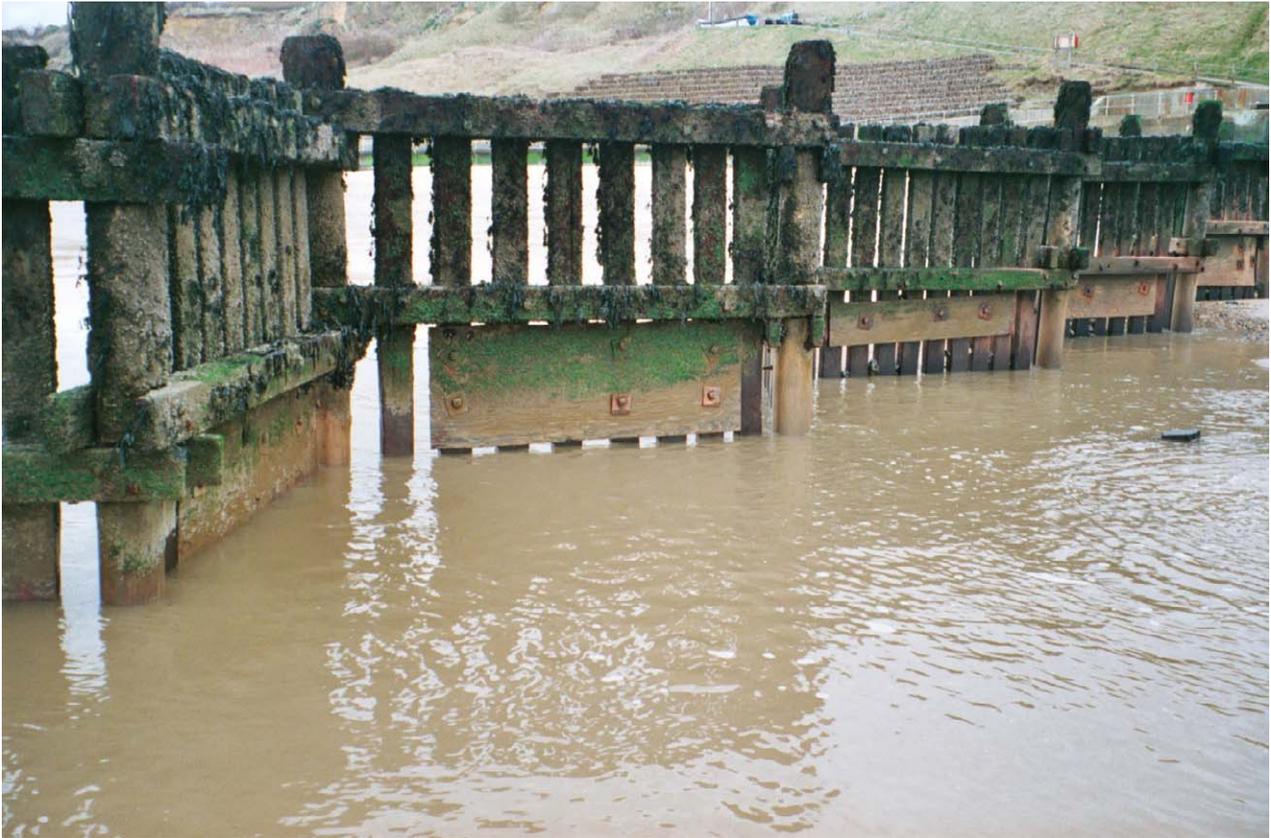
Plate 3.6 **Photo OP6** **Close up of Groyne 2**

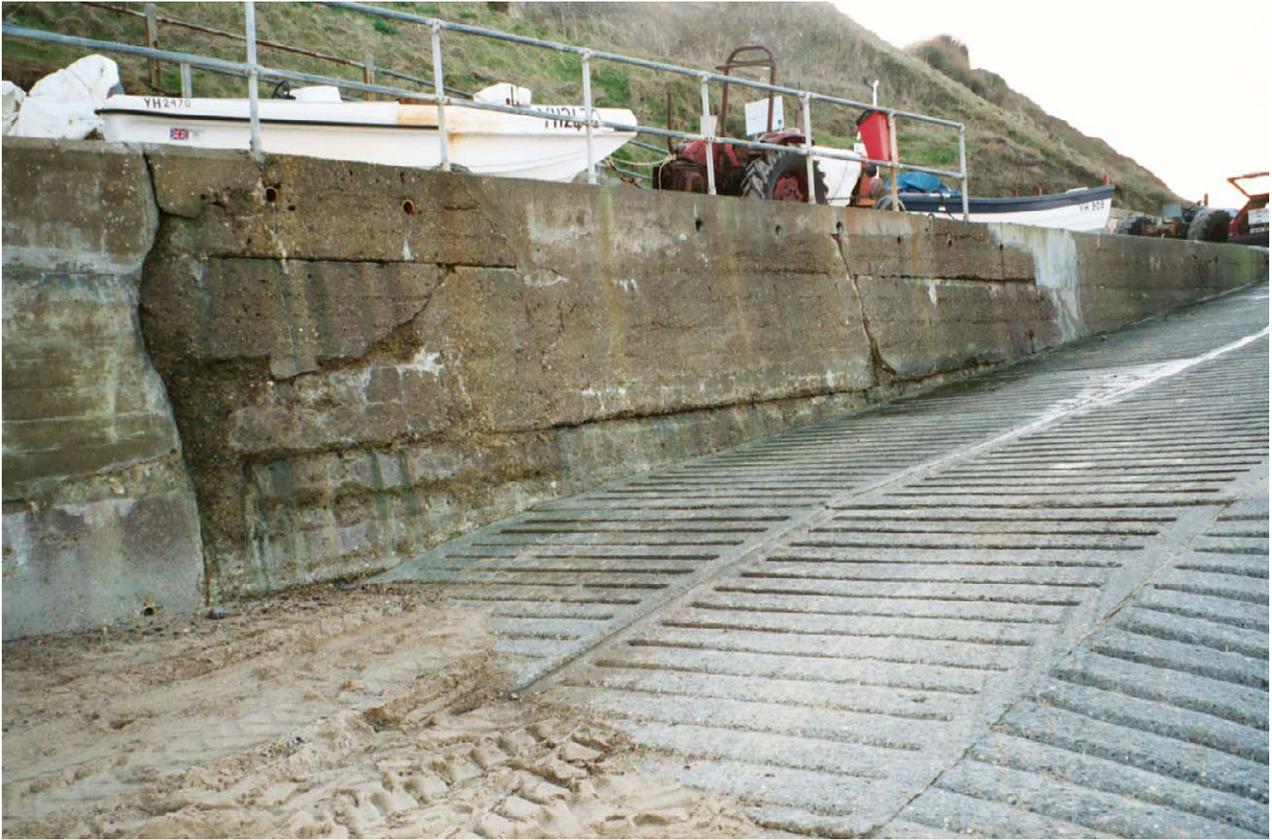
Plate 3.8 Photo OP51 Poor condition of Sea Wall to the East of the ramp

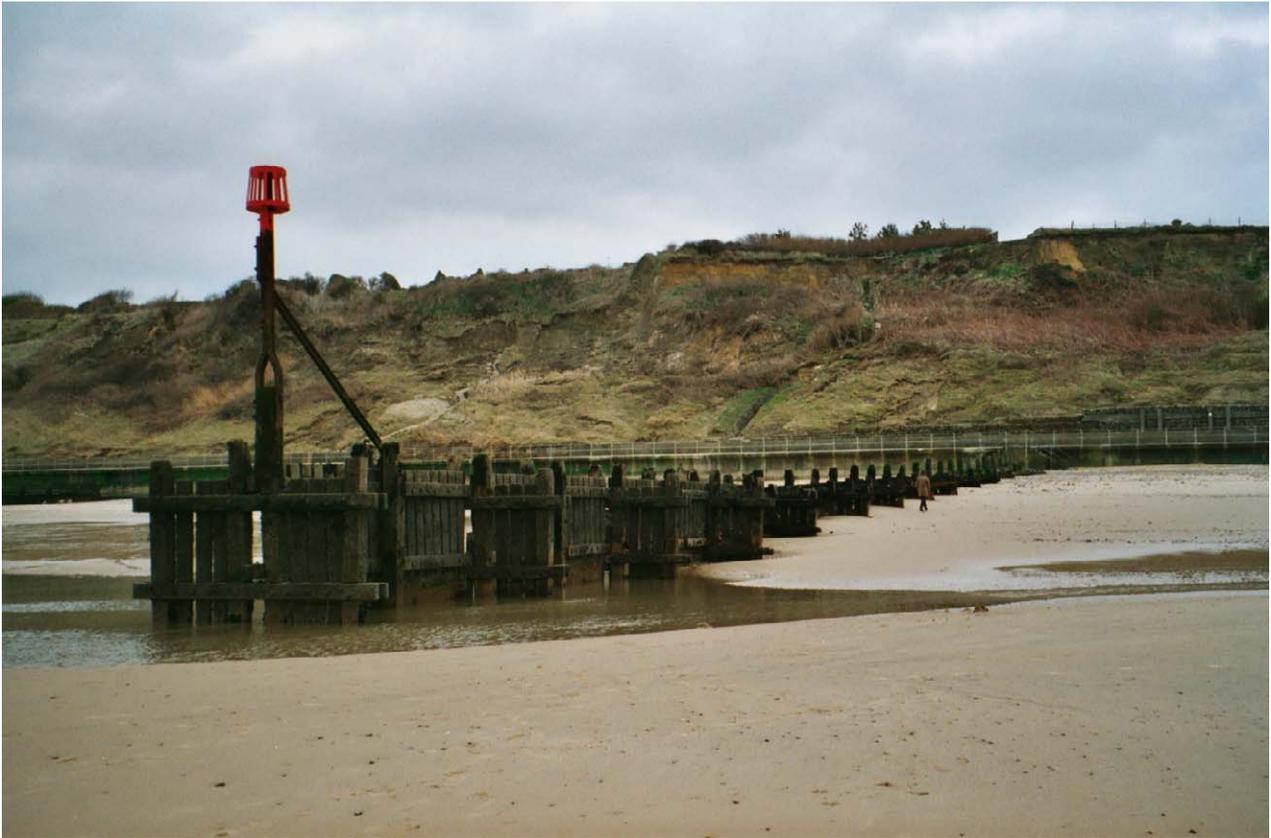
Plate 3.9 Photo OP13 View of the West Elevation of Groyne 3, towards the Sea Wall

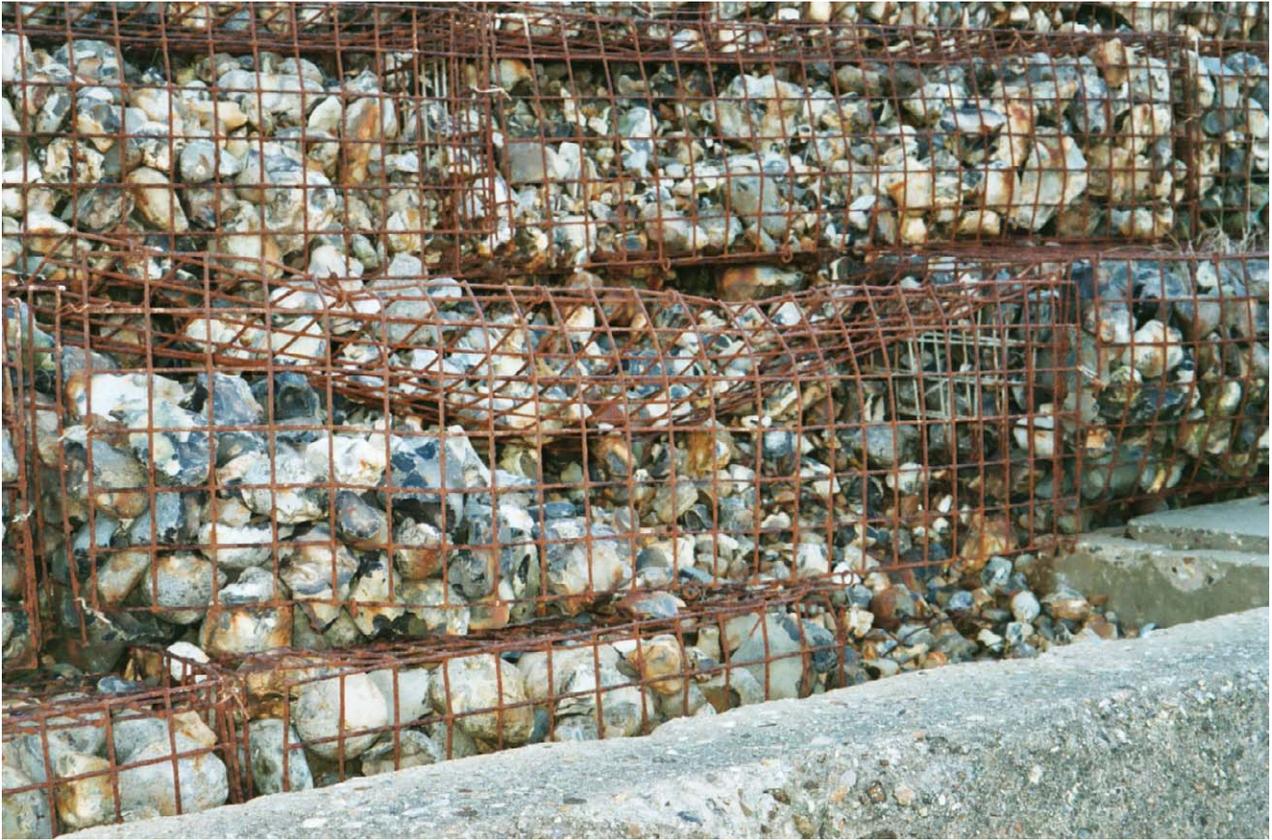
Plate 3.11 Photo OP56 Spillage from a damaged Gabion Basket Slope Protection

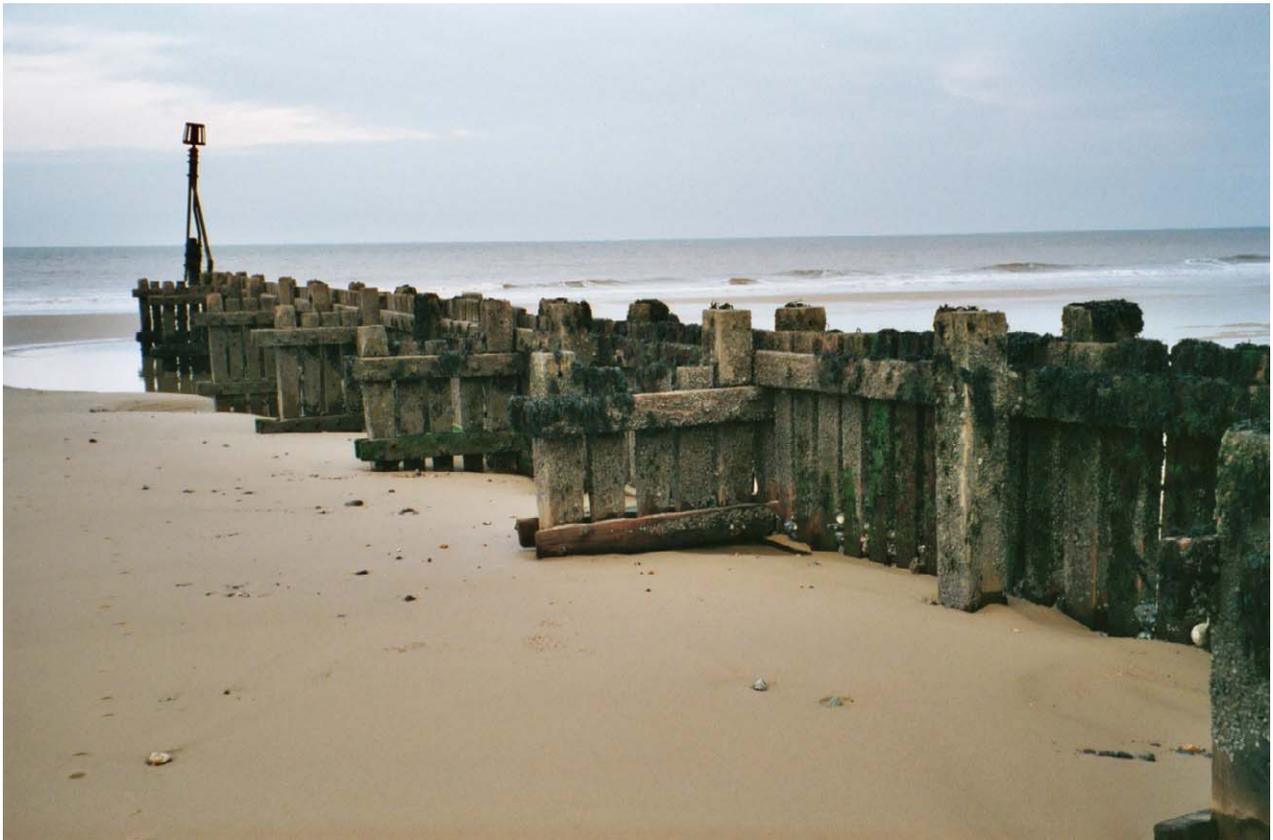
Plate 3.12 Photo OP18 View along Groyne 4, from the Sea Wall

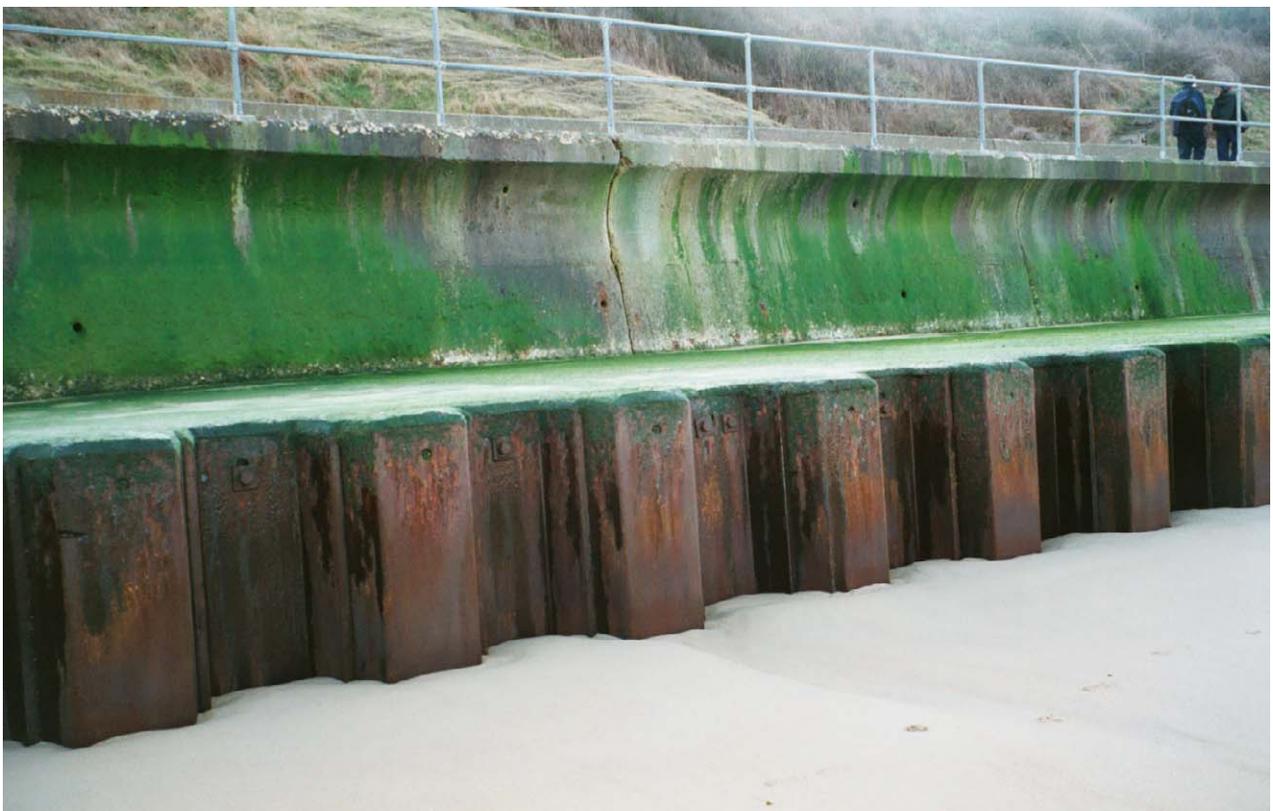
Plate 3.13 Photo OP42 View of Sea Wall

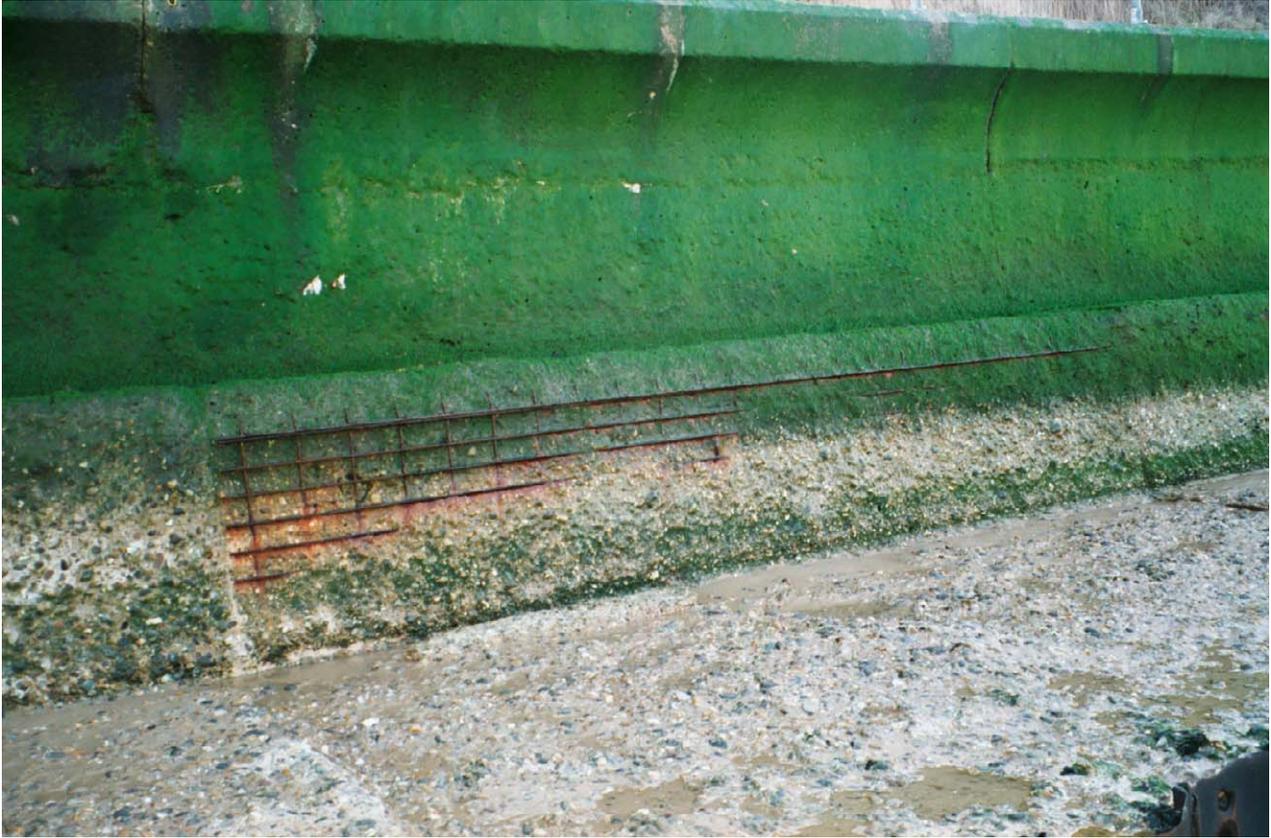
Plate 3.14 Photo OP40 View of the rough surface of the Apron and abrasion damage at base of seawall

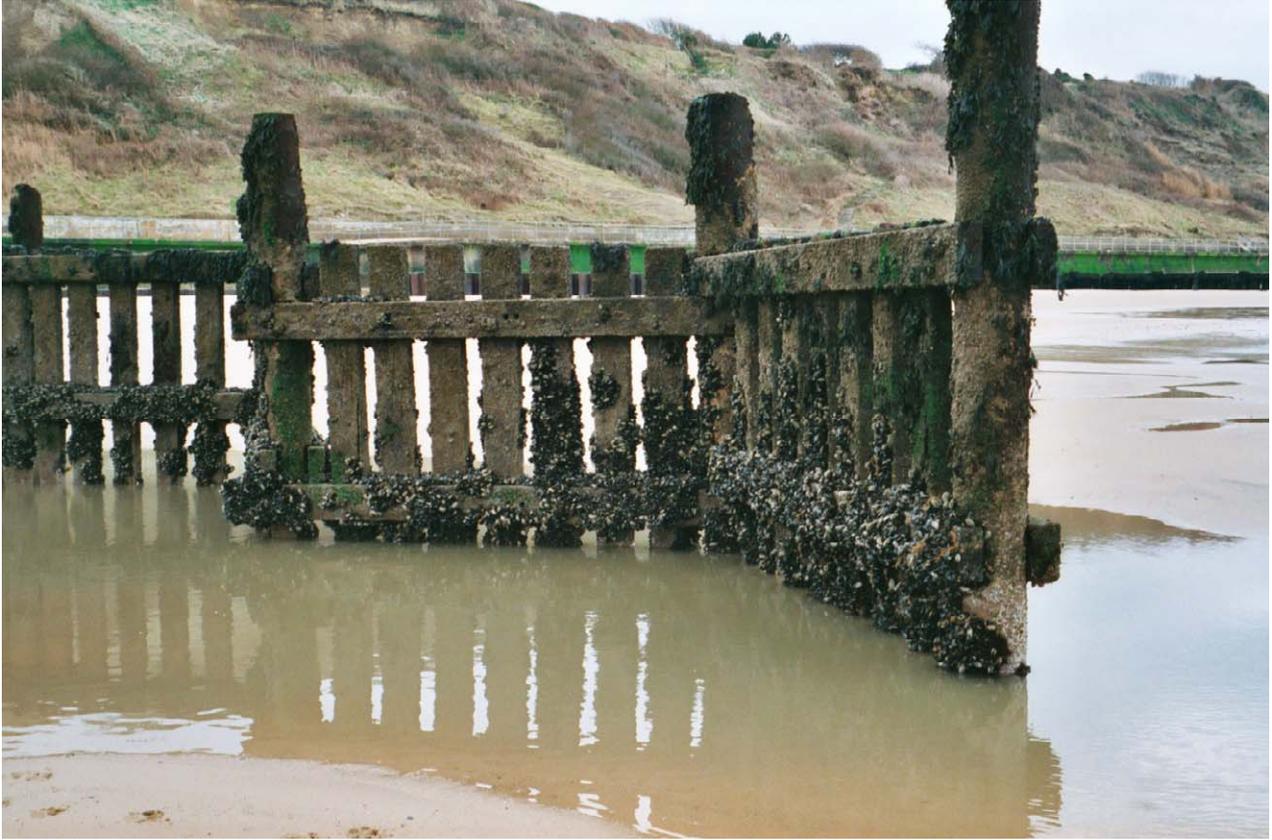
Plate 3.15 Photo OP23 Close up of the end of Groyne 5

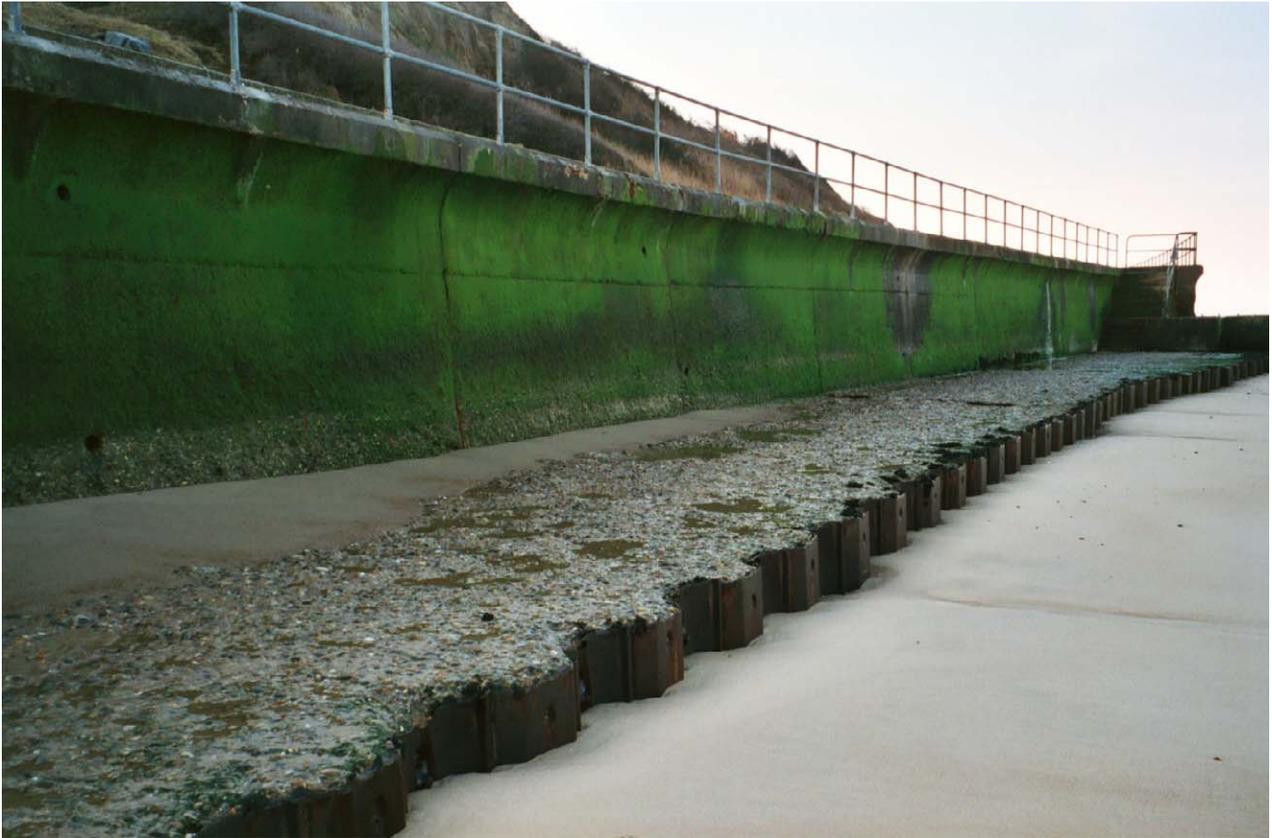
Plate 3.16 Photo OP38 View rough surface of the Apron along base of Sea Wall

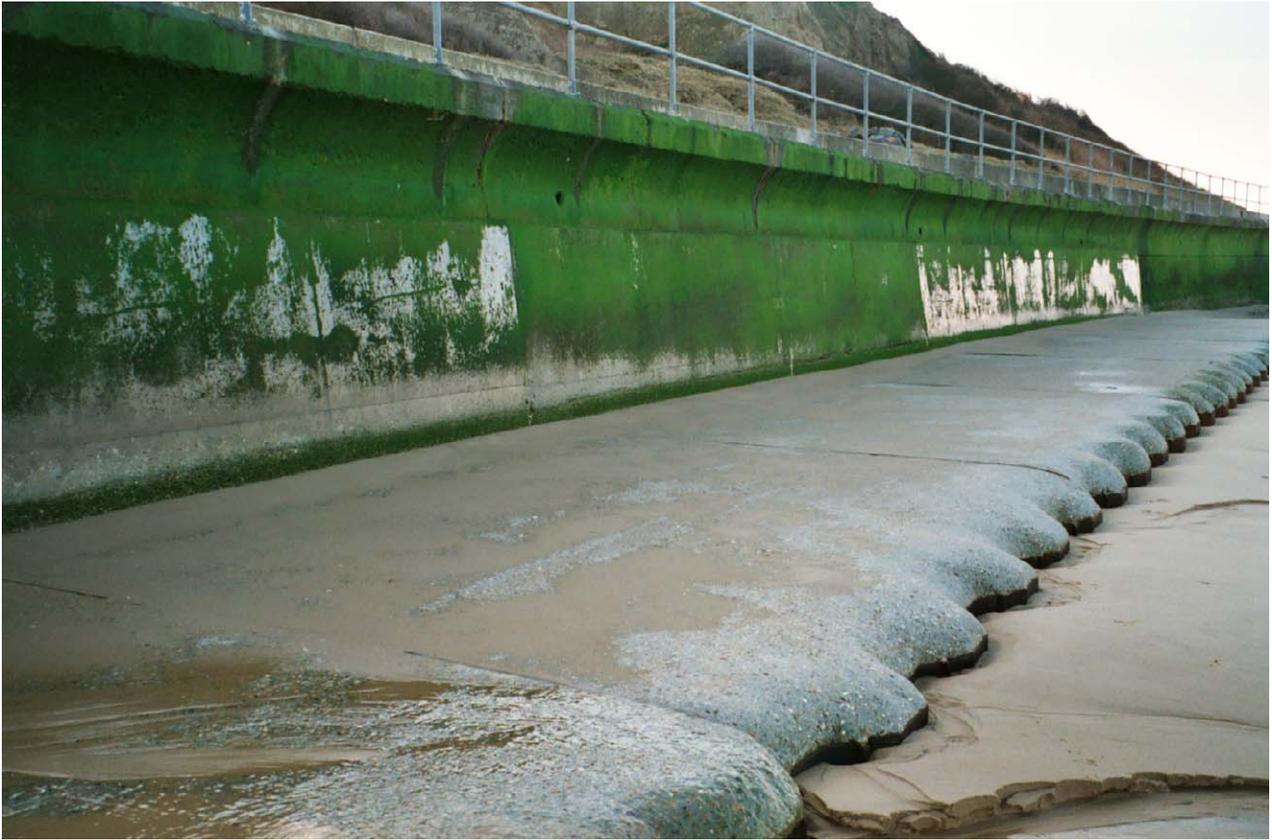
Plate 3.18 Photo OP37 View of the Apron along the base of the Sea Wall

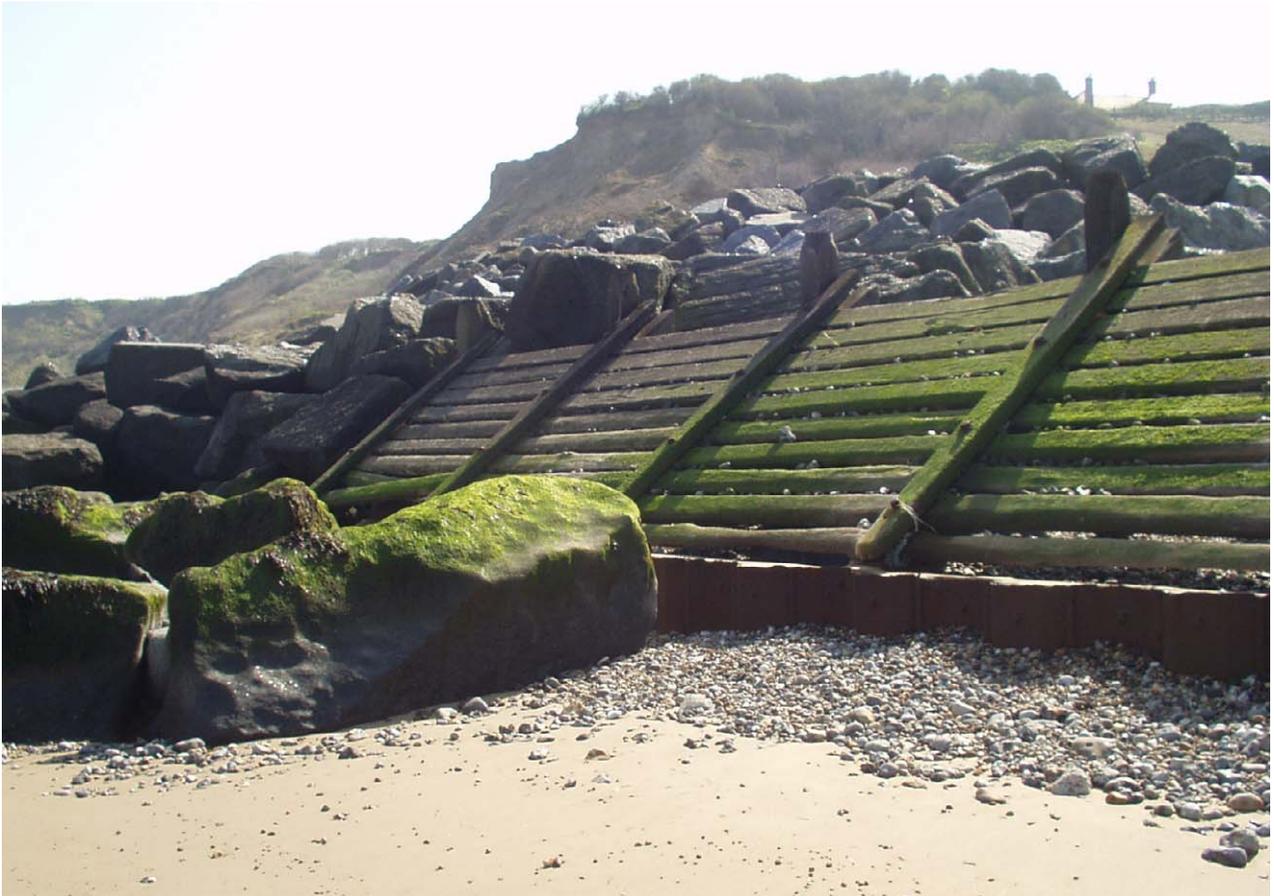
Plate 3.19 Photo X20 Intersection of Rock and Timber Revetments

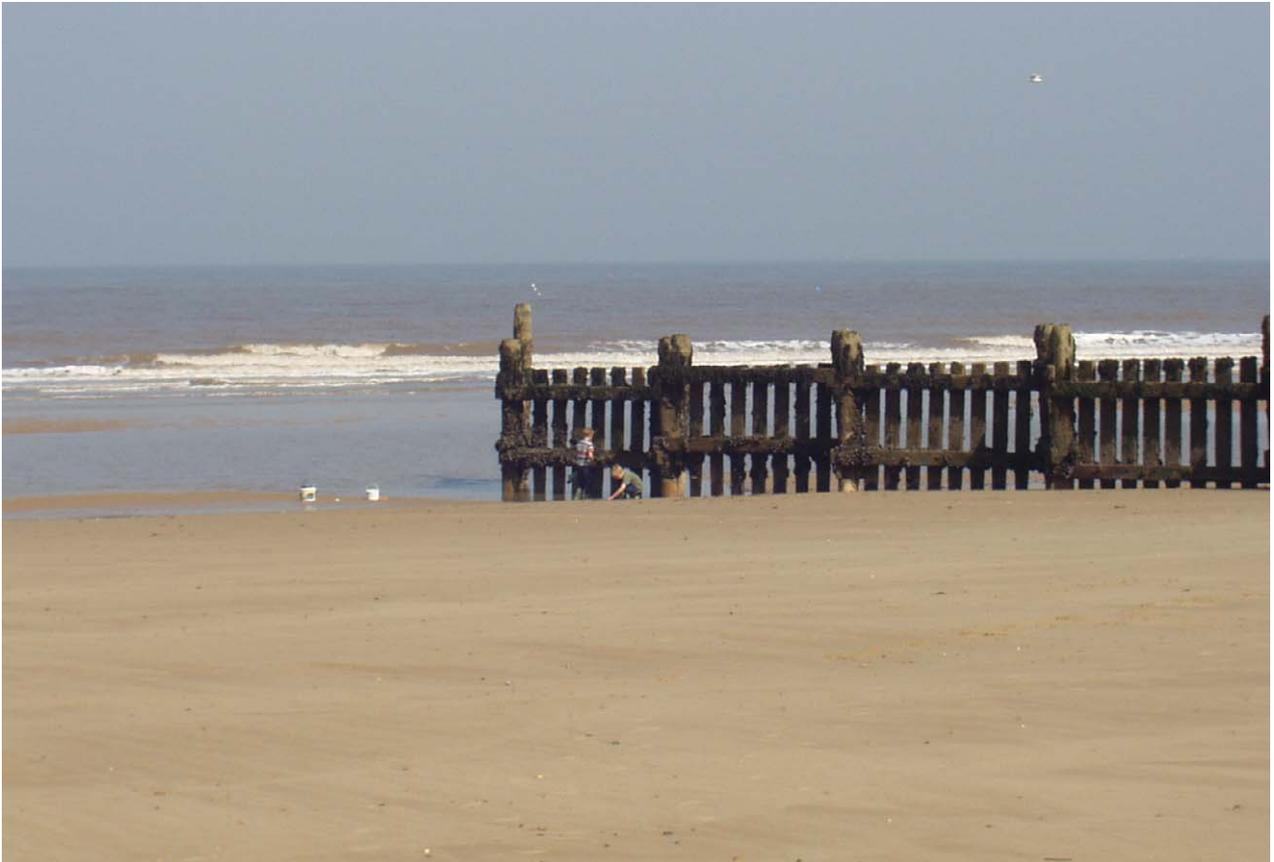
Plate 3.20 Photo X22 View of the End of a Groyne

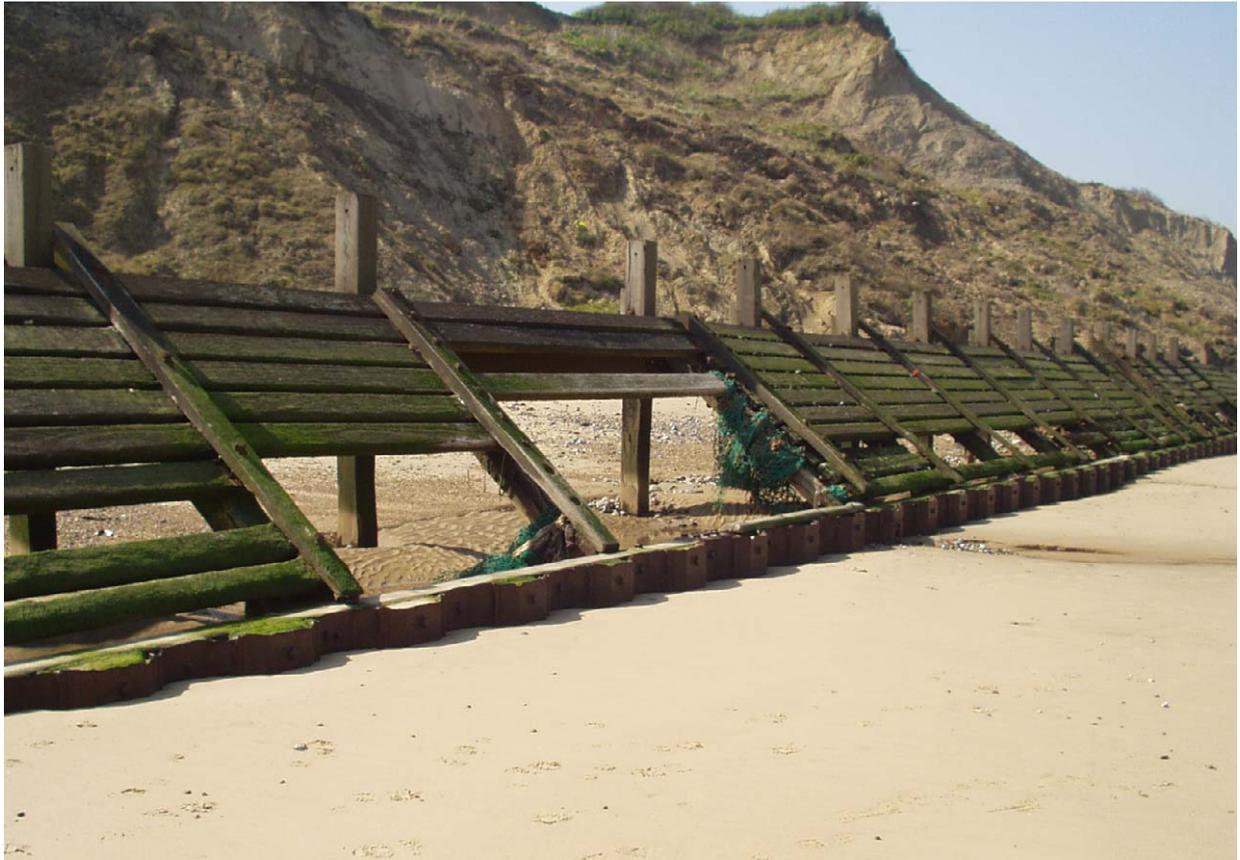
Plate 3.21 Photo X14 Badly Damaged Wooden Revetment

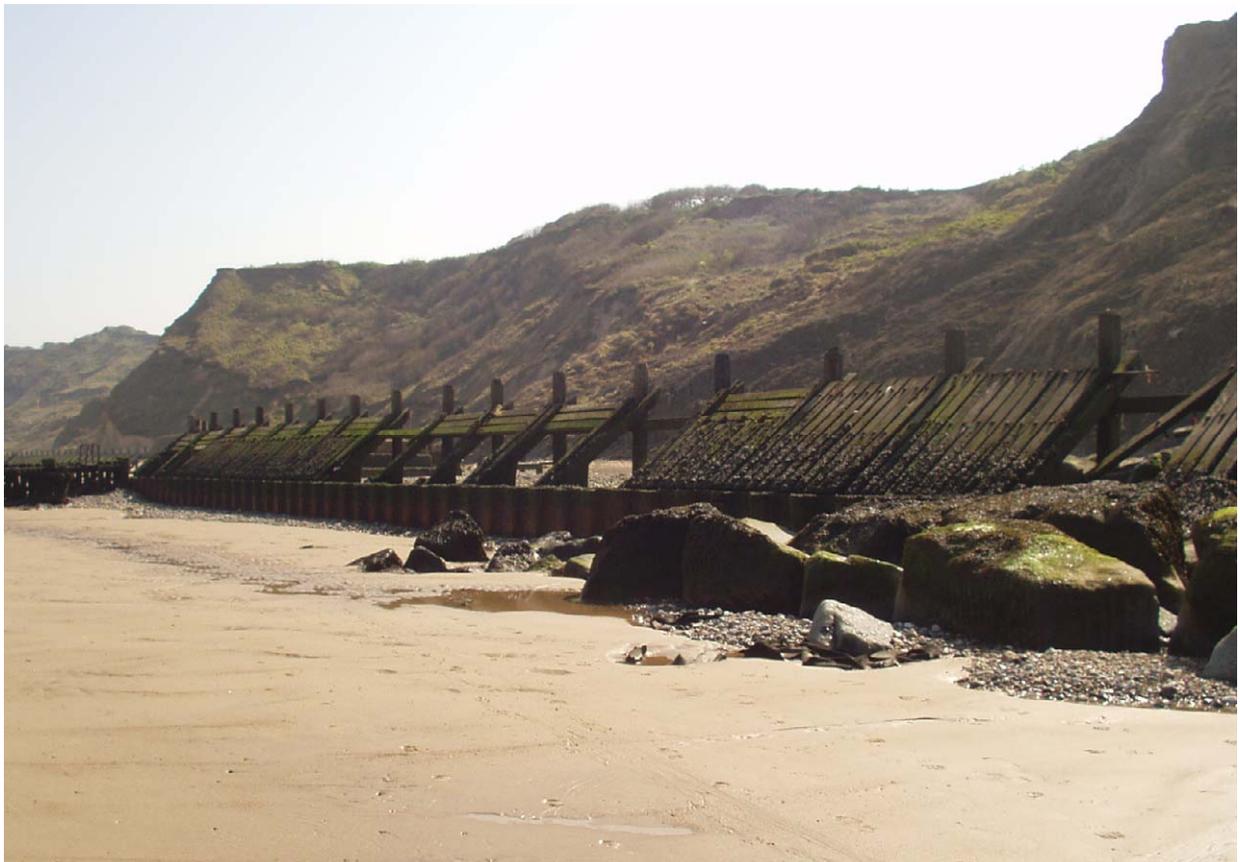
Plate 3.22 Photo X16 View South East Along the Revetment

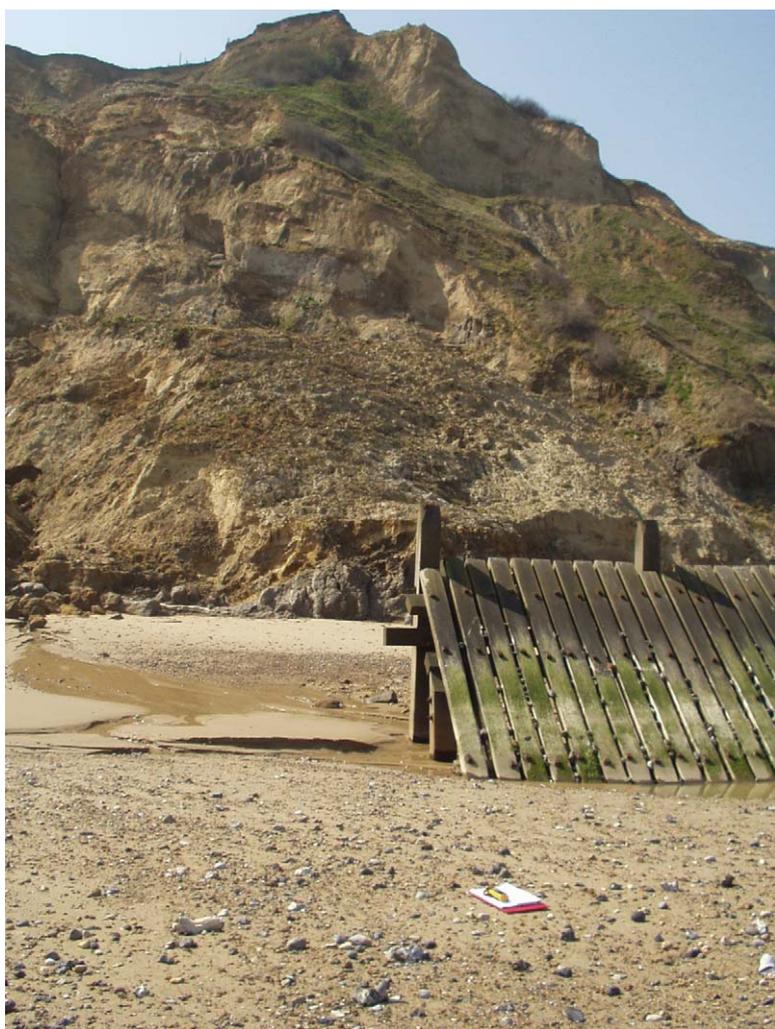
Plate 4.1 Photo X1 Termination of Wooden Revetment
