Overstrand to Walcott

Defence Condition Survey

**Interim Report
October 2003**

This report describes work commissioned by North Norfolk District Council whose representative was Mr Peter Frew. The HR Wallingford job numbers were CDR3212 and CDR3214. The work was carried out by Mr Peter Lawton of St La Haye Consulting Engineers. The HR Wallingford project manager was Mr Paul Sayers.

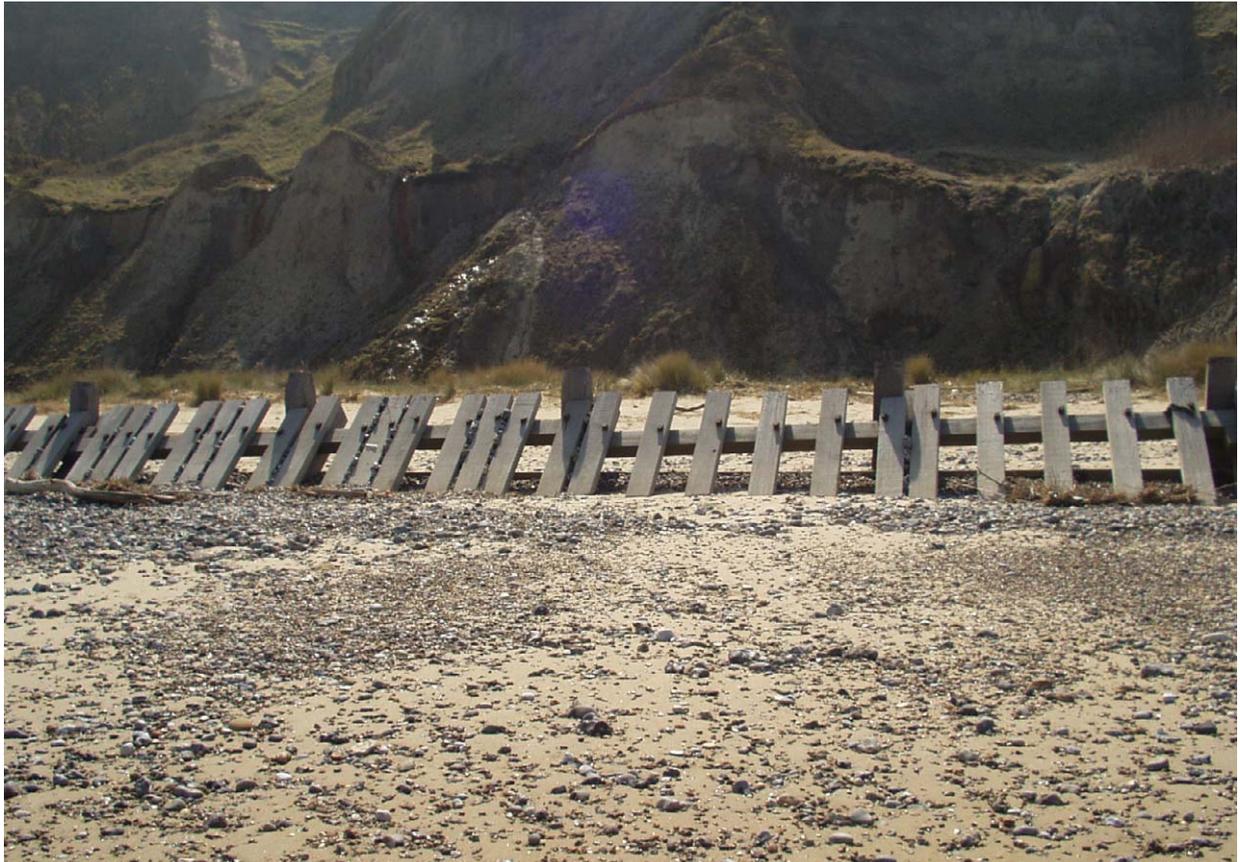
Plate 4.2 Photo X8 View of a Wooden Revetment with Boards Missing

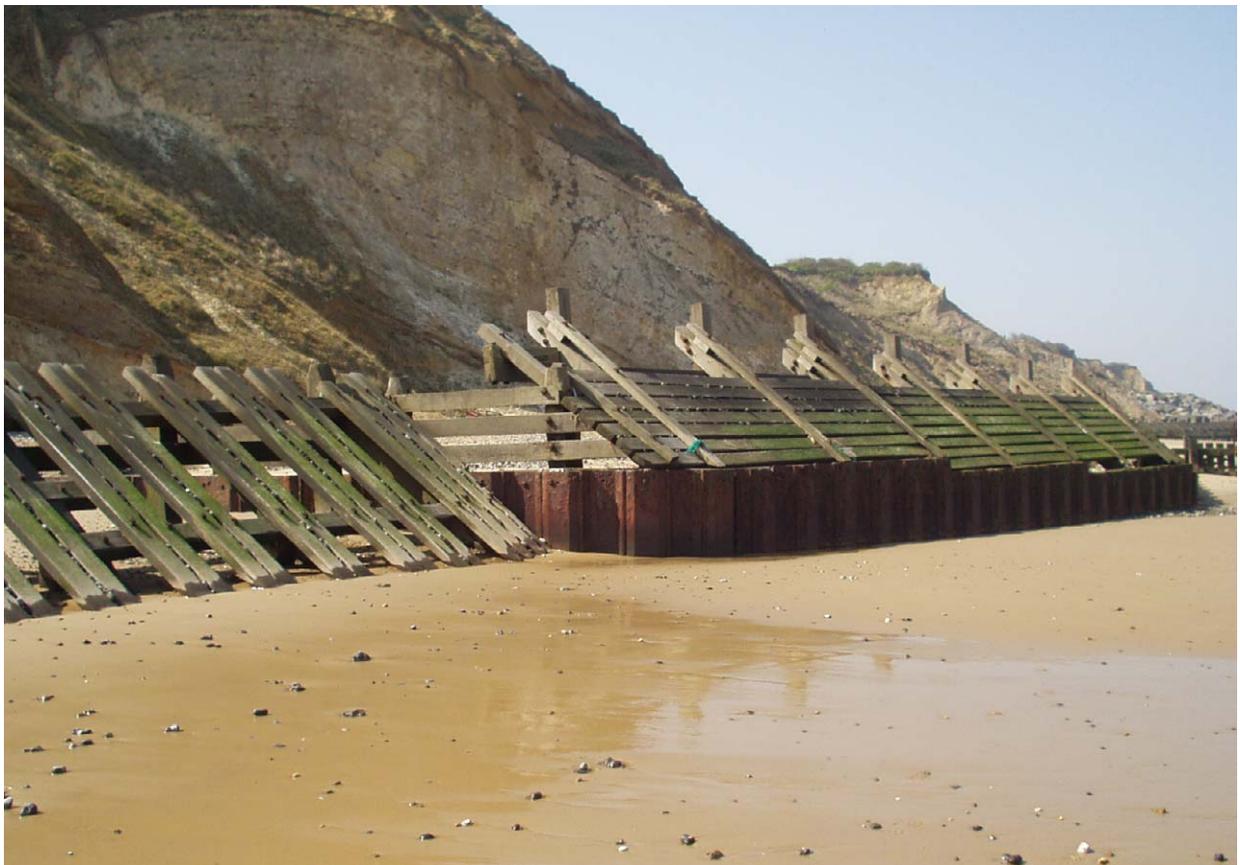
Plate 4.3 Photo X10 Wooden Revetment with Exposed Sheet Pile Toe

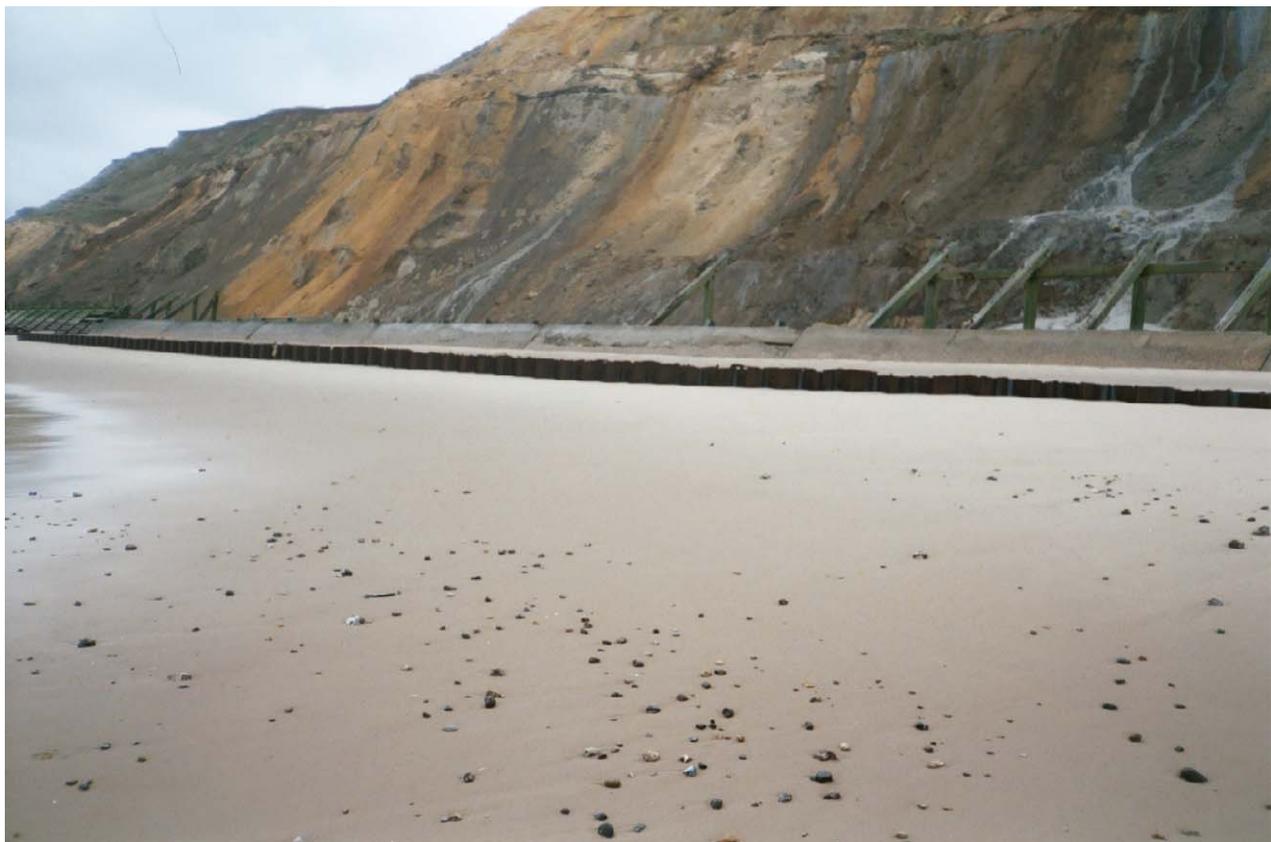
Plate 5.1 Photo PT16 Seawall and derelict revetment

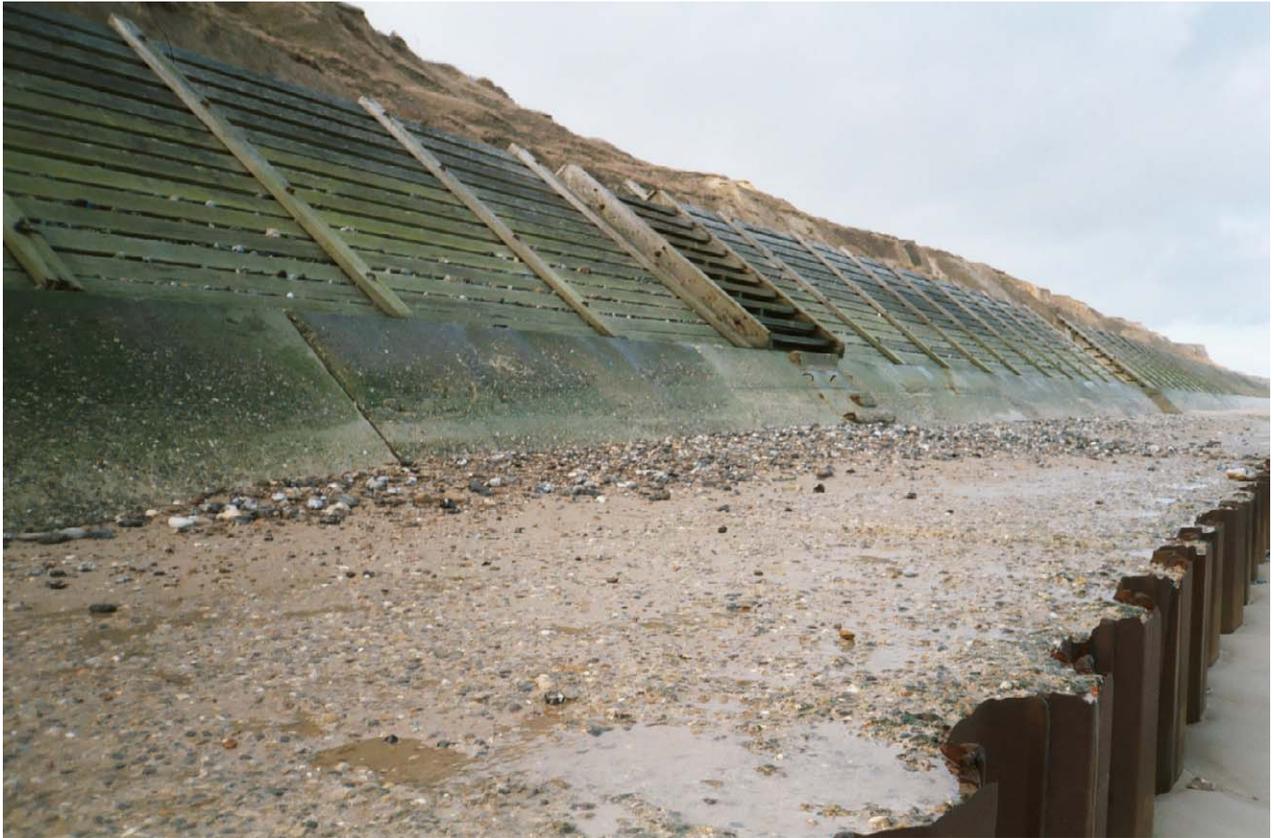
Plate 5.2 Photo PT23 Apron to wall

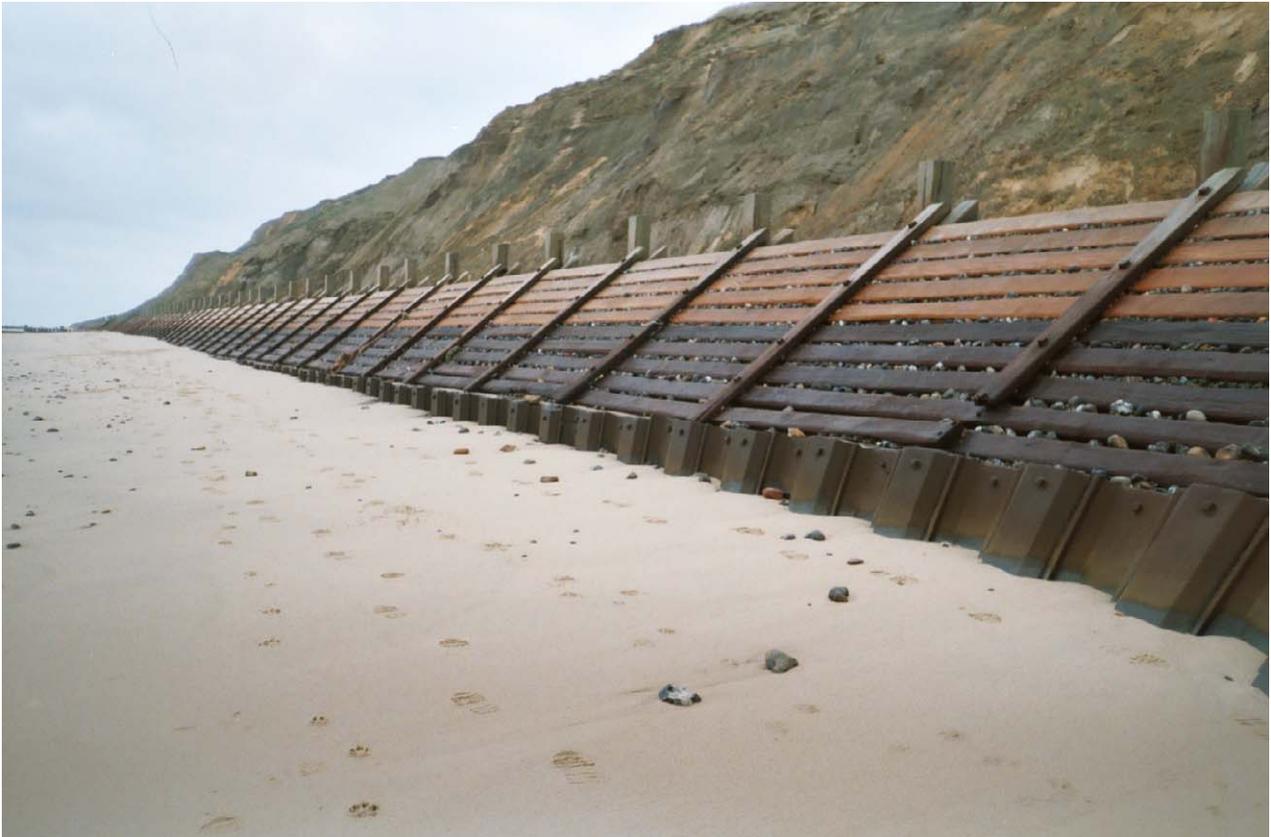
Plate 5.5 Photo PT10 Revetment, note damaged piles

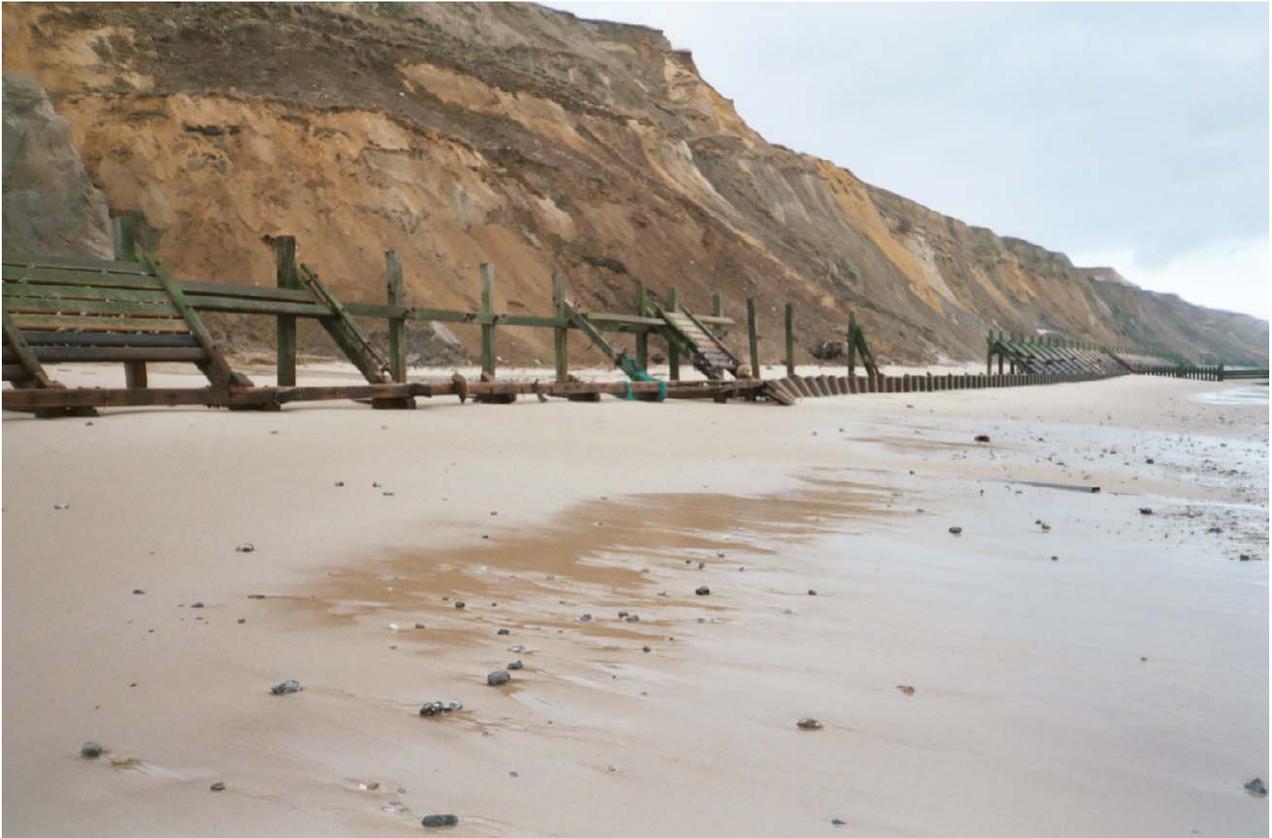
Plate 5.6 **Photo PT14** **Skeletal revetment, no piles**

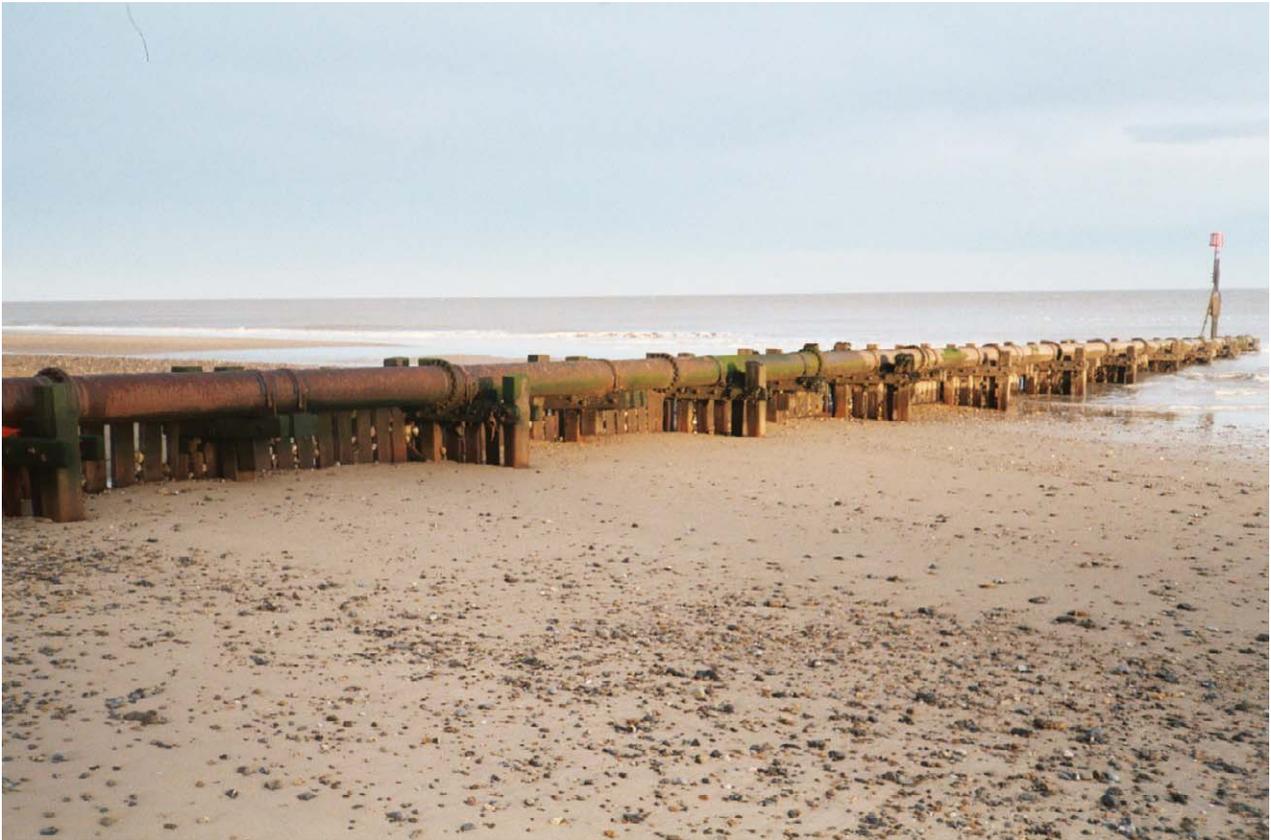
Plate 6.3 Photo M7 Groyne I1, surface water outfall

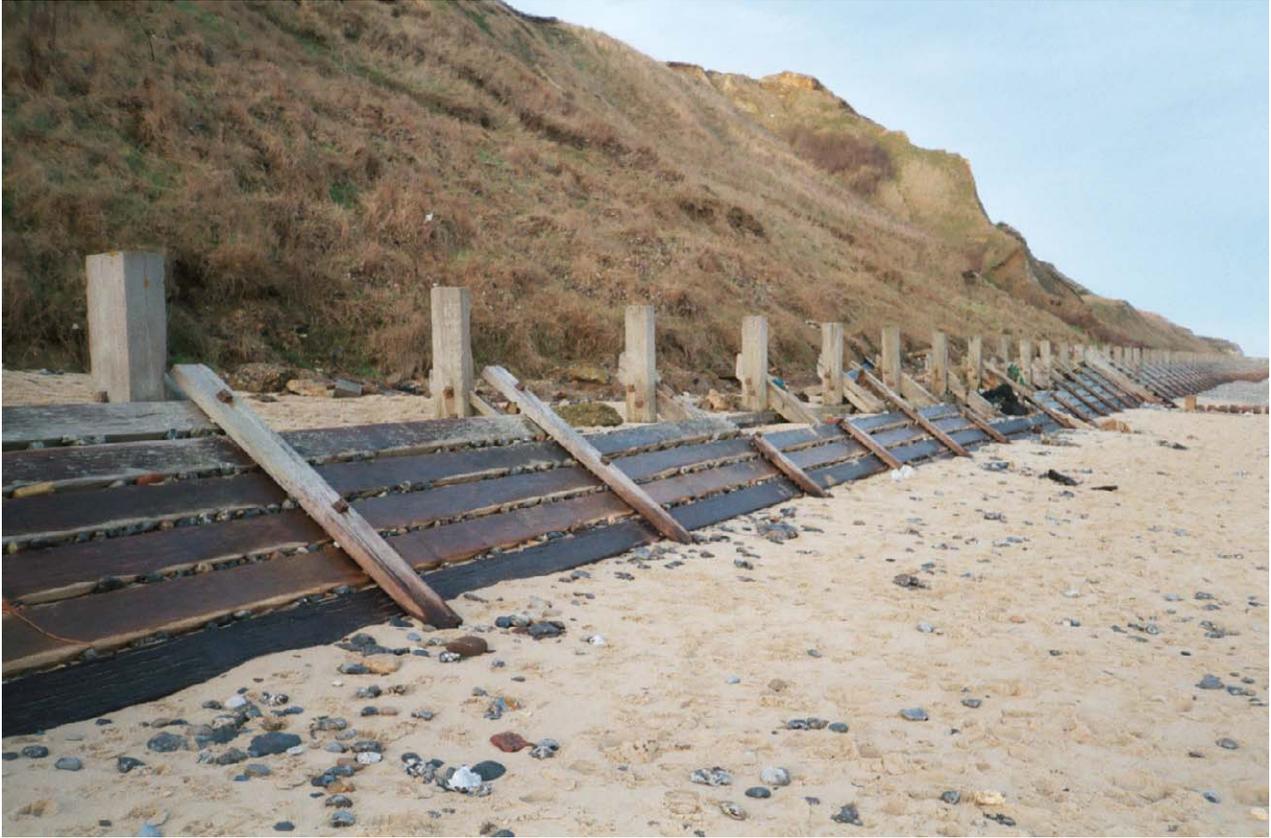
Plate 6.4 Photo M10 Local damage to revetment

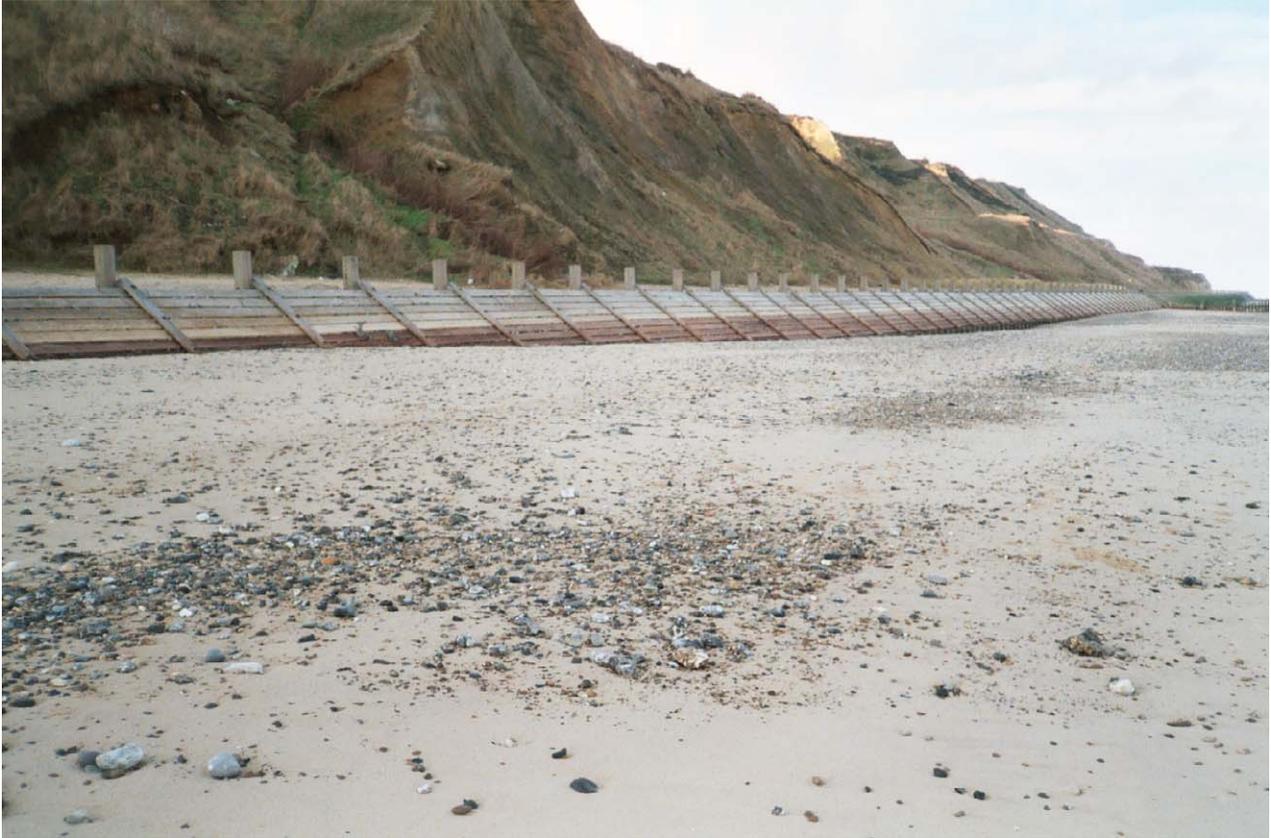
Plate 6.5 Photo TG17 General view of revetment

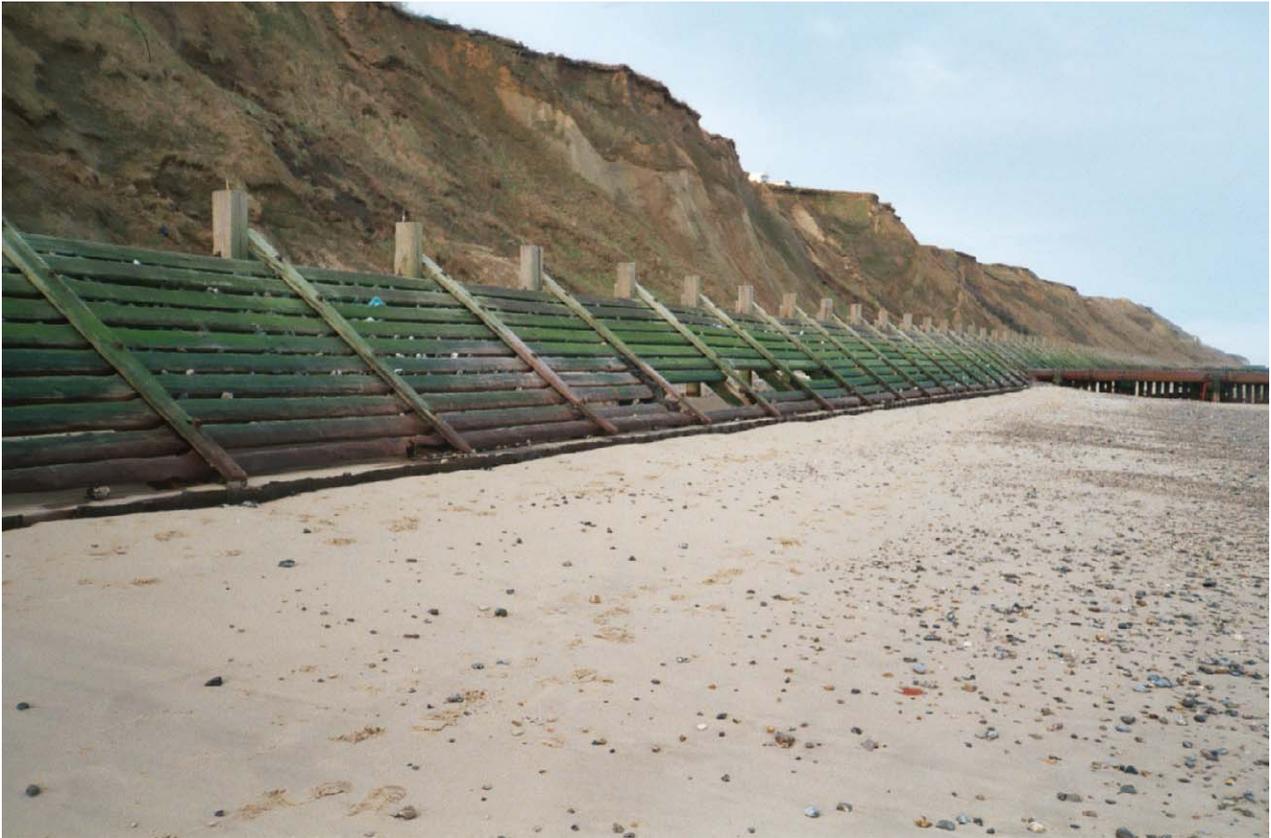
Plate 7.1 Photo M11 Revetment showing missing panels

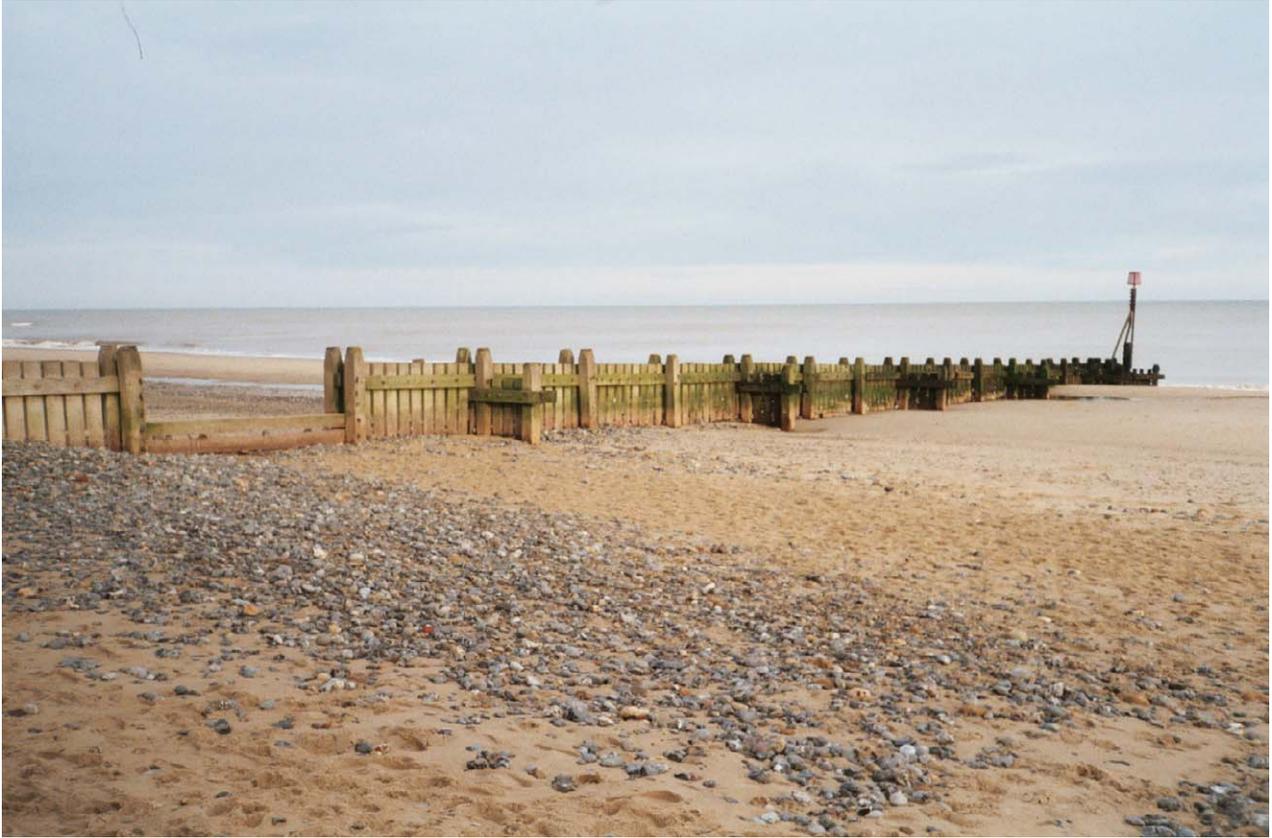
Plate 7.2 Photo M12 Groyne I6

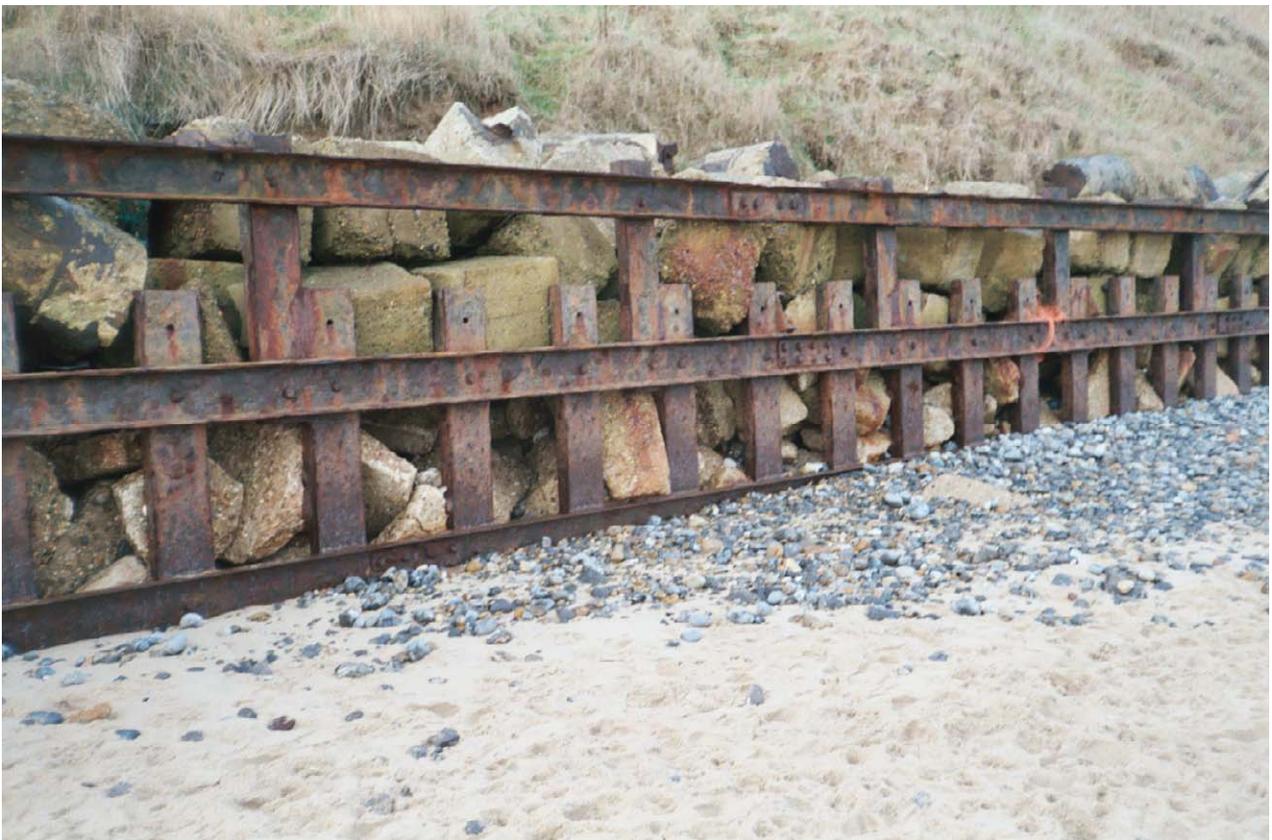
Plate 7.3 Photo M14 Blockwork revetment

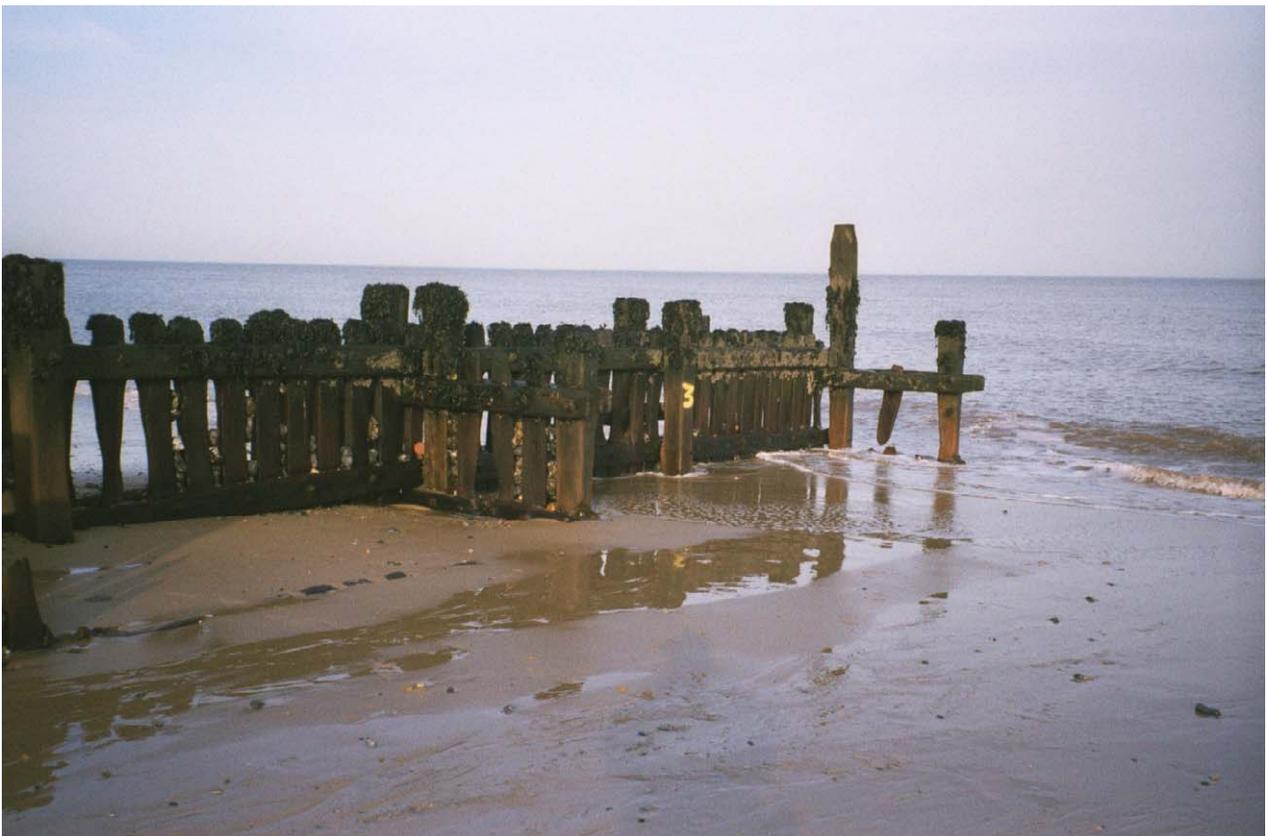
Plate 7.6 Photo MP80 View of Groyne 3

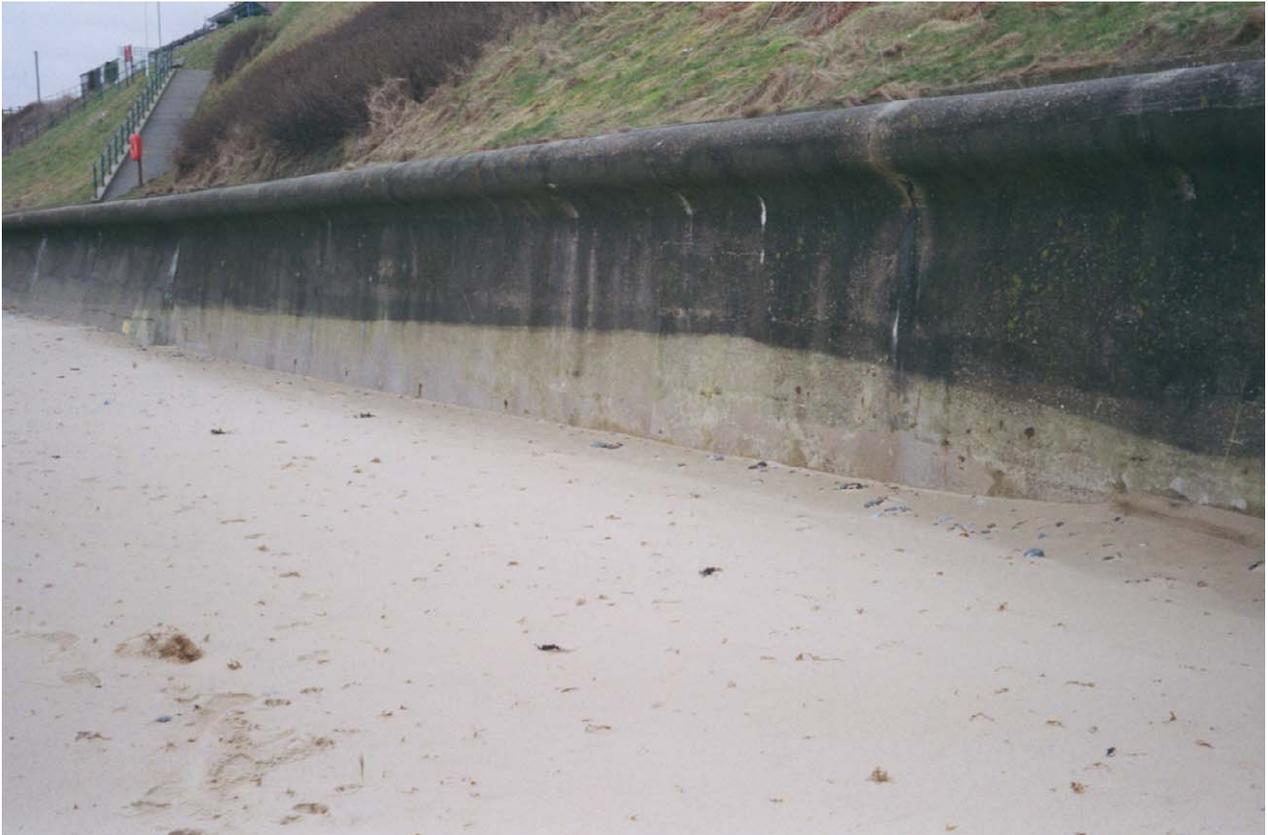
Plate 7.7 Photo MP39 View of Sea Wall

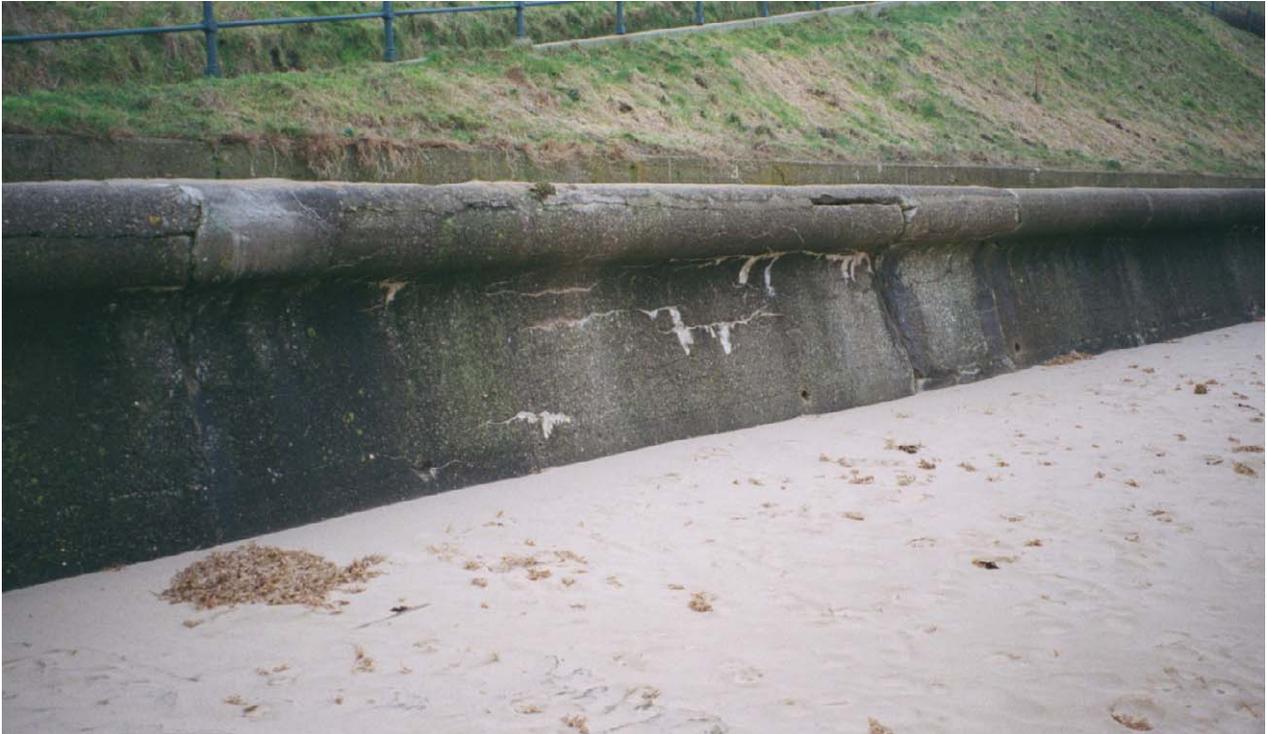
Plate 7.8 Photo MP30 View of Sea Wall

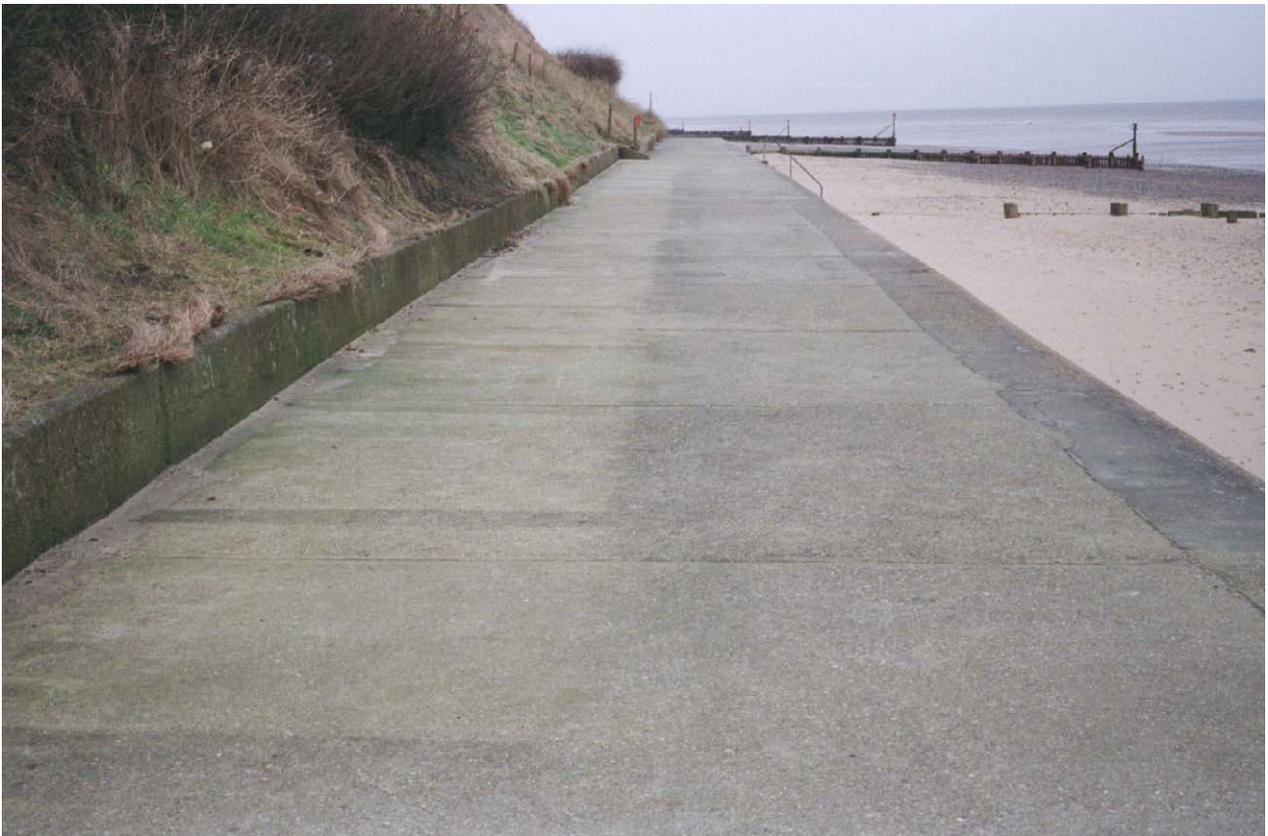
Plate 7.9 Photo MP35 Promenade along top of Sea Wall

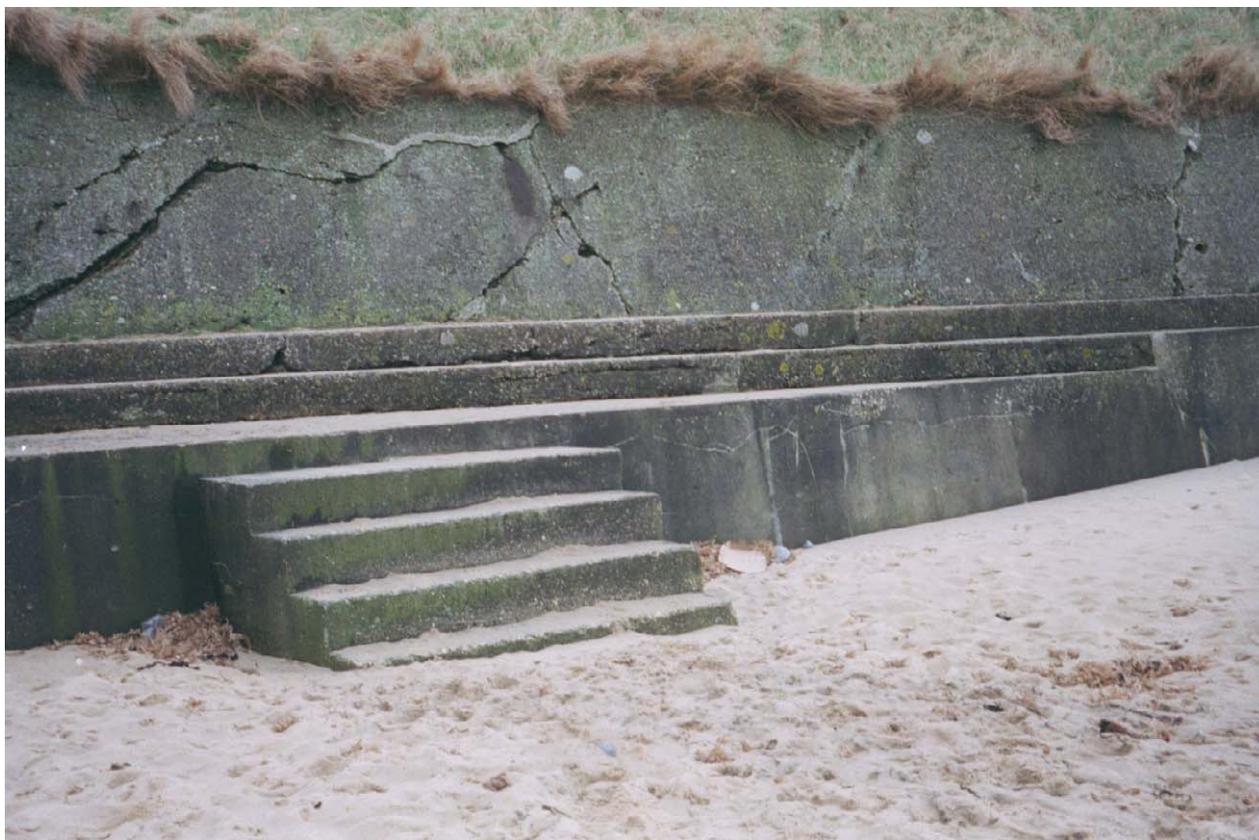
Plate 7.10 Photo MP22 Steps leading down from the Sea Wall

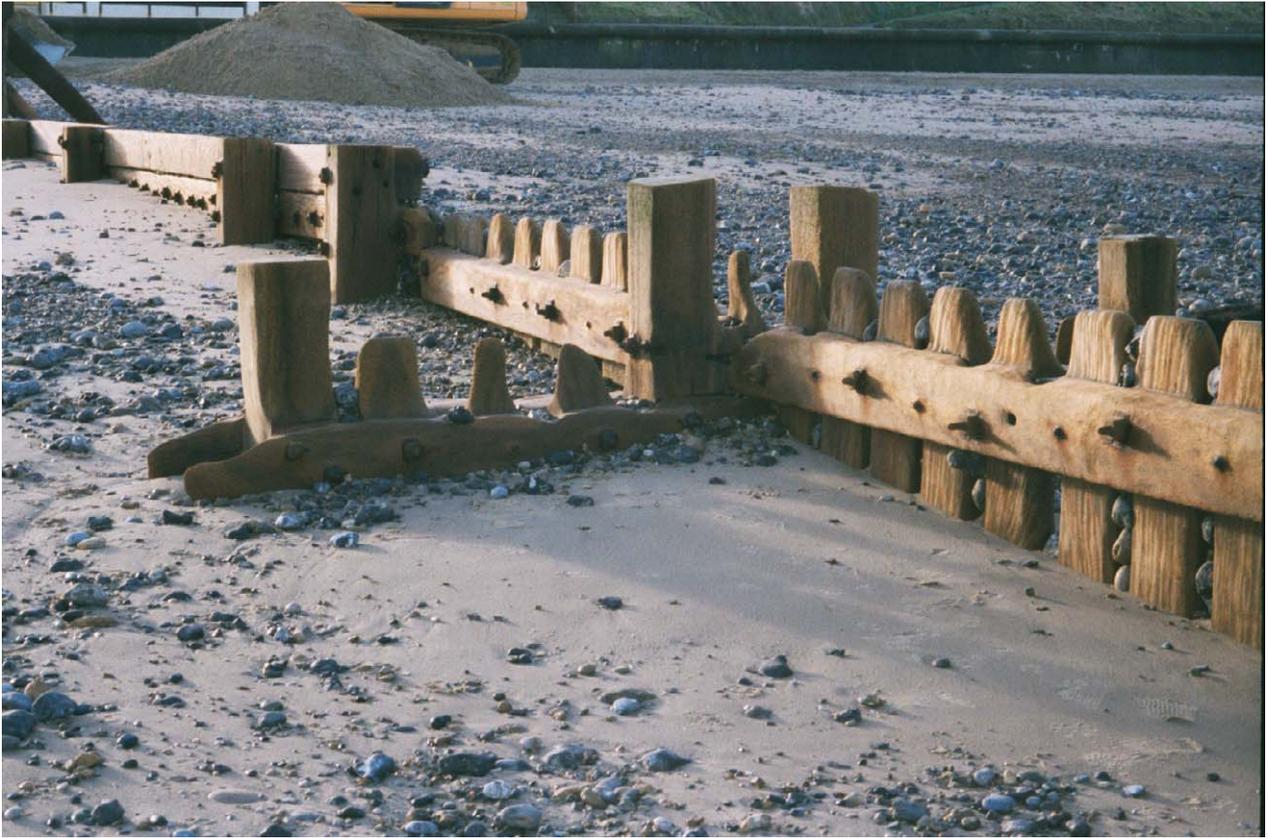
Plate 7.11 Photo MP84 Close up of Groyne 4

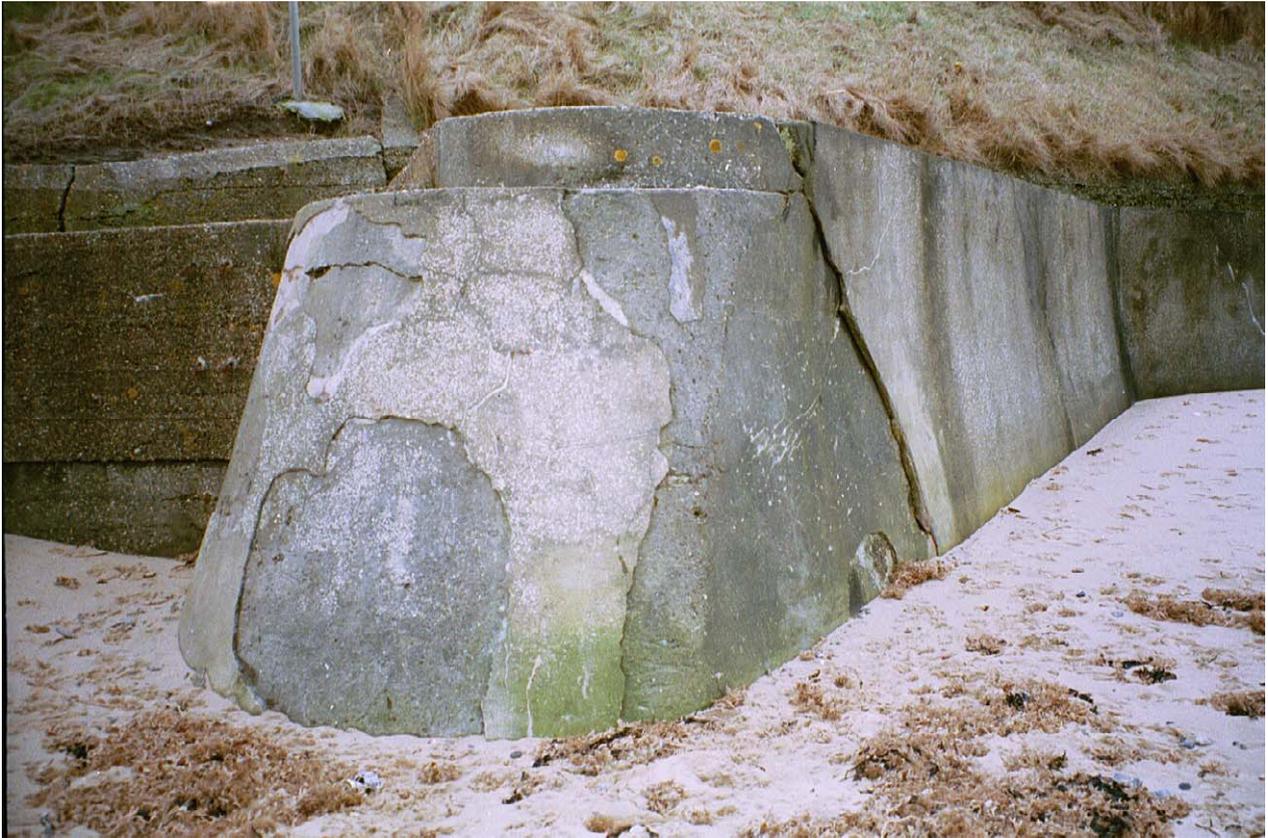
Plate 7.12 Photo MP17 Corner of Sea Wall

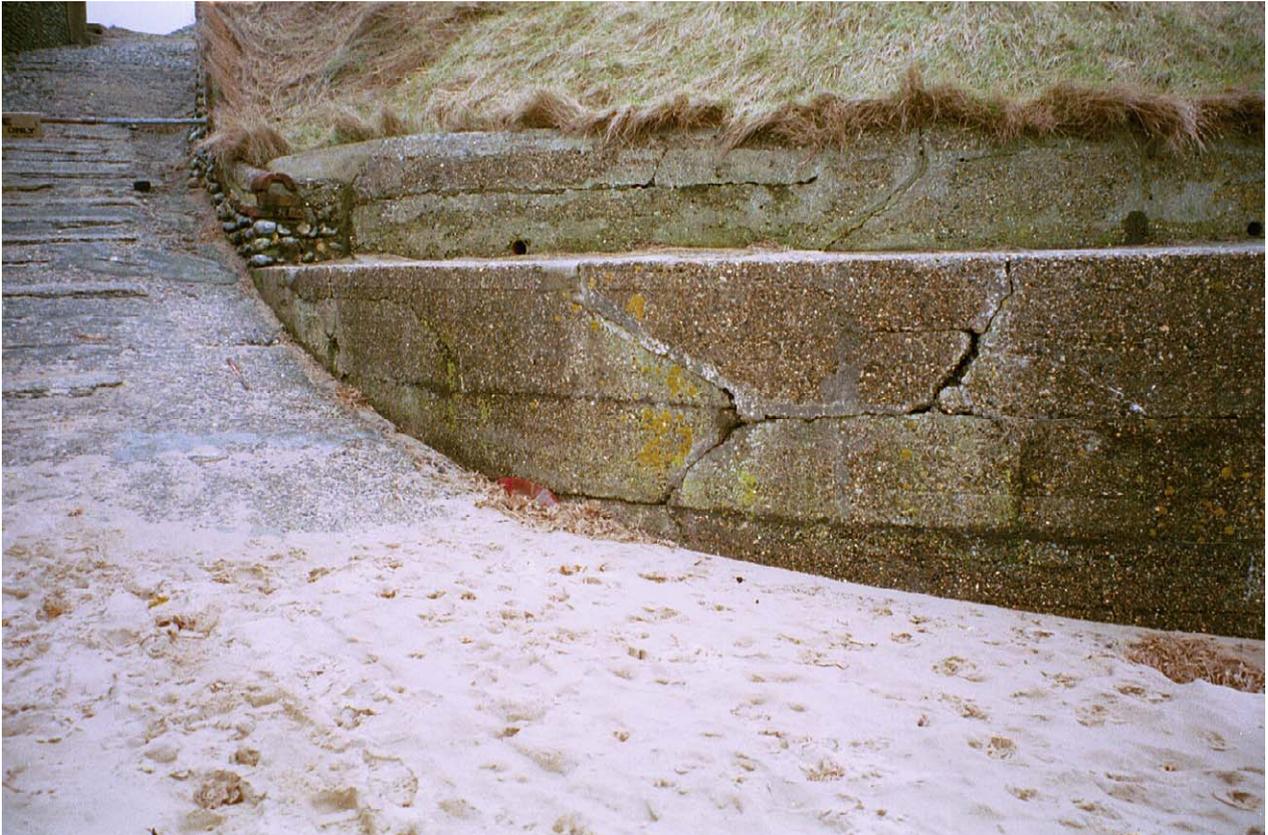
Plate 7.13 Photo MP14 Cracks in the Sea Wall next to an access ramp

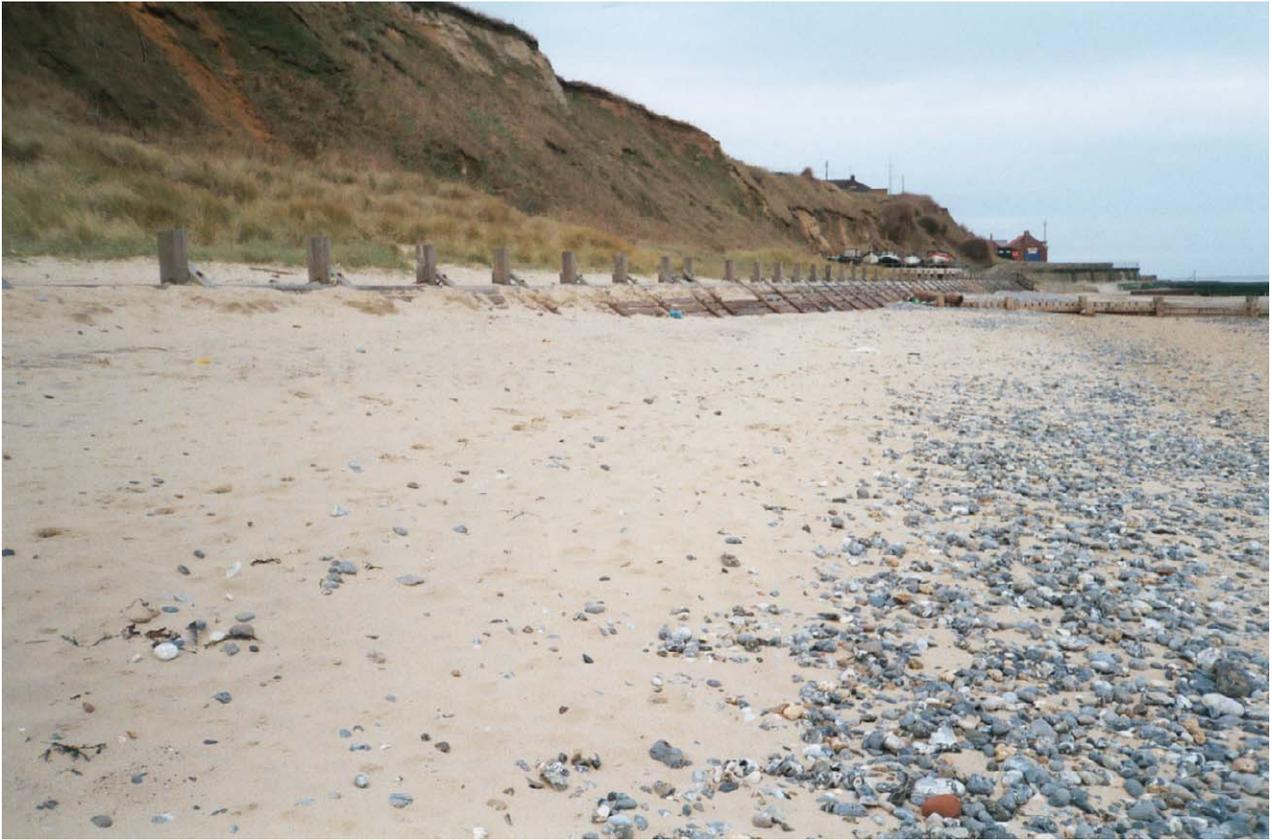
Plate 7.19 Photo M20 General view
