Overstrand to Walcott

Defence Condition Survey

**Interim Report
October 2003**

This report describes work commissioned by North Norfolk District Council whose representative was Mr Peter Frew. The HR Wallingford job numbers were CDR3212 and CDR3214. The work was carried out by Mr Peter Lawton of St La Haye Consulting Engineers. The HR Wallingford project manager was Mr Paul Sayers.

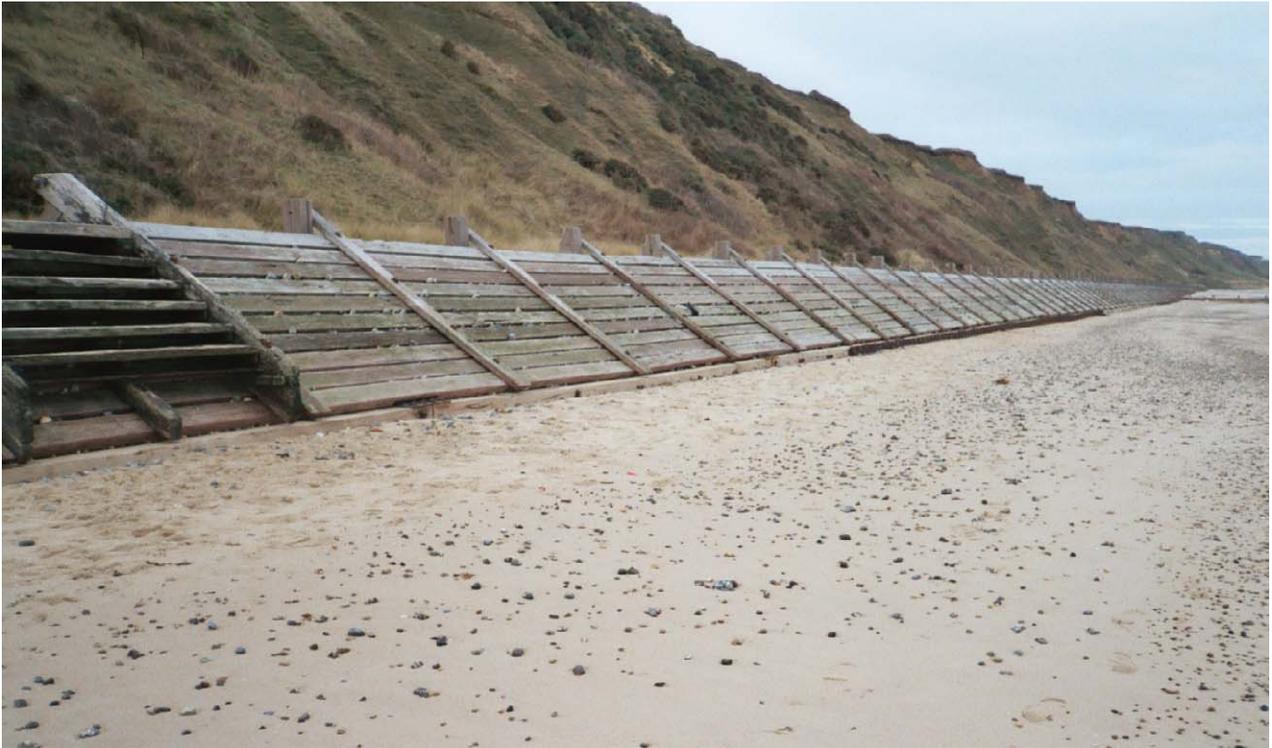
Plate 8.1 Photo M25 Revetment

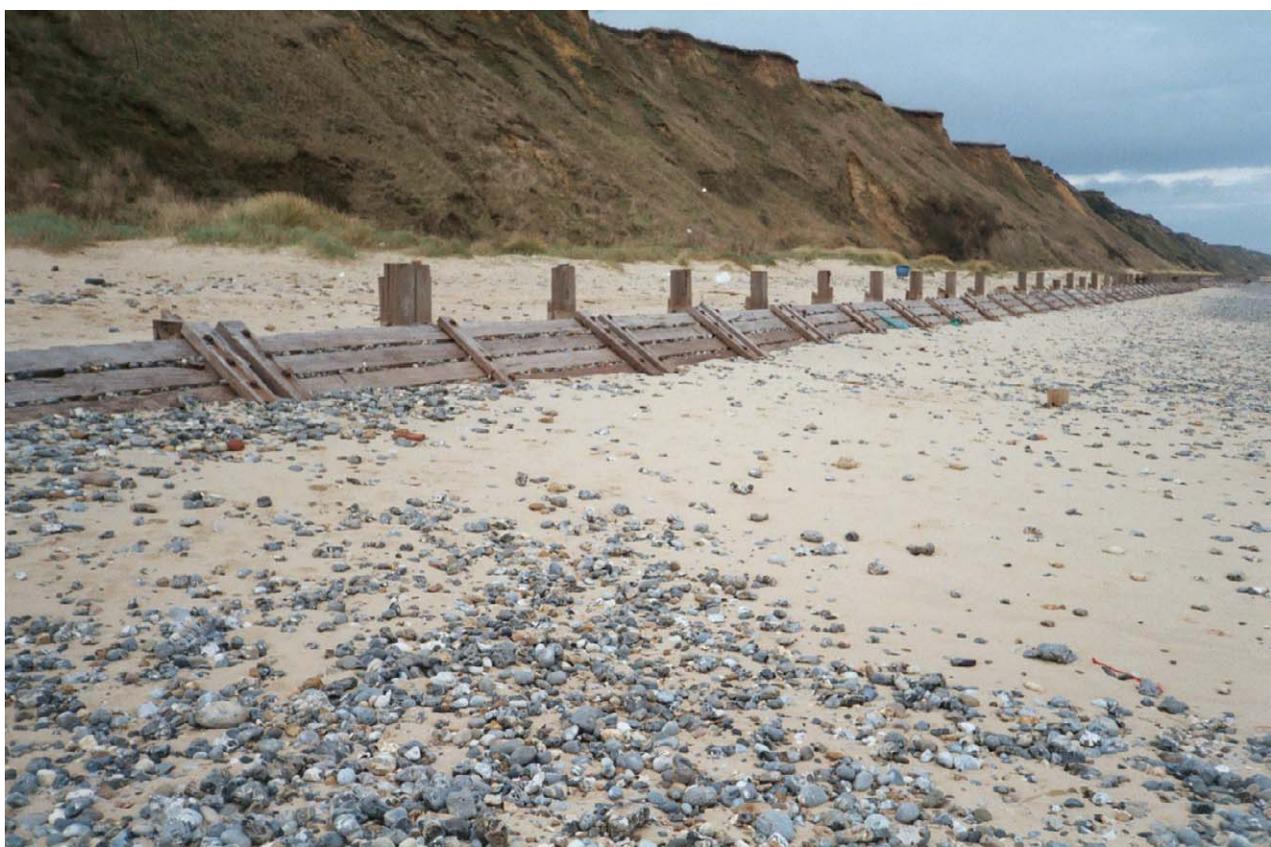
Plate 9.1 Photo M28 Revetment

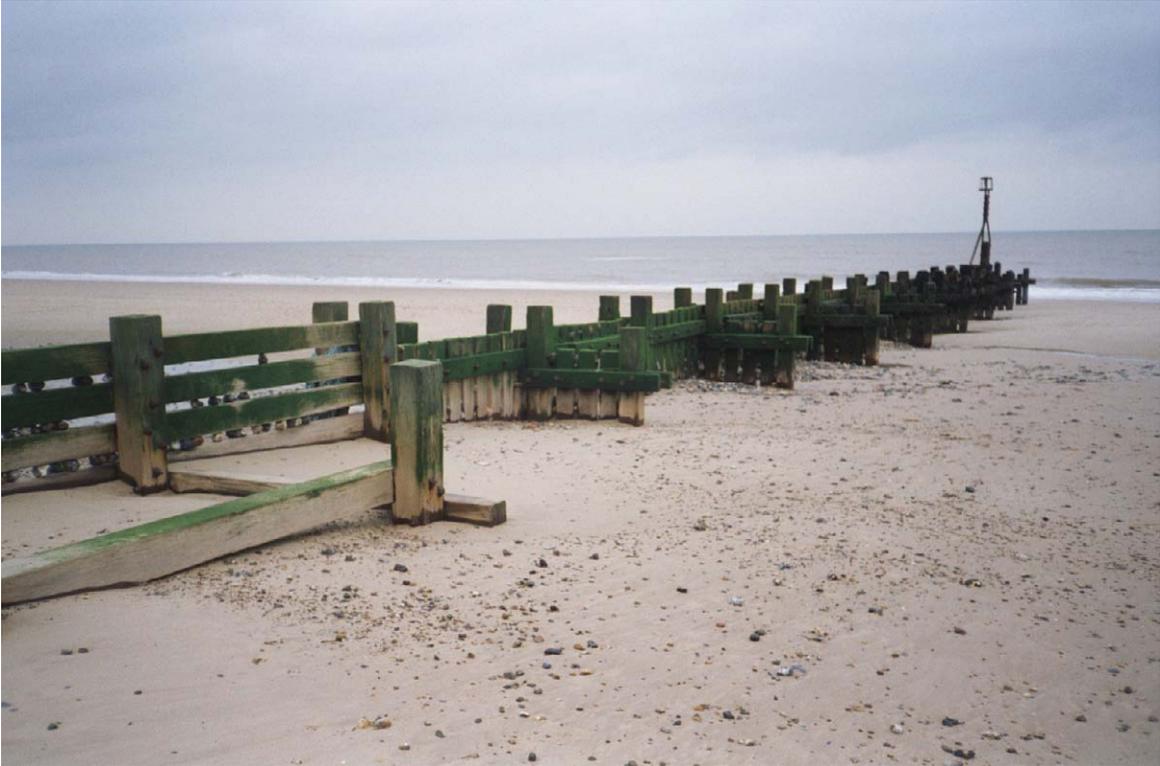
Plate 9.4 Photo W10 Groyne K7

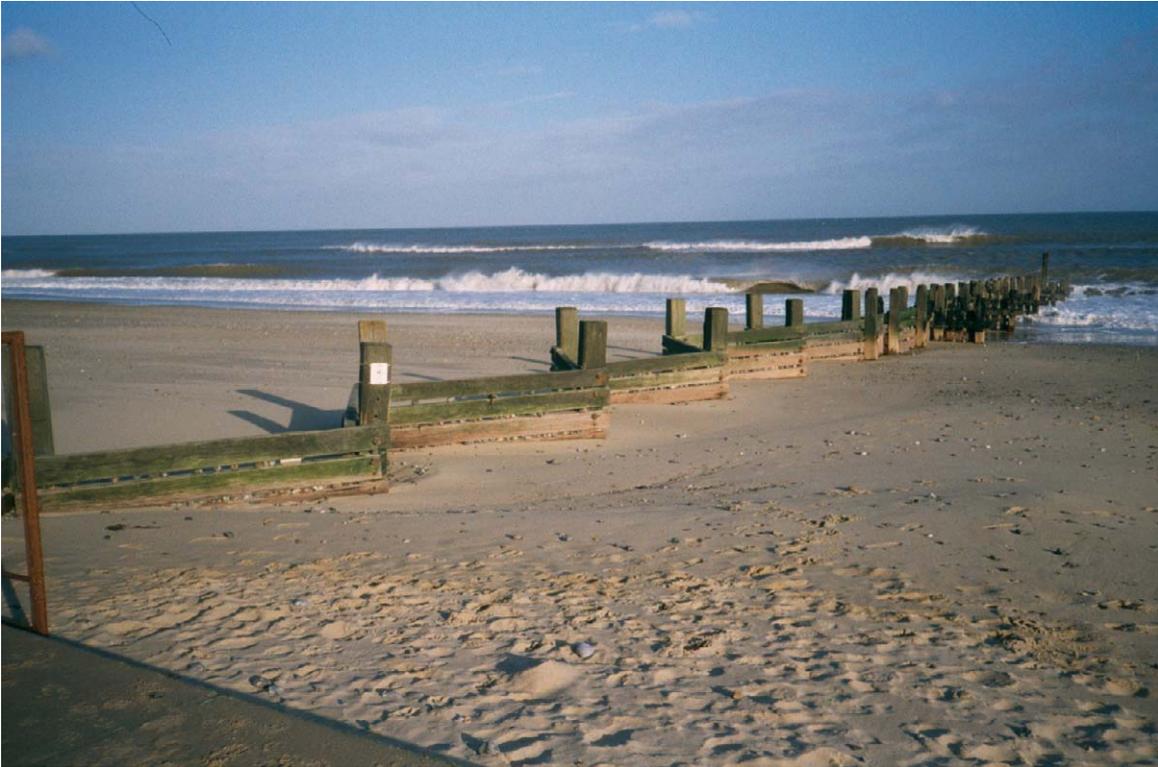
Plate 9.9 Photo WE9 Groyne K24

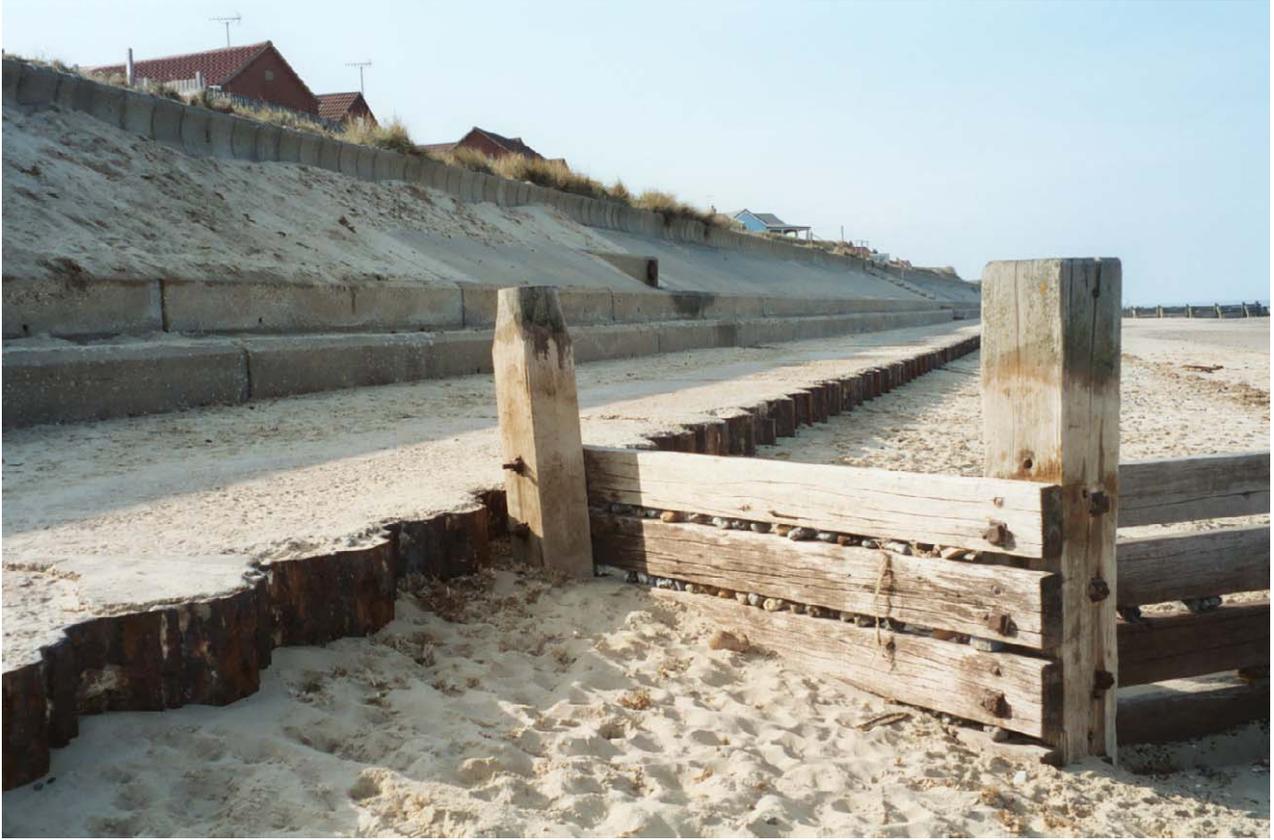
Plate 9.11 Photo XW6 View of Groyne meeting Sea Wall

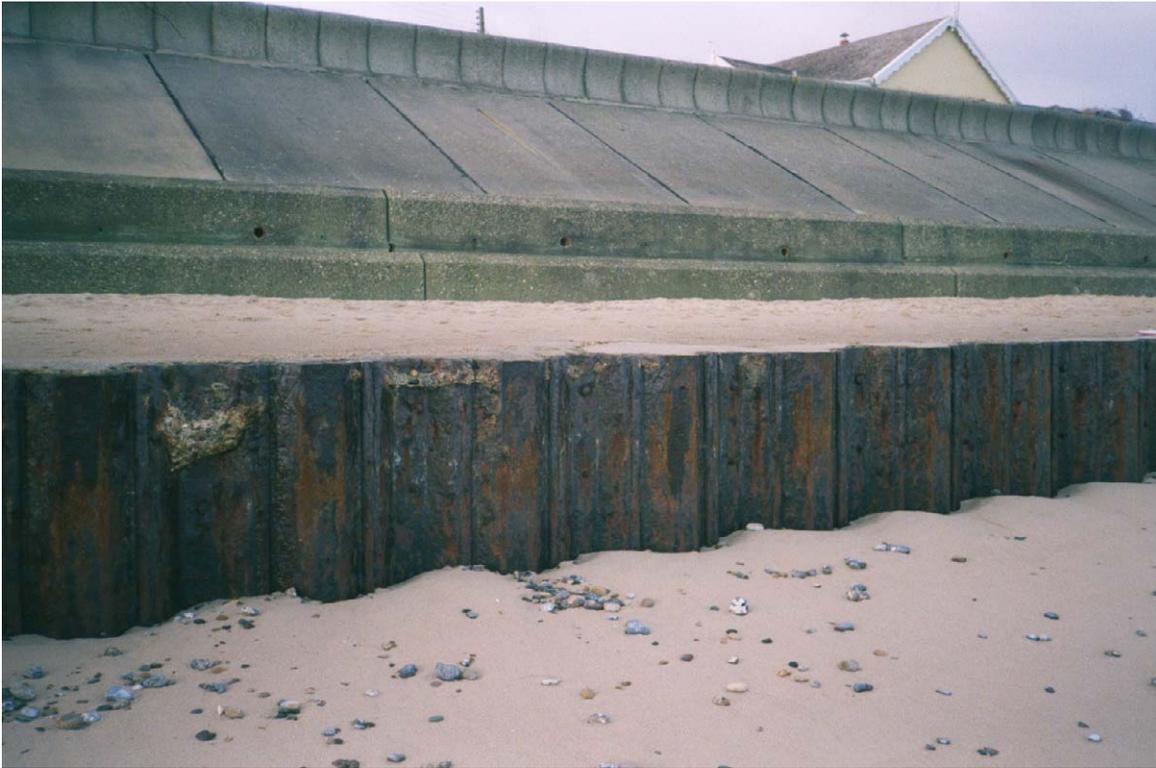
Plate 9.12 Photo WE6 Seawall

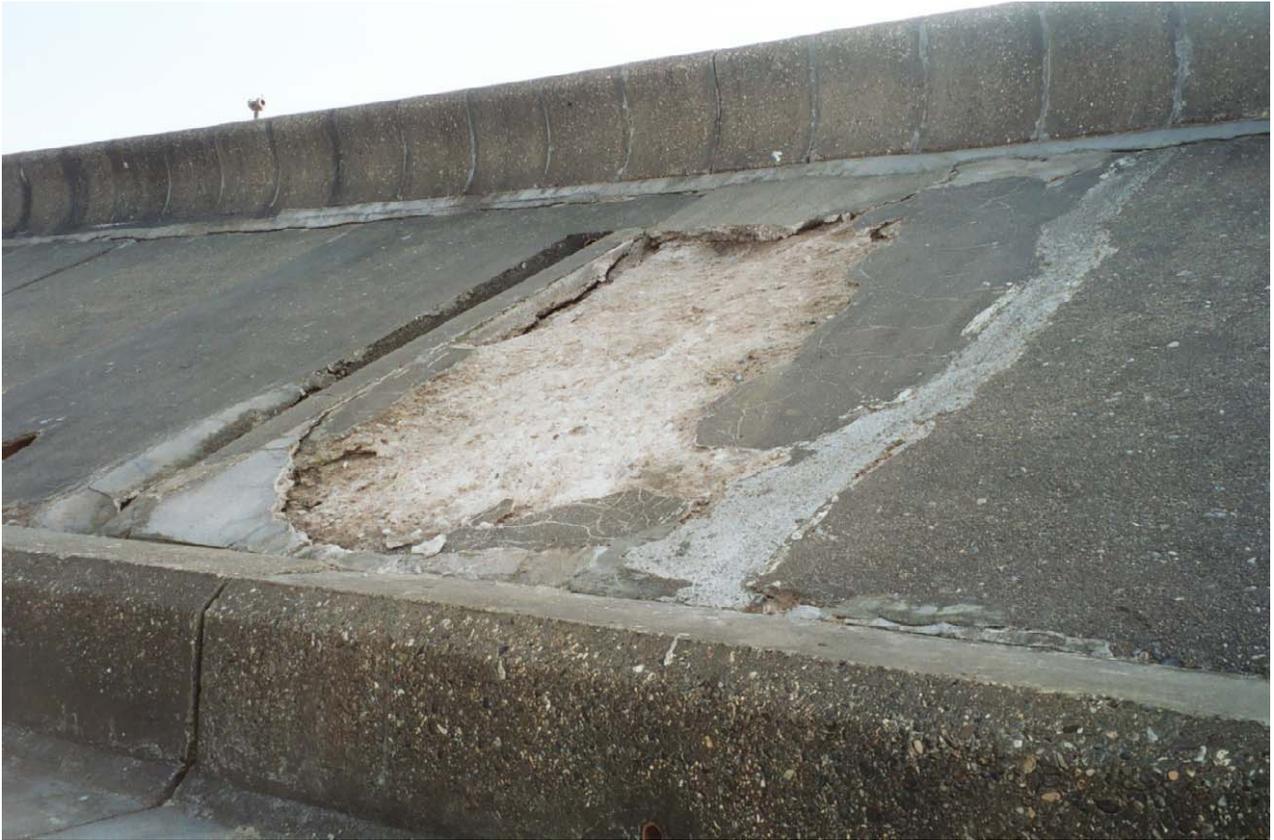
Plate 9.14 Photo XW2 Significant Spalling Damage to Sea Wall

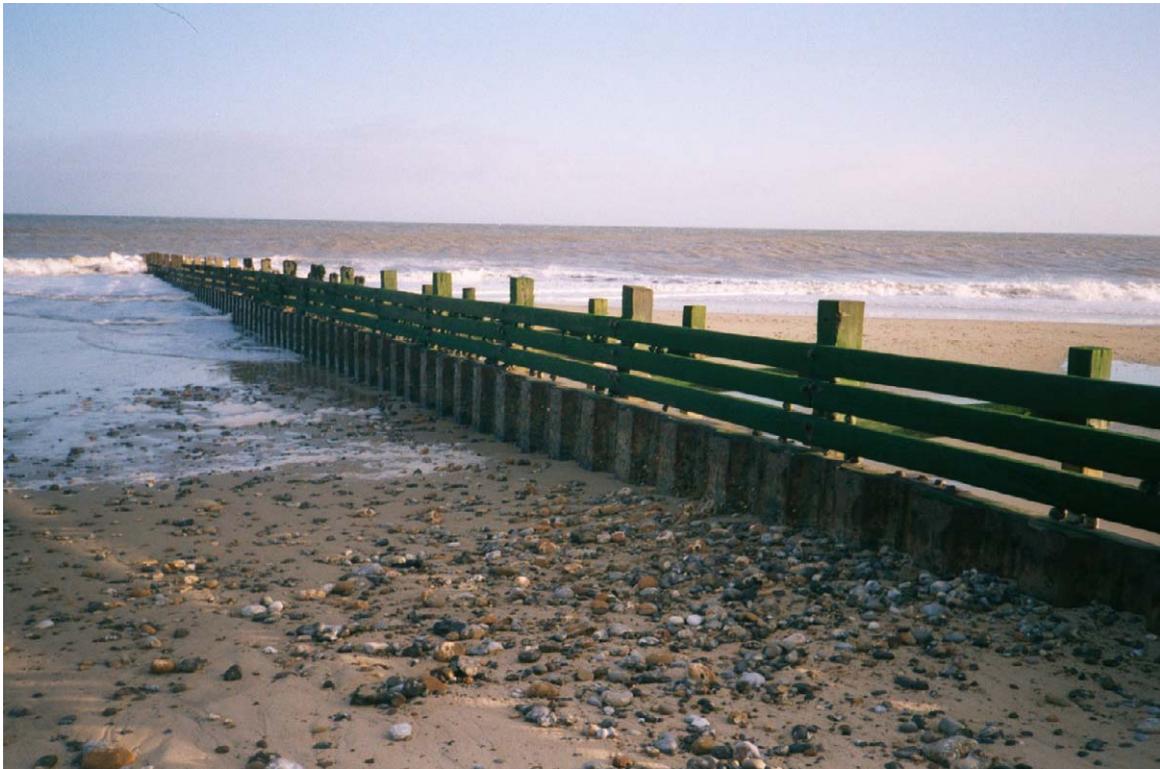
Plate 9.15 Photo WE3 Groyne L1
