# Cromer to Winterton Ness Study

Appendix A: Coastal Defence Condition Survey Update

November 2012  
North Norfolk District Council

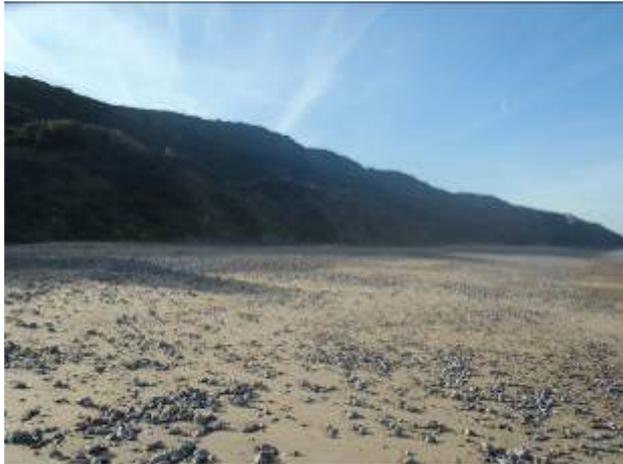
A

Timber groynes are present. These groynes are in a good condition with no damage to the structure or fittings. The beach appears stable and comprises sand and cobbles, there is a build up of beach material around the groynes which are buried around the upper (landward) end.

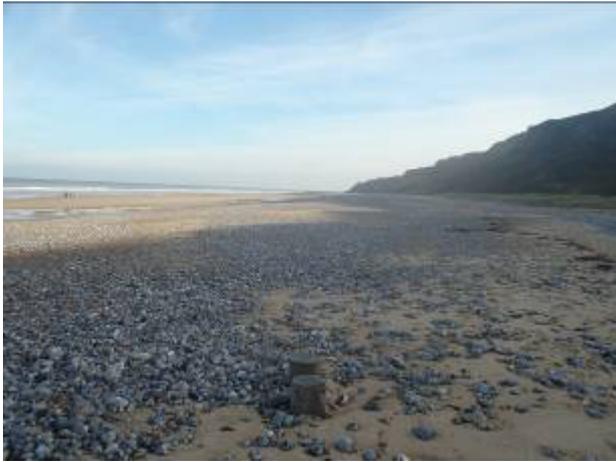
A

Timber groynes are present. These groynes are in a good condition with no damage to the structure or fittings. The beach appears stable and comprises sand and cobbles, there is a build up of beach material around the groynes which are buried around the upper (landward) end.

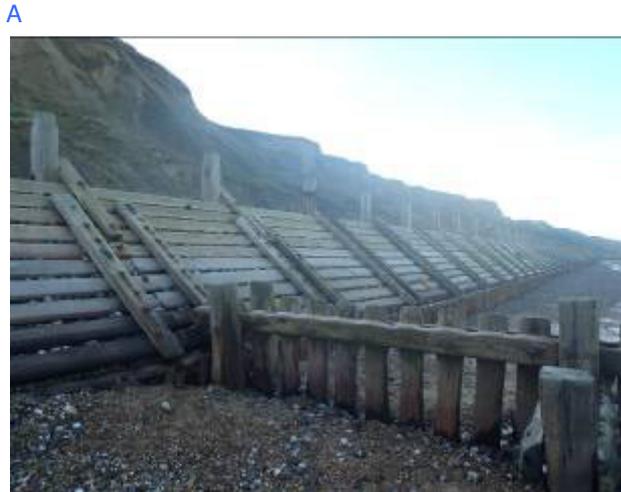
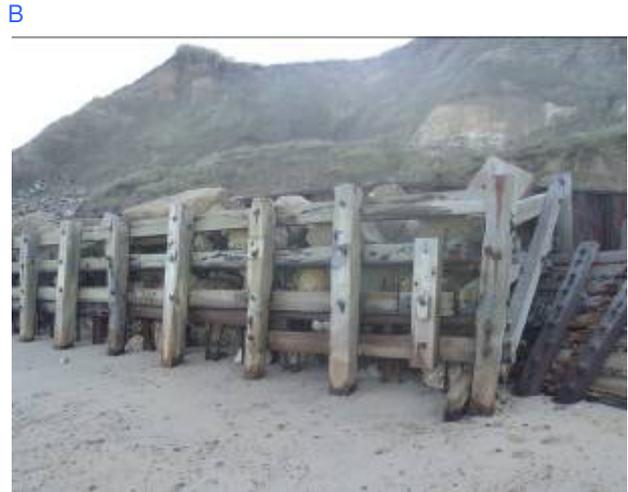
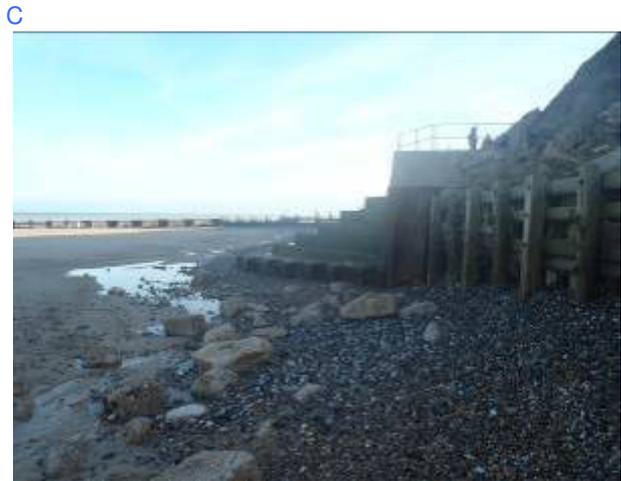
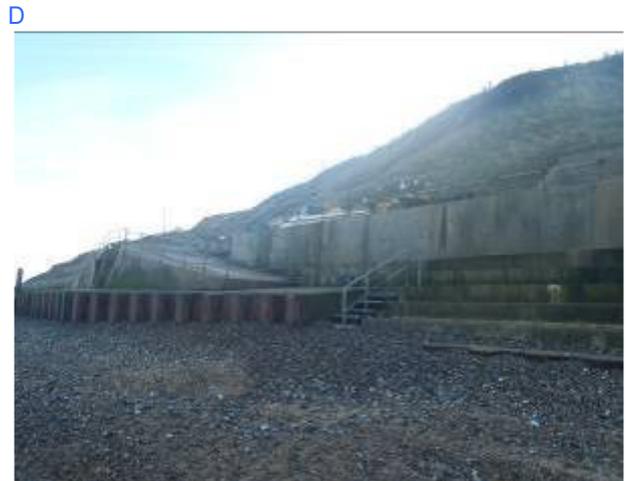
The timber groynes run through the section and are in a good condition with no missing boards and minimal wear on the timber, though the fittings are starting to corrode.

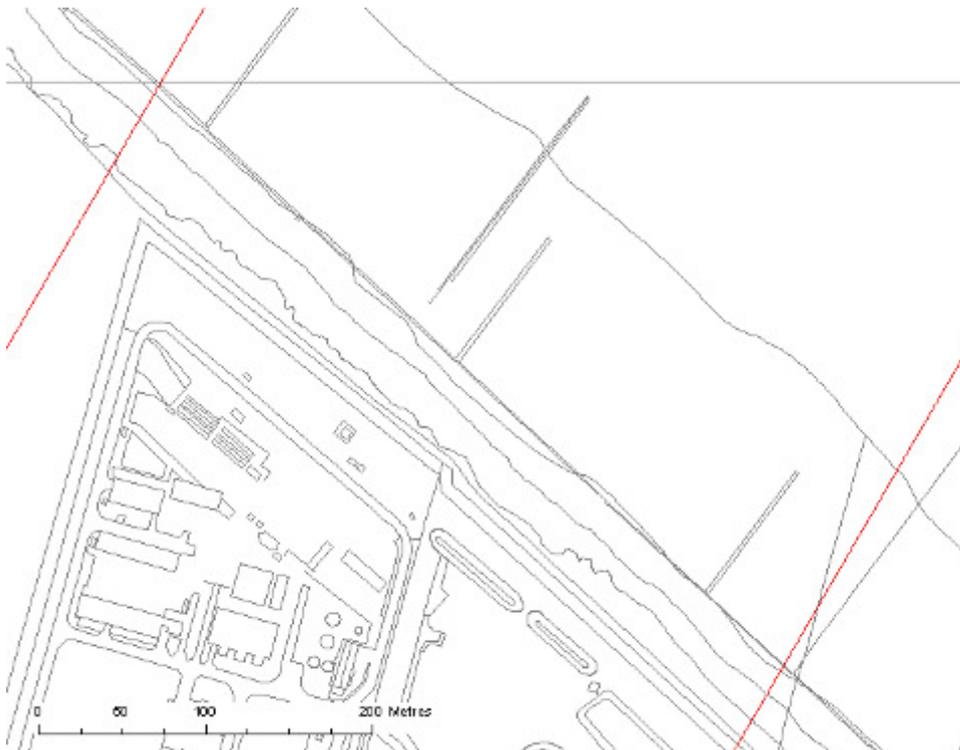
The timber groynes are retaining a significant amount of beach material in the area and are partially buried toward the landward end. The structures are in a good condition with general and expected wear to the timber and corrosion of the fixtures and fittings.

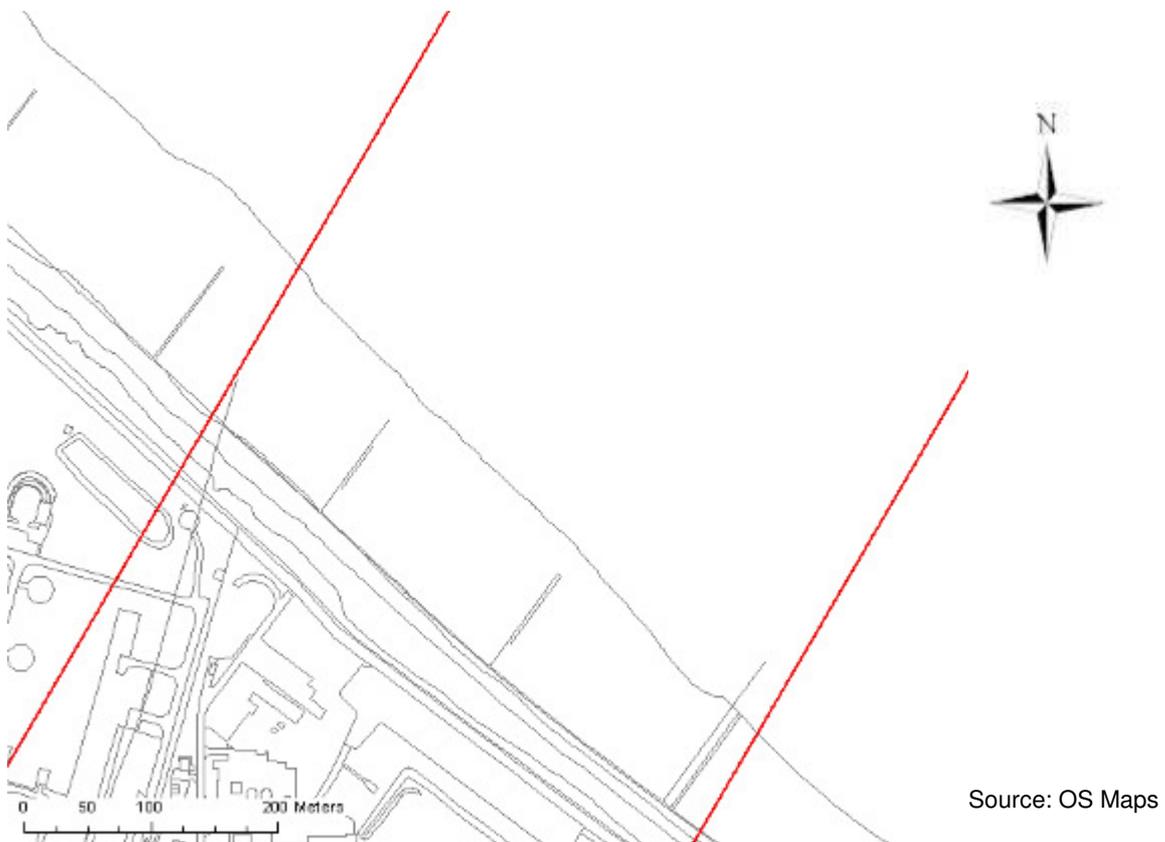
The timber groynes are retaining a significant amount of beach material in the area and are partially buried toward the landward end. The structures are in a good condition with general and expected wear to the timber and corrosion of the fixtures and fittings.

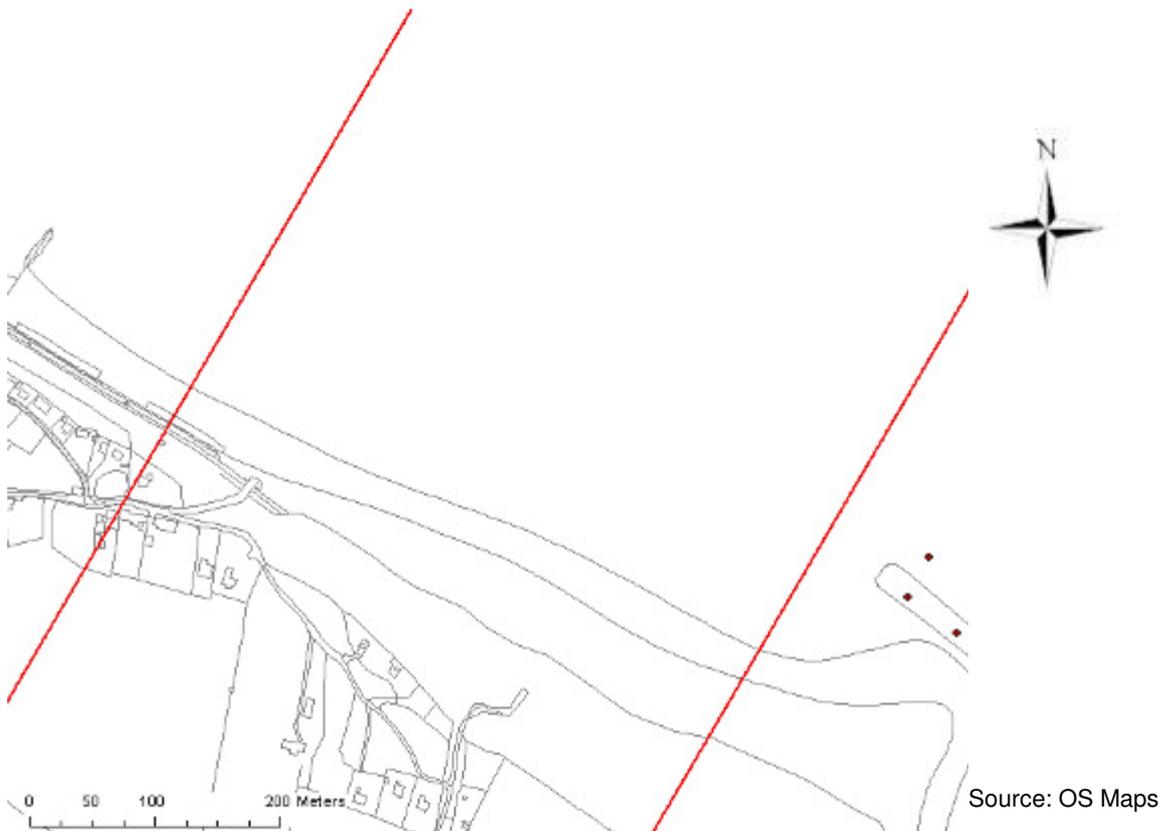
The beach level appears stable and the foreshore narrows towards the western end of the section by the access point.
