Asbestos Refurbishment Survey Of

Potting Sheds North Lodge Park Grounds NR27 0AH

Report Number: S-14709

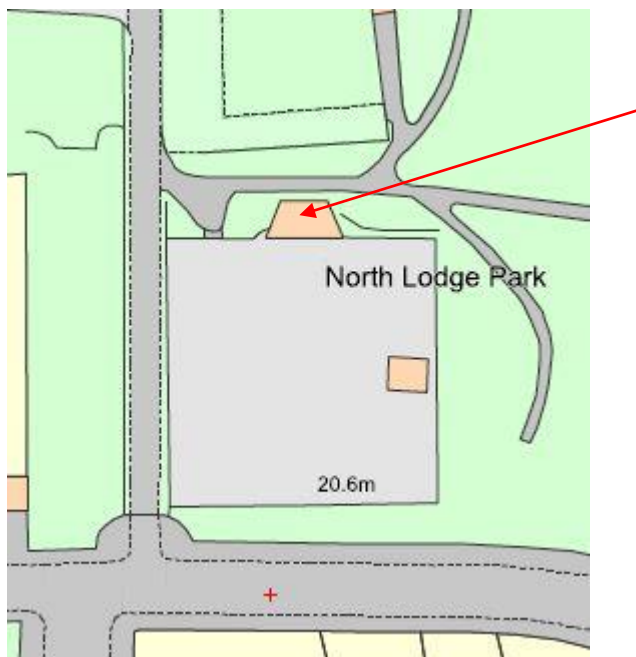
Refurbishment survey of entire shed. Shown by red arrow.

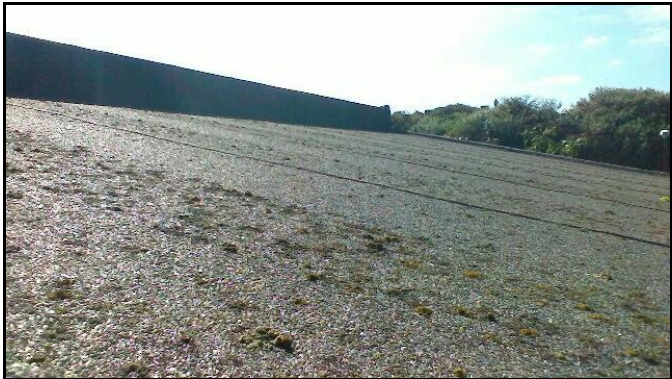
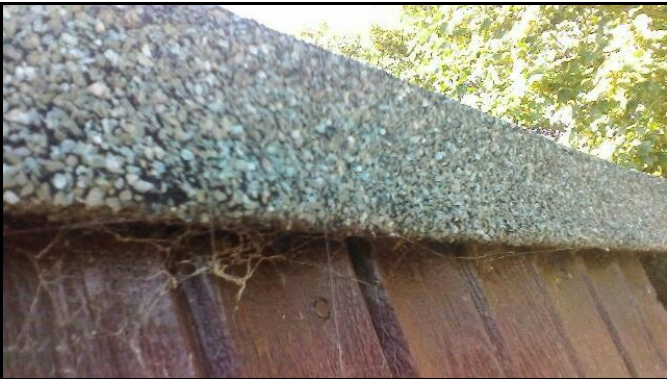
Description		Roof - Bituminous Product			
Sample Notes		Bitumen felt to roof.			
Analysis Result		NADIS			
Extent (approximate)		60 m ²			
Recommendation		No action required			
Notes		-			
Material assessment score					
Product Type		-			0
Surface treatment		-			0
Extent of Damage		-			0
Asbestos type		-			0
Total Score / Risk		-			-

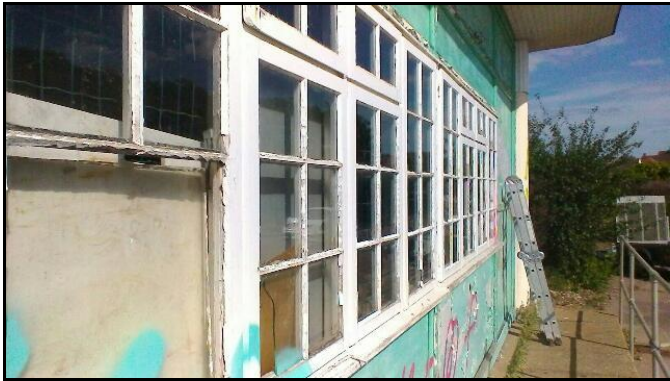
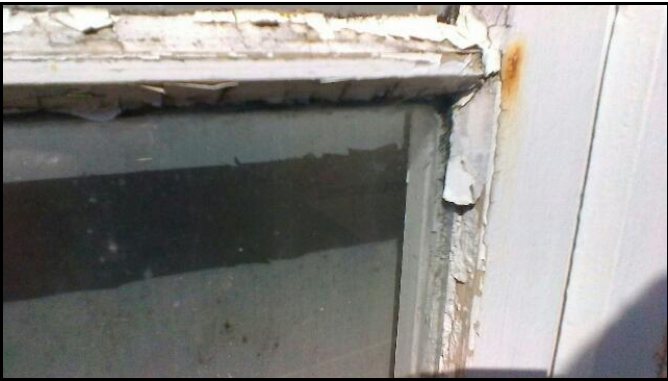
Description		Putty - Mastic			
Sample Notes		Putty to glazing in windows.			
Analysis Result		NADIS			
Extent (approximate)		16 lin m			
Recommendation		No action required			
Notes		-			
Material assessment score					
Product Type	-			0	
Surface treatment	-			0	
Extent of Damage	-			0	
Asbestos type	-			0	
Total Score / Risk	-			-

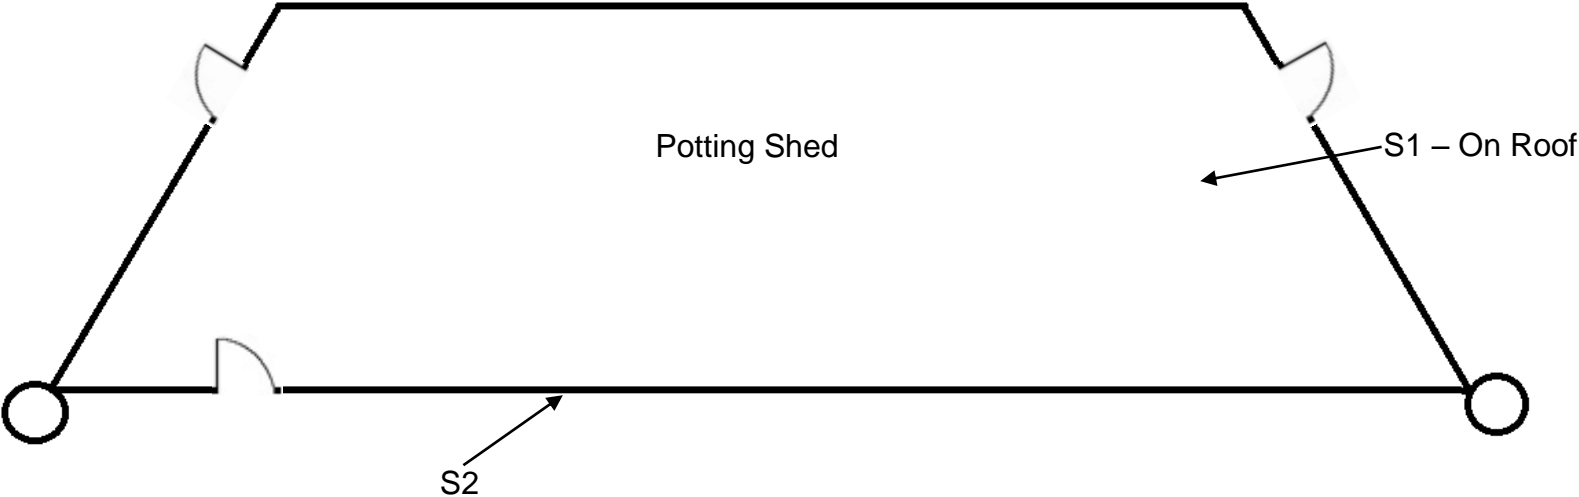
The plans show sampling points and any areas of ACM's are highlighted as defined in the key.
