# Asbestos Survey Report

**1a & 3 New Road  
North Walsham  
Norfolk  
NR28 9DE**

## Refurbishment & Demolition Survey

**Project:** ANG6425

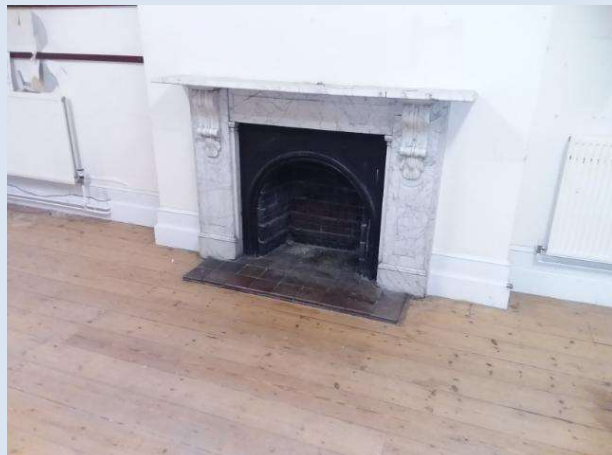
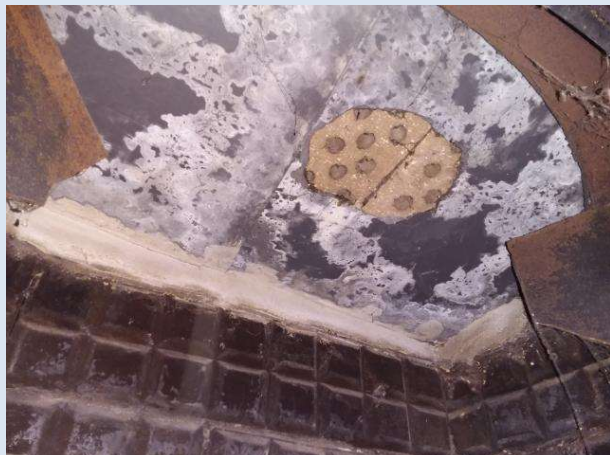
SAMPLE REFERENCE	ID01	ASBESTOS	NO
PRESUMPTION REFERENCE	N/A	RISK LEVEL	N/A

LOCATION	Council chambers	MATERIAL ASSESSMENT	
LEVEL	0	PRODUCT TYPE	0 - NADIS
UNIQUE ROOM IDENTIFIER	/001 Council chambers	DAMAGE	0 - NADIS
DESCRIPTION OF SAMPLE TAKEN OR PRESUMPTION	Cement panels covering chimney flue within fireplace	SURFACE TREATMENT	0 - NADIS
EXTENT	<1m²	ASBESTOS TYPE	0 - NADIS
ACCESSIBILITY	N/A	MATERIAL ASSESSMENT SCORE	0
LEVEL OF IDENTIFICATION	Sampled	POTENTIAL TO RELEASE FIBRES	N/A
DRAWING REFERENCE	See Section 4	RECOMMENDATIONS COMMENTS	
RECOMMENDATIONS			
No Action Required			
LOCATION NON-SUSPECT ITEMS			
Lathe and plaster ceiling, solid walls, timber floorboards, wall mounted metal radiators with uninsulated metal pipes, stone surround to fireplace, timber framed windows, timber door and frame.

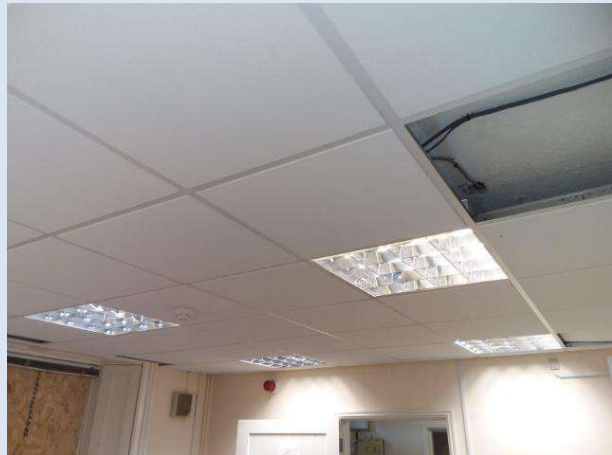
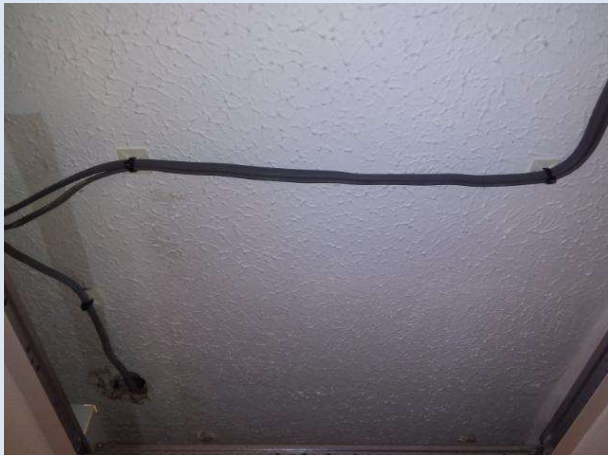
SAMPLE REFERENCE	ID02	ASBESTOS	NO
PRESUMPTION REFERENCE	N/A	RISK LEVEL	N/A

LOCATION	Office	MATERIAL ASSESSMENT	
LEVEL	0	PRODUCT TYPE	0 - NADIS
UNIQUE ROOM IDENTIFIER	/002 Office	DAMAGE	0 - NADIS
DESCRIPTION OF SAMPLE TAKEN OR PRESUMPTION	Textured coating bonded onto plasterboard ceiling above suspended grid ceiling tiles	SURFACE TREATMENT	0 - NADIS
EXTENT	16m²	ASBESTOS TYPE	0 - NADIS
ACCESSIBILITY	N/A	MATERIAL ASSESSMENT SCORE	0
LEVEL OF IDENTIFICATION	Sampled	POTENTIAL TO RELEASE FIBRES	N/A
DRAWING REFERENCE	See Section 4	RECOMMENDATIONS COMMENTS	
RECOMMENDATIONS			
No Action Required			
LOCATION NON-SUSPECT ITEMS			
Plasterboard ceiling with lathe and plaster ceiling above, solid walls, timber floor covered with timber sheets and carpet, wall mounted metal radiator with uninsulated metal pipes, stone surround to fireplace, timber framed window, timber doors and frames.

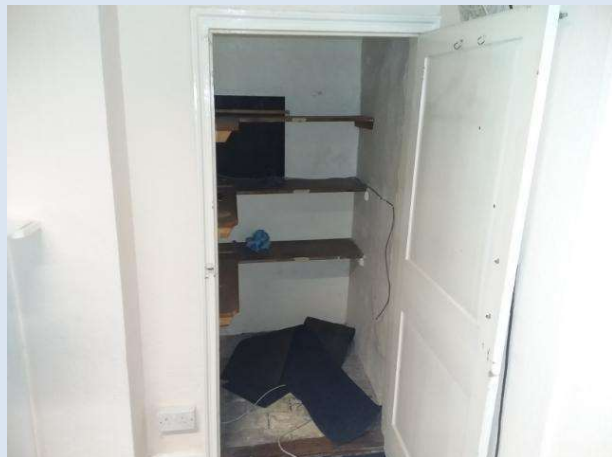
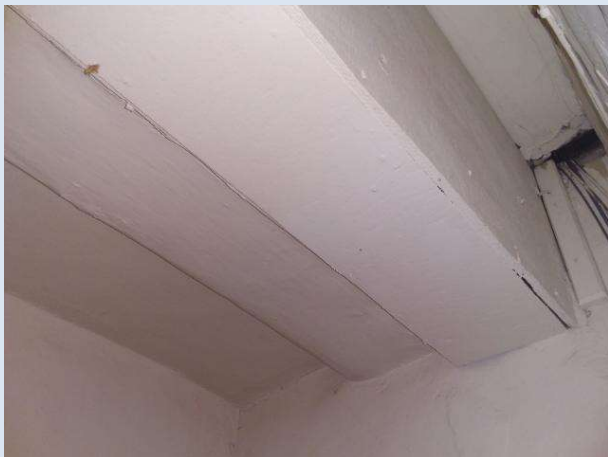
SAMPLE REFERENCE	ID03	ASBESTOS	NO
PRESUMPTION REFERENCE	N/A	RISK LEVEL	N/A

LOCATION	Reception cupboard	MATERIAL ASSESSMENT	
LEVEL	0	PRODUCT TYPE	0 - NADIS
UNIQUE ROOM IDENTIFIER	/004 Reception cupboard	DAMAGE	0 - NADIS
DESCRIPTION OF SAMPLE TAKEN OR PRESUMPTION	Insulating board boxing	SURFACE TREATMENT	0 - NADIS
EXTENT	1m²	ASBESTOS TYPE	0 - NADIS
ACCESSIBILITY	N/A	MATERIAL ASSESSMENT SCORE	0
LEVEL OF IDENTIFICATION	Sampled	POTENTIAL TO RELEASE FIBRES	N/A
DRAWING REFERENCE	See Section 4	RECOMMENDATIONS COMMENTS	
RECOMMENDATIONS			
No Action Required			
LOCATION NON-SUSPECT ITEMS			
Lathe and plaster ceiling, solid walls, solid floor, timber door and frame.

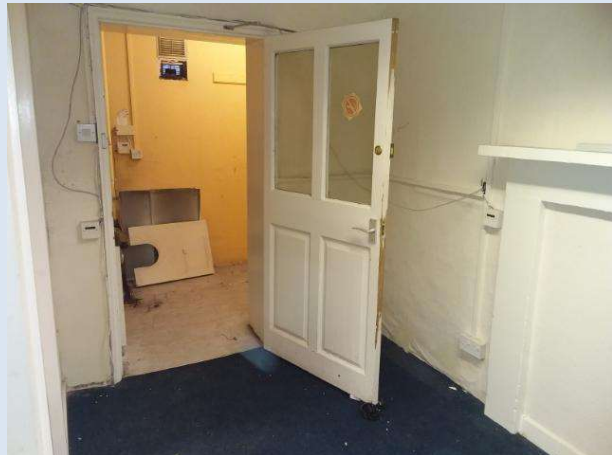
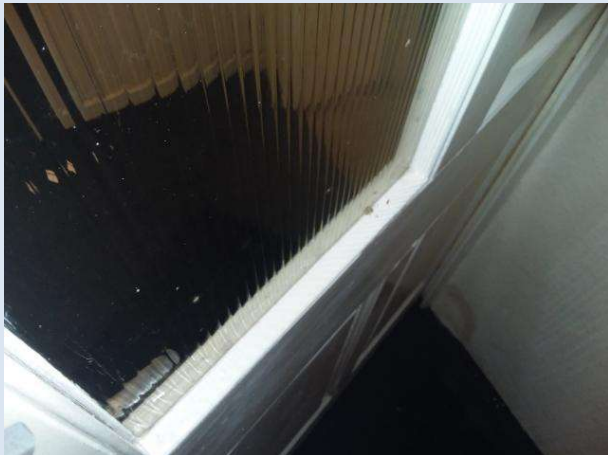
SAMPLE REFERENCE	ID04	ASBESTOS	NO
PRESUMPTION REFERENCE	N/A	RISK LEVEL	N/A

LOCATION	House admin	MATERIAL ASSESSMENT	
LEVEL	0	PRODUCT TYPE	0 - NADIS
UNIQUE ROOM IDENTIFIER	/005 House admin	DAMAGE	0 - NADIS
DESCRIPTION OF SAMPLE TAKEN OR PRESUMPTION	Putty to windows in door	SURFACE TREATMENT	0 - NADIS
EXTENT	3lm	ASBESTOS TYPE	0 - NADIS
ACCESSIBILITY	N/A	MATERIAL ASSESSMENT SCORE	0
LEVEL OF IDENTIFICATION	Sampled	POTENTIAL TO RELEASE FIBRES	N/A
DRAWING REFERENCE	See Section 4	RECOMMENDATIONS COMMENTS	
RECOMMENDATIONS			
No Action Required			
LOCATION NON-SUSPECT ITEMS			
Lathe and plaster ceiling, solid and plasterboard walls, solid floor covered with carpet, wall mounted metal radiators with uninsulated metal pipes, timber framed windows, timber doors and frames.

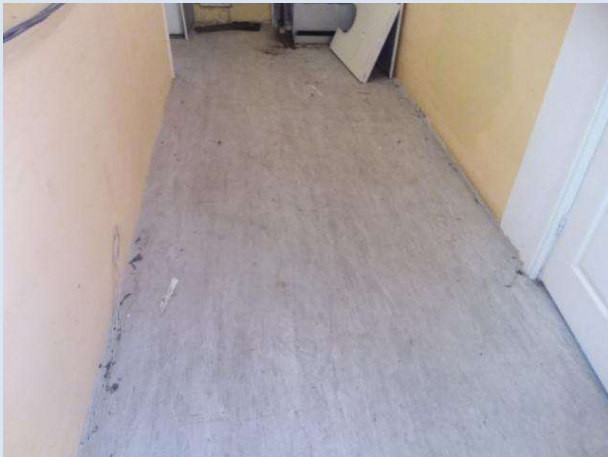
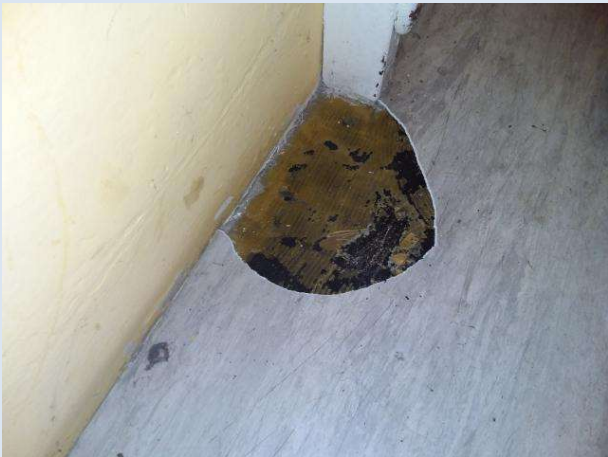
SAMPLE REFERENCE	ID05	ASBESTOS	YES
PRESUMPTION REFERENCE	N/A	RISK LEVEL	Very Low

LOCATION	Corridor	MATERIAL ASSESSMENT	
LEVEL	0	PRODUCT TYPE	1 - Asbestos reinforced composites etc.
UNIQUE ROOM IDENTIFIER	/007 Corridor	DAMAGE	0 - No Visible Damage
DESCRIPTION OF SAMPLE TAKEN OR PRESUMPTION	Bitumen adhesive to floor beneath modern vinyl	SURFACE TREATMENT	0 - Composite materials containing asbestos, reinforced plastics, resins, vinyl tiles
EXTENT	18m²	ASBESTOS TYPE	1 - Chrysotile
ACCESSIBILITY	Usually inaccessible	MATERIAL ASSESSMENT SCORE	2
LEVEL OF IDENTIFICATION	Sampled	POTENTIAL TO RELEASE FIBRES	Very Low

DRAWING REFERENCE	See Section 4	RECOMMENDATIONS COMMENTS	
RECOMMENDATIONS			
Removal by Trained Operatives			
LOCATION NON-SUSPECT ITEMS			
Plasterboard ceiling, solid walls, solid floor covered with modern vinyl, modern floor standing boiler with metal flue, wall mounted metal radiator with uninsulated metal pipes, timber framed window, timber doors and frames.

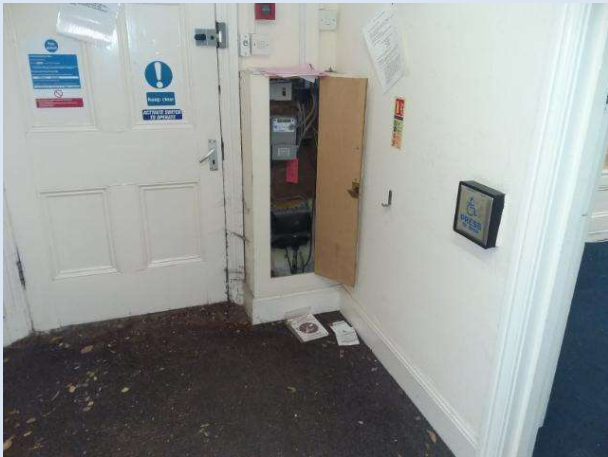
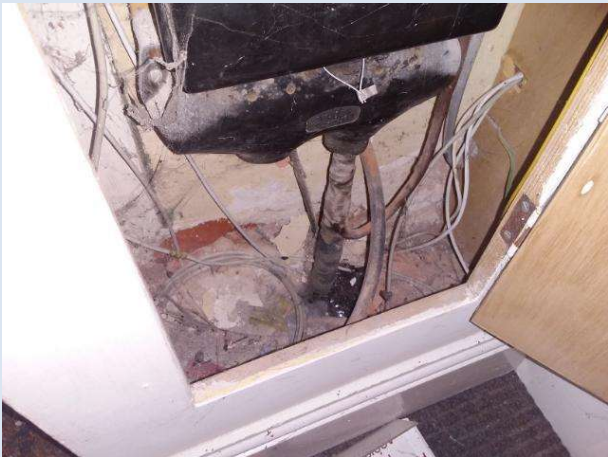
SAMPLE REFERENCE	ID06	ASBESTOS	NO
PRESUMPTION REFERENCE	N/A	RISK LEVEL	N/A

LOCATION	Reception lobby	MATERIAL ASSESSMENT	
LEVEL	0	PRODUCT TYPE	0 - NADIS
UNIQUE ROOM IDENTIFIER	/009 Reception lobby	DAMAGE	0 - NADIS
DESCRIPTION OF SAMPLE TAKEN OR PRESUMPTION	Textile cable wrap	SURFACE TREATMENT	0 - NADIS
EXTENT	<1lm	ASBESTOS TYPE	0 - NADIS
ACCESSIBILITY	N/A	MATERIAL ASSESSMENT SCORE	0
LEVEL OF IDENTIFICATION	Sampled	POTENTIAL TO RELEASE FIBRES	N/A
DRAWING REFERENCE	See Section 4	RECOMMENDATIONS COMMENTS	
RECOMMENDATIONS			
No Action Required			
LOCATION NON-SUSPECT ITEMS			
Lathe and plaster ceiling, solid walls, solid floor, wall mounted metal radiators with uninsulated metal pipes, timber doors and frames.

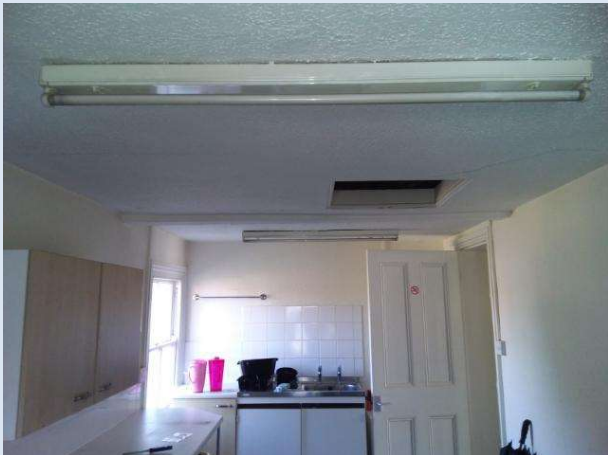
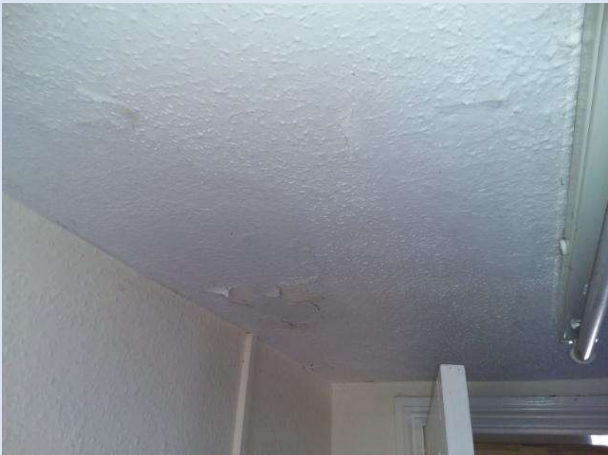
SAMPLE REFERENCE	ID07	ASBESTOS	NO
PRESUMPTION REFERENCE	N/A	RISK LEVEL	N/A

LOCATION	Kitchen	MATERIAL ASSESSMENT	
LEVEL	1	PRODUCT TYPE	0 - NADIS
UNIQUE ROOM IDENTIFIER	/001 Kitchen	DAMAGE	0 - NADIS
DESCRIPTION OF SAMPLE TAKEN OR PRESUMPTION	Textured coating bonded onto plasterboard ceiling	SURFACE TREATMENT	0 - NADIS
EXTENT	12m²	ASBESTOS TYPE	0 - NADIS
ACCESSIBILITY	N/A	MATERIAL ASSESSMENT SCORE	0
LEVEL OF IDENTIFICATION	Sampled	POTENTIAL TO RELEASE FIBRES	N/A
DRAWING REFERENCE	See Section 4	RECOMMENDATIONS COMMENTS	
RECOMMENDATIONS			
No Action Required			
LOCATION NON-SUSPECT ITEMS			
Plasterboard ceiling, solid walls, timber floor covered with timber panels and carpet, wall mounted metal radiator with uninsulated metal pipes, timber framed windows, timber door and frame.

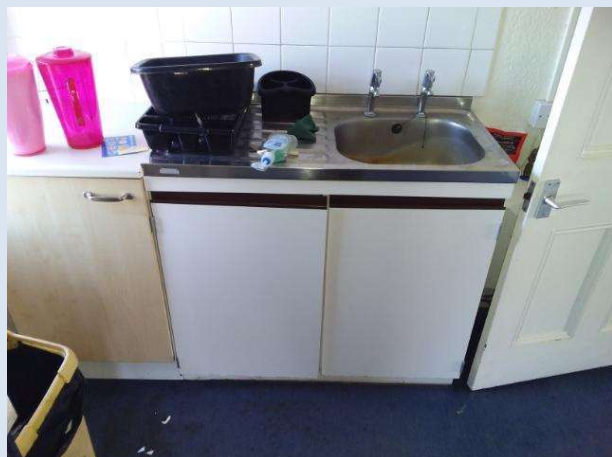
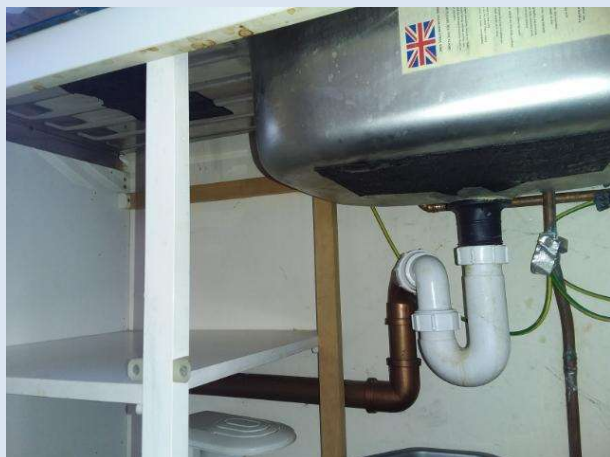
SAMPLE REFERENCE	ID08	ASBESTOS	NO
PRESUMPTION REFERENCE	N/A	RISK LEVEL	N/A

LOCATION	Kitchen	MATERIAL ASSESSMENT	
LEVEL	1	PRODUCT TYPE	0 - NADIS
UNIQUE ROOM IDENTIFIER	/001 Kitchen	DAMAGE	0 - NADIS
DESCRIPTION OF SAMPLE TAKEN OR PRESUMPTION	Sink pad	SURFACE TREATMENT	0 - NADIS
EXTENT	2no	ASBESTOS TYPE	0 - NADIS
ACCESSIBILITY	N/A	MATERIAL ASSESSMENT SCORE	0
LEVEL OF IDENTIFICATION	Sampled	POTENTIAL TO RELEASE FIBRES	N/A
DRAWING REFERENCE	See Section 4	RECOMMENDATIONS COMMENTS	
RECOMMENDATIONS			
No Action Required			
LOCATION NON-SUSPECT ITEMS

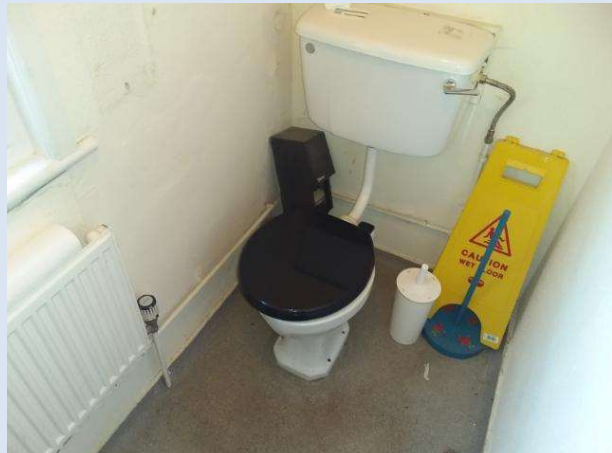
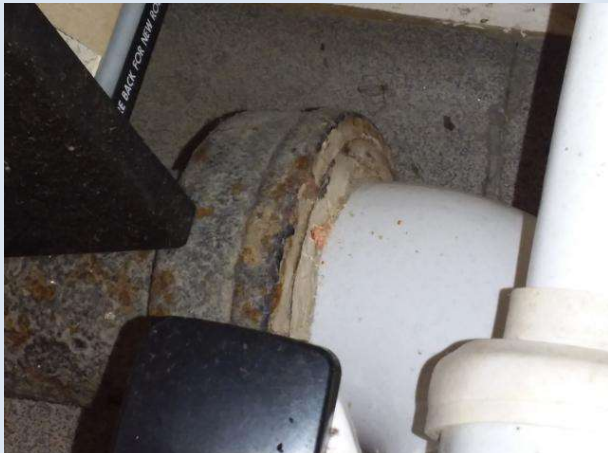
SAMPLE REFERENCE	ID09	ASBESTOS	NO
PRESUMPTION REFERENCE	N/A	RISK LEVEL	N/A

LOCATION	WC	MATERIAL ASSESSMENT	
LEVEL	1	PRODUCT TYPE	0 - NADIS
UNIQUE ROOM IDENTIFIER	/003 WC	DAMAGE	0 - NADIS
DESCRIPTION OF SAMPLE TAKEN OR PRESUMPTION	Putty to soil pipe	SURFACE TREATMENT	0 - NADIS
EXTENT	<1lm	ASBESTOS TYPE	0 - NADIS
ACCESSIBILITY	N/A	MATERIAL ASSESSMENT SCORE	0
LEVEL OF IDENTIFICATION	Sampled	POTENTIAL TO RELEASE FIBRES	N/A
DRAWING REFERENCE	See Section 4	RECOMMENDATIONS COMMENTS	
RECOMMENDATIONS			
No Action Required			
LOCATION NON-SUSPECT ITEMS			
Plasterboard ceiling, solid walls, timber floor covered with modern vinyl, wall mounted metal radiator with uninsulated metal pipes, timber framed window, timber door and frame.

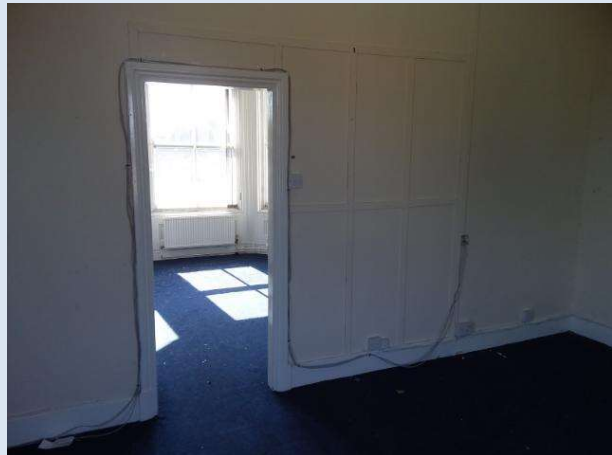
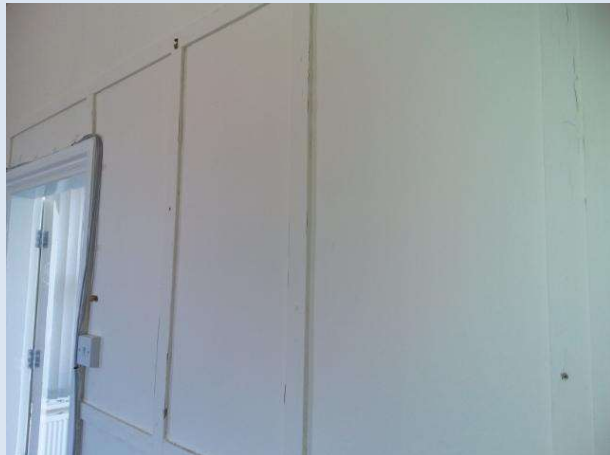
SAMPLE REFERENCE	ID10	ASBESTOS	NO
PRESUMPTION REFERENCE	N/A	RISK LEVEL	N/A

LOCATION	Office	MATERIAL ASSESSMENT	
LEVEL	1	PRODUCT TYPE	0 - NADIS
UNIQUE ROOM IDENTIFIER	/005 Office	DAMAGE	0 - NADIS
DESCRIPTION OF SAMPLE TAKEN OR PRESUMPTION	Insulating board forming partition wall	SURFACE TREATMENT	0 - NADIS
EXTENT	2m²	ASBESTOS TYPE	0 - NADIS
ACCESSIBILITY	N/A	MATERIAL ASSESSMENT SCORE	0
LEVEL OF IDENTIFICATION	Sampled	POTENTIAL TO RELEASE FIBRES	N/A
DRAWING REFERENCE	See Section 4	RECOMMENDATIONS COMMENTS	
RECOMMENDATIONS			
No Action Required			
LOCATION NON-SUSPECT ITEMS			
Lathe and plaster ceiling, solid walls, timber floor covered with carpet, wall mounted metal radiators with uninsulated metal pipes, timber framed windows, timber doors and frames.

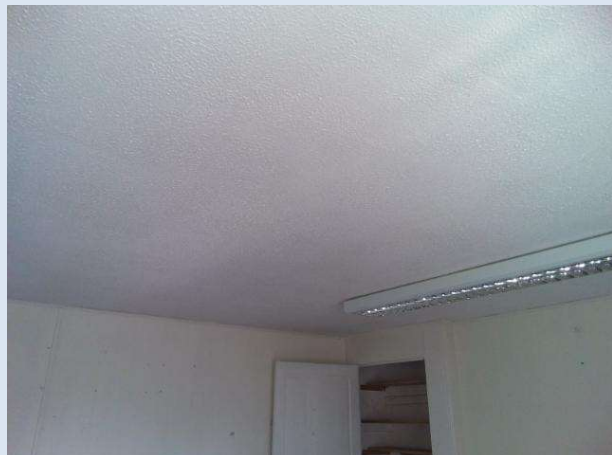
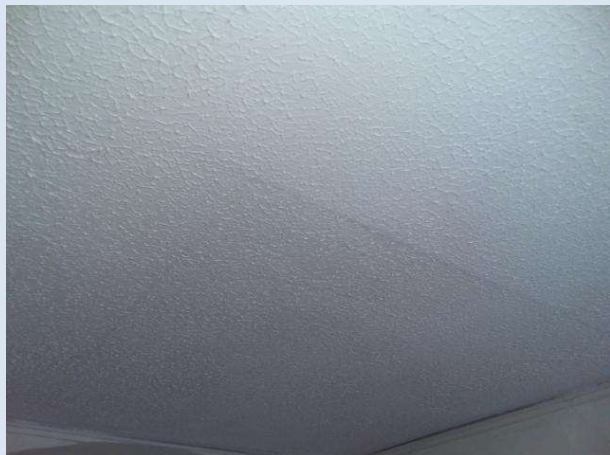
SAMPLE REFERENCE	ID12	ASBESTOS	NO
PRESUMPTION REFERENCE	N/A	RISK LEVEL	N/A

LOCATION	Office	MATERIAL ASSESSMENT	
LEVEL	1	PRODUCT TYPE	0 - NADIS
UNIQUE ROOM IDENTIFIER	/007 Office	DAMAGE	0 - NADIS
DESCRIPTION OF SAMPLE TAKEN OR PRESUMPTION	Textured coating bonded onto plasterboard ceiling	SURFACE TREATMENT	0 - NADIS
EXTENT	20m²	ASBESTOS TYPE	0 - NADIS
ACCESSIBILITY	N/A	MATERIAL ASSESSMENT SCORE	0
LEVEL OF IDENTIFICATION	Sampled	POTENTIAL TO RELEASE FIBRES	N/A
DRAWING REFERENCE	See Section 4	RECOMMENDATIONS COMMENTS	
RECOMMENDATIONS			
No Action Required			
LOCATION NON-SUSPECT ITEMS			
Plasterboard ceiling, solid walls, timber floor covered with carpet, wall mounted metal radiator with uninsulated metal pipes, timber framed window, timber door and frame.

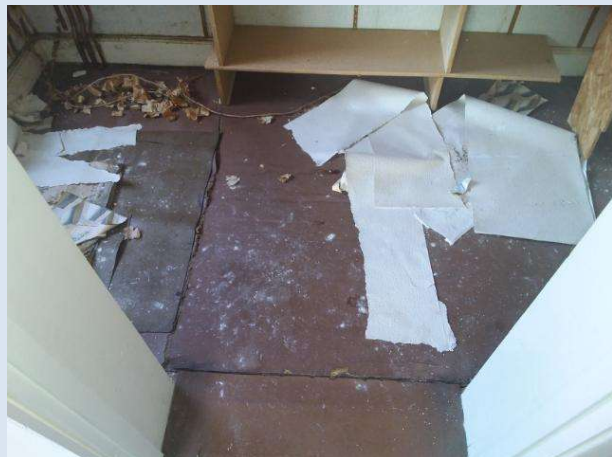
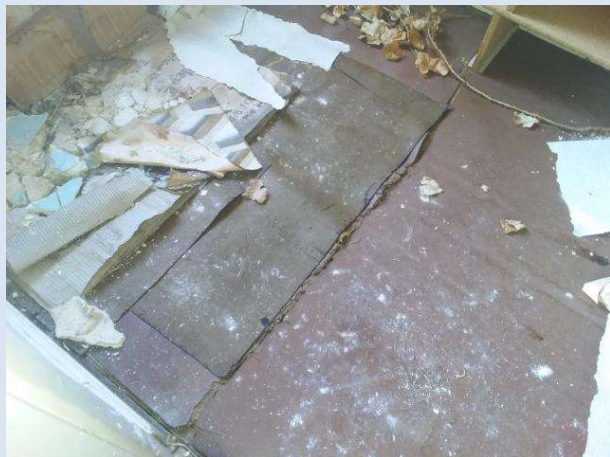
SAMPLE REFERENCE	ID13	ASBESTOS	NO
PRESUMPTION REFERENCE	N/A	RISK LEVEL	N/A

LOCATION	Storeroom	MATERIAL ASSESSMENT	
LEVEL	1	PRODUCT TYPE	0 - NADIS
UNIQUE ROOM IDENTIFIER	/013 Storeroom	DAMAGE	0 - NADIS
DESCRIPTION OF SAMPLE TAKEN OR PRESUMPTION	Brown vinyl to floor	SURFACE TREATMENT	0 - NADIS
EXTENT	4m²	ASBESTOS TYPE	0 - NADIS
ACCESSIBILITY	N/A	MATERIAL ASSESSMENT SCORE	0
LEVEL OF IDENTIFICATION	Sampled	POTENTIAL TO RELEASE FIBRES	N/A
DRAWING REFERENCE	See Section 4	RECOMMENDATIONS COMMENTS	
RECOMMENDATIONS			
No Action Required			
LOCATION NON-SUSPECT ITEMS			
Lathe and plaster ceiling, solid walls, timber floor, uninsulated metal pipes, timber framed window, timber door and frame.

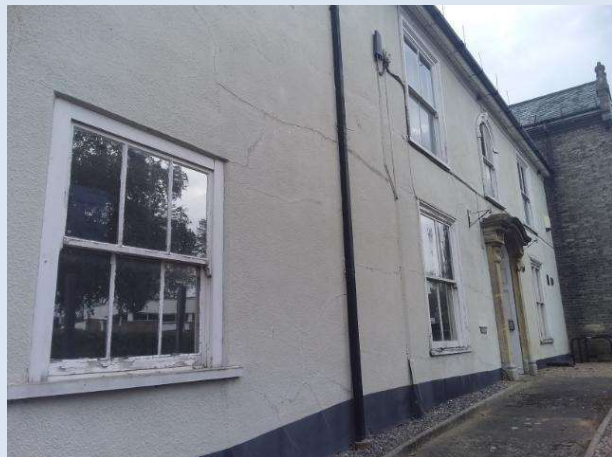
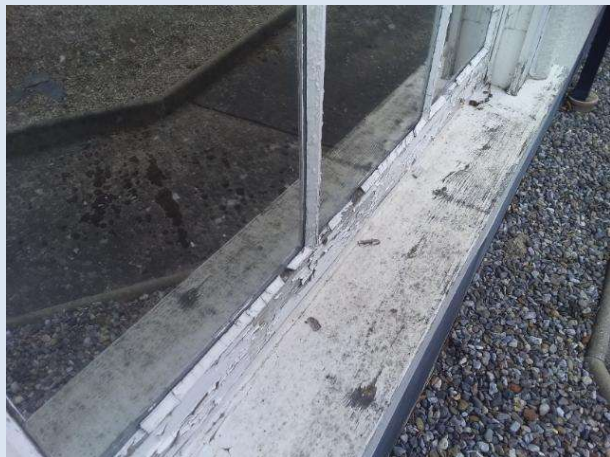
SAMPLE REFERENCE	ID14	ASBESTOS	NO
PRESUMPTION REFERENCE	N/A	RISK LEVEL	N/A

LOCATION	External areas	MATERIAL ASSESSMENT	
LEVEL	99	PRODUCT TYPE	0 - NADIS
UNIQUE ROOM IDENTIFIER	/001 External areas	DAMAGE	0 - NADIS
DESCRIPTION OF SAMPLE TAKEN OR PRESUMPTION	Putty to windows	SURFACE TREATMENT	0 - NADIS
EXTENT	80lm	ASBESTOS TYPE	0 - NADIS
ACCESSIBILITY	N/A	MATERIAL ASSESSMENT SCORE	0
LEVEL OF IDENTIFICATION	Sampled	POTENTIAL TO RELEASE FIBRES	N/A
DRAWING REFERENCE	See Section 4	RECOMMENDATIONS COMMENTS	
RECOMMENDATIONS			
No Action Required			
LOCATION NON-SUSPECT ITEMS			
Slate roof tiles, plastic rainwater goods, timber fascia boards, timber framed windows, timber doors and frames.

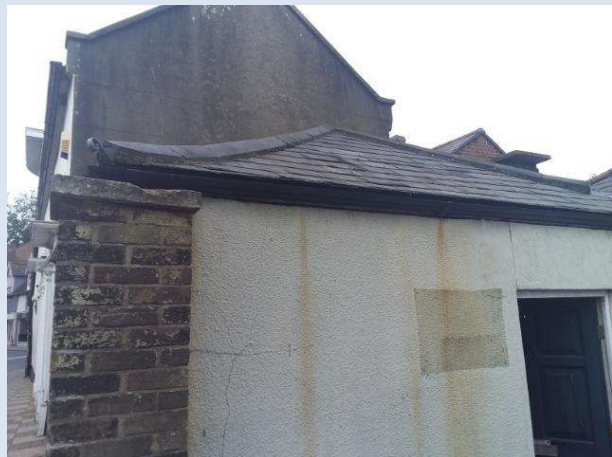
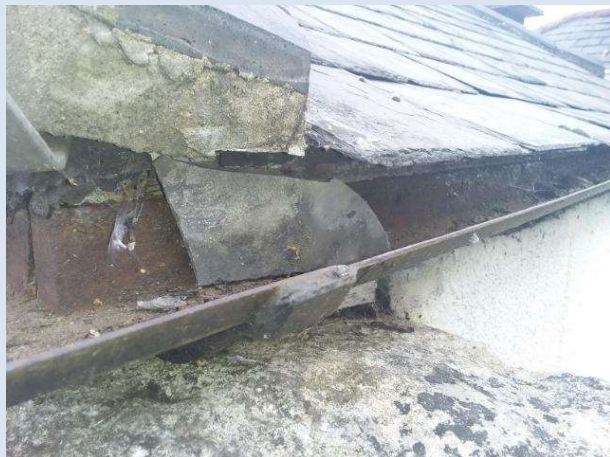
SAMPLE REFERENCE	ID15	ASBESTOS	NO
PRESUMPTION REFERENCE	N/A	RISK LEVEL	N/A

LOCATION	External areas	MATERIAL ASSESSMENT	
LEVEL	99	PRODUCT TYPE	0 - NADIS
UNIQUE ROOM IDENTIFIER	/001 External areas	DAMAGE	0 - NADIS
DESCRIPTION OF SAMPLE TAKEN OR PRESUMPTION	Cement under cloaking	SURFACE TREATMENT	0 - NADIS
EXTENT	6lm	ASBESTOS TYPE	0 - NADIS
ACCESSIBILITY	N/A	MATERIAL ASSESSMENT SCORE	0
LEVEL OF IDENTIFICATION	Sampled	POTENTIAL TO RELEASE FIBRES	N/A
DRAWING REFERENCE	See Section 4	RECOMMENDATIONS COMMENTS	
RECOMMENDATIONS			
No Action Required			
LOCATION NON-SUSPECT ITEMS

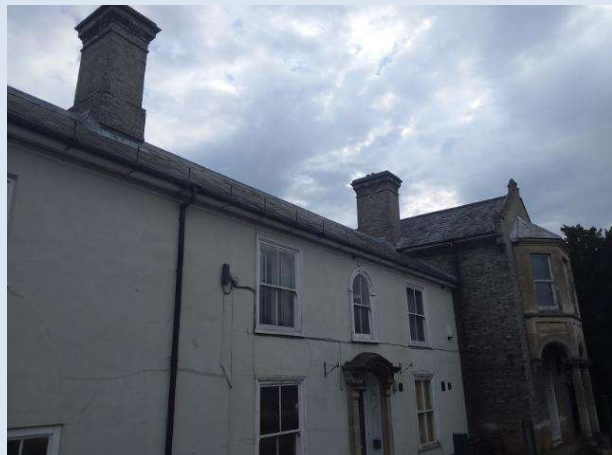
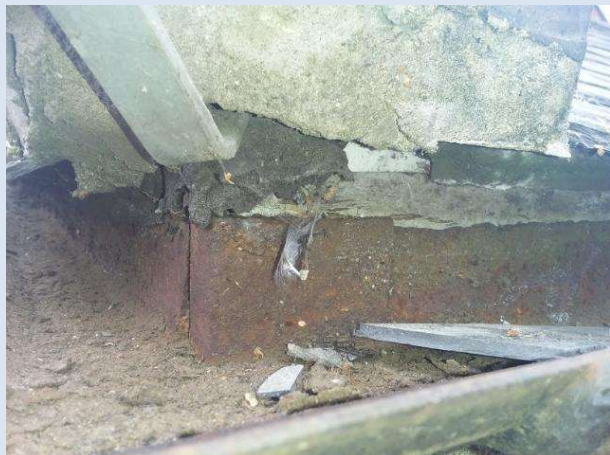
SAMPLE REFERENCE	ID16	ASBESTOS	NO
PRESUMPTION REFERENCE	N/A	RISK LEVEL	N/A

LOCATION	External areas	MATERIAL ASSESSMENT	
LEVEL	99	PRODUCT TYPE	0 - NADIS
UNIQUE ROOM IDENTIFIER	/001 External areas	DAMAGE	0 - NADIS
DESCRIPTION OF SAMPLE TAKEN OR PRESUMPTION	Roof felt	SURFACE TREATMENT	0 - NADIS
EXTENT	300m²	ASBESTOS TYPE	0 - NADIS
ACCESSIBILITY	N/A	MATERIAL ASSESSMENT SCORE	0
LEVEL OF IDENTIFICATION	Sampled	POTENTIAL TO RELEASE FIBRES	N/A
DRAWING REFERENCE	See Section 4	RECOMMENDATIONS COMMENTS	
RECOMMENDATIONS			
No Action Required			
LOCATION NON-SUSPECT ITEMS

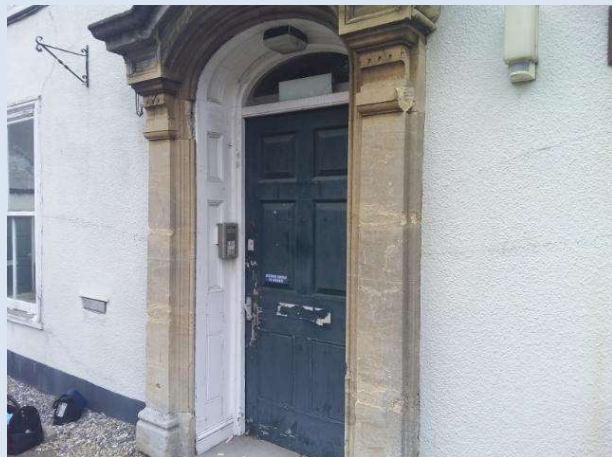
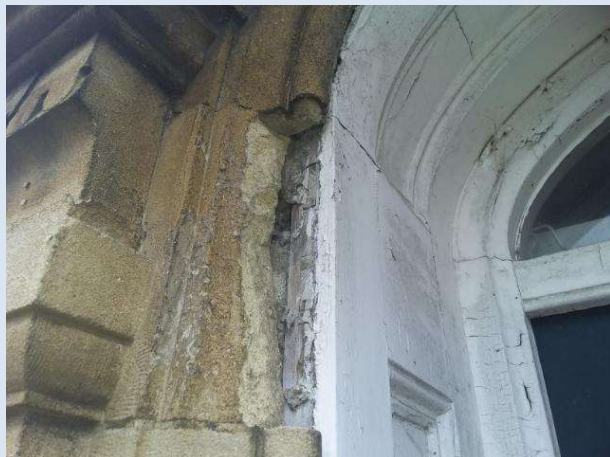
SAMPLE REFERENCE	ID17	ASBESTOS	NO
PRESUMPTION REFERENCE	N/A	RISK LEVEL	N/A

LOCATION	External areas	MATERIAL ASSESSMENT	
LEVEL	99	PRODUCT TYPE	0 - NADIS
UNIQUE ROOM IDENTIFIER	/001 External areas	DAMAGE	0 - NADIS
DESCRIPTION OF SAMPLE TAKEN OR PRESUMPTION	Putty to door frame	SURFACE TREATMENT	0 - NADIS
EXTENT	4lm	ASBESTOS TYPE	0 - NADIS
ACCESSIBILITY	N/A	MATERIAL ASSESSMENT SCORE	0
LEVEL OF IDENTIFICATION	Sampled	POTENTIAL TO RELEASE FIBRES	N/A
DRAWING REFERENCE	See Section 4	RECOMMENDATIONS COMMENTS	
RECOMMENDATIONS			
No Action Required			
LOCATION NON-SUSPECT ITEMS

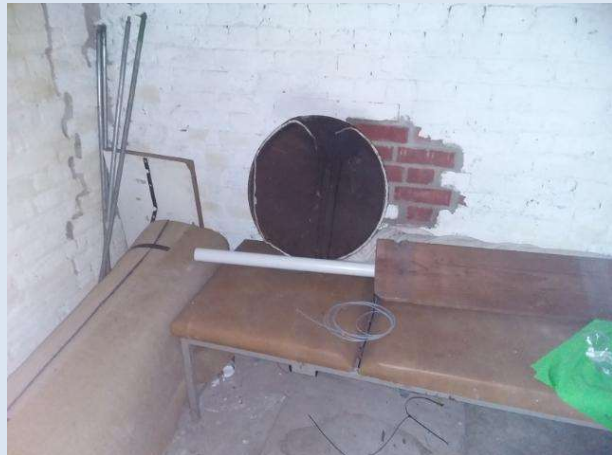
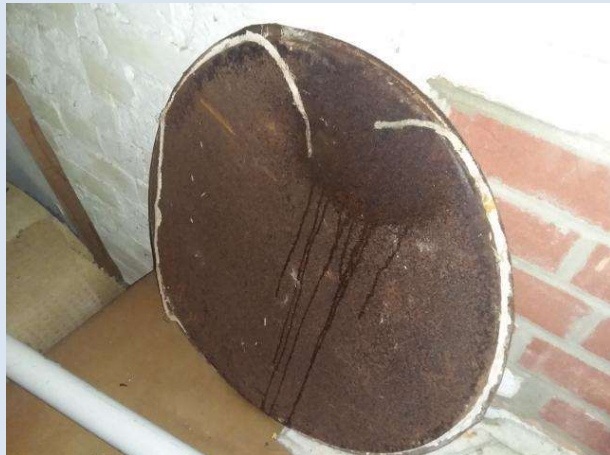
SAMPLE REFERENCE	ID18	ASBESTOS	YES
PRESUMPTION REFERENCE	N/A	RISK LEVEL	Low

LOCATION	Storeroom	MATERIAL ASSESSMENT	
LEVEL	1	PRODUCT TYPE	2 - Asbestos insulating board, millboards, gaskets & ropes etc.
UNIQUE ROOM IDENTIFIER	/016 Storeroom	DAMAGE	1 - Low Damage
DESCRIPTION OF SAMPLE TAKEN OR PRESUMPTION	Rope seal to metal lid	SURFACE TREATMENT	1 - Enclosed sprays and lagging, asbestos insulating board (with exposed face painted or encapsulated)
EXTENT	<1lm	ASBESTOS TYPE	1 - Chrysotile
ACCESSIBILITY	Usually inaccessible	MATERIAL ASSESSMENT SCORE	5
LEVEL OF IDENTIFICATION	Sampled	POTENTIAL TO RELEASE FIBRES	Low
DRAWING REFERENCE	See Section 4	RECOMMENDATIONS COMMENTS	
RECOMMENDATIONS			
Removal by Trained Operatives			
LOCATION NON-SUSPECT ITEMS			
Timber joists to ceiling, solid walls, timber floor covered with carpet, metal framed window.

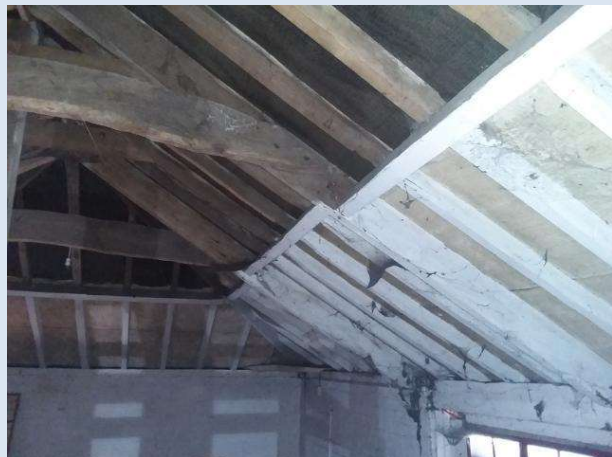
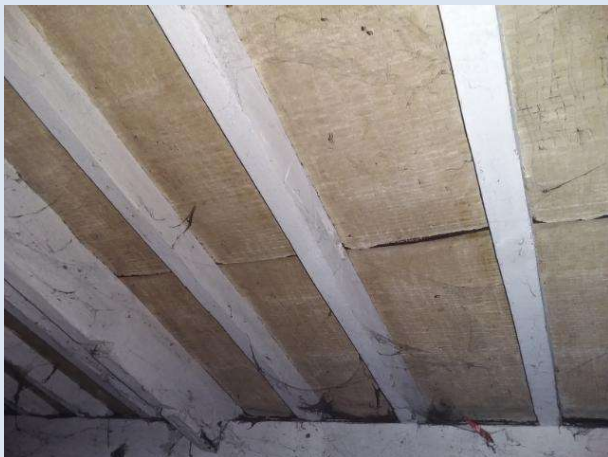
SAMPLE REFERENCE	ID19	ASBESTOS	NO
PRESUMPTION REFERENCE	N/A	RISK LEVEL	N/A

LOCATION	Storeroom	MATERIAL ASSESSMENT	
LEVEL	1	PRODUCT TYPE	0 - NADIS
UNIQUE ROOM IDENTIFIER	/016 Storeroom	DAMAGE	0 - NADIS
DESCRIPTION OF SAMPLE TAKEN OR PRESUMPTION	Roof felt	SURFACE TREATMENT	0 - NADIS
EXTENT	35m²	ASBESTOS TYPE	0 - NADIS
ACCESSIBILITY	N/A	MATERIAL ASSESSMENT SCORE	0
LEVEL OF IDENTIFICATION	Sampled	POTENTIAL TO RELEASE FIBRES	N/A
DRAWING REFERENCE	See Section 4	RECOMMENDATIONS COMMENTS	
RECOMMENDATIONS			
No Action Required			
LOCATION NON-SUSPECT ITEMS

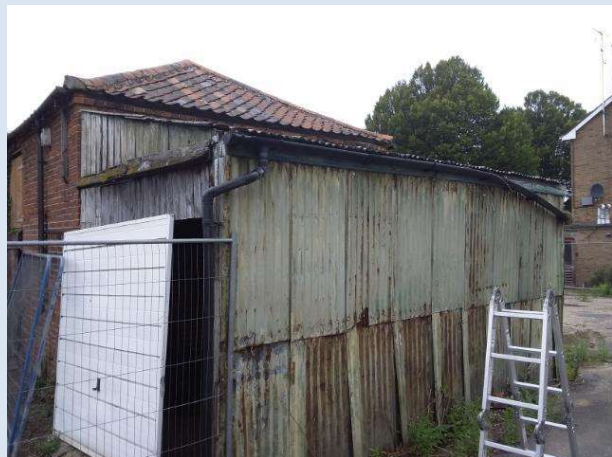
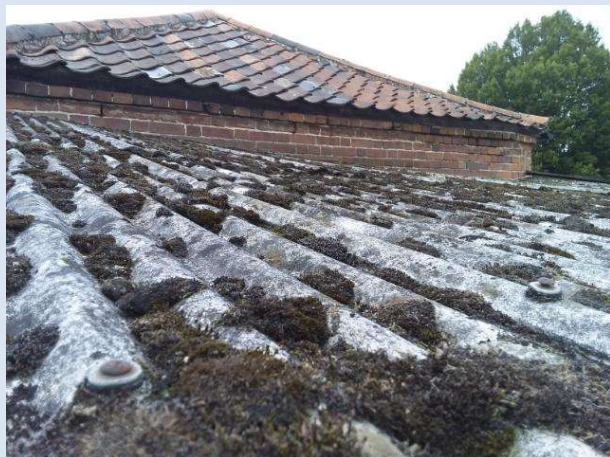
SAMPLE REFERENCE	ID21	ASBESTOS	YES
PRESUMPTION REFERENCE	N/A	RISK LEVEL	Very Low

LOCATION	External areas	MATERIAL ASSESSMENT	
LEVEL	99	PRODUCT TYPE	1 - Asbestos Cement
UNIQUE ROOM IDENTIFIER	/001 External areas	DAMAGE	1 - Low Damage
DESCRIPTION OF SAMPLE TAKEN OR PRESUMPTION	Cement roof sheets	SURFACE TREATMENT	1 - Asbestos Cement
EXTENT	20m²	ASBESTOS TYPE	1 - Chrysotile
ACCESSIBILITY	Usually inaccessible	MATERIAL ASSESSMENT SCORE	4
LEVEL OF IDENTIFICATION	Sampled	POTENTIAL TO RELEASE FIBRES	Very Low
DRAWING REFERENCE	See Section 4	RECOMMENDATIONS COMMENTS	
RECOMMENDATIONS			
Removal by Trained Operatives			
LOCATION NON-SUSPECT ITEMS

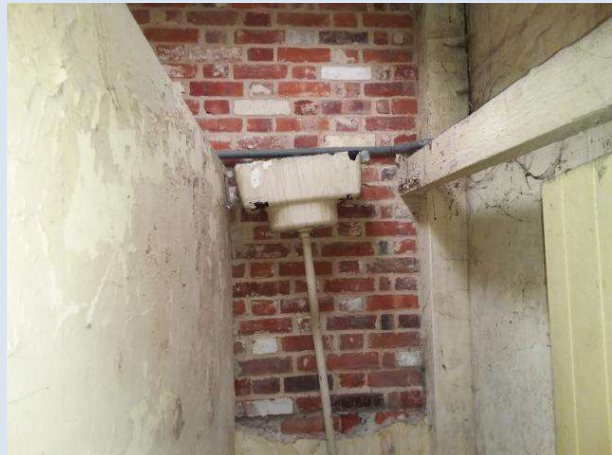
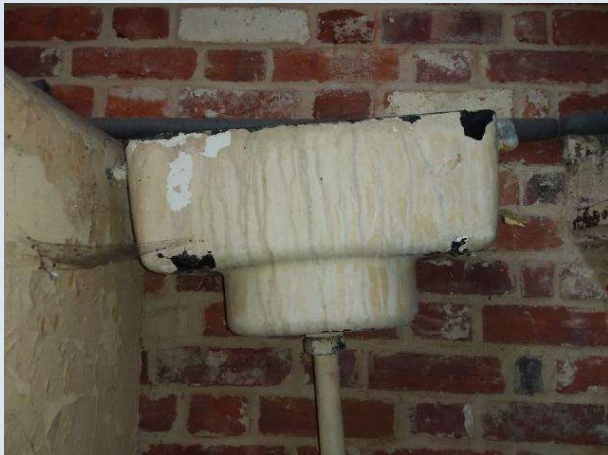
SAMPLE REFERENCE	ID22	ASBESTOS	YES
PRESUMPTION REFERENCE	N/A	RISK LEVEL	Very Low

LOCATION	External store 3	MATERIAL ASSESSMENT	
LEVEL	99	PRODUCT TYPE	1 - Asbestos reinforced composites etc.
UNIQUE ROOM IDENTIFIER	/004 External store 3	DAMAGE	0 - No Visible Damage
DESCRIPTION OF SAMPLE TAKEN OR PRESUMPTION	Black toilet cistern	SURFACE TREATMENT	0 - Composite materials containing asbestos, reinforced plastics, resins, vinyl tiles
EXTENT	1no	ASBESTOS TYPE	1 - Chrysotile
ACCESSIBILITY	Usually inaccessible	MATERIAL ASSESSMENT SCORE	2
LEVEL OF IDENTIFICATION	Sampled	POTENTIAL TO RELEASE FIBRES	Very Low
DRAWING REFERENCE	See Section 4	RECOMMENDATIONS COMMENTS	
RECOMMENDATIONS			
Removal by Trained Operatives			
LOCATION NON-SUSPECT ITEMS

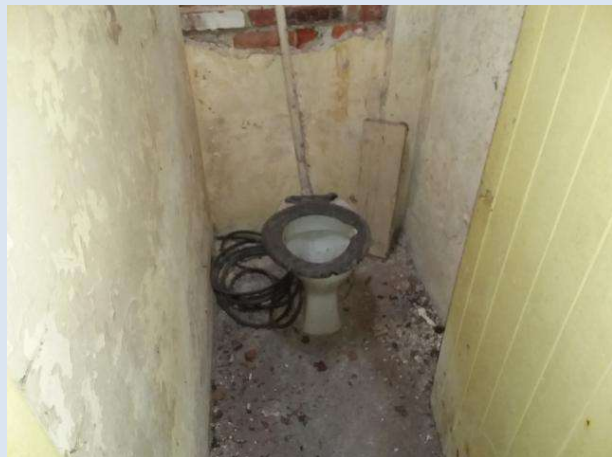
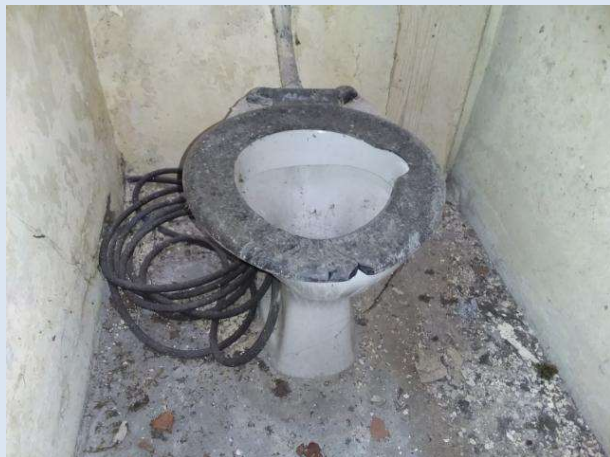
SAMPLE REFERENCE	ID23	ASBESTOS	NO
PRESUMPTION REFERENCE	N/A	RISK LEVEL	N/A

LOCATION	External store 3	MATERIAL ASSESSMENT	
LEVEL	99	PRODUCT TYPE	0 - NADIS
UNIQUE ROOM IDENTIFIER	/004 External store 3	DAMAGE	0 - NADIS
DESCRIPTION OF SAMPLE TAKEN OR PRESUMPTION	Black toilet seat	SURFACE TREATMENT	0 - NADIS
EXTENT	1no	ASBESTOS TYPE	0 - NADIS
ACCESSIBILITY	N/A	MATERIAL ASSESSMENT SCORE	0
LEVEL OF IDENTIFICATION	Sampled	POTENTIAL TO RELEASE FIBRES	N/A
DRAWING REFERENCE	See Section 4	RECOMMENDATIONS COMMENTS	
RECOMMENDATIONS			
No Action Required			
LOCATION NON-SUSPECT ITEMS

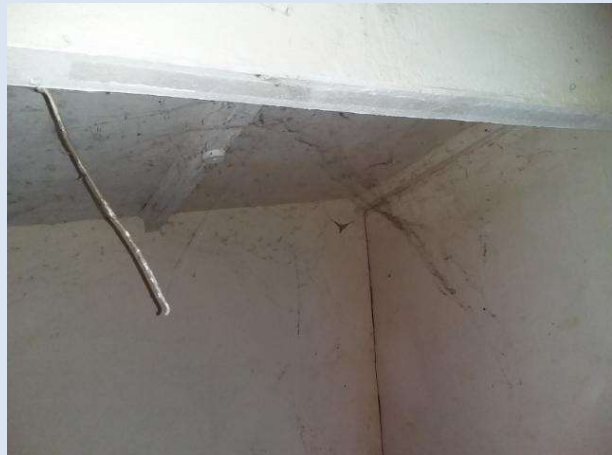
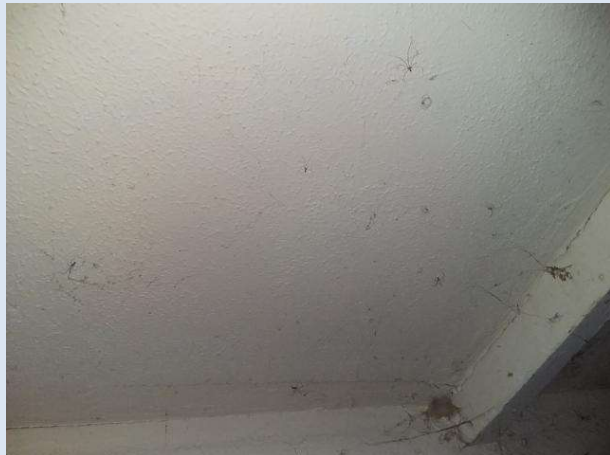
SAMPLE REFERENCE	ID24	ASBESTOS	YES
PRESUMPTION REFERENCE	N/A	RISK LEVEL	Very Low

LOCATION	External store 5	MATERIAL ASSESSMENT	
LEVEL	99	PRODUCT TYPE	1 - Asbestos reinforced composites etc.
UNIQUE ROOM IDENTIFIER	/005 External store 5	DAMAGE	1 - Low Damage
DESCRIPTION OF SAMPLE TAKEN OR PRESUMPTION	Textured coating bonded onto plasterboard ceiling	SURFACE TREATMENT	0 - Composite materials containing asbestos, reinforced plastics, resins, vinyl tiles
EXTENT	14m²	ASBESTOS TYPE	1 - Chrysotile
ACCESSIBILITY	Usually inaccessible	MATERIAL ASSESSMENT SCORE	3
LEVEL OF IDENTIFICATION	Sampled	POTENTIAL TO RELEASE FIBRES	Very Low
DRAWING REFERENCE	See Section 4	RECOMMENDATIONS COMMENTS	
RECOMMENDATIONS			
Removal by Trained Operatives			
LOCATION NON-SUSPECT ITEMS

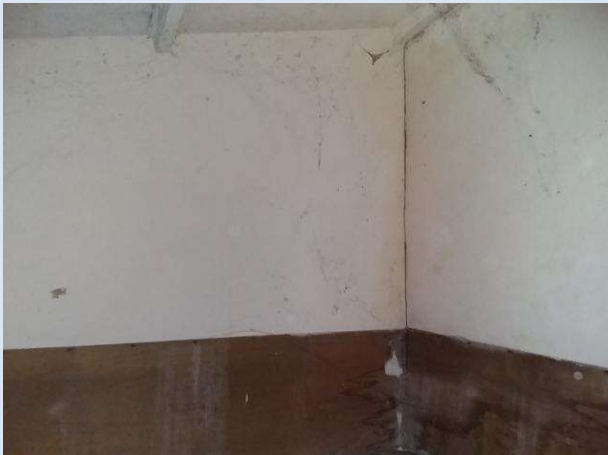
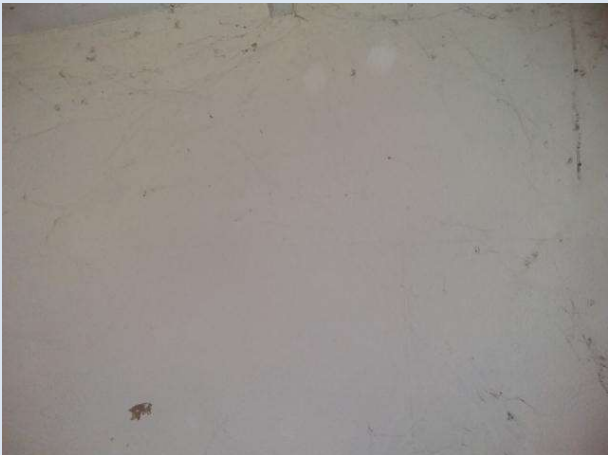
SAMPLE REFERENCE	ID25	ASBESTOS	YES
PRESUMPTION REFERENCE	N/A	RISK LEVEL	Low

LOCATION	External store 5	MATERIAL ASSESSMENT	
LEVEL	99	PRODUCT TYPE	1 - Asbestos reinforced composites etc.
UNIQUE ROOM IDENTIFIER	/005 External store 5	DAMAGE	1 - Low Damage
DESCRIPTION OF SAMPLE TAKEN OR PRESUMPTION	Textured coating bonded onto solid and plasterboard walls	SURFACE TREATMENT	3 - Unsealed Lagging / Spray
EXTENT	20m²	ASBESTOS TYPE	1 - Chrysotile
ACCESSIBILITY	Easily Disturbed	MATERIAL ASSESSMENT SCORE	6
LEVEL OF IDENTIFICATION	Sampled	POTENTIAL TO RELEASE FIBRES	Low
DRAWING REFERENCE	See Section 4	RECOMMENDATIONS COMMENTS	
RECOMMENDATIONS			
Removal by Trained Operatives			
LOCATION NON-SUSPECT ITEMS

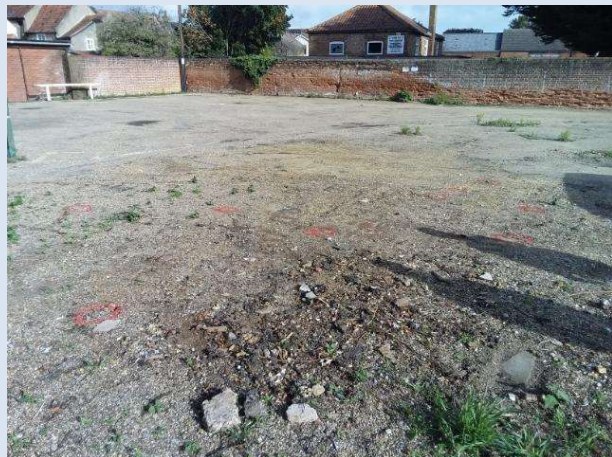
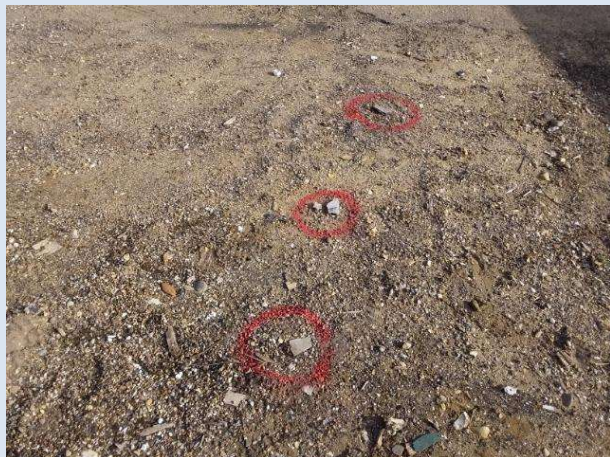
SAMPLE REFERENCE	ID26	ASBESTOS	YES
PRESUMPTION REFERENCE	N/A	RISK LEVEL	Low

LOCATION	External areas	MATERIAL ASSESSMENT	
LEVEL	99	PRODUCT TYPE	1 - Asbestos Cement
UNIQUE ROOM IDENTIFIER	/001 External areas	DAMAGE	3 - High Damage
DESCRIPTION OF SAMPLE TAKEN OR PRESUMPTION	Cement debris to floor	SURFACE TREATMENT	1 - Asbestos Cement
EXTENT	<1m²	ASBESTOS TYPE	1 - Chrysotile
ACCESSIBILITY	Routinely Disturbed	MATERIAL ASSESSMENT SCORE	6
LEVEL OF IDENTIFICATION	Sampled	POTENTIAL TO RELEASE FIBRES	Low
DRAWING REFERENCE	See Section 4	RECOMMENDATIONS COMMENTS	
RECOMMENDATIONS		Found in various locations on the surface and within the earth – refer to floor plan for the area the debris covers	
Removal by Trained Operatives			
LOCATION NON-SUSPECT ITEMS

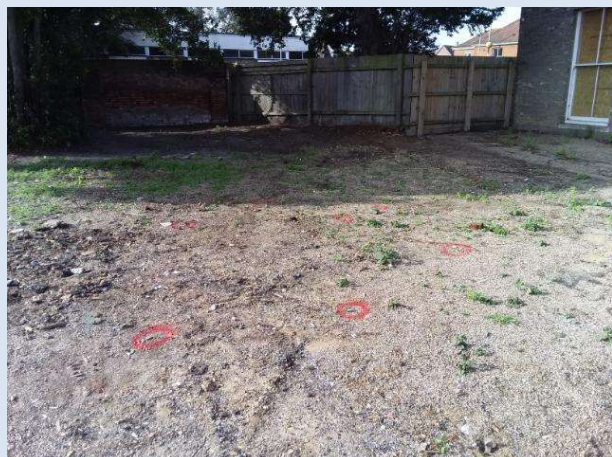
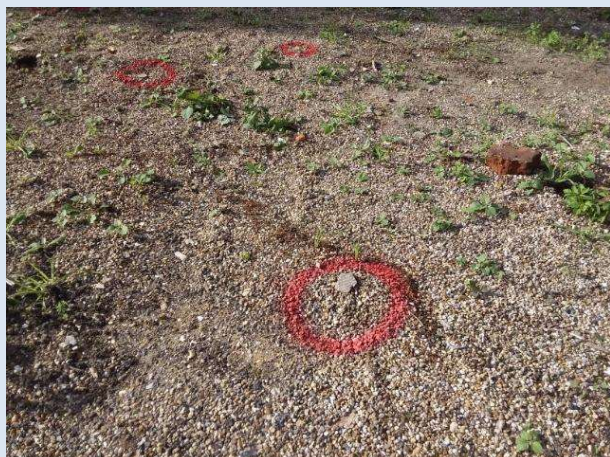
SAMPLE REFERENCE	ID27	ASBESTOS	YES
PRESUMPTION REFERENCE	N/A	RISK LEVEL	Low

LOCATION	External areas	MATERIAL ASSESSMENT	
LEVEL	99	PRODUCT TYPE	1 - Asbestos Cement
UNIQUE ROOM IDENTIFIER	/001 External areas	DAMAGE	3 - High Damage
DESCRIPTION OF SAMPLE TAKEN OR PRESUMPTION	Cement debris to floor	SURFACE TREATMENT	1 - Asbestos Cement
EXTENT	<1m²	ASBESTOS TYPE	1 - Chrysotile
ACCESSIBILITY	Routinely Disturbed	MATERIAL ASSESSMENT SCORE	6
LEVEL OF IDENTIFICATION	Sampled	POTENTIAL TO RELEASE FIBRES	Low
DRAWING REFERENCE	See Section 4	RECOMMENDATIONS COMMENTS	
RECOMMENDATIONS		Found in various locations on the surface and within the earth – refer to floor plan for the area the debris covers	
Removal by Trained Operatives			
LOCATION NON-SUSPECT ITEMS

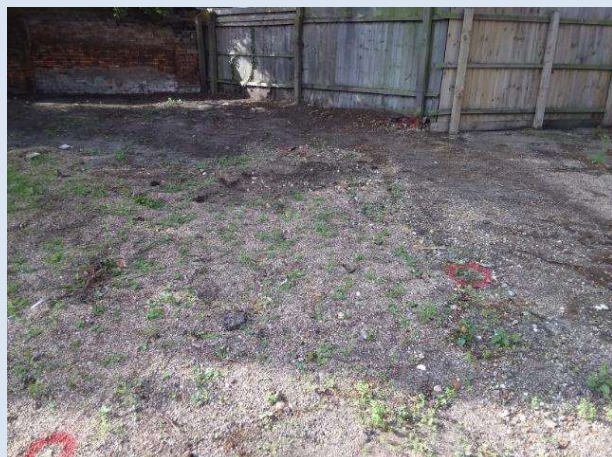
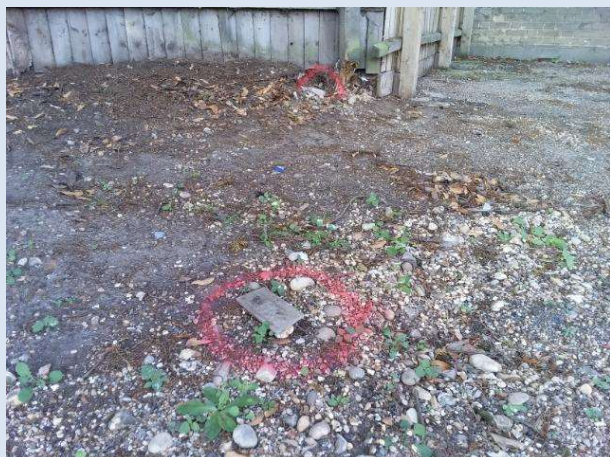
SAMPLE REFERENCE	ID28	ASBESTOS	YES
PRESUMPTION REFERENCE	N/A	RISK LEVEL	Low

LOCATION	External areas	MATERIAL ASSESSMENT	
LEVEL	99	PRODUCT TYPE	1 - Asbestos Cement
UNIQUE ROOM IDENTIFIER	/001 External areas	DAMAGE	3 - High Damage
DESCRIPTION OF SAMPLE TAKEN OR PRESUMPTION	Cement debris to floor	SURFACE TREATMENT	1 - Asbestos Cement
EXTENT	<1m <sup>2</sup>	ASBESTOS TYPE	1 - Chrysotile
ACCESSIBILITY	Routinely Disturbed	MATERIAL ASSESSMENT SCORE	6
LEVEL OF IDENTIFICATION	Sampled	POTENTIAL TO RELEASE FIBRES	Low
DRAWING REFERENCE	See Section 4	RECOMMENDATIONS COMMENTS	
RECOMMENDATIONS		Found in various locations on the surface and within the earth – refer to floor plan for the area the debris covers	
Removal by Trained Operatives			
LOCATION NON-SUSPECT ITEMS

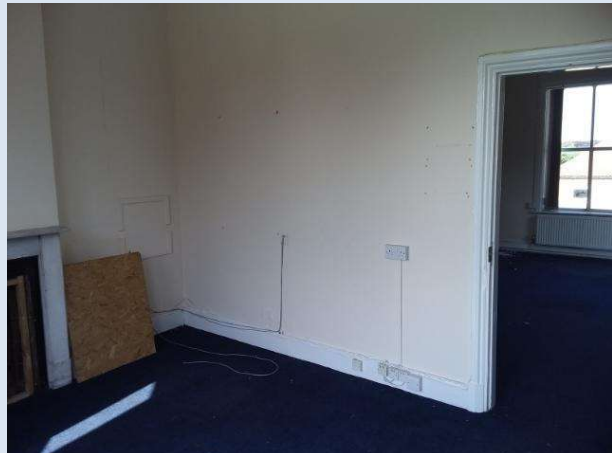
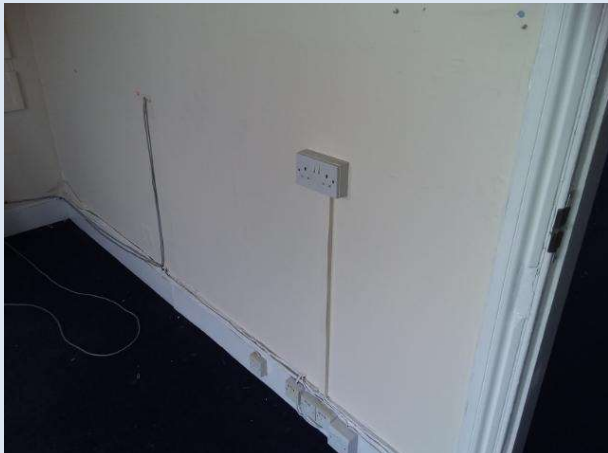
SAMPLE REFERENCE	N/A	ASBESTOS	NO
PRESUMPTION REFERENCE	SPID10	RISK LEVEL	N/A

LOCATION	Office	MATERIAL ASSESSMENT	
LEVEL	1	PRODUCT TYPE	0 - NADIS
UNIQUE ROOM IDENTIFIER	/006 Office	DAMAGE	0 - NADIS
DESCRIPTION OF SAMPLE TAKEN OR PRESUMPTION	Insulating board forming partition wall	SURFACE TREATMENT	0 - NADIS
EXTENT	2m²	ASBESTOS TYPE	0 - NADIS
ACCESSIBILITY	N/A	MATERIAL ASSESSMENT SCORE	0
LEVEL OF IDENTIFICATION	Strongly Presumed as per a Previous Sample	POTENTIAL TO RELEASE FIBRES	N/A
DRAWING REFERENCE	See Section 4	RECOMMENDATIONS COMMENTS	
RECOMMENDATIONS			
No Action Required			
LOCATION NON-SUSPECT ITEMS			
Lathe and plaster ceiling, solid walls, timber floor covered with carpet, wall mounted metal radiators with uninsulated metal pipes, timber framed windows, timber doors and frames.

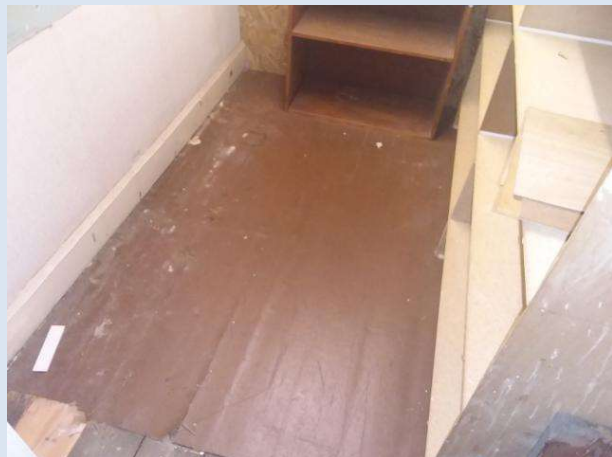
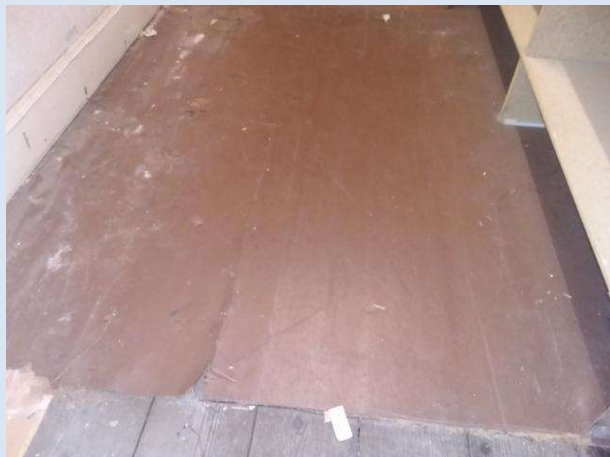
SAMPLE REFERENCE	N/A	ASBESTOS	NO
PRESUMPTION REFERENCE	SPID13	RISK LEVEL	N/A

LOCATION	Storeroom	MATERIAL ASSESSMENT	
LEVEL	1	PRODUCT TYPE	0 - NADIS
UNIQUE ROOM IDENTIFIER	/014 Storeroom	DAMAGE	0 - NADIS
DESCRIPTION OF SAMPLE TAKEN OR PRESUMPTION	Brown vinyl to floor	SURFACE TREATMENT	0 - NADIS
EXTENT	3m²	ASBESTOS TYPE	0 - NADIS
ACCESSIBILITY	N/A	MATERIAL ASSESSMENT SCORE	0
LEVEL OF IDENTIFICATION	Strongly Presumed as per a Previous Sample	POTENTIAL TO RELEASE FIBRES	N/A
DRAWING REFERENCE	See Section 4	RECOMMENDATIONS COMMENTS	
RECOMMENDATIONS			
No Action Required			
LOCATION NON-SUSPECT ITEMS			
Lathe and plaster ceiling, solid walls, timber floor, timber door and frame.

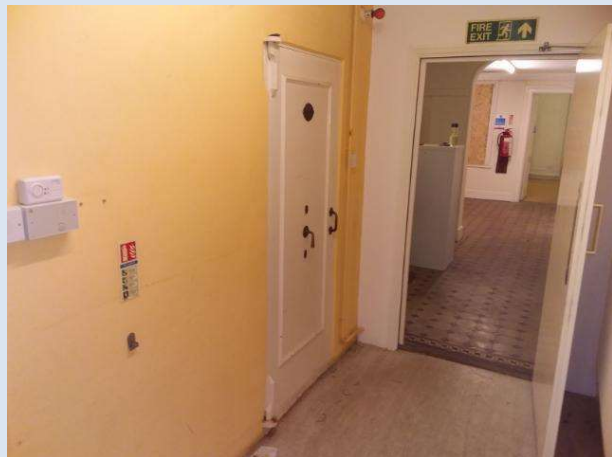
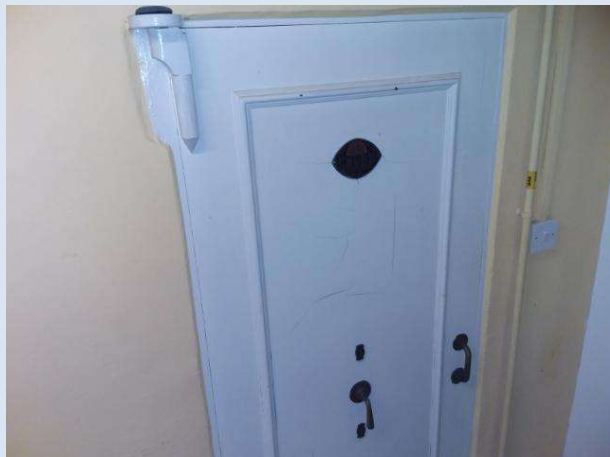
SAMPLE REFERENCE	N/A	ASBESTOS	YES
PRESUMPTION REFERENCE	P01	RISK LEVEL	Low

LOCATION	Corridor	MATERIAL ASSESSMENT	
LEVEL	0	PRODUCT TYPE	2 - Asbestos insulating board, millboards, gaskets & ropes etc.
UNIQUE ROOM IDENTIFIER	/007 Corridor	DAMAGE	0 - No Visible Damage
DESCRIPTION OF SAMPLE TAKEN OR PRESUMPTION	Presumed asbestos containing materials within locked safe	SURFACE TREATMENT	1 - Enclosed sprays and lagging, asbestos insulating board (with exposed face painted or encapsulated)
EXTENT	3lm	ASBESTOS TYPE	3 – Crocidolite
ACCESSIBILITY	Usually inaccessible	MATERIAL ASSESSMENT SCORE	6
LEVEL OF IDENTIFICATION	Presumed	POTENTIAL TO RELEASE FIBRES	Low
DRAWING REFERENCE	See Section 4	RECOMMENDATIONS COMMENTS	
RECOMMENDATIONS			
Further Investigation Needed			
LOCATION NON-SUSPECT ITEMS
