Asbestos Management Survey Of

> PC Melbourne Slope The Promenade Cromer Norwich NR27 9HE

Report Number: BGL/9801

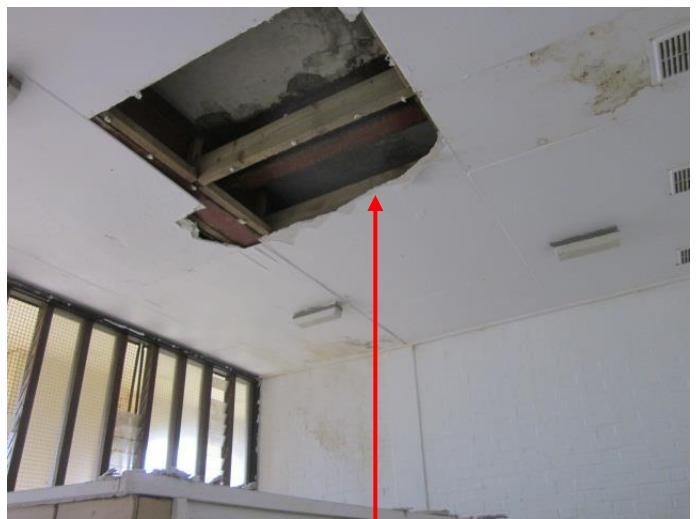
PHOTOGRAPH 01, SAMPLE 01: Insulating board ceiling panels – Ladies W.C (No asbestos detected in sample)

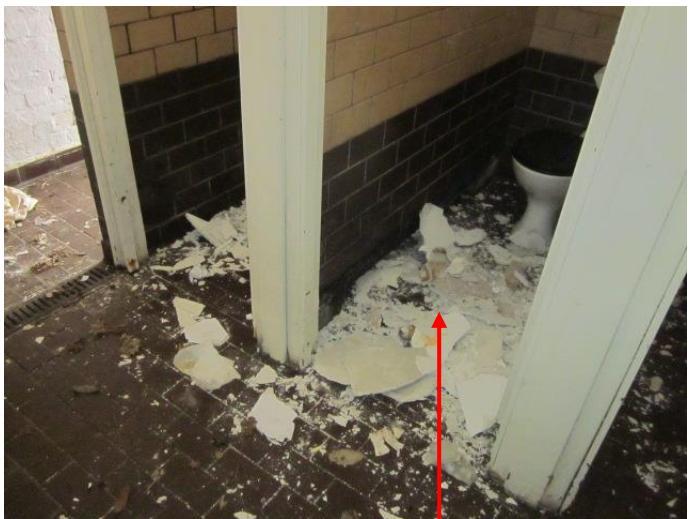
PHOTOGRAPH 02, SAMPLE AS01: Insulating board debris to floor – Ladies W.C (No asbestos detected in sample)

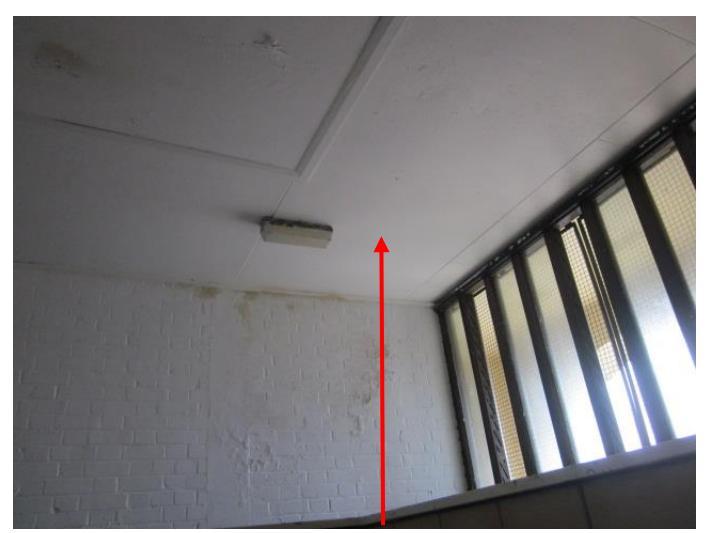
PHOTOGRAPH 03, SAMPLE AS01: Insulating board ceiling panels – Gents W.C (No asbestos detected in sample)

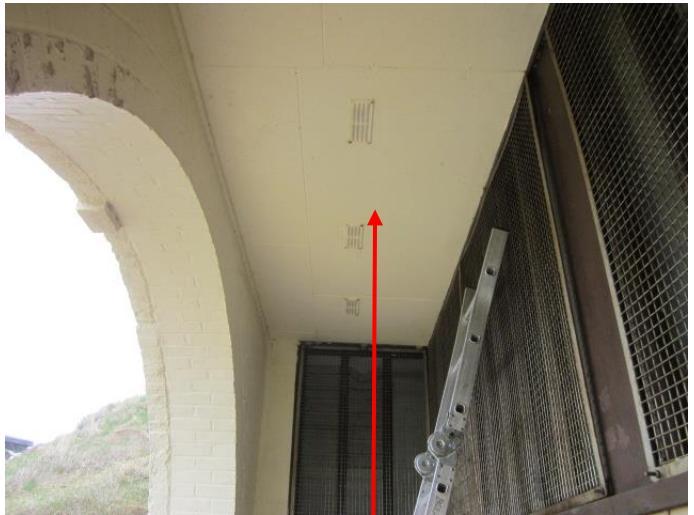
PHOTOGRAPH 04, SAMPLE AS01: Insulating board ceiling tiles – Canopy (No asbestos detected in sample)

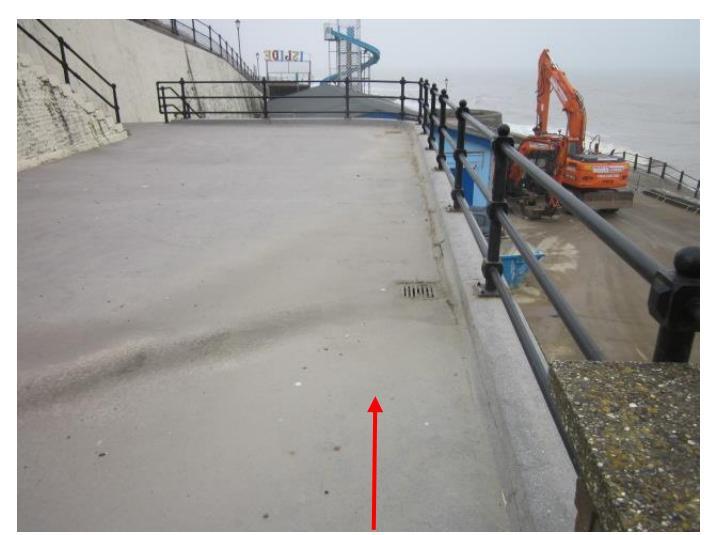
PHOTOGRAPH 05, SAMPLE 02: Bitumen roof covering – External (No asbestos detected in sample)
