Understanding water and cliff failure at Sidestrand and Trimingham

November 2024

Document reference: 100120302 | 0002 | P03 |

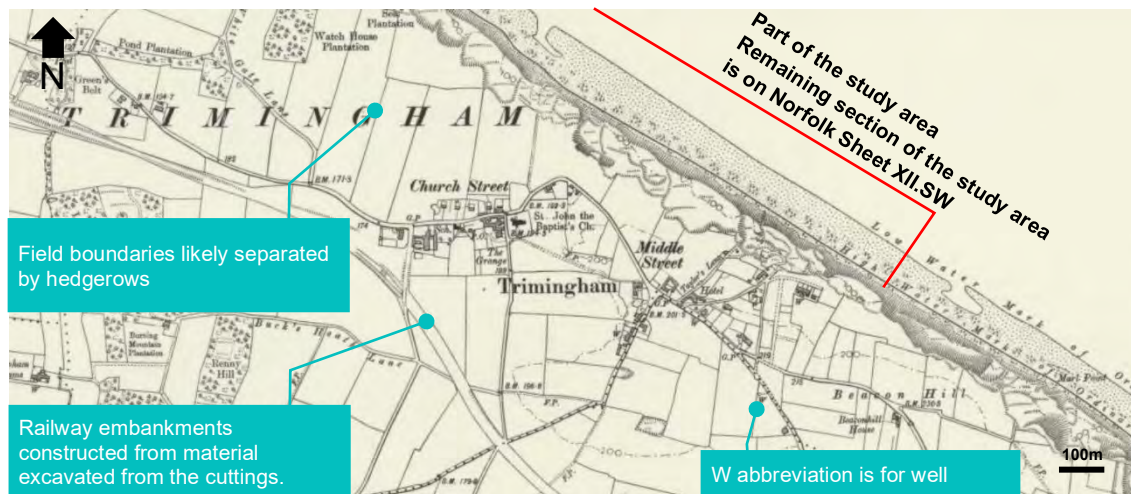
Source: An extract from Norfolk Sheet XX.NW, revised: 1905, published: 1932. Historical map reproduced with the permission of the National Library of Scotland.

From the earliest available mapping in 1885, most of the area was used for farming. This was in small, privately owned parcels of land. This continued until the latest available historical map in 1946. Limited resources (maps and aerial photography) were available in the 1960s, but it is likely during this time that the fields were expanded by the combination of multiple small fields into bigger fields (farmland consolidation). Previous field boundaries (e.g. hedgerows and possibly drainage) were lost in farmland consolidation, which would have reduced the flow of surface runoff.

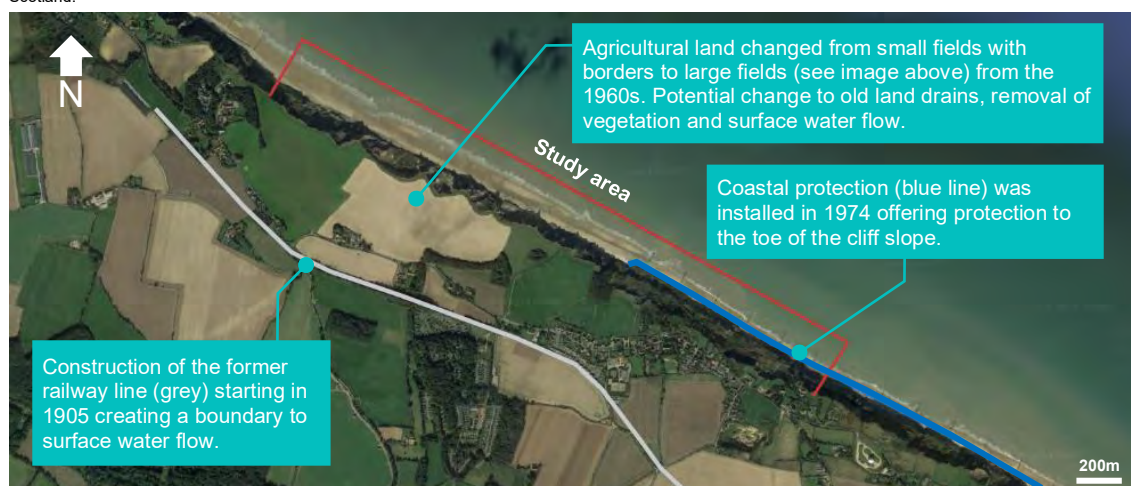
Source: Aerial image from ESRI ArcGIS World Imagery. Date of railway construction estimated from historical maps. Note – only recent and significant land use changes have been highlighted.

The study area and surrounding land has a long history of farming. Two significant land changes were identified with the construction of the railway line (now disused) starting in 1905 and the coastal protection in 1974.

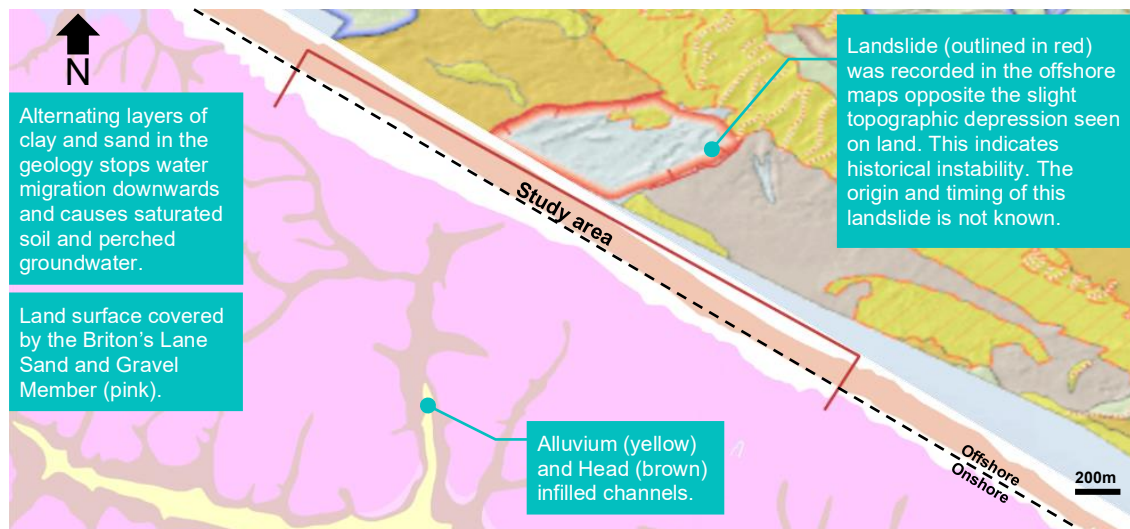
Source: Onshore superficial geology reproduced from BGS Geology - 50k (DiGMapGB-50) Bedrock version 8 published by British Geological Survey (BGS). Offshore geology reproduced from Seabed Geology: Offshore East Anglia digital map 10k, released by the BGS in 2024.

A thick sequence of Superficial geology (up to 60m) deposited in the Quaternary Period is controlling the slope stability and groundwater levels.

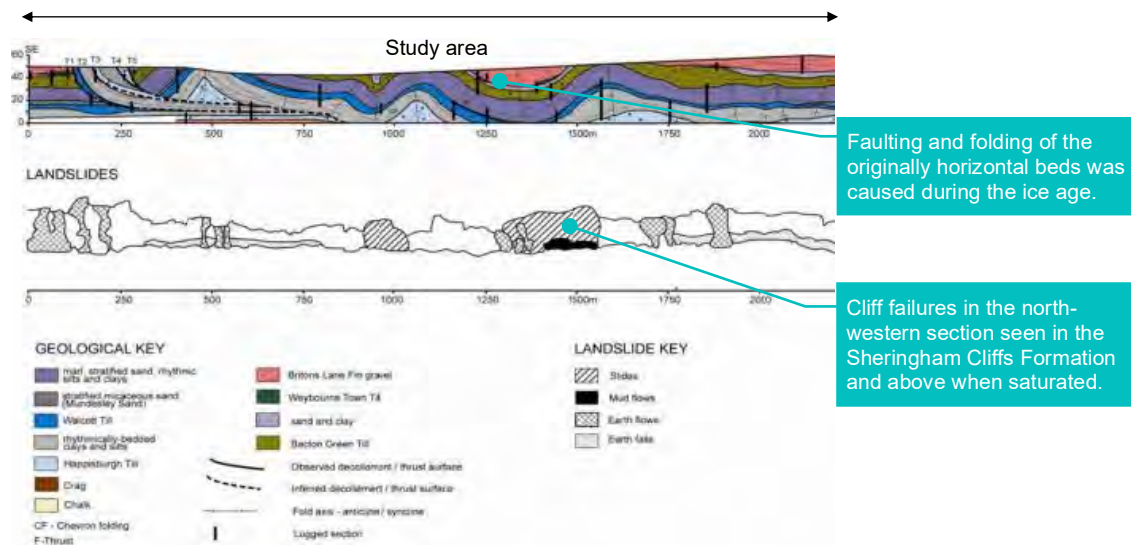
Source: Reproduced from Lee et al., 2011 (modified from Hart, 1990)

Regional uplift of land and advancing ice sheets has made the geological sequence structurally complex along the cliff faces with faulting and folding.

A later ice sheet advance from the north generated compression on the existing ice sheets which shortened the Cromer Ridge and this created the folding and thrust fault seen between Sidestrand and Trimingham (shown in the cross section image above), known as glaciotectionics. This large-scale ground movement forced older deposits to break up and be deposited in the more recent deposits, such as chalk rafts (or erratics) seen in the cliff section.

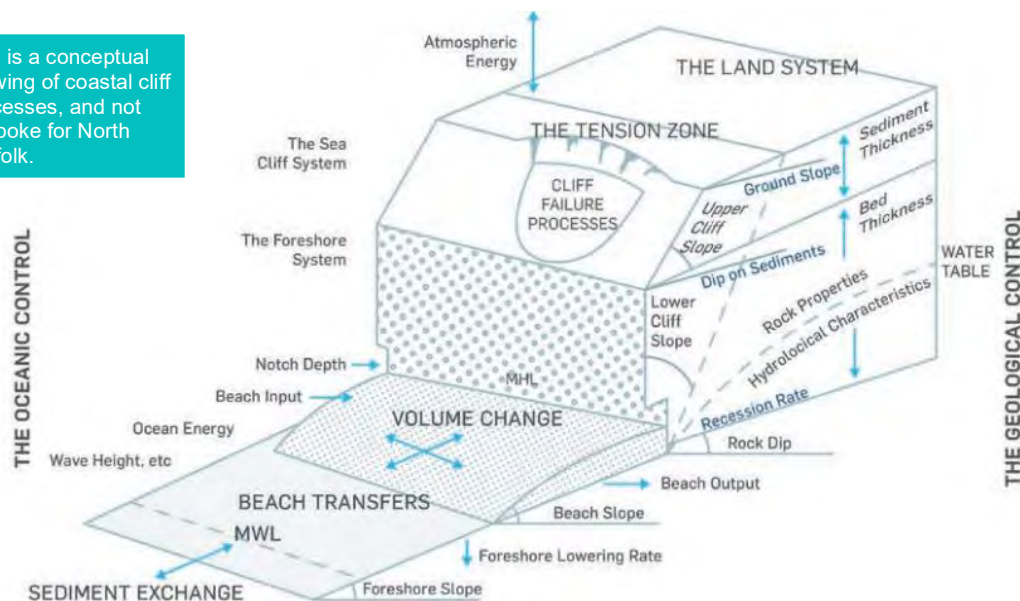
This is a conceptual drawing of coastal cliff processes, and not bespoke for North Norfolk.

Source: Reproduced from Figure 2.6 in CIRIA C810, 2023 (taken from Lee and Brunsten, 2001) Titled "Process model of forcing functions and system responses around a coastal cliff".

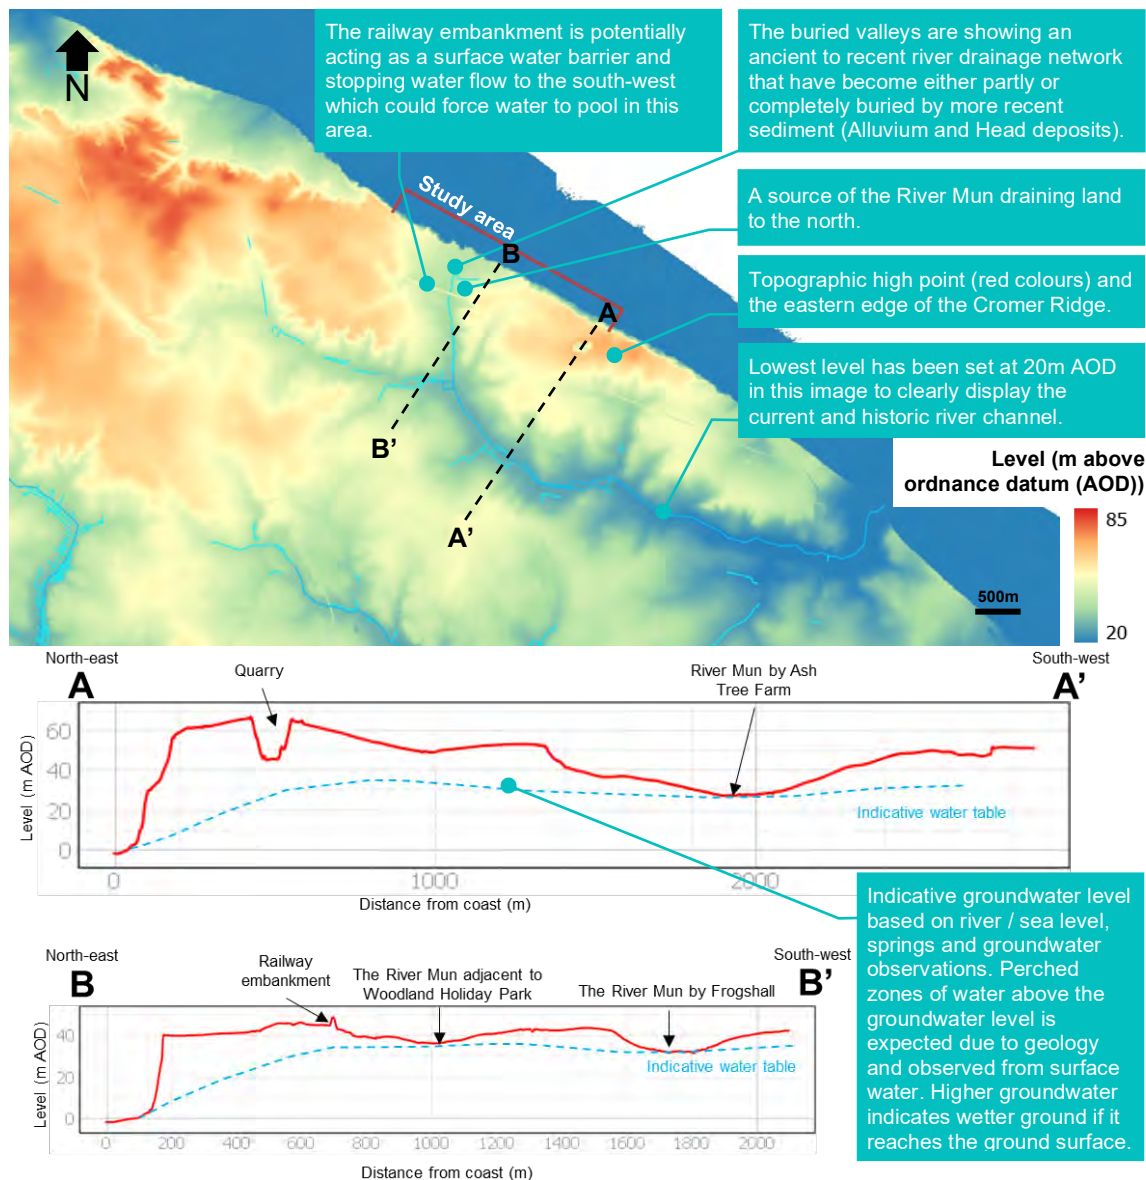
Source: LIDAR Composite Digital Terrain Model (DTM) 1m from 2022 produced by the Environment Agency for tiles TG23ne, TG23nw, TG24se, TG24sw. Watercourse downloaded from OS Open Rivers published by Ordnance Survey.

The landscape of North Norfolk has been determined by glaciation, with topographic high points from the Cromer Ridge and low points from ancient river erosion. Both are seen within the study area and dictate groundwater and surface water flow.

The LIDAR data identified the wider catchment for the River Mun (which runs into the North Sea in the village of Mundesley) but also channels near the cliff edge.

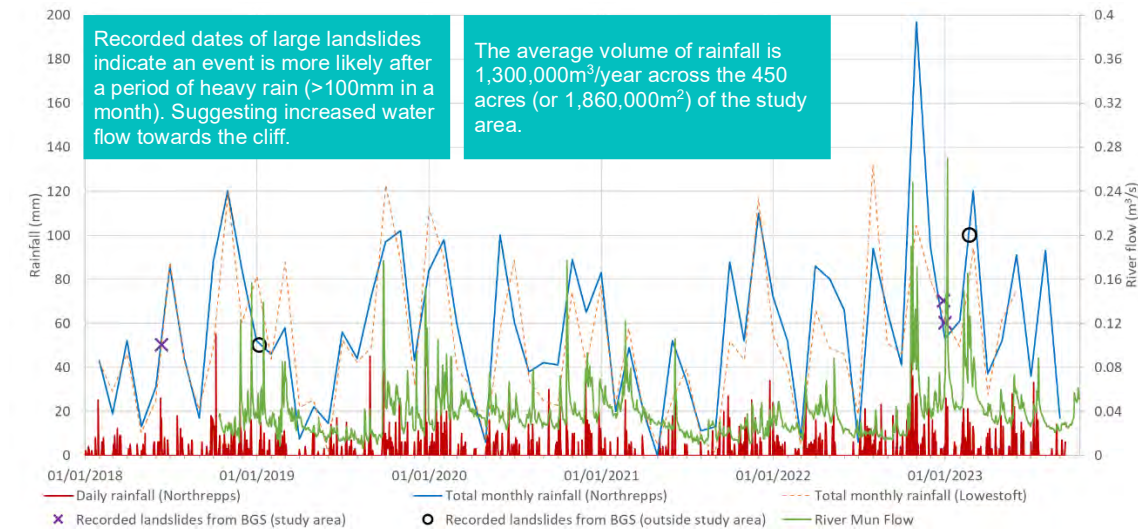
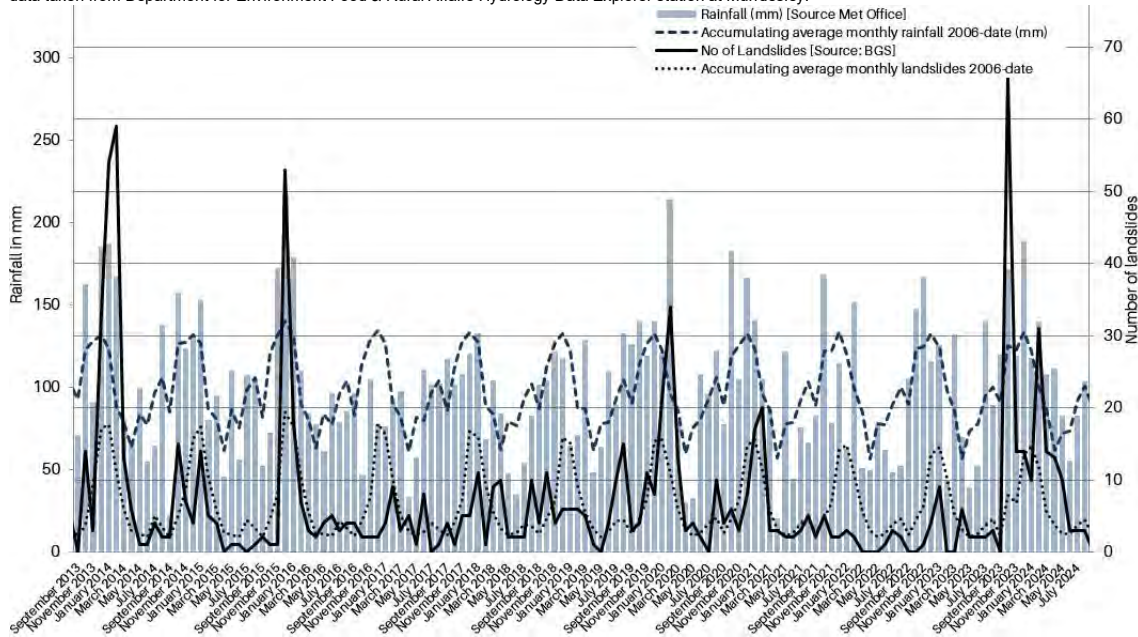
Source: Lowestoft rainfall data downloaded from Met Office. Northrepps rainfall data provided by NNDC with the permission of John Claydon. River Mun flow data taken from Department for Environment Food & Rural Affairs Hydrology Data Explorer station at Mundesley.

Source: Reproduced from the BGS on UK rainfall and landslides. Rainfall sourced from Met Office and landslides sourced from BGS.

Short and intense rainfall typically causes shallow landslides and deeper landslides generally require prolonged rainfall events. The graphs above show there is a strong correlation between the average monthly rainfall being >100mm and landslides occurring.

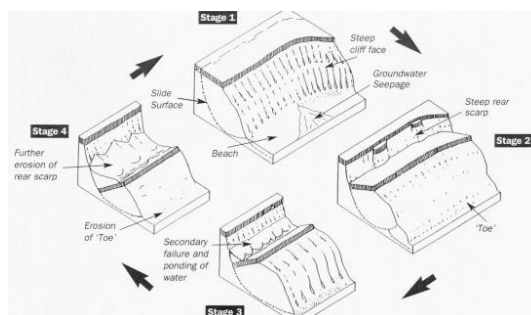
Landslide ponds - Sections of the cliff at Trimmingham have experienced deep-seated rotational failure which has resulted in back-tilt in the cliff morphology which forms ponds (See Stage 3 in adjacent image). Continuous catchment and seepage from these ponds often leads to the reactivation of landslides.

Source: Reproduced from Peter Frew, Coastal Management Unit NNDC 2009 Document 1 - An Introduction to the North Norfolk Coastal Environment (based on Bromhead, 1979)

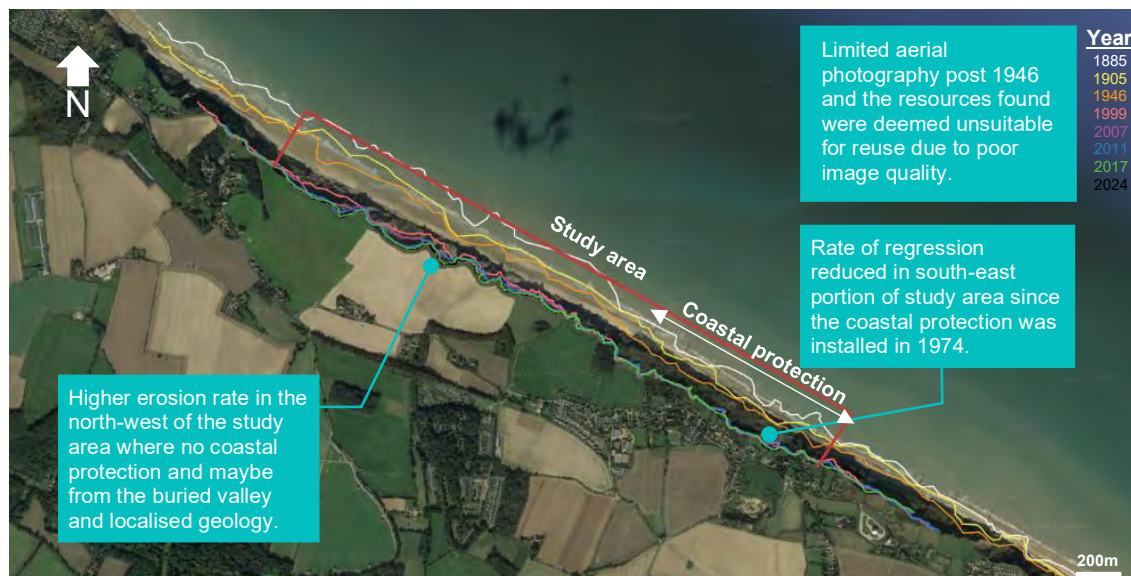
Source: Aerial image from ESRI ArcGIS World Imagery. Historical coastline taken from maps on National Library of Scotland 1885, 1905 and 1946, and Google Earth historical images 1999, 2007, 2011 and 2017. 1985 historical images were deemed unsuitable for reuse due to poor image quality.

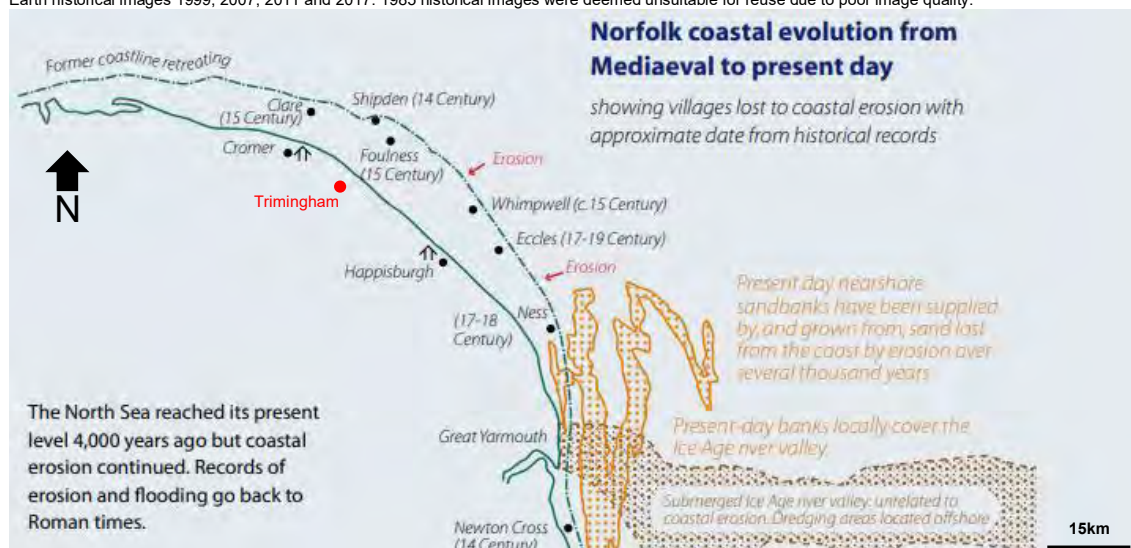
Source: An extract reproduced from Aggregate dredging and the Norfolk coastline by The Crown Estate & British Marine Aggregate Producers Association,

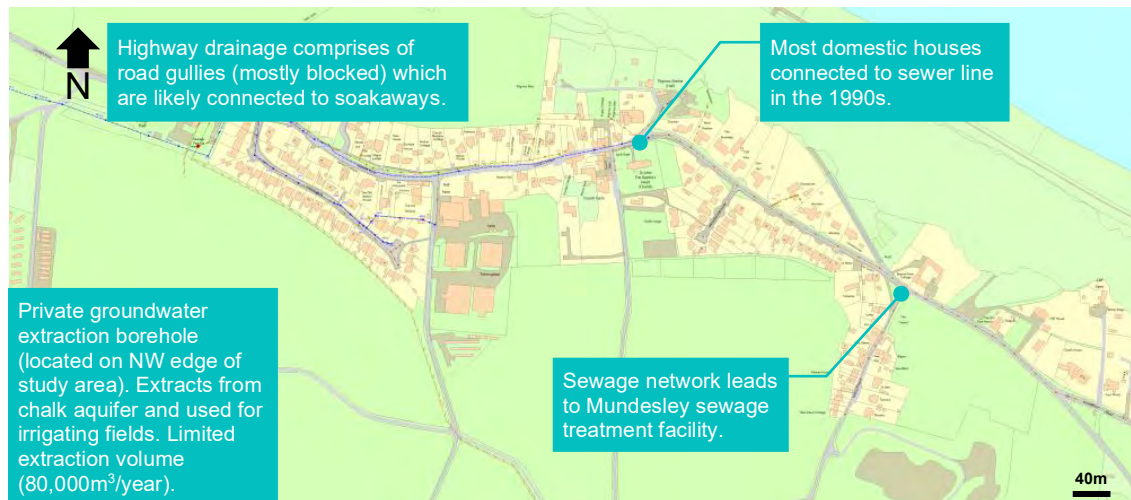
Source: Anglian Water wastewater plan of Trimingham purchased (Oct 2024) through www.digdat.co.uk (reference: 1588778-2). Highway drainage data from Highways, Transport & Waste department of the Norfolk County Council.

The change from private soakaways to a sewer system in the 1990s will have reduced the volume of water entering the ground. However, it is not known whether all the houses are connected to the mains and where the water from road drainage ends up.

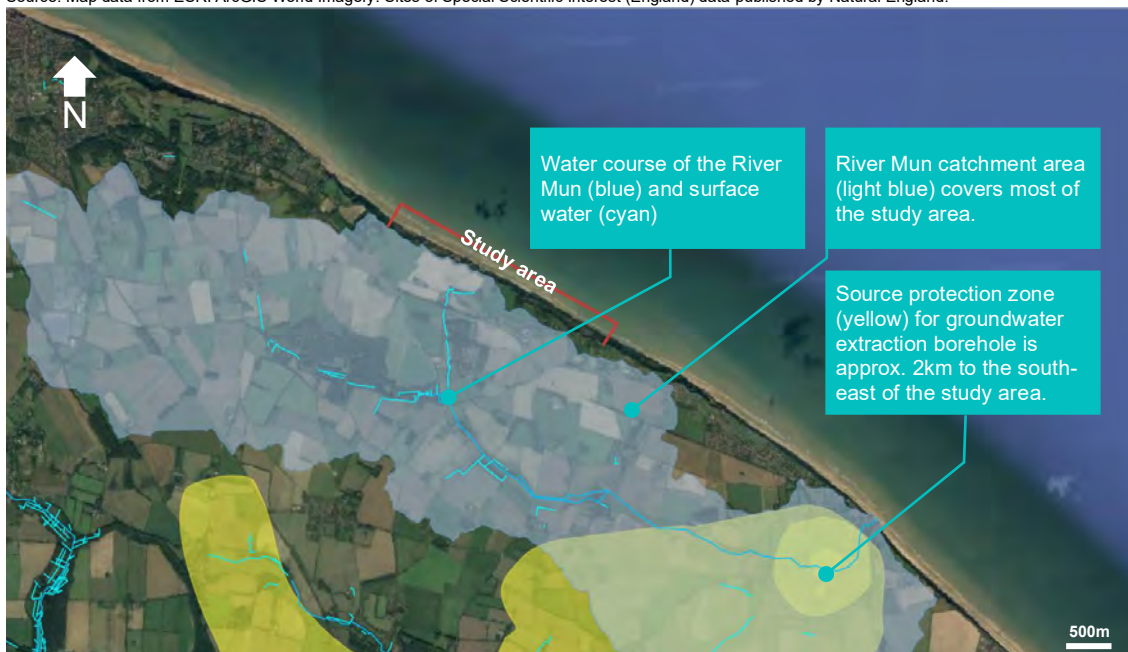
Source: Map data from ESRI ArcGIS World Imagery. Groundwater source protection zones data and the river catchment for Mun Water Body data both published by Environment Agency. Watercourse and surface water data published by Ordnance Survey.

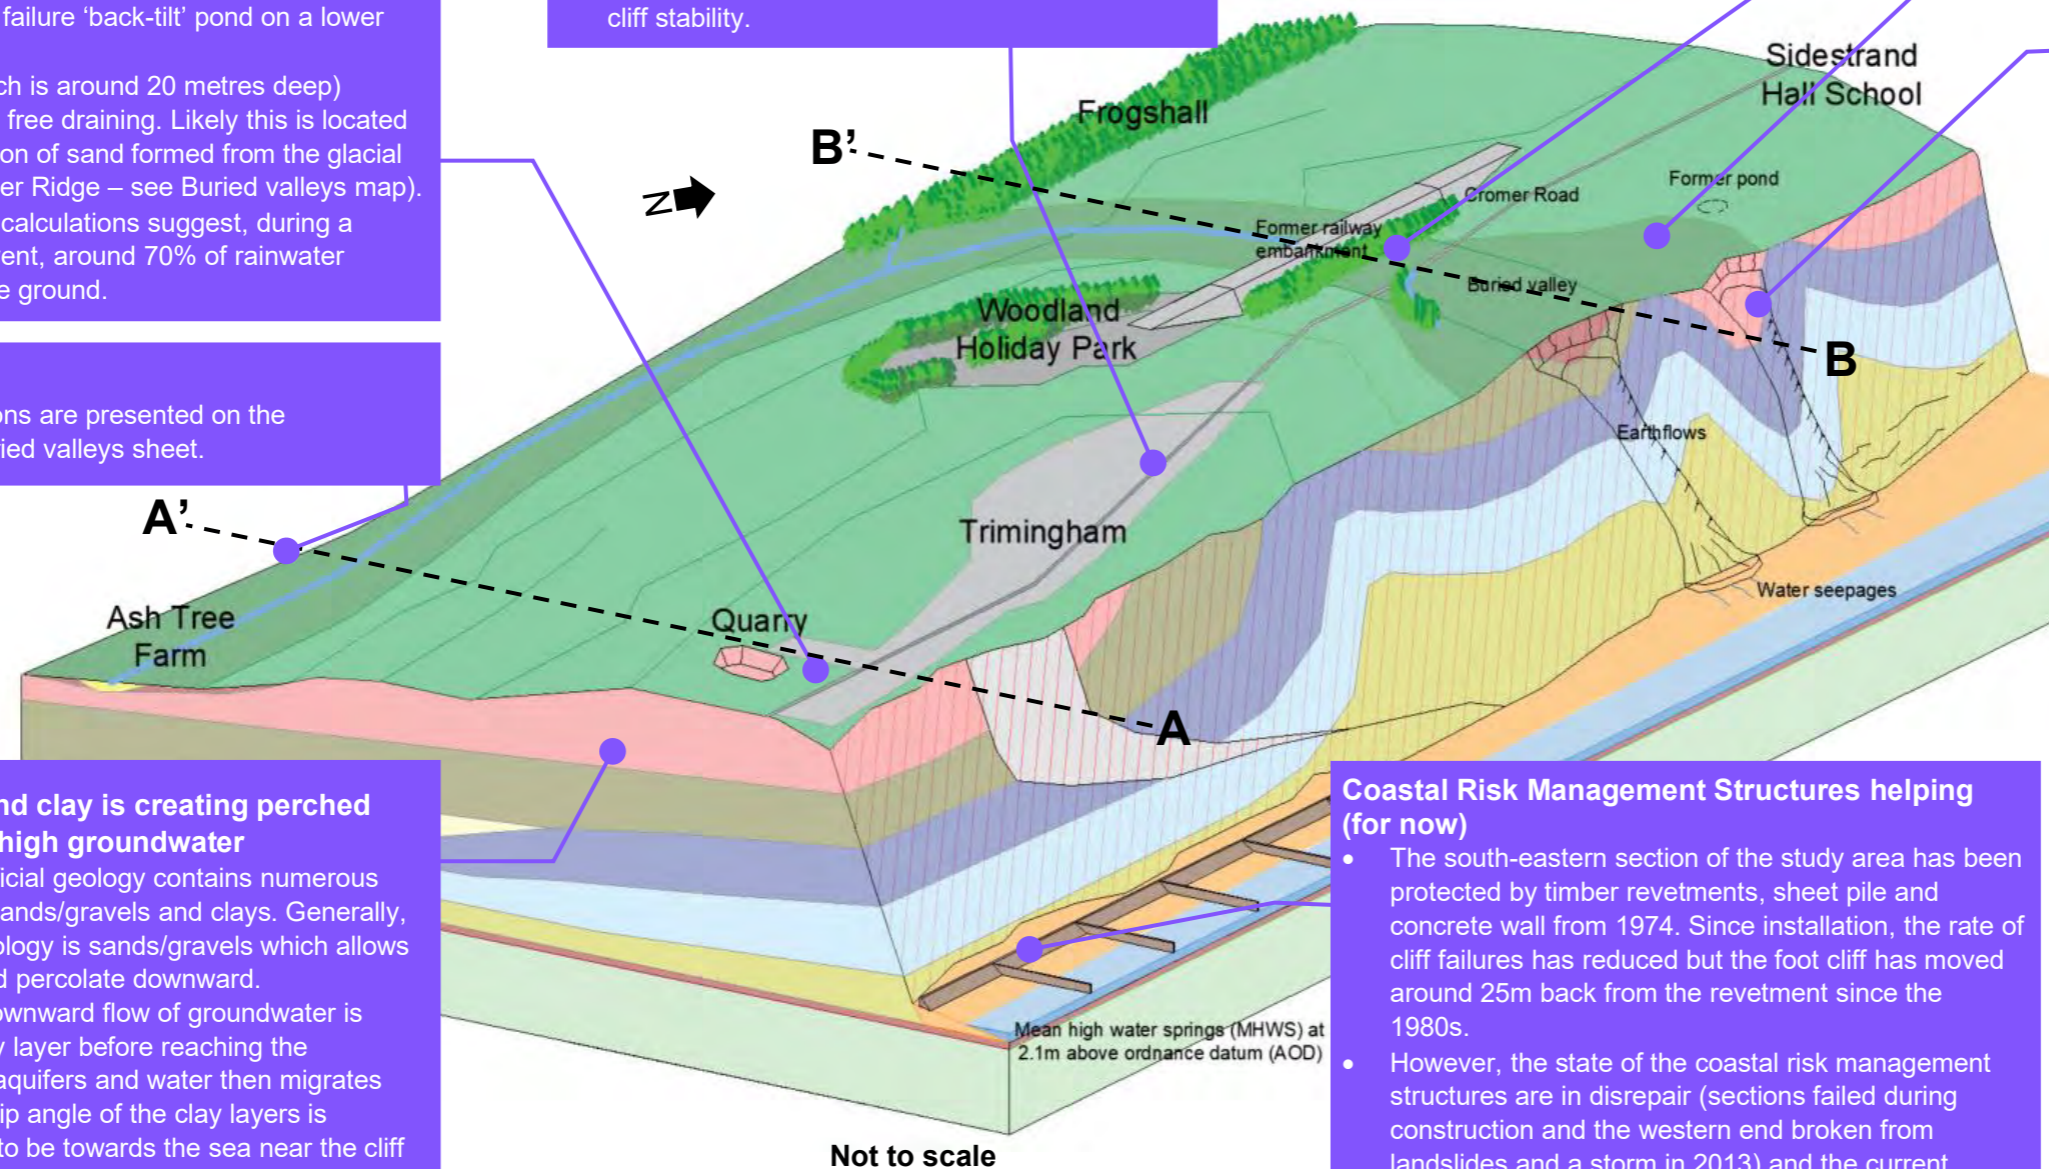
3 Relationship between water and cliff failures at Trimingham - Oblique view of conceptual 3D site model

- On the northern side of Mundesley Road at the same location the surface often remains free of ponded water after rainfall.
- Where the former Crown and Anchor pub was located, the ground gently slopes to the cliff. Evidence for surface water flowing over cliff edge and into the cliff failure 'back-tilt' pond on a lower bench.

Where the surface geology indicates a buried valley, the failure type is large earthflow and mudflow. Typically, this occurs when clay, silt and fine sand become saturated with water and flow down slope. Water seepages can be seen at the toe of the failures.

The complex Superficial geology contains numerous bands and folds of sands/gravels and clays. Generally, the near surface geology is sands/gravels which allows water to infiltrate and percolate downward. Conceptually, the downward flow of groundwater is intercepted by a clay layer before reaching the underlying bedrock aquifers and water then migrates horizontally. While dip angle of the clay layers is unknown, it is likely to be towards the sea near the cliff edge. This can lead to water flowing out of the cliff, removing finer material which reduces the strength and stability of the cliff.

- The south-eastern section of the study area has been protected by timber revetments, sheet pile and concrete wall from 1974. Since installation, the rate of cliff failures has reduced but the foot cliff has moved around 25m back from the revetment since the 1980s.
- However, the state of the coastal risk management structures are in disrepair (sections failed during construction and the western end broken from landslides and a storm in 2013) and the current Shoreline Management Plan (SMP6) approach is for no active intervention and for a natural shoreline. This means the protection will not be repaired or replaced.
