Coastal Processes

North Norfolk District Council
Holt Road, Cromer, Norfolk, NR27 9EN

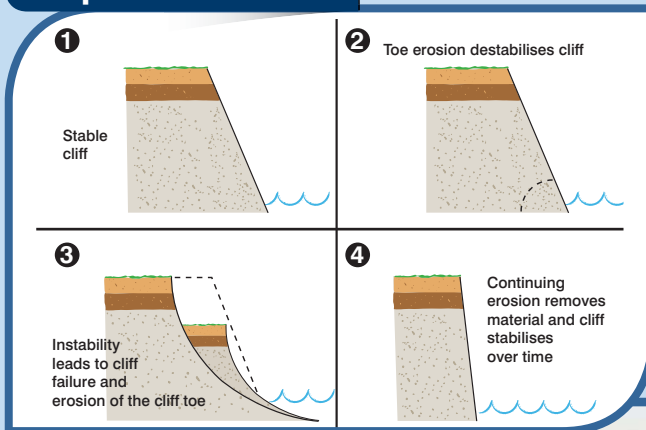
Simple Cliff Erosion

Coastal erosion is the process of cliff materials wearing away due to regularly being hit by waves. The cliffs in North Norfolk are made up of soft sands, silts, clays and gravels and are susceptible to erosion and failure. A key driver of this is the action of the waves, through four erosional types:

Hydraulic Action	The sheer force of the wave hitting the cliff causes air that is trapped inside to compress, which can weaken the whole cliff
Solution	Sea water can dissolve cliffs on the shoreline. Rocks that are likely to dissolve are soft rocks such as chalk
Attrition	Rocks carried with the waves hit against each other and break down into smaller, smoother rocks and pebbles; this creates different grades of beach materials.
Abrasion	Material such as rock and sand within the waves hit the cliff when the wave breaks against it and causes the cliff to be ground down

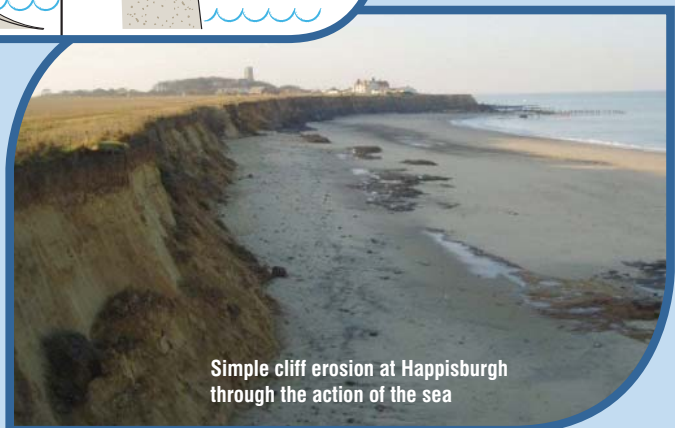
Simple cliff erosion at Happisburgh through the action of the sea

Cliff failure can be problematic for a number of reasons, including limiting beach access, and impacting on coastal communities; however the material released from cliff erosion is essential to maintain beach levels further down the coast.

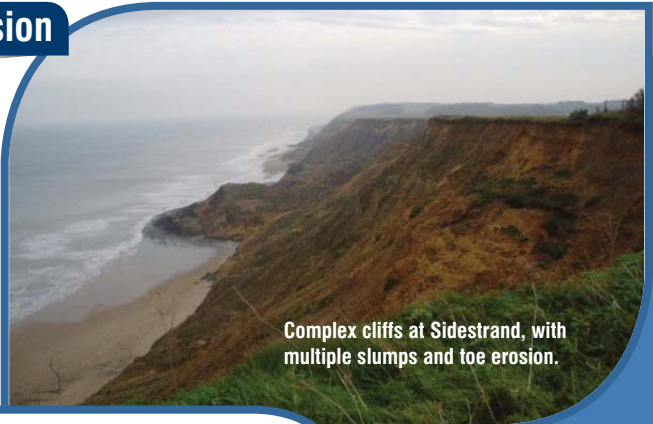
Complex cliffs at Sidestrاند, with multiple slumps and toe erosion.

Collapse caused by wave action is supplemented on large cliffs by the impact of groundwater. Clay layers within the cliff become saturated with rain water and become impermeable to percolating rain water traveling down through the cliff.

The water begins to pool within the cliff increasing the water pressure and weight of the cliff making it unstable. The only way this pressure in the cliff can be released is by mud slides, slumps and cliff failures.

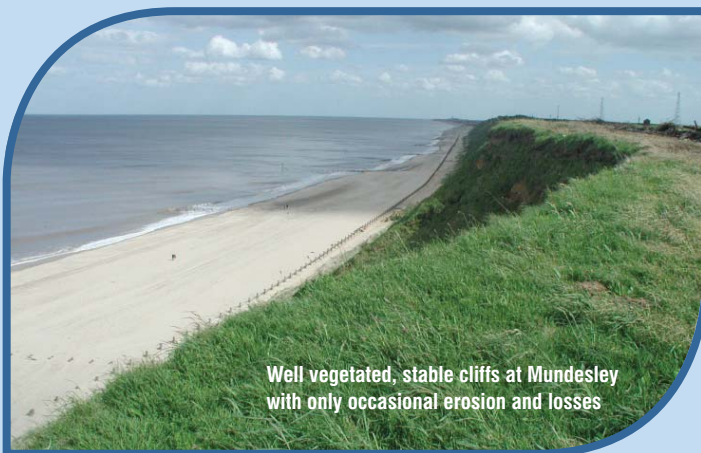
Well vegetated, stable cliffs at Mundesley with only occasional erosion and losses

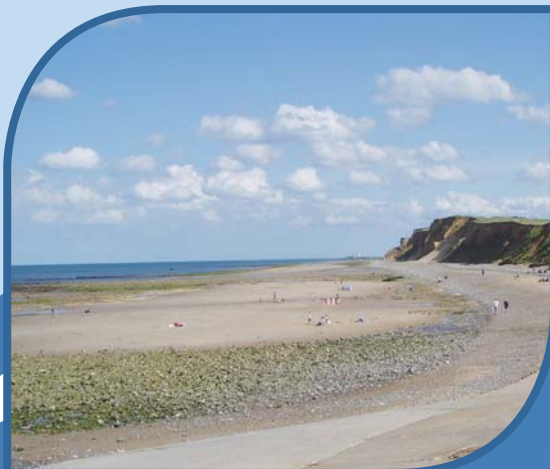
Beaches are also subject to longshore drift, a process of sediment transport caused by waves and tides. Material can be moved in four different ways:

Traction	Large material is rolled along the sea bed by the power of the waves
Suspension	Small material is carried along in the water, which can make it look cloudy
Saltation	Small pebbles or large sand is bounced along the sea bed, as the current is unable to keep larger material afloat for long
Solution	Minerals are dissolved in sea water and carried. It is invisible and can come from chalk or limestone cliffs.

In North Norfolk, sediment generally moves westerly from Weybourne and easterly from Sheringham towards Great Yarmouth. The high cliffs from Overstrand to Mundesley provide a significant contribution to beach materials and therefore feed much of the East Norfolk beaches. Many years of coastal protection have led to less material being released onto beaches resulting in a general fall in beach levels. In turn, this exposes the cliff toe to further action of the sea and increases sea defence maintenance costs.
