Happisburgh Rock Sill Recovery and Re-Location

St La Haye Limited

November 2014

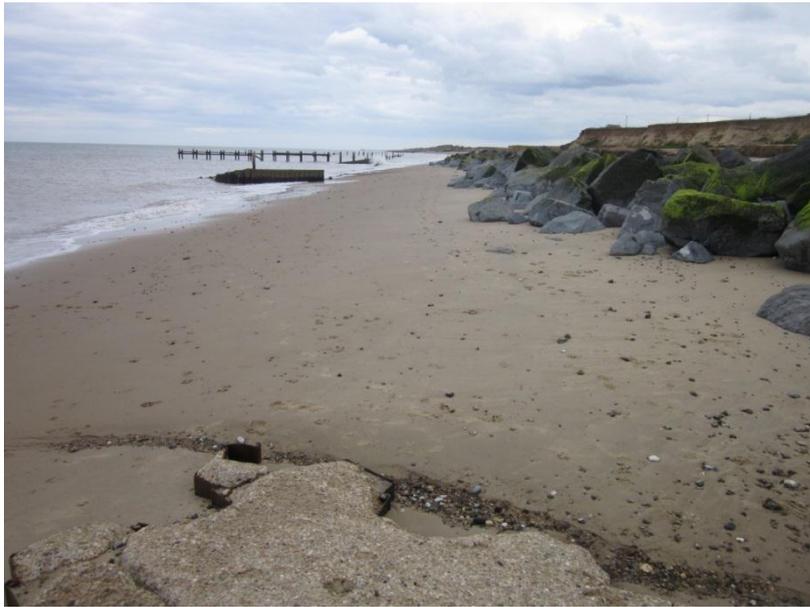
Figure 1. Rock Sill

Seven options have been considered including the do nothing option. The existing sill protects approximately 400 metres of cliff. In discussing the options below, the suggestion for the sites of the relocated defence is tempered by the practicalities of recovering the rock, transporting the rock, and cost. Environmental issues are discussed later in the report. It can be seen in figure 1 that a reasonably good beach will facilitate access to the complete length of the sill. Hence, with the appropriate equipment, most of the rock can be recovered. However there can be no guarantee that all of the rock will be recovered.

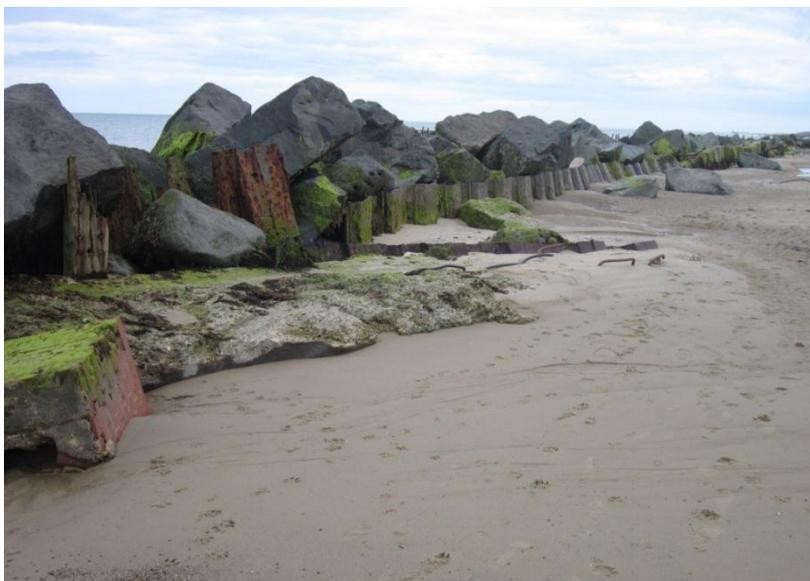
Figure 2. Older derelict defences behind the sill

Any scheme for the recovery of the rock will also require the removal of the remains of older and derelict defences currently forming part of the rock sill close to the remains of the old lifeboat ramp. The cost of this work is approximately an additional £15,000 which is not included in the estimated

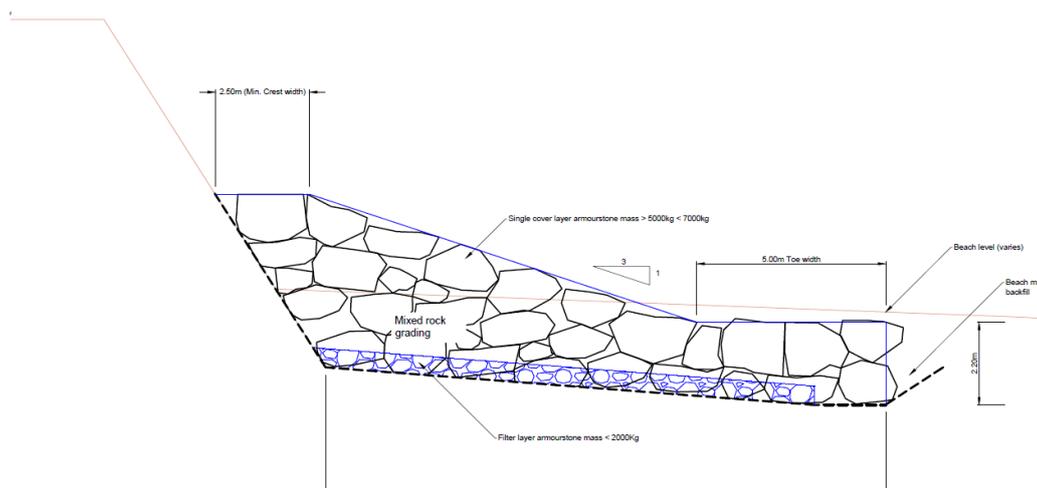
Figure 3. Cross section through rock revetment

The diagram below shows a cross section through a rock revetment originally designed as part of a previous study of defence options at Cart Gap but considered to be appropriate for this site.

A rock revetment requires a core of smaller rock with the larger rocks used as armour to the sill. The smaller rock helps improve the hydrodynamic performance of the sill and acts as a filter layer.

Roughly one third to a half of the rock tonnage needed to construct the revetment would be the smaller sized rock. Only 8,900 tonnes of rock is available: All of which is of a size that would normally be used as armouring rather than core material in a revetment.

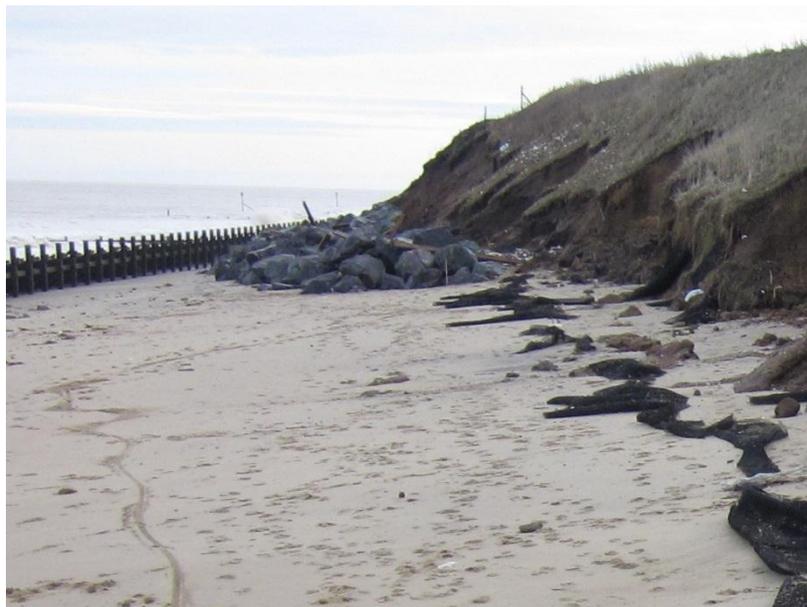
Figure 4. Cliff erosion behind rock revetment at Bacton

The 8,900 tonnes could be used in a revetment but the length protected would be not more than 100 metres. i.e. less than a quarter of the length protected by the existing sill. If the large rock available was used alone it would provide a reasonable degree of protection but it would not be as effective as a designed rock revetment using smaller rock as core material. Experience has shown that in severe events a rock revetment without a designed core will not prevent extensive damage to the cliff. The photograph below shows cliff damage behind such a privately funded revetment at

Bacton following the December 2013 storm surge event.

This rock bund will provide some protection to the base of the cliff in that wave energy will be dissipated partially. However, the large voids in the structure will allow waves, albeit with reduced energy, to attack the base of the cliff. Waves will also break on the structure with the spray always landing on the face of the cliff. Hence, the defence does not counter the damage caused by overtopping. As described in Option 4, this type of defence will not prevent substantial damage during a storm event. The damage is likely to be even more severe than that shown in figure 4 given that the rock bund has a relatively smaller cross section.

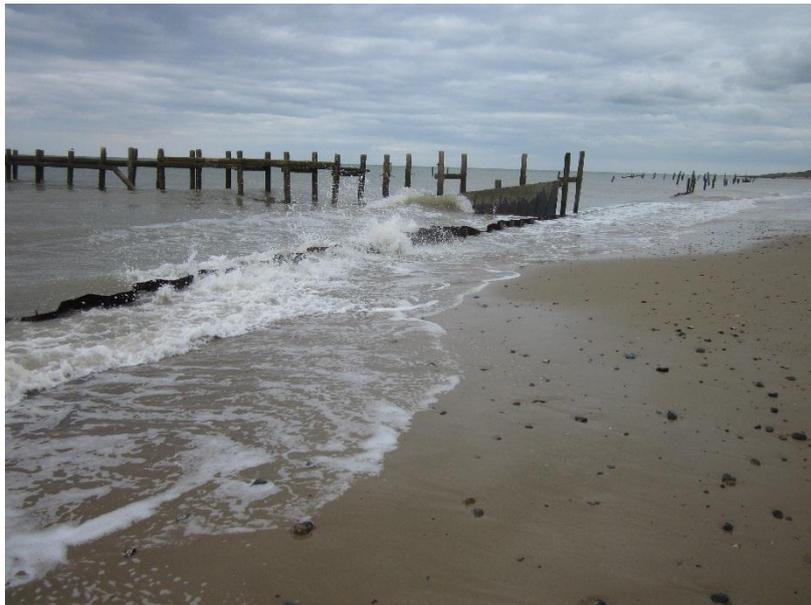
Figure 5 Derelict defences

Figure 5 illustrates an example of the remains of groynes and revetment seaward of the existing rock armour sill. A good beach, such as that shown, would allow access to much of the remaining derelict defences allowing heavy plant to be used to remove them. If the rock sill is removed or relocated, it is quite possible that beach will be lower at this position militating against the safe removal of the dereliction. As a result, these derelict defences and, in particular, the steel piles will be a submerged hazard to people in or on the water. It is recommended that the derelict defences be removed, as far as is practicable in the circumstances, in conjunction with any scheme to relocate the existing rock armour sill.

Given the nature of the work, it is not possible to provide an accurate estimate of the costs of this work. If the work was to be done as part of a rock relocation scheme, an additional budget of £17,000 might be appropriate: Much higher if done separately.
