Overstrand to Walcott Strategy Study

Cliff Processes

Part II: Technical Support Information

**Report EX 4692
February 2003**

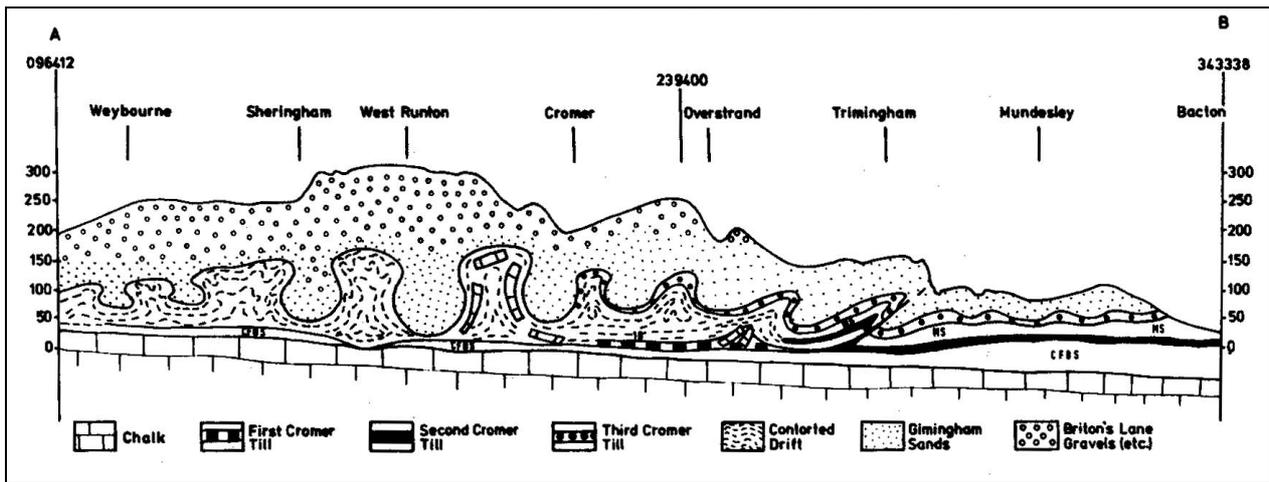
Figure 2.1 Cliff section along the north Norfolk coast (Banham 1975)

The diamicton is highly deformed (i.e. contorted) comprising laminations and deformed blocks of clay, sand and gravel, and large rafts (*schollen*) of Beeston chalk (Figure 2.1). The deformations are believed to be the result of shearing, extension, and flow of the highly saturated materials beneath the ice sheet (Figure 2.2).

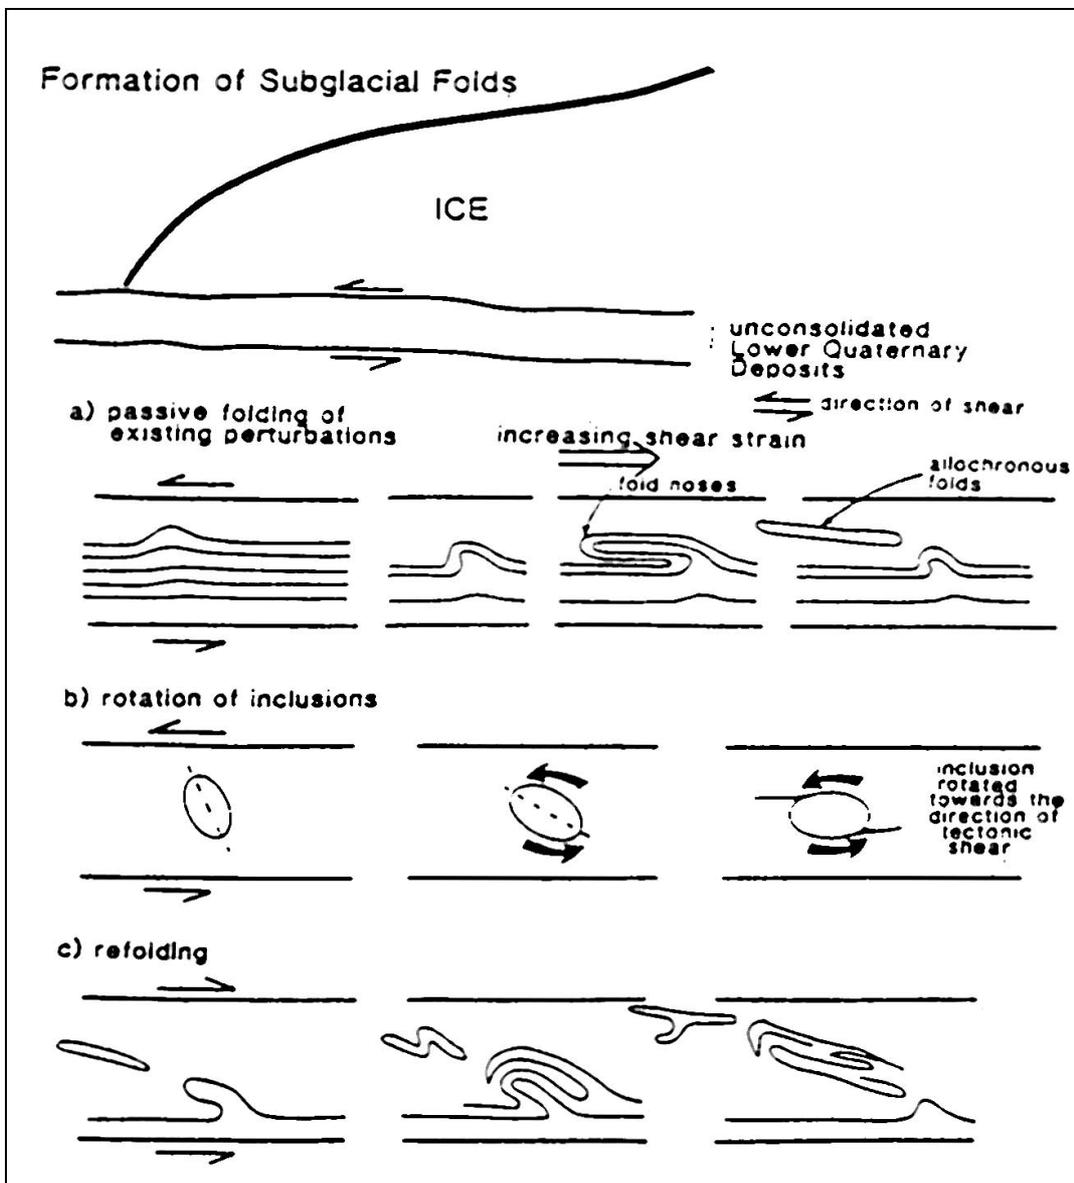
Figure 2.2 A summary of the mechanisms of sub-glacial deformation (Hart 1987)

Overburden loading by the Gimingham Sands and Briton's Lane Gravels caused diapirism of the underlying water saturated tills, leading to compensatory sinking of the sand units between the diapirs.

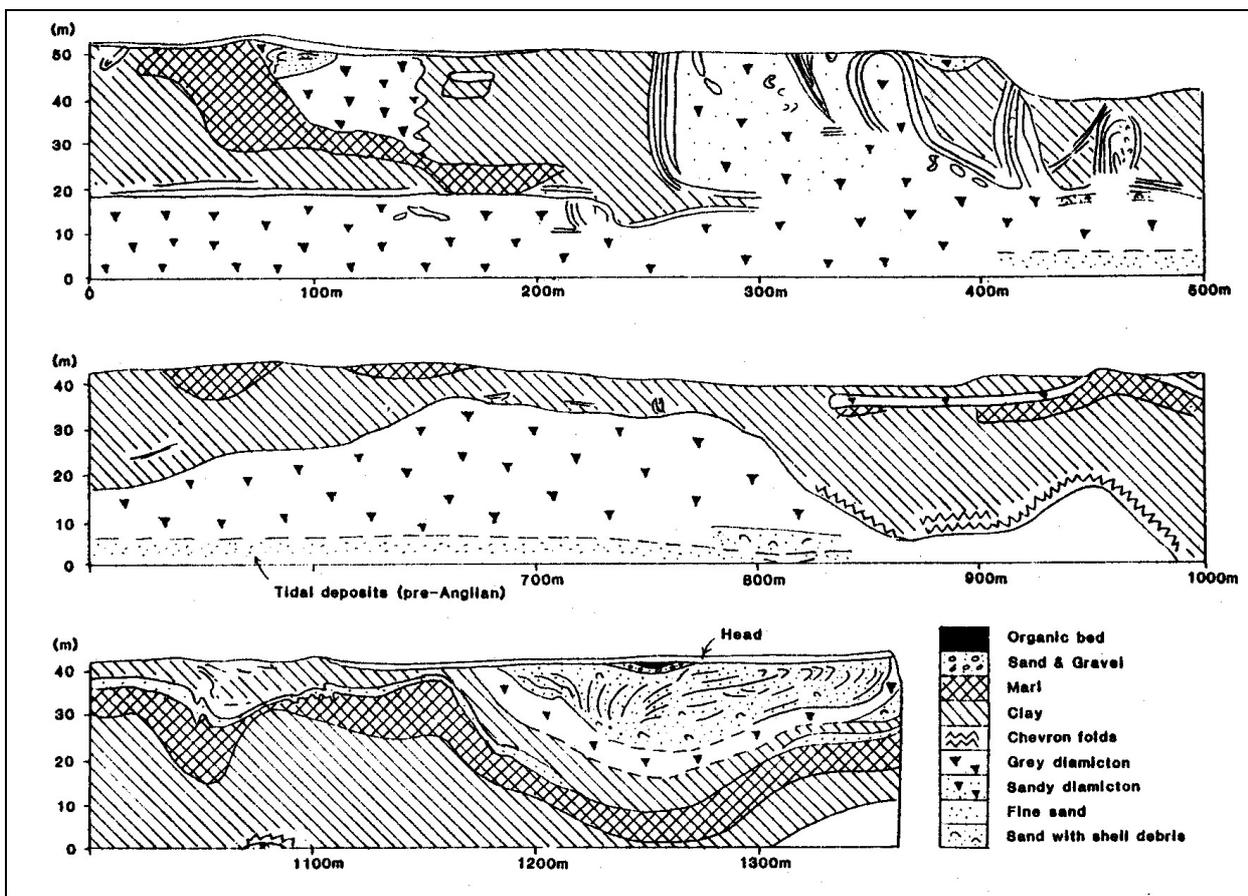
Figure 2.3 Coastal exposure at Trimingham, 1985 (Gibbard and Zalseiwicz 1998)

Trimingham Cliffs, see Figure 2.3 (Gibbard and Zalasiewicz 1988)

Head		
Sidestrand lacustrine unit		Infilled hollows on the till surface.
Upper diamicton unit	Outwash sand D	Probably corresponds with the Third Cromer Till, plus Gimingham Sands and Mundesley Sands
	Upper diamicton	
	Outwash sand C	
Trimingham unit	Upper clay	Probably corresponds with the Intermediate Beds. These are glacial lake deposits ('Lake Trimingham'), up to 45m thick. The sequence comprises varved clays, homogeneous clays, lake marls, aeolian sands.
	Fine sand	
	Marl	
	Homogeneous clay	
	Lower or rhythmic clay	
Lower diamicton unit	Lower diamicton	Probably corresponds with the First Cromer Till. The till includes deformed blocks of chalk 1-2m long
	Outwash sand A	
Pre-glacial deposits

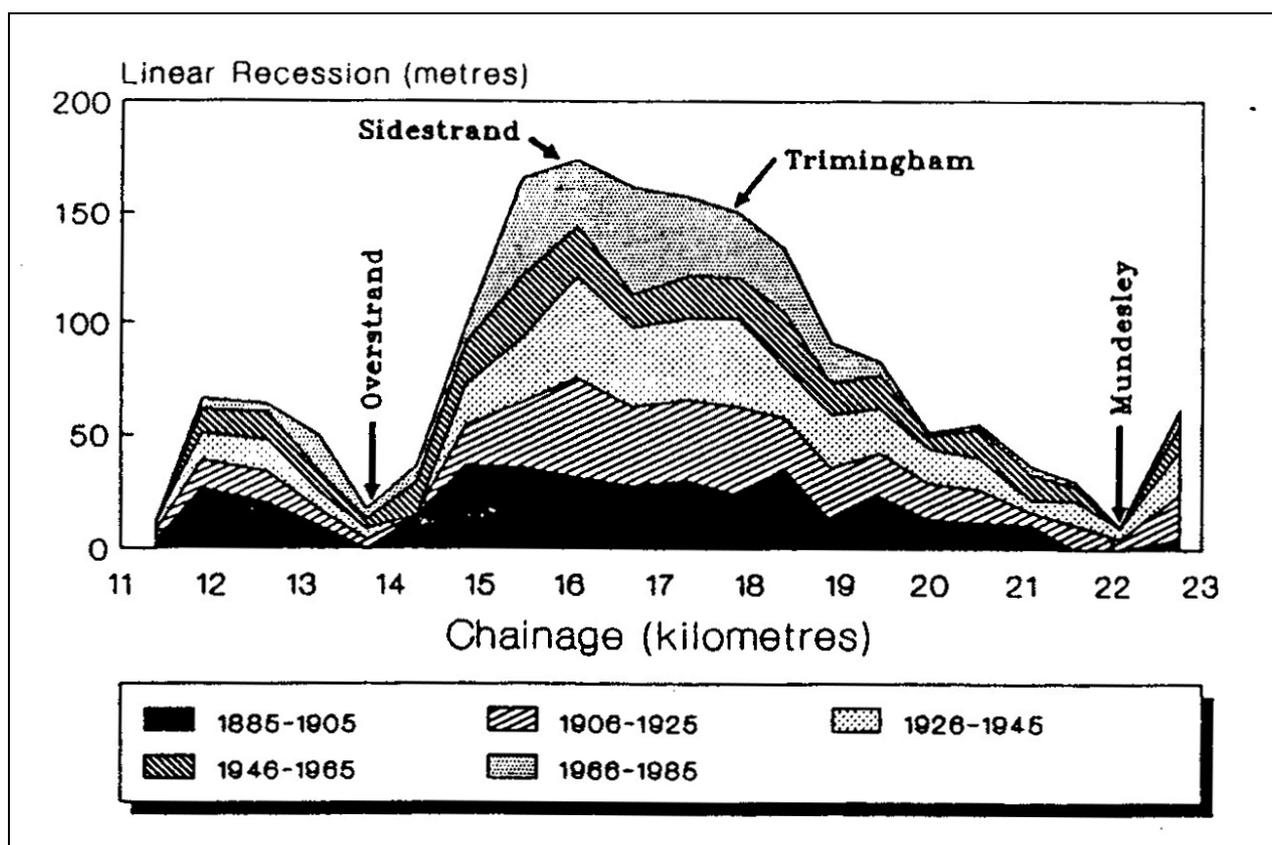
Figure 3.1 A summary of the cumulative recession along the North Norfolk cliffs (Clayton and Coventry 1986)

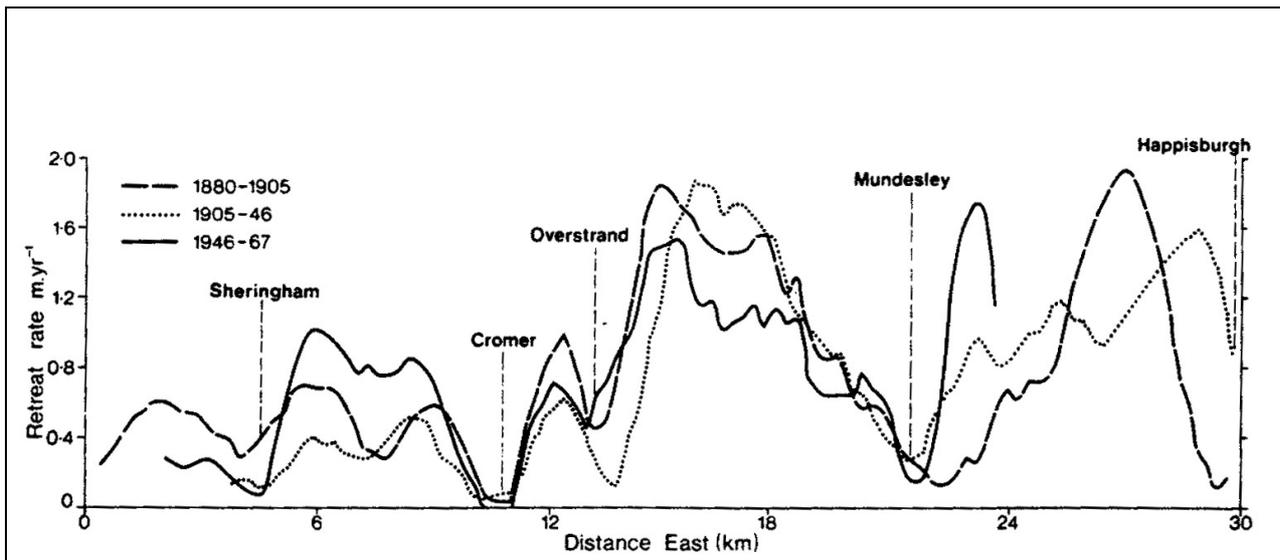
Figure 3.2 Variation in cliff recession rates along the North Norfolk coast (Cambers 1976)

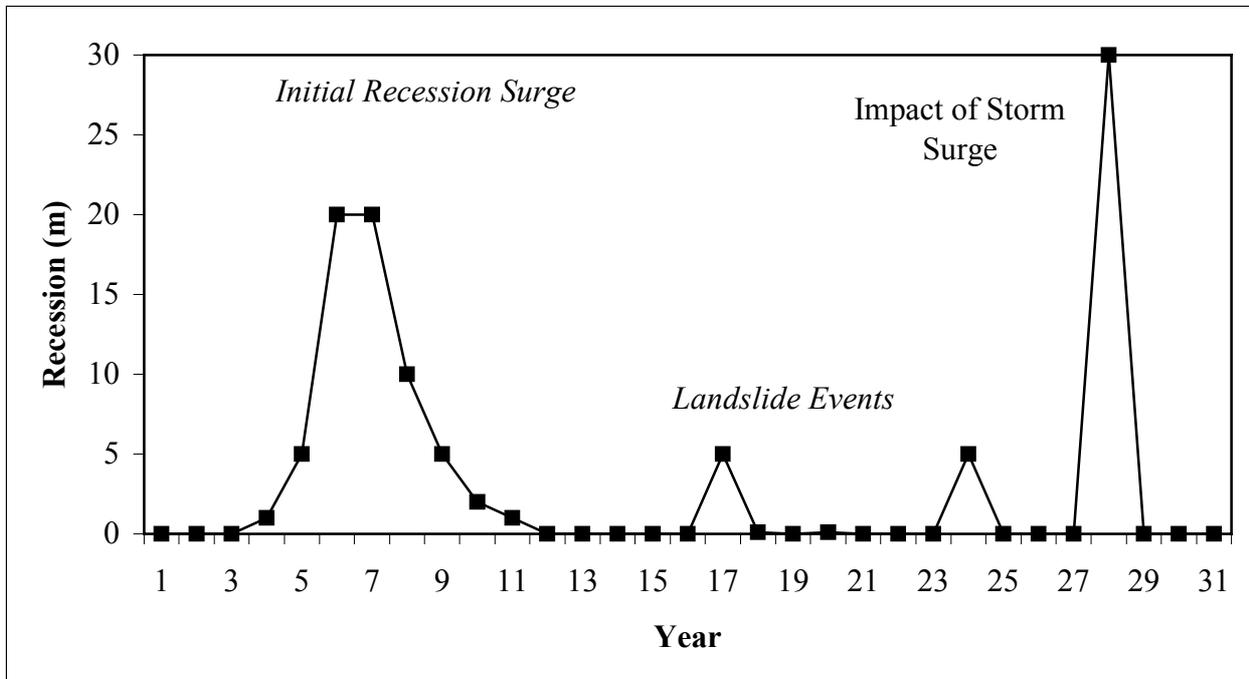
Figure 3.3 A hypothetical recession sequence, following seawall failure at year 0

As noted earlier, the cliff recession process, caused by occasional relatively large landslides, is episodic rather than continuous. For this reason it is better to express the long-term recession rate as up to 26m every 10 years rather than 2.6m/year. Figure 3.3 presents a hypothetical sequence of recession events that might follow failure/removal of the defences.

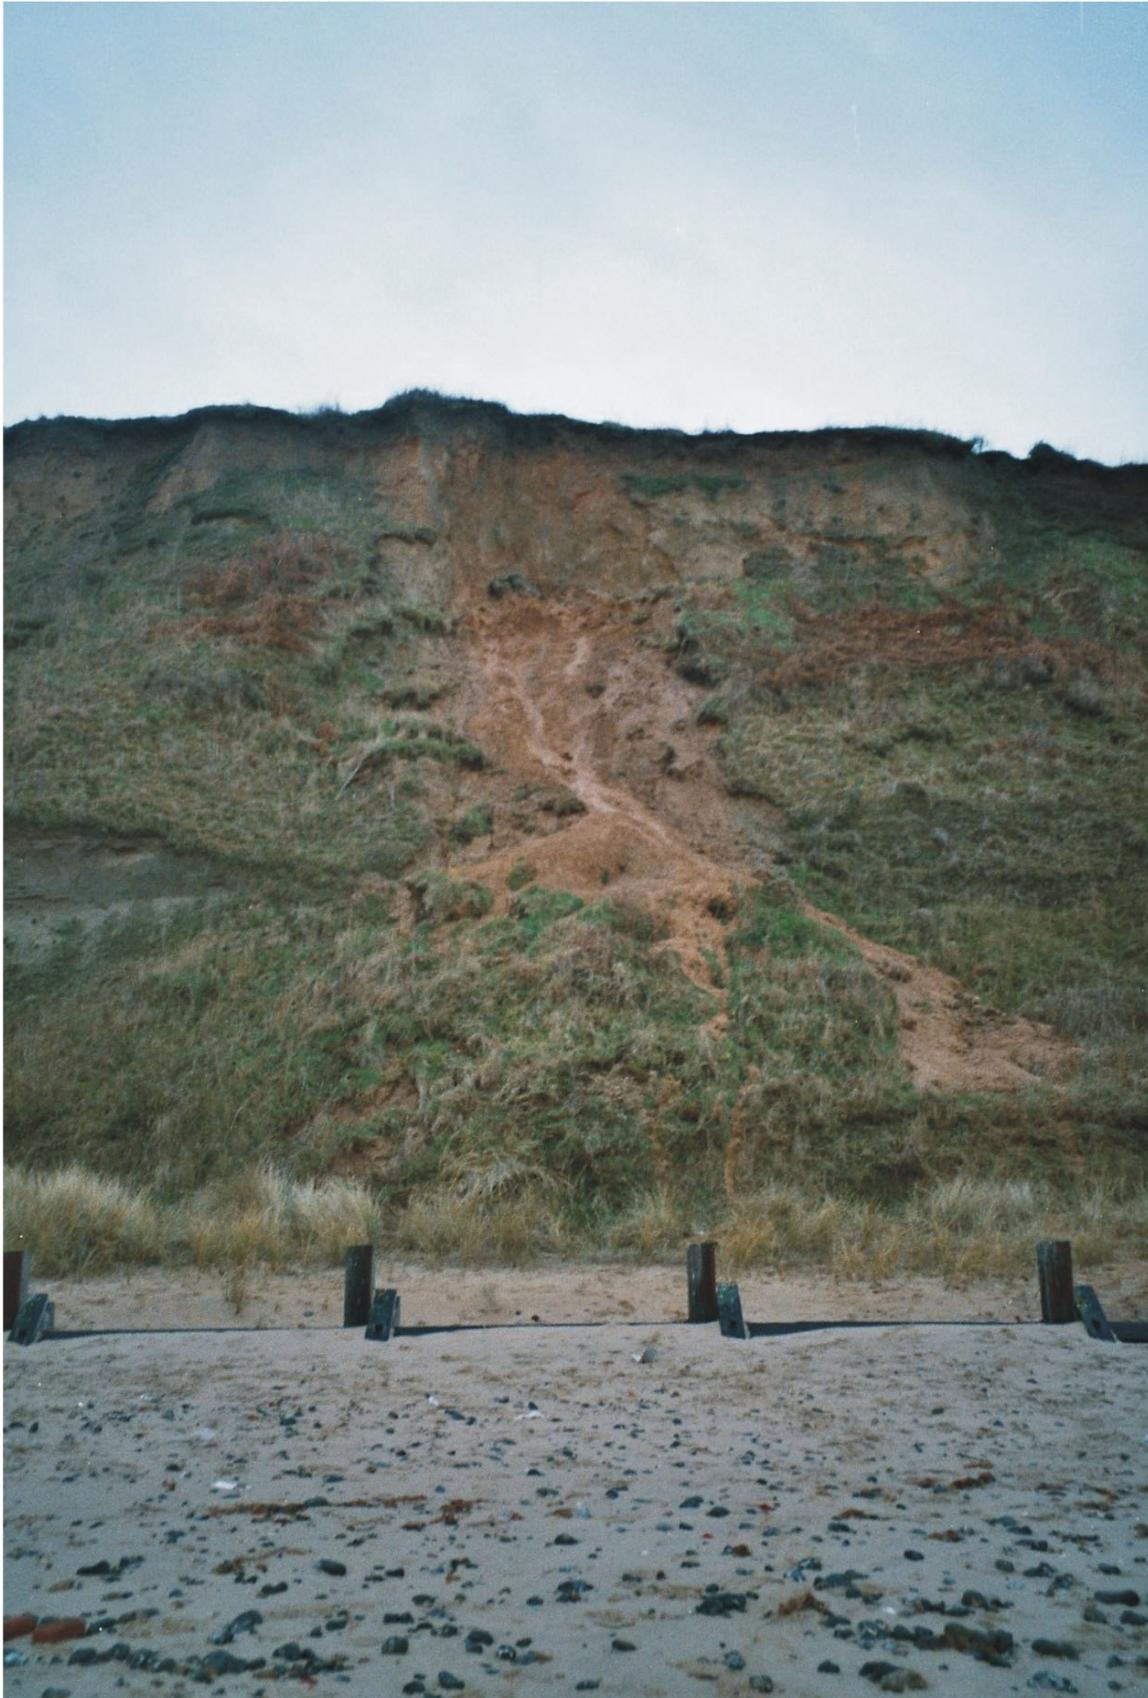
Plate 2 Cliff behavioural unit 16 – small-scale sand flow

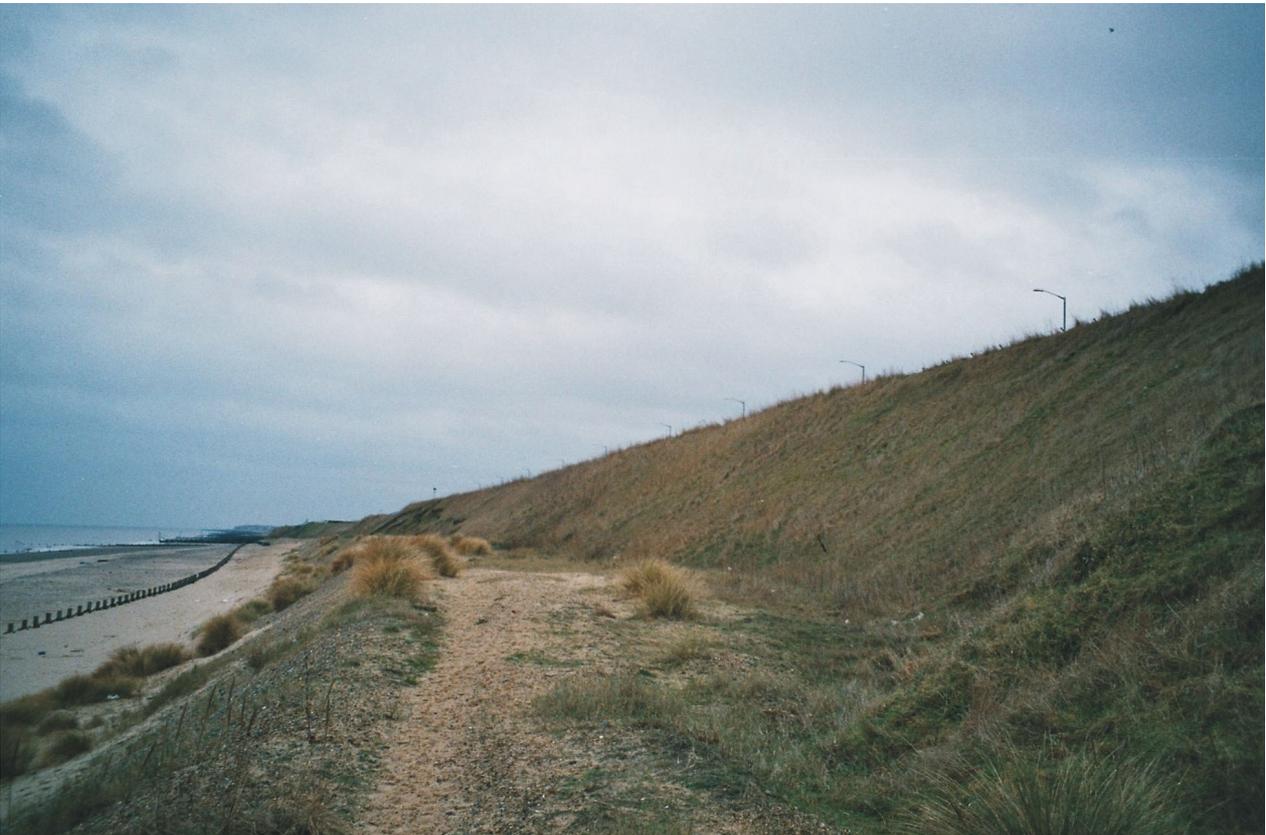
Plate 4 Cliff behavioural unit 18 – view east; note the regraded slopes

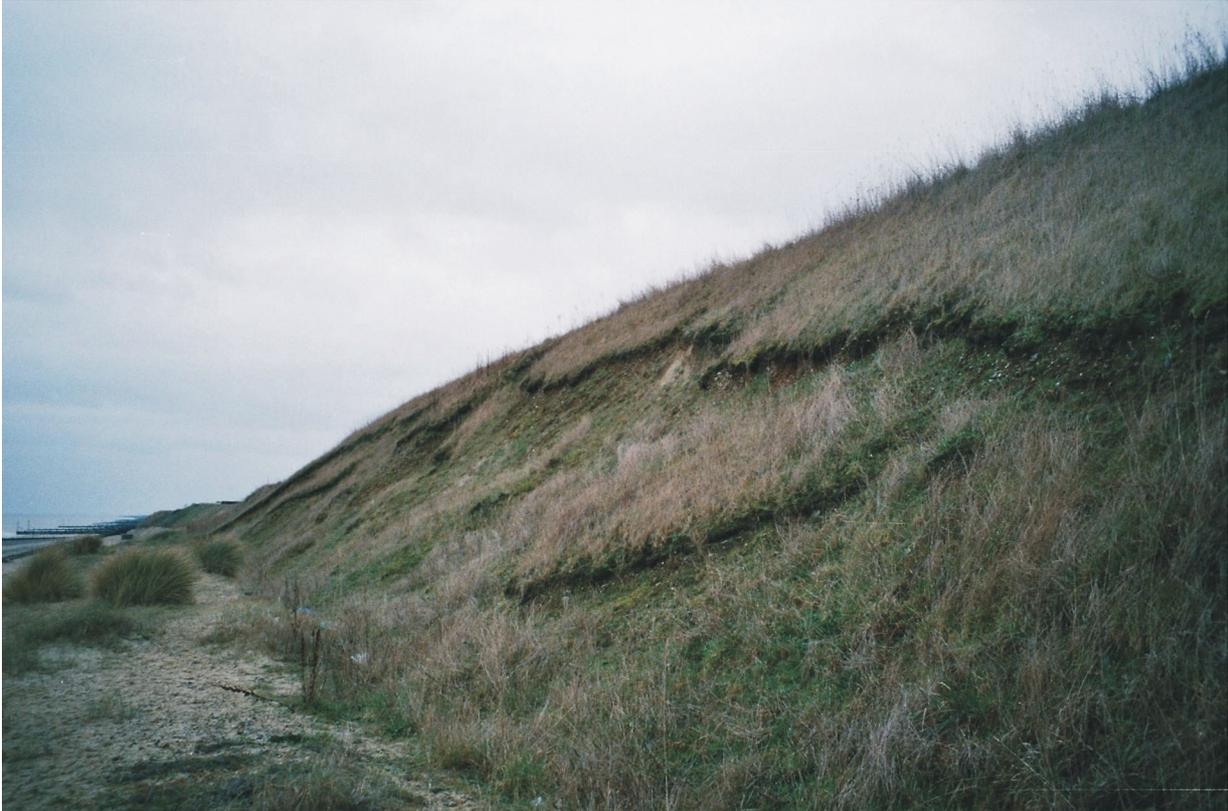
Plate 5 Cliff behavioural unit 18 – view east; note the localised small failures of the regraded slope

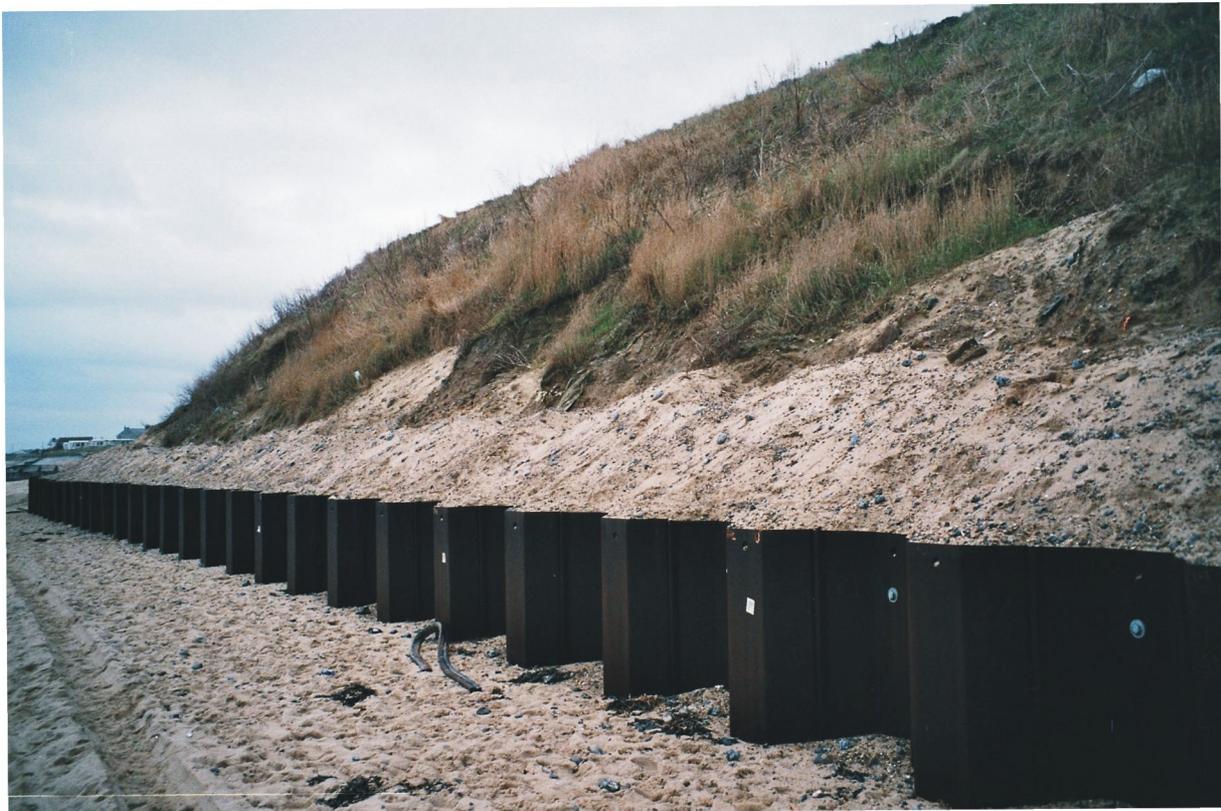
Plate 6 Cliff behavioural unit 19 – view east; note the recent sheet pile wall at the cliff toe

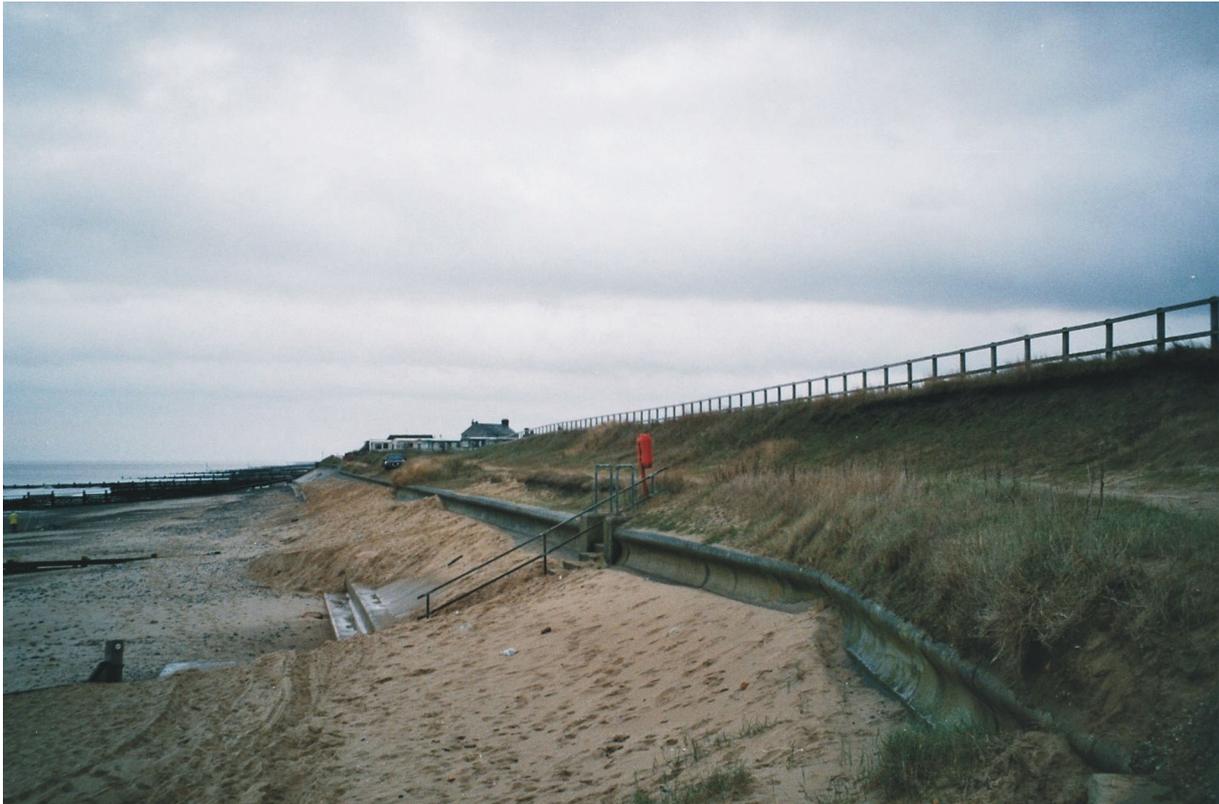
Plate 7 Cliff behavioural unit 20 – Bacton Green, view east; note the seawall in front of a low cliff

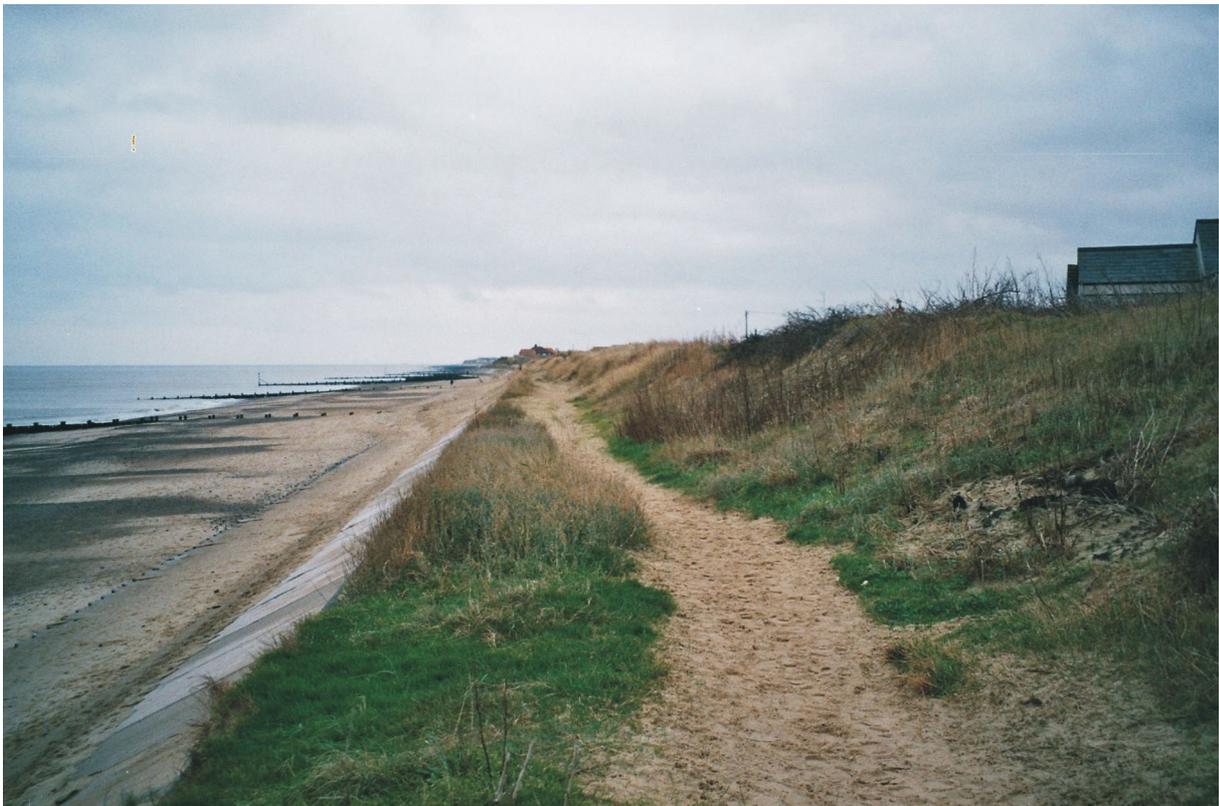
Plate 8 Cliff behavioural unit 20 – Keswick, view east; note the seawall in front of a low cliff

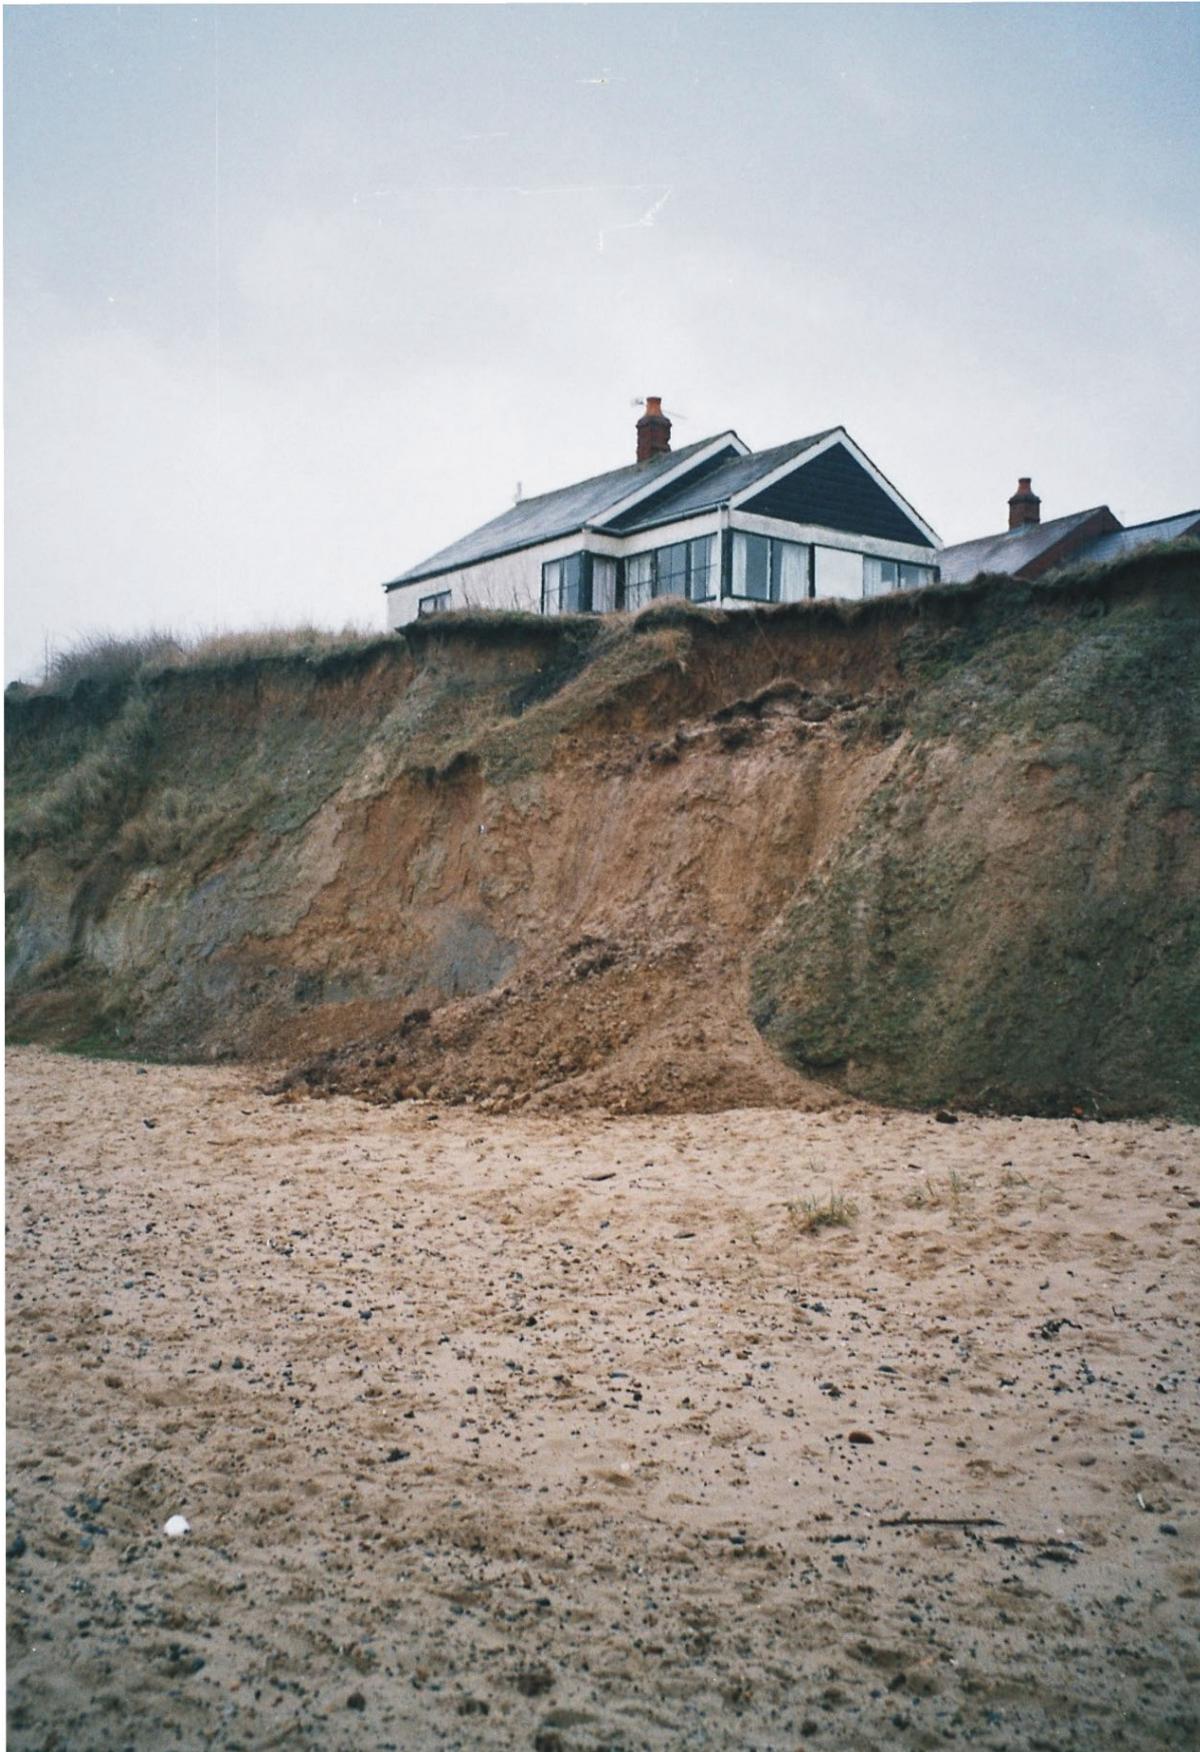
Plate 9 Cliff behavioural unit 21 – Ostend, view east; note the recent small cliff failure
