Kelling to Cromer Strategy Study

Option appraisal and strategy recommendations

Project	Kelling to Cromer Strategy Study
Report title	Option appraisal and strategy recommendations
Client	North Norfolk District Council
Client Representative	Mr P Frew
Project No.	CDR3567
Report No.	EX 4985
Project Manager	Dr Noel Beech
Project Sponsor	Dr Keith Powell

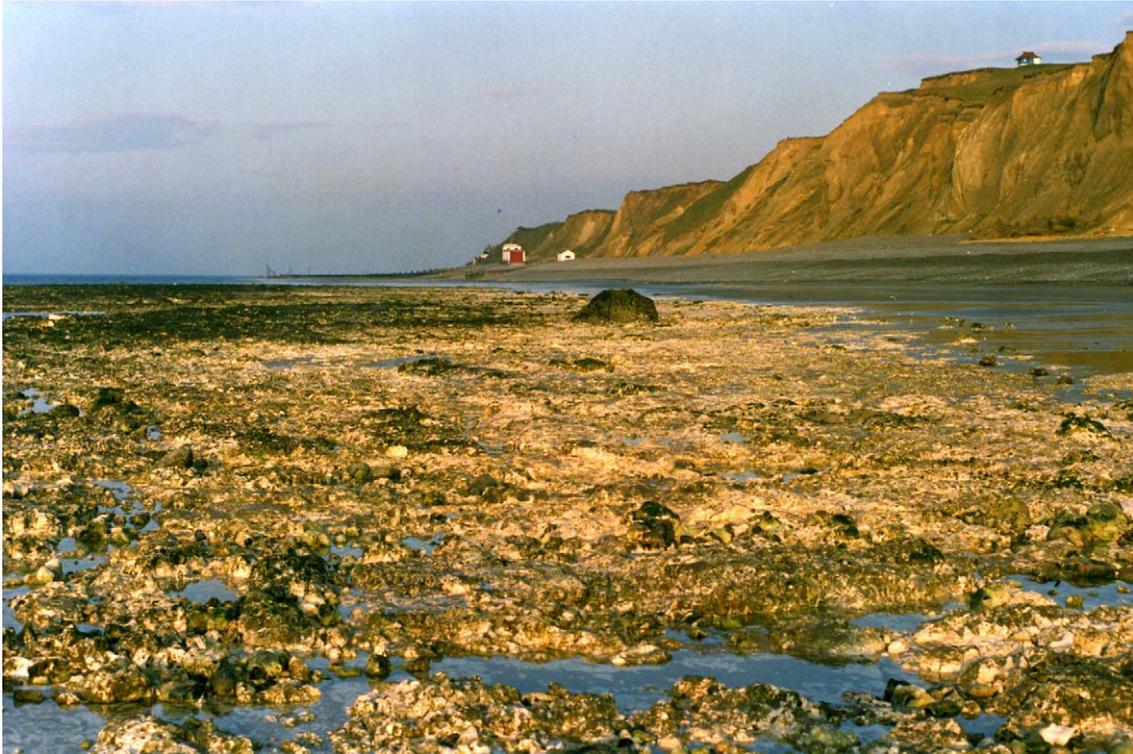
The management unit (MU1/CU1) continues uninterrupted into the adjoining management unit to the westward, which is outside the Strategy Study Area. MU1/CU1 stretches from Kelling Hard up to the western outskirts of Sheringham. The shoreline along this length is composed of a 5.5 km long shingle beach that is in “very good condition”, having a wide, energy dissipative crest. The beach thins out slightly towards the lifeboat station at the western outskirts of Sheringham. In this area the chalk platform is normally exposed, having only small sand patches around it, as shown in the photograph below.

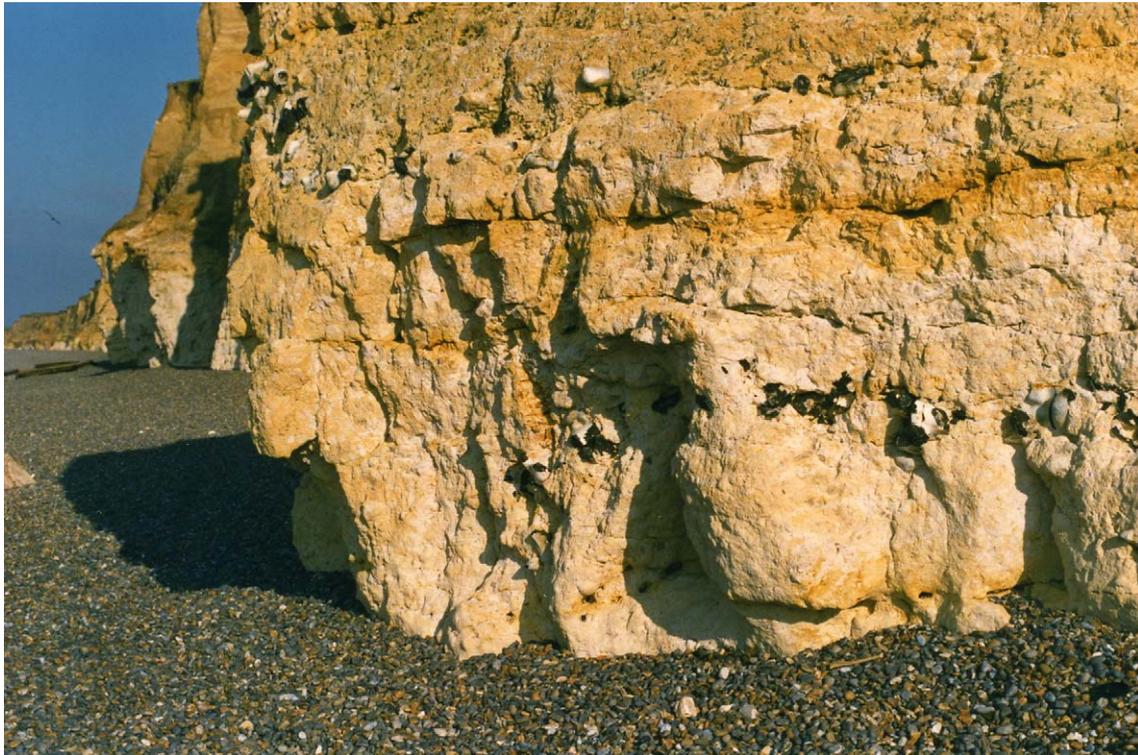
In general the cliffs are quite sandy in areas and are prone to undercutting rather than land slippage due to “internal instability” as shown in the photograph below.

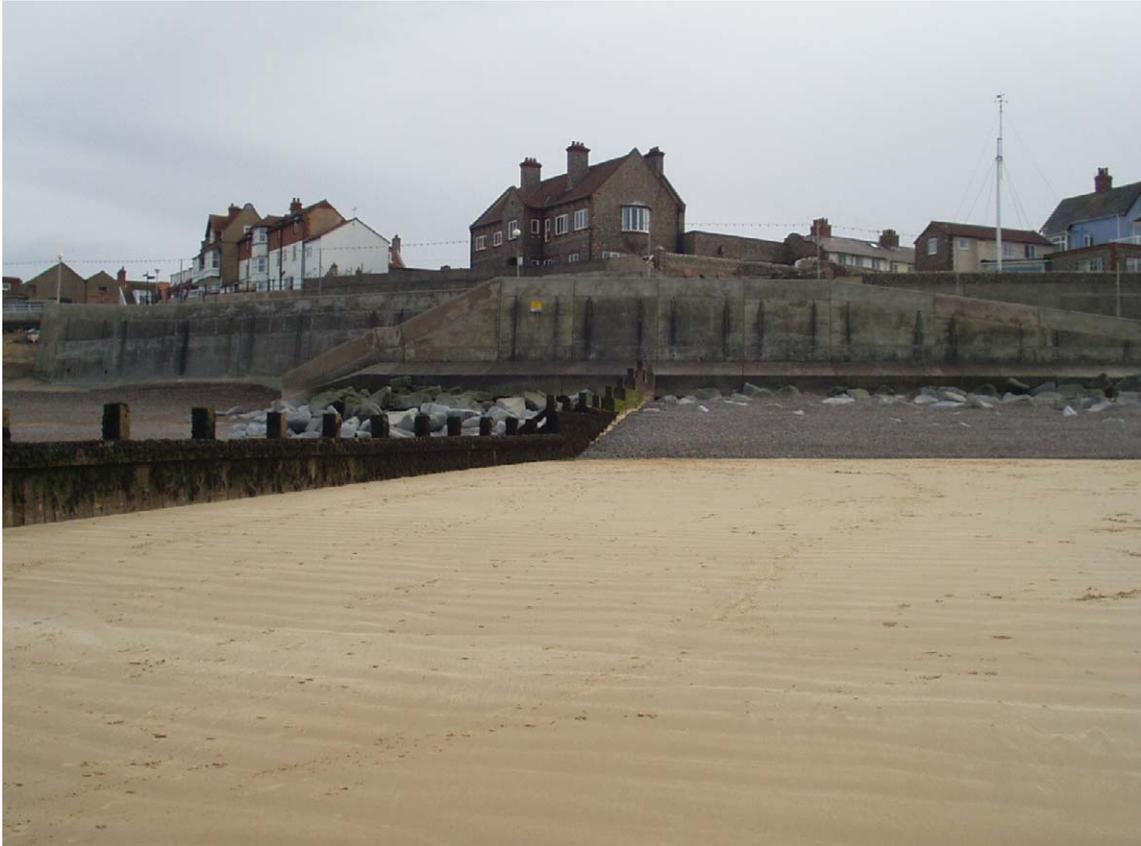
The high, vertical seawalls have been subject to considerable wave forces at high tide, causing damage to the concrete fabric. To reduce wave action on the walls, some stretches have rock armouring at the seawall toe. The photograph below shows the way the walls were exposed to damage prior to the addition of the rock armour stone. Note how the short buttress groynes as well as the wall itself were subject to local undermining. The shingle ridge in this area provides only a small amount of protection and the walls are subject to heavy wave impact forces and experience some overtopping also.

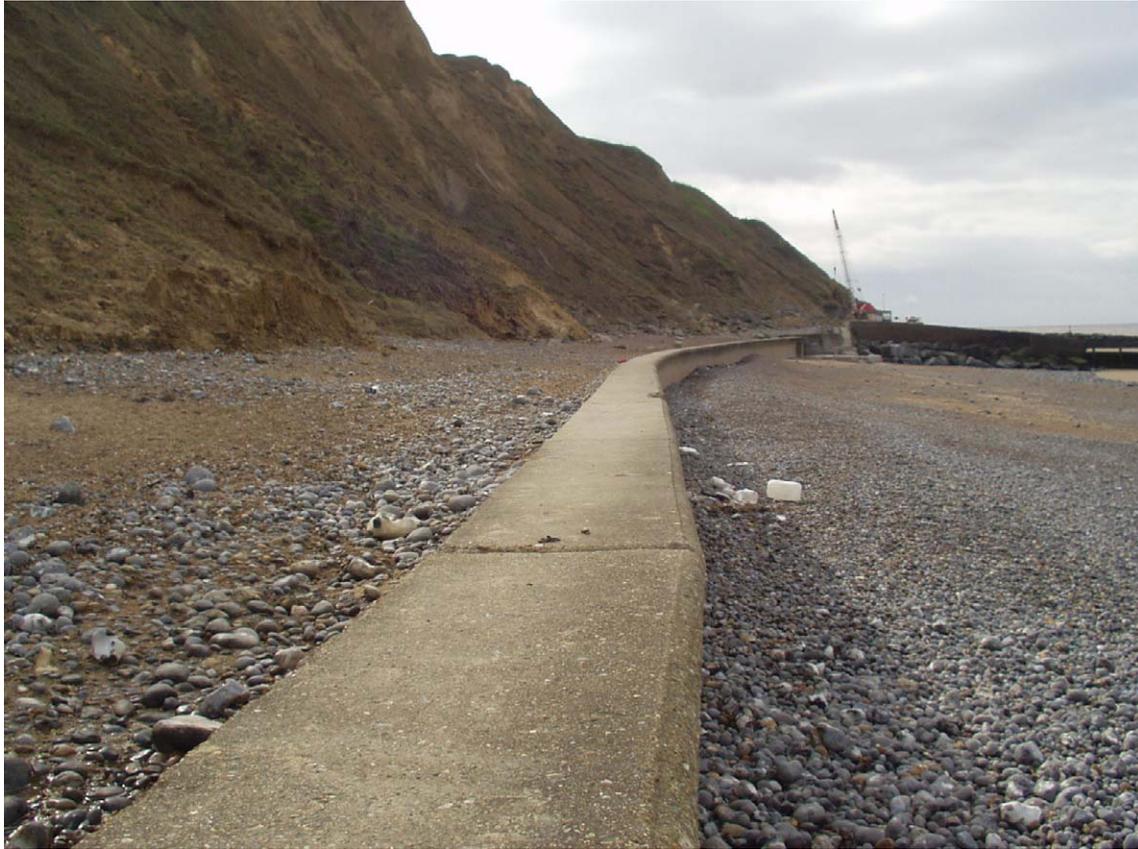
As a result of the early development of this frontage the shoreline recession has been halted for many decades. Of course, beach lowering continues to take place. However, analysis of historic data indicates that the volumetric losses appear to be slight, particularly in the western part of the frontage. There are more marked losses to the east of Fishermens Beach, where substantial repairs and rock armouring has been required in the recent past. Immediately to the east of Fishermens Beach only a remnant shingle beach remains. The shingle beach then gains width at the more lightly defended eastern end of the frontage, as shown in the photograph below.

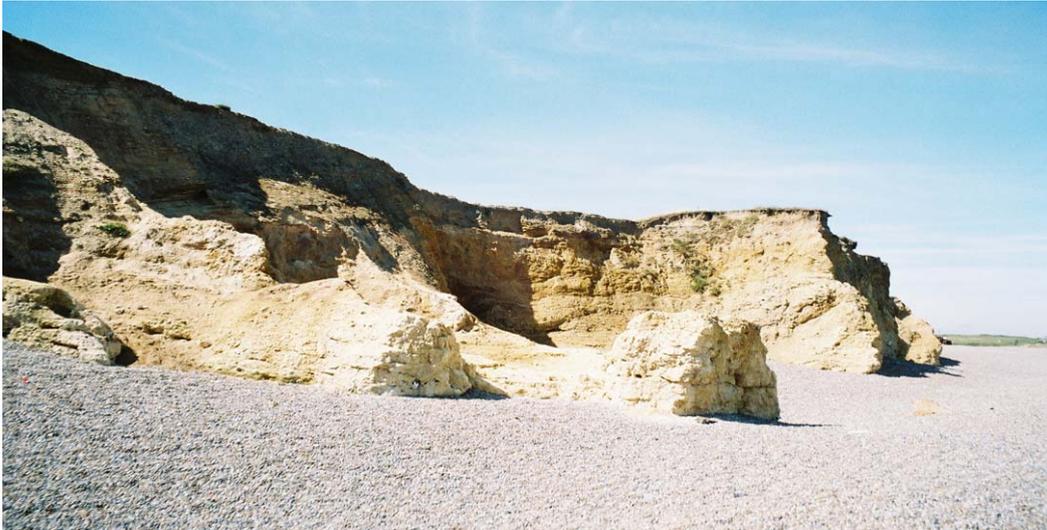
Plate 2.1 Cliffs East of Weybourne

The cliffs east of Weybourne afford the best Pleistocene sections (Plate 2.1), showing the pre-Cromerian deposits of the Cromer Forest bed. The Pastonian ‘Weybourne Crag’, here at its type locality, with its marine molluscs, has been known since the early days of geology. This is a historic site with outstanding Pleistocene sections of national importance. The marine “craggs” here have yielded both large and small mammal remains, of Pastonian and probably also pre-Pastonian age. Little has been published on these important fossils and the site remains one with considerable potential for future vertebrate finds. Additionally, biological interest is provided by colonies of sand martins in the cliff-face and of fulmars (73 pairs in 1982) on the cliff ledges.

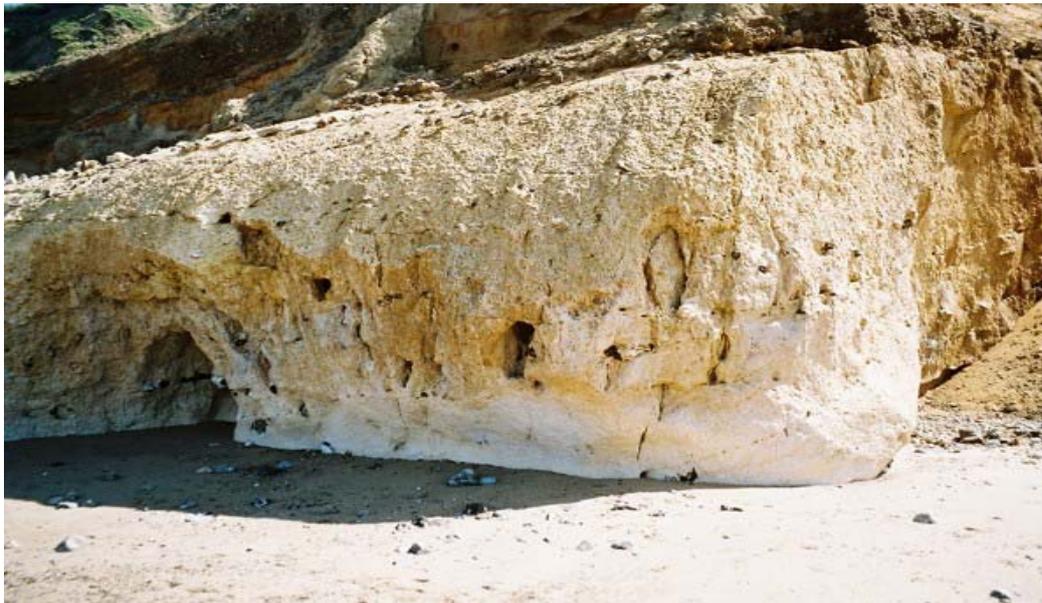
The foreshore at East Runton exposes pre-Cromerian (Lower Pleistocene) sediments, including successively 'Weybourne Crag', Pastonian clay conglomerate and marine shell beds, overlain in turn by marine silts (Pa II pollen zone). In the cliff can be seen spectacular rafts of chalk (Plate 2.3) of glaciectonic origin (i.e. ice transported) and highly deformed 'Contorted Drift'. The marine Lower Pleistocene deposits, here of pre-

Plate 2.3 Raft of chalk (East Runton cliffs)

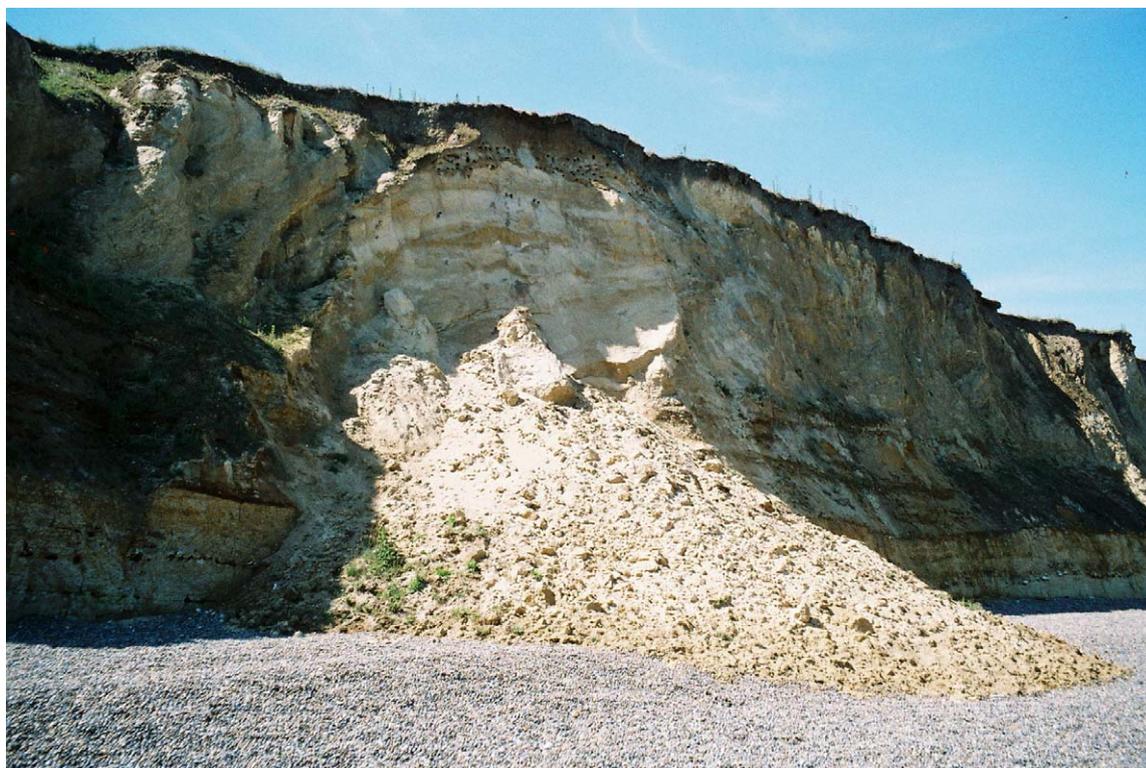
Figure 5.1 Landsliding on the coast, Dead Mans Hill area (view westward)

The littoral processes discussed above, and particularly the effects of longshore drift, are fundamentally important to the evolution of the beaches in the study area. While the recession of the cliff is of greatest concern to the residents and property owners, these two processes are closely linked. Where beach levels are low, or the beach has disappeared entirely, waves and tides can act directly on the seawalls and, by overtopping, on the cliff face as well. Should the seawalls deteriorate and fail (e.g. as a result of undermining following removal of the beaches at its toe and lowering of the shore platform) then the rate of cliff top recession will increase. Conversely, a high healthy beach will prevent direct wave attack on the seawalls and the cliff face and hence greatly reduce the rate of recession of the cliff top edge. However, even the complete protection of the base of the cliffs will not completely halt cliff top recession because of erosion and weathering of the cliff face as well as the dangers of slumping or land-sliding caused by ground water flows from the land as shown in Figure 5.1.

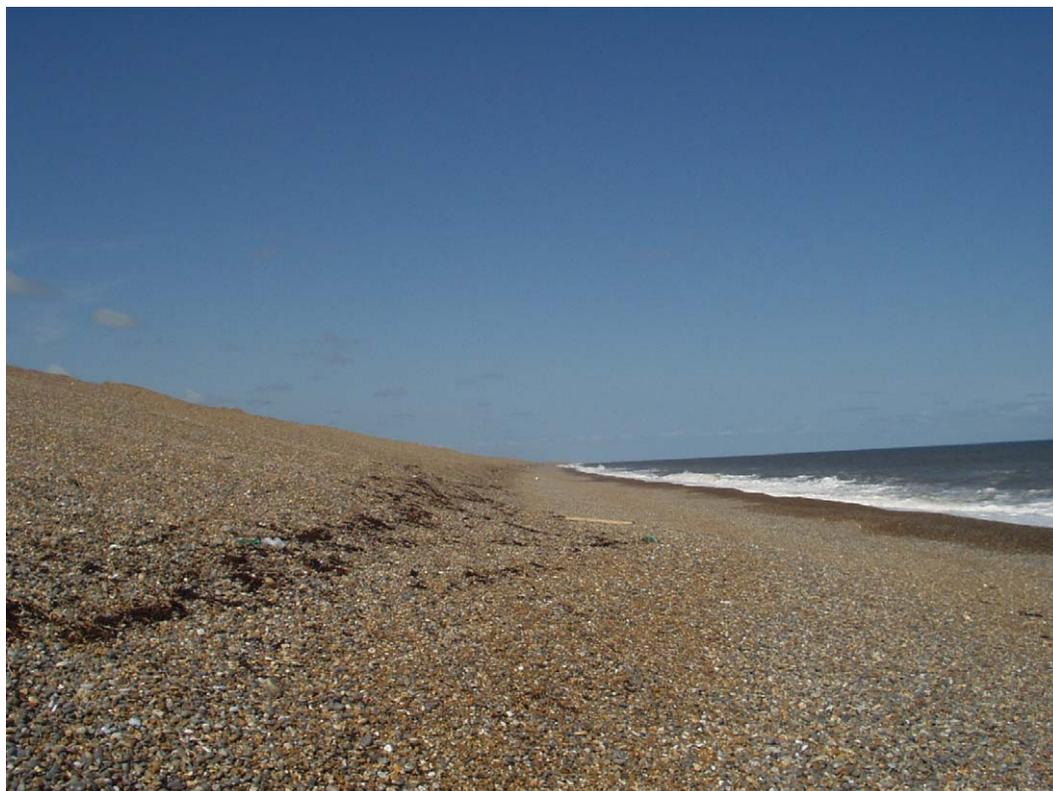
Plate 3.1 View along beach to west

Likely Failure Mechanism: Undermining and slip of cliff face

Consequence of Failure: Landward retreat of cliffs

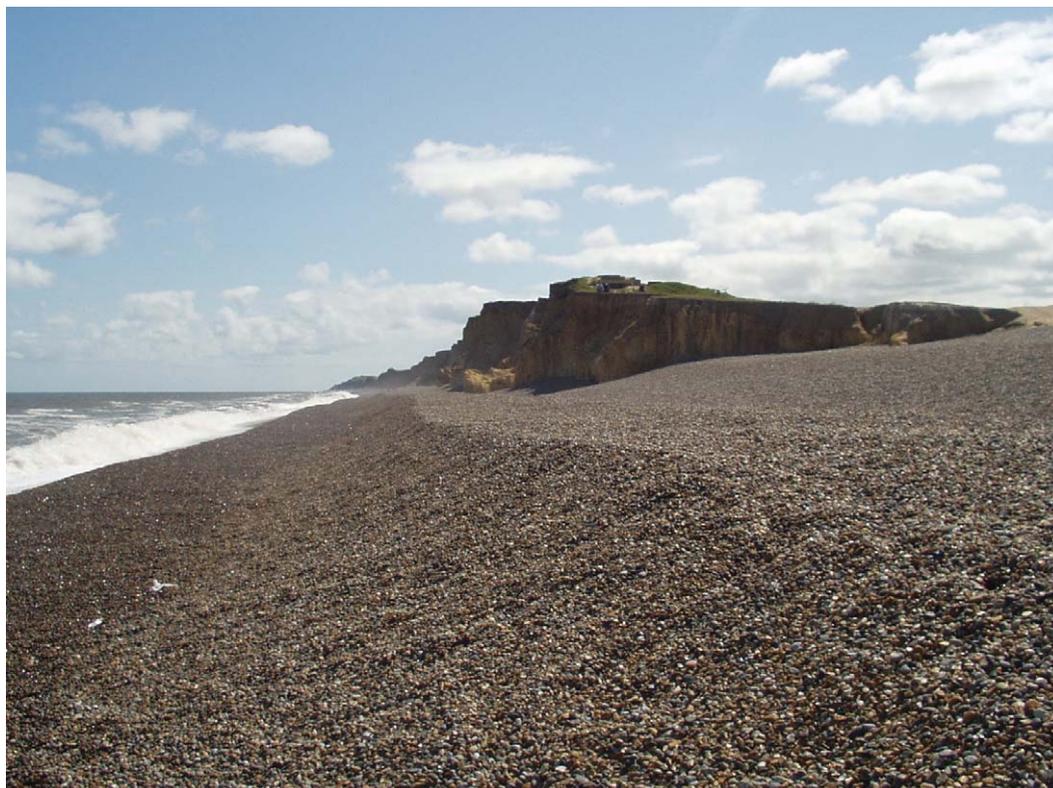
Plate 3.2 View to east

Likely Failure Mechanism: Undermining and slip of cliff face

Consequence of Failure: Landward retreat of cliffs

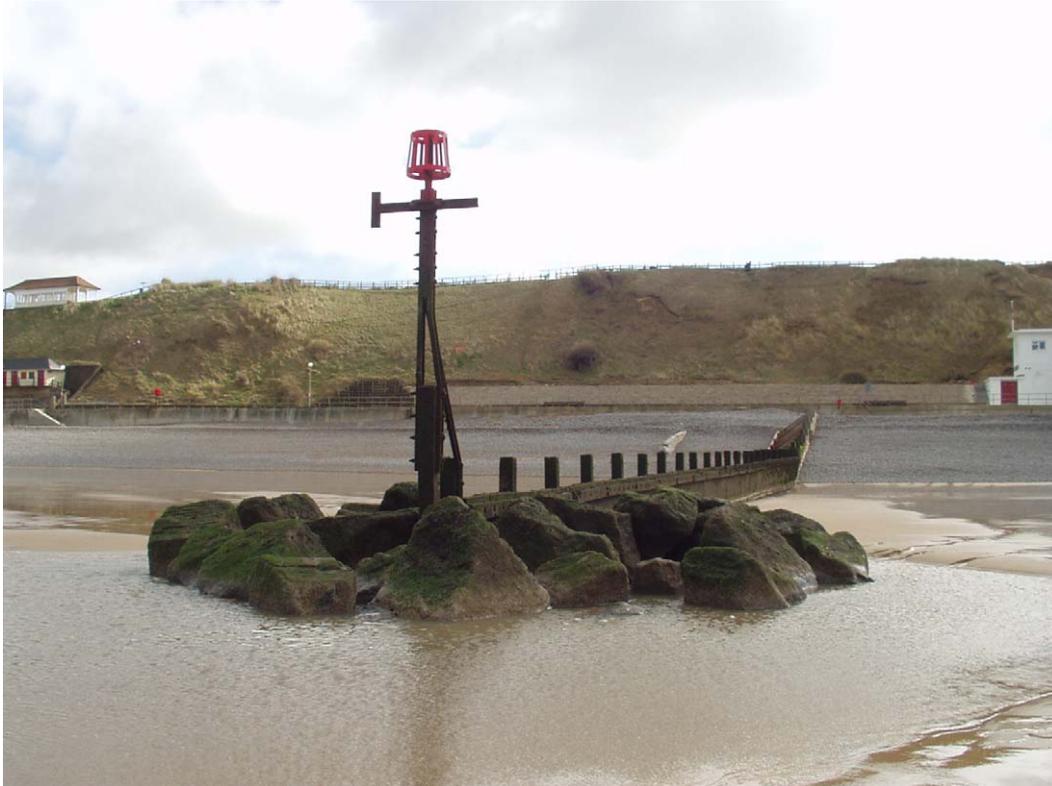
Location	Sheringham		
Groyne No.	A3		
Start / Finish NG Co-ordinates	Root		Survey Date:
Easting:	615305	615306	April/May 2004
Northing:	343533	343632	
Length:	100m		
Management Unit:	RUN1		Defence Length Reference: 02
<u>Conditions and Performance of Groyne</u>			
Type:	Timber	Built: 1974	Refurbished: 1997
Defence Condition Rating:	Very good		
Updates to CPSE (1997):			
Comment:	Rock scour protection at seaward end

Plate 4.4 Groyne A3

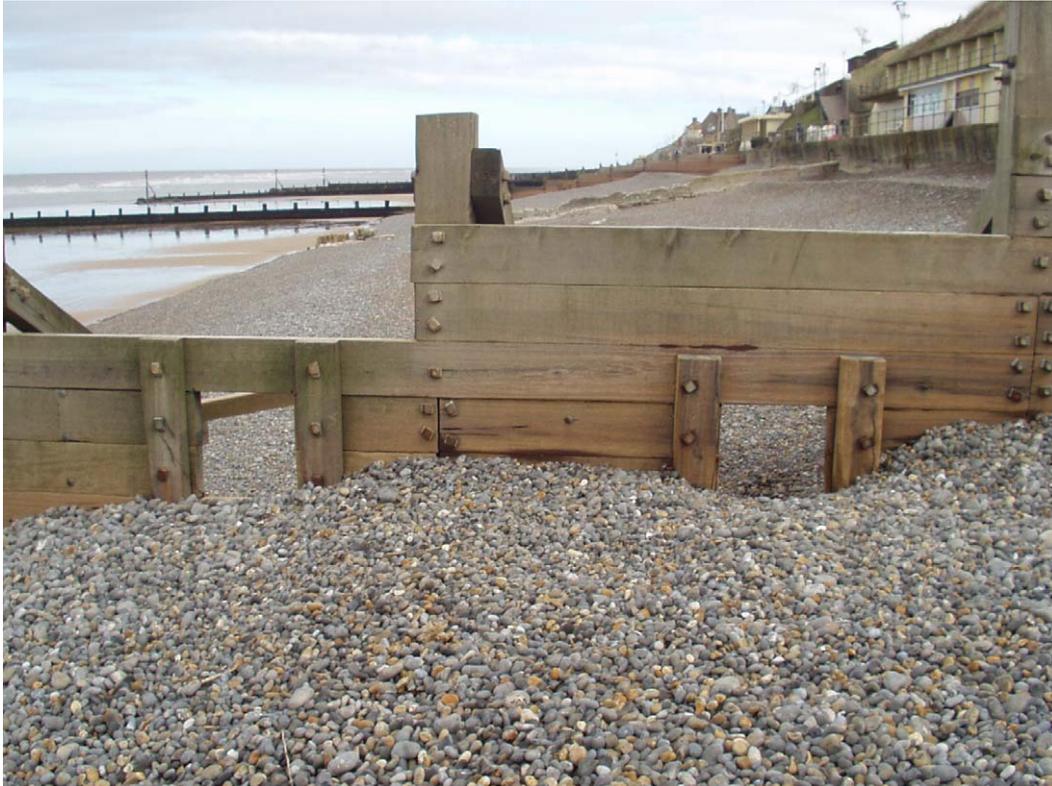
Plate 4.6 Groyne A4 inshore end note shingle gates

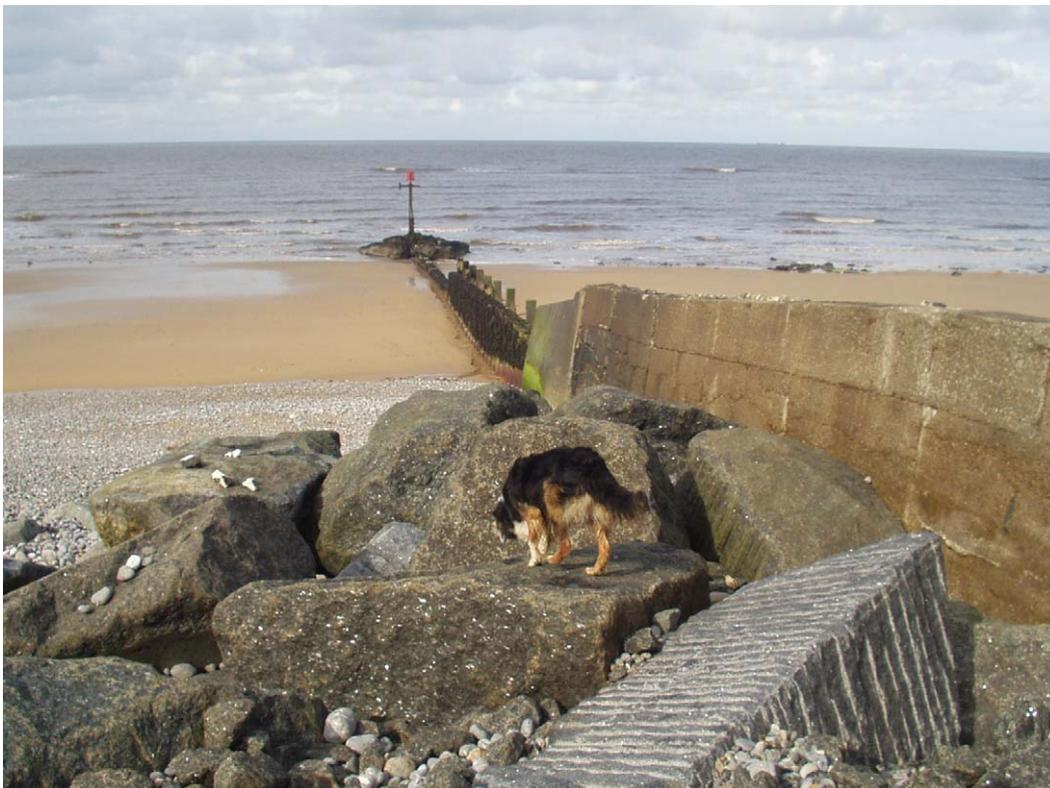
Location	Sheringham		
Groyne No.	A13		
Start / Finish NG Co-ordinates	Root		Survey Date:
Easting:	616588	616602	April/May 2004
Northing:	343414	343507	
Length:	93m		
Management Unit:	RUN1		Defence Length Reference: 06
<u>Conditions and Performance of Groyne</u>			
Type:	Timber and steel pile		Built: Refurbished:
Defence Condition Rating: poor			
Updates to CPSE (1997):			
Comment:

Plate 4.13 Base of groyne A13

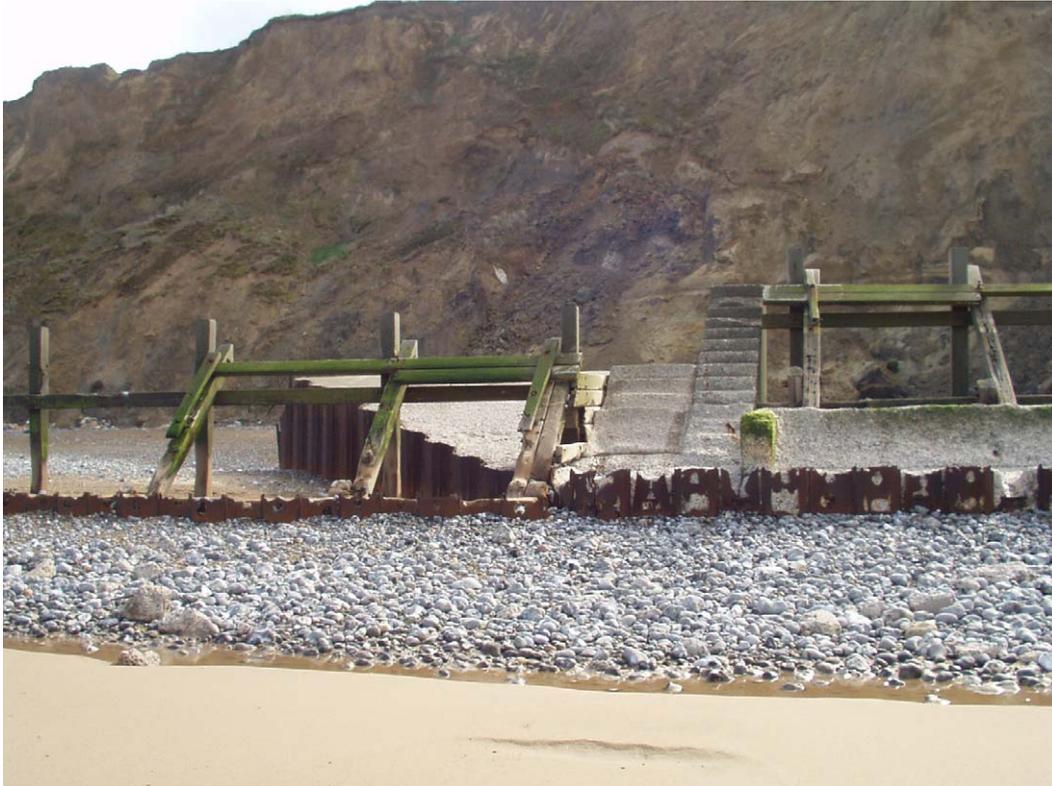
Plate 4.16 Derelict revetment at transition

Location	Sheringham		
Groyne No.	B1		
Start / Finish NG Co-ordinates	Root		Survey Date:
Easting:	617035	617049	April/May 2004
Northing:	343343	343400	
Length:	58m		
Management Unit:	RUN1		Defence Length Reference: 06
<u>Conditions and Performance of Groyne</u>			
Type:	Timber	Built: 1976	Refurbished:
Defence Condition Rating:	Fair		
Updates to CPSE (1997):			
Comment:	No beacon

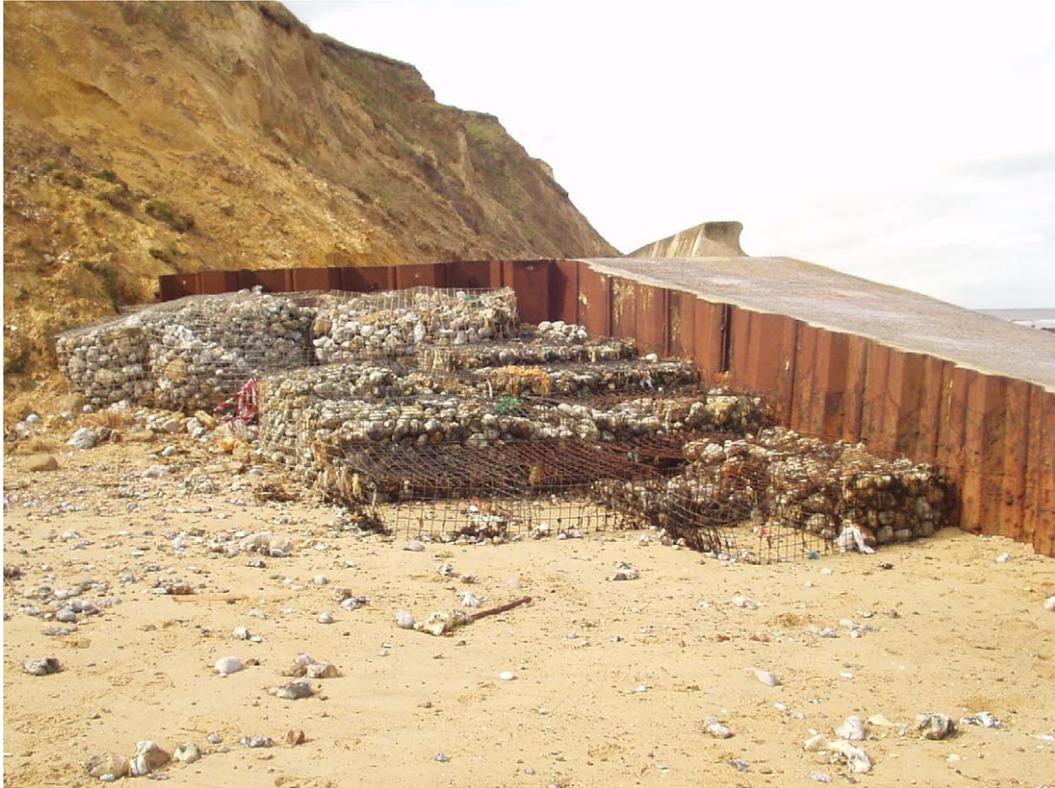
Plate 5.3 Gabions at eastern flank

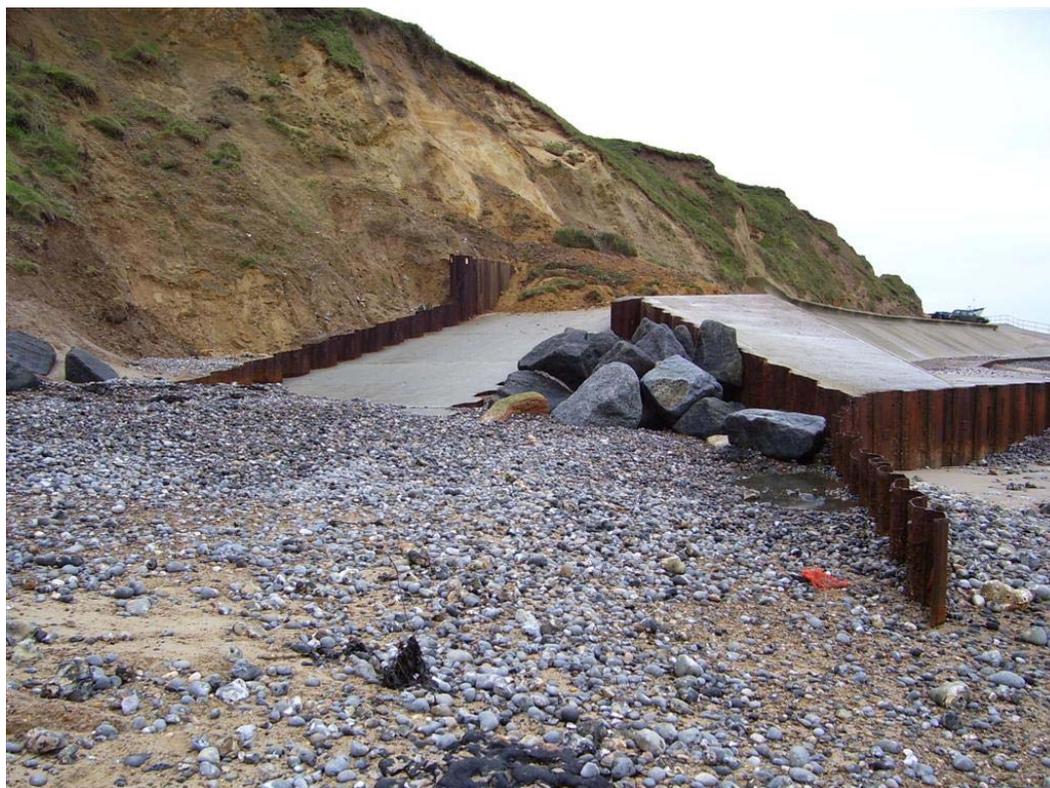
Since the completion of the condition survey in 2004, North Norfolk District Council (NNDC) has built an additional ramp onto the beach at the eastern side of the gap. The construction of this ramp, which is designed to facilitate beach access at low beach levels, provides additional protection against outflanking in the short to medium term.

The addition of this ramp has not improved the assessed condition rating of the defences here.

Plate 5.5 View of new ramp at eastern side of the gap

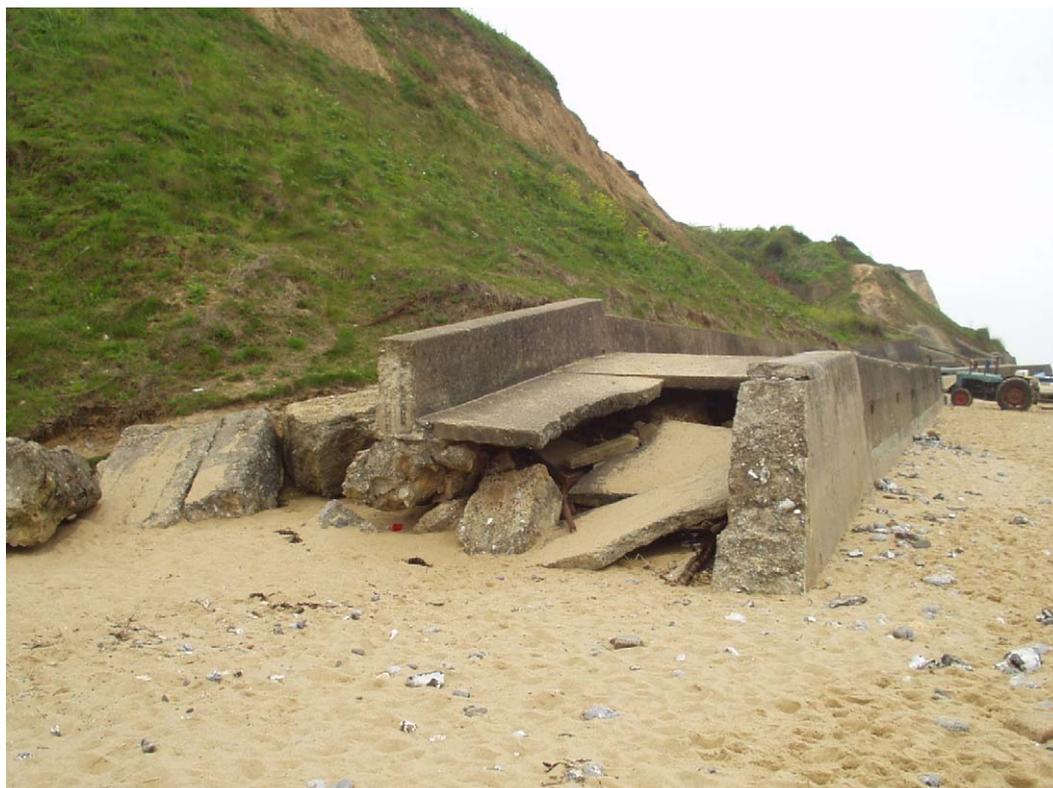
Plate 5.7 Failure of end of west wall

Consequence of Failure: Loss of important access

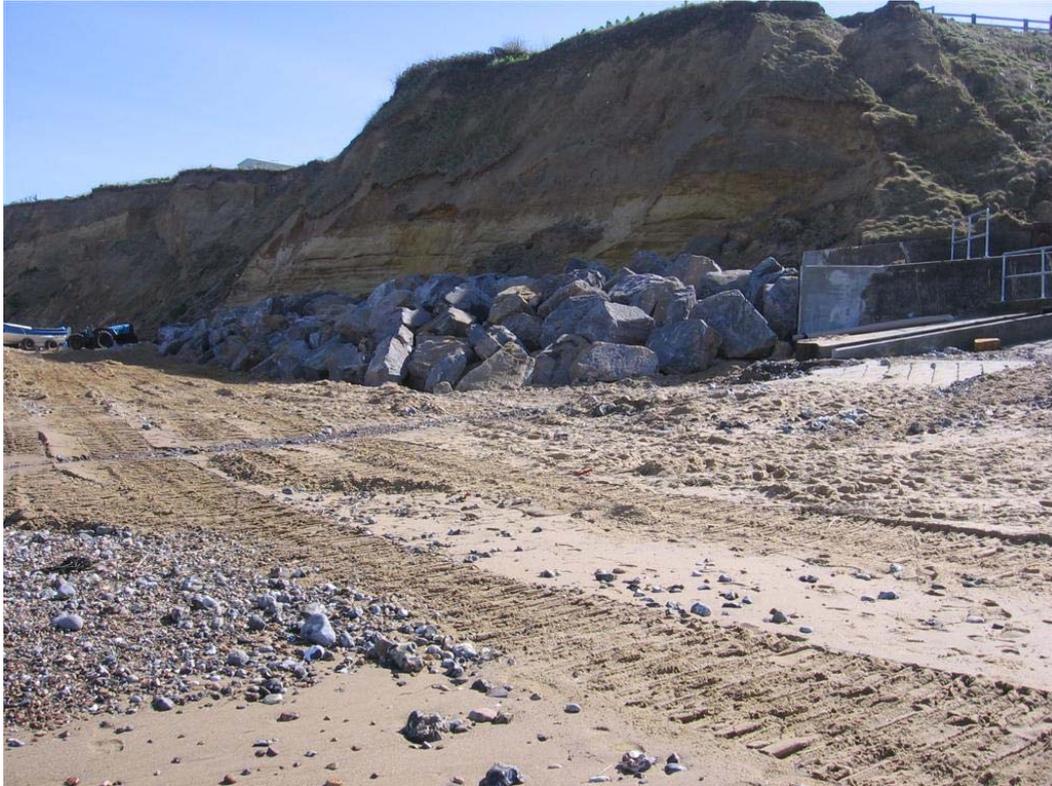
Plate 5.9 View of rock armour revetment, east flank

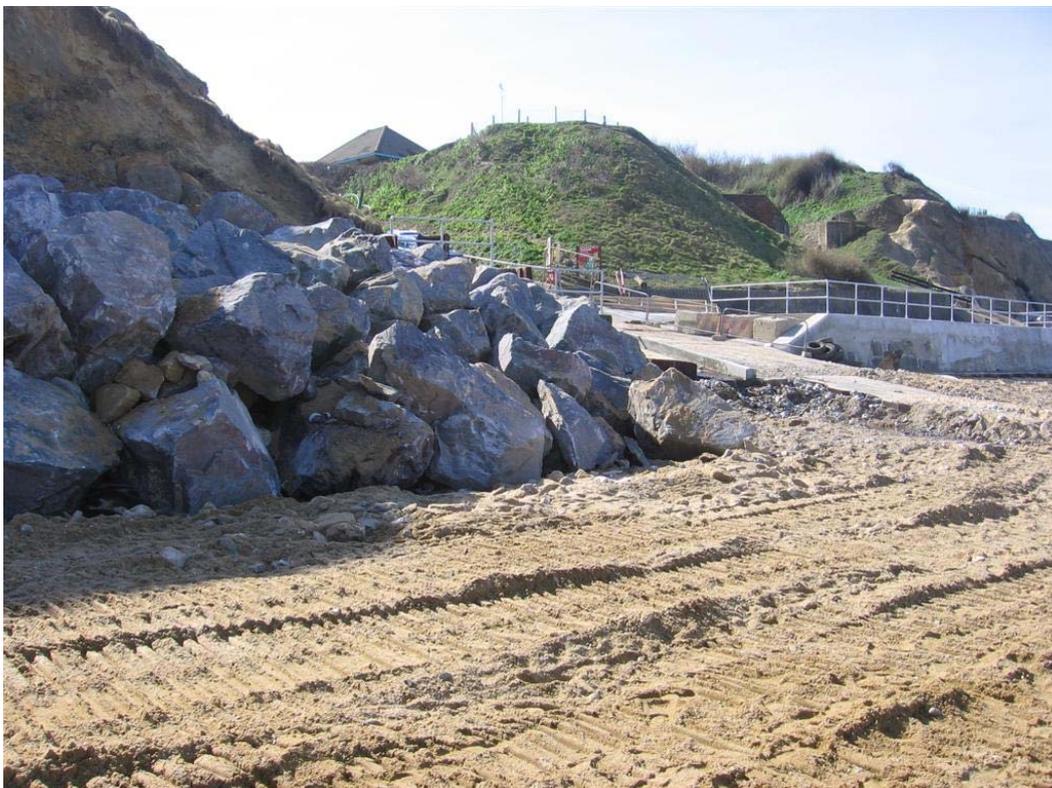
Plate 5.10 Rock armour revetment, east flank

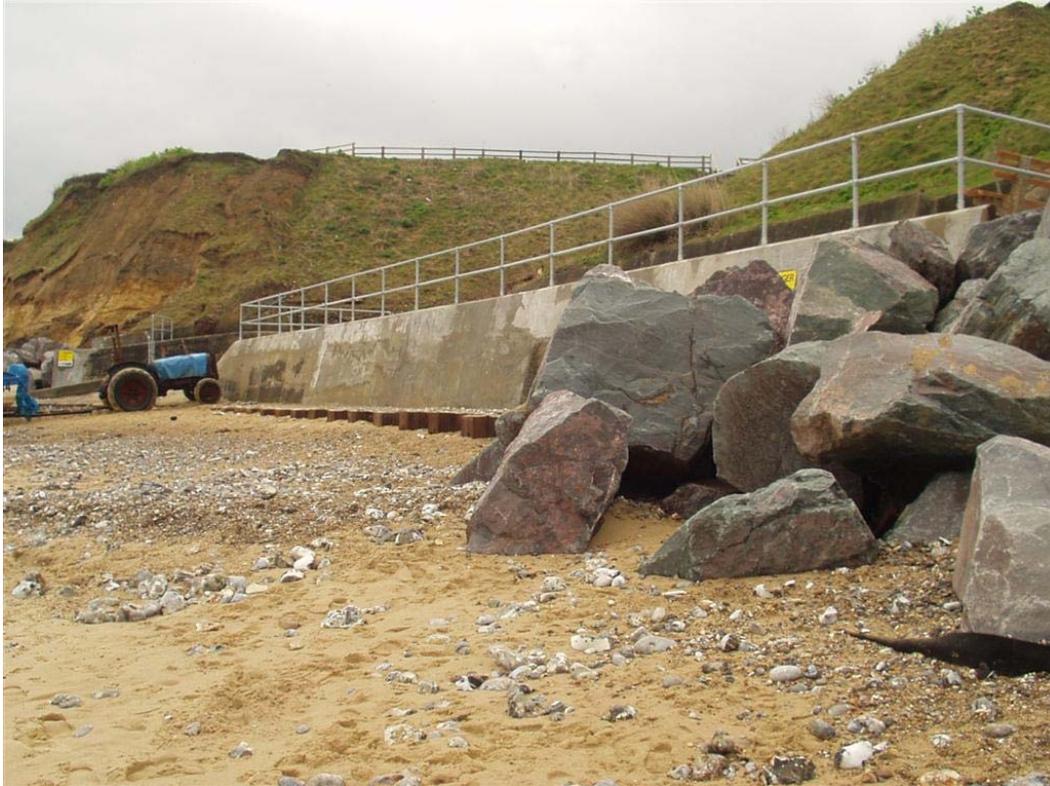
Plate 5.11 Sea wall and rock armour outflanking revetment, west flank
