Cromer Seafront Heritage

The sea defences at Cromer protect the town from the force of the North Sea. They were built in various phases as the town expanded, the earliest dating back to 1836. Over the years the walls and groynes have withstood many storms and have been maintained, enhanced and repaired as and when required. The current scheme is part of Cromer's long history with the sea; the current work on sea defence is a continuation of that on-going relationship.

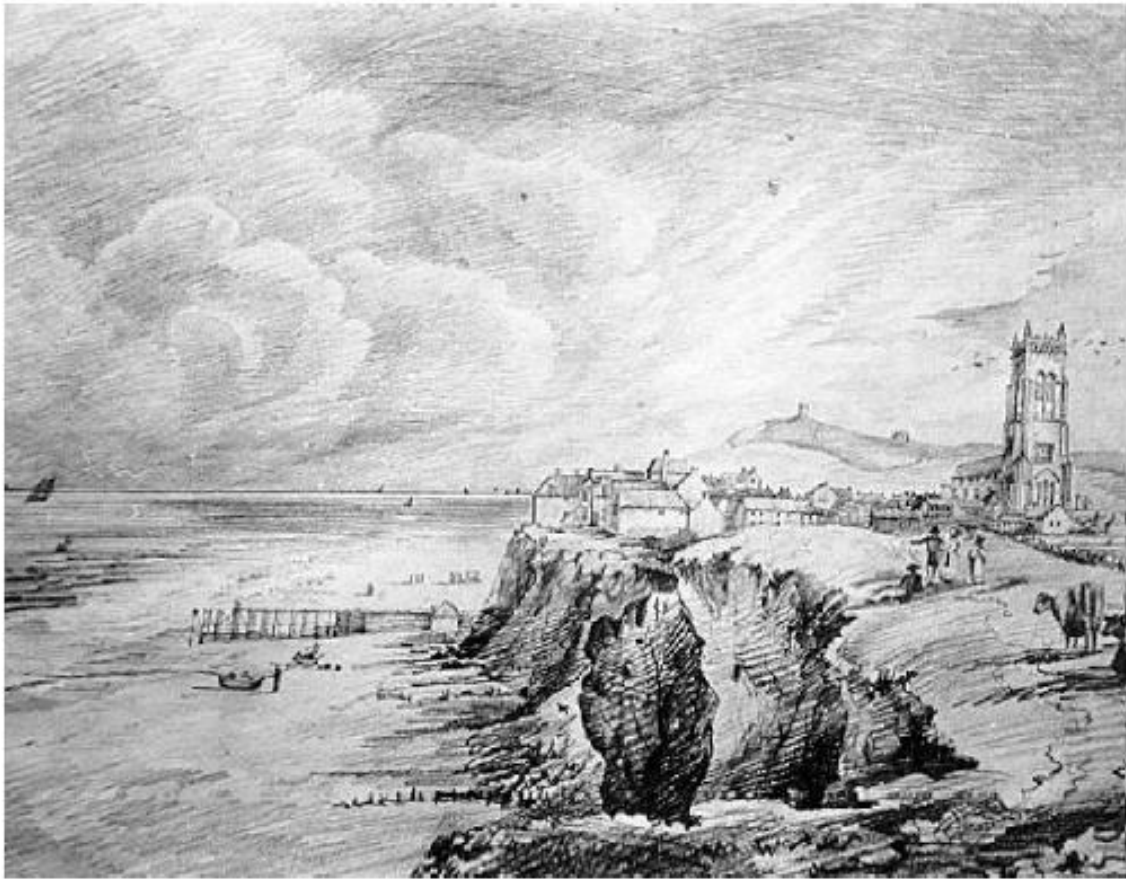
Slumping and overhanging cliffs with little protection from the sea, 1822.
With thanks to Cromer Museum for the image.

Steep cliffs to the west of the town are depicted in this 1822 drawing. Sections overhang and debris from earlier cliff falls can be seen on the beach. No sea defences are evident other than what appears to be a small timber groyne in the foreground. A two day storm in 1836 caused considerable damage and some of the cottages depicted here on the cliff edge were lost. This picture also identifies the church; this was begun in the 1390's after the earlier Saxon church was lost to the sea.

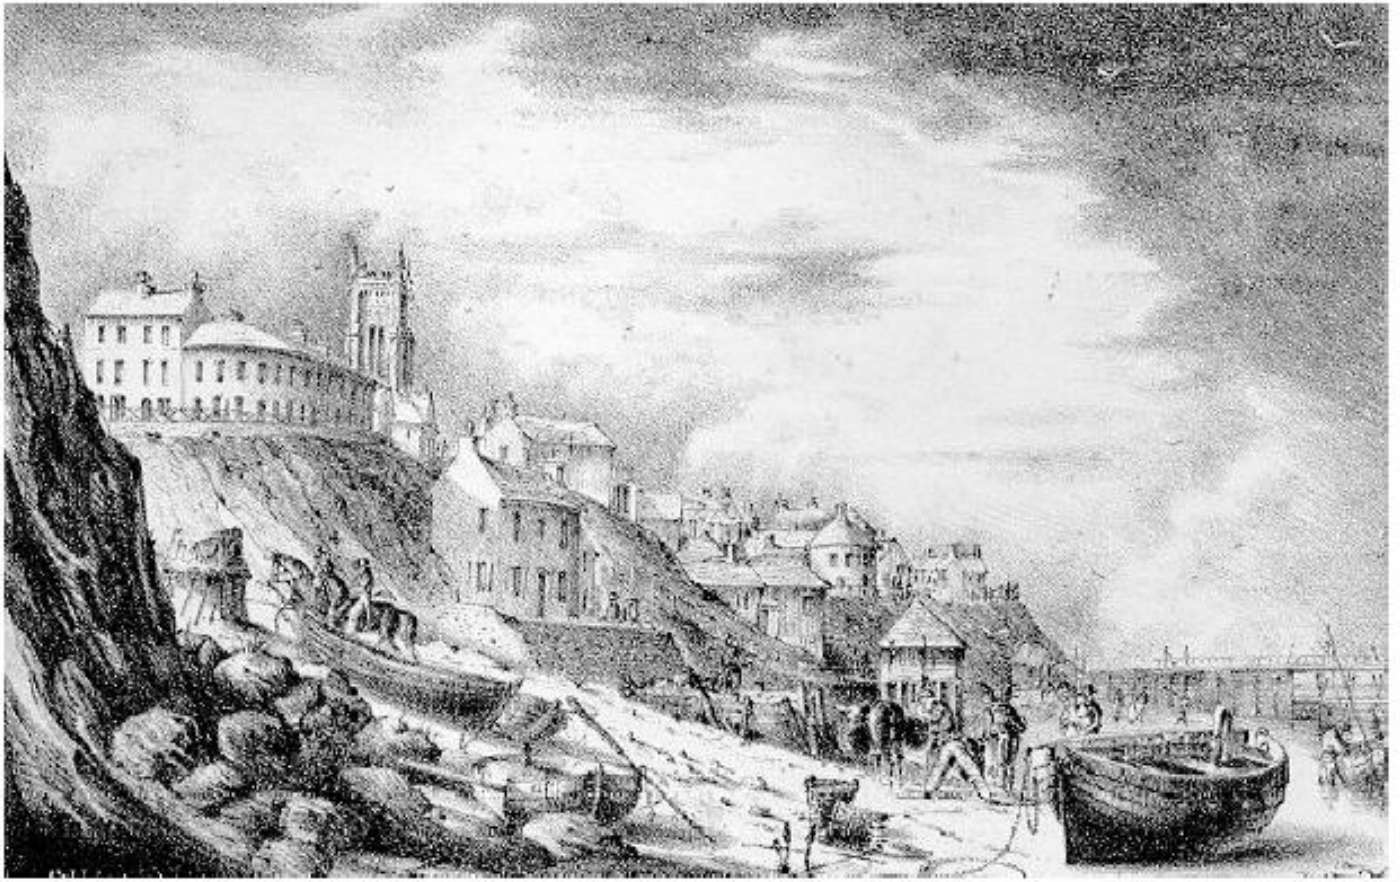
The gangway busy with the towns fishing fleet, as it still is today. 1831.
With thanks to Cromer Museum for the image.

This 1831 scene is recognisable today, church, smart terraced houses, the gangway busy with activity. The Bath House at the base of the cliffs shown in this print was washed away in the storm of 1836, the small walls and timber palisades provided little protection from the force of the North Sea.

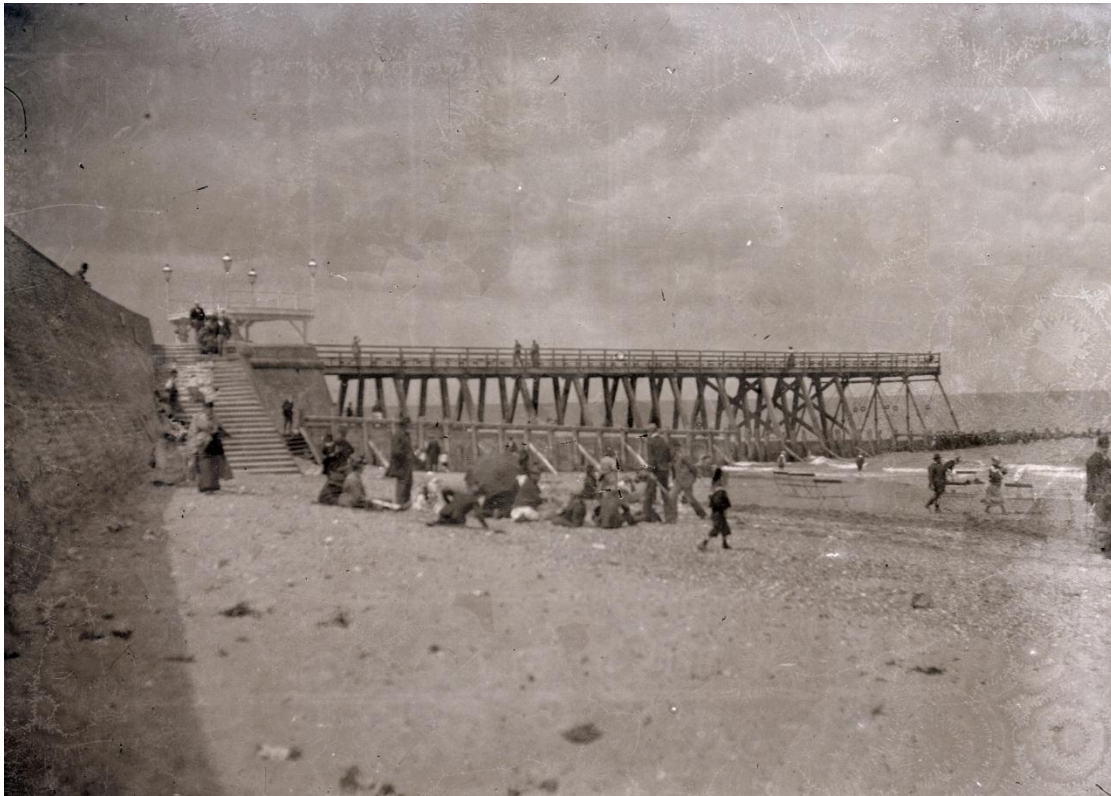
The Jetty built in 1846 and sea walls protecting the town, 1890's.
With thanks to Cromer Museum for the image.

Residents and visitors to Cromer had affection for the jetty built in 1846. The structure was badly damaged by a severe storm in November 1897, following which the remains of the jetty were sold. Sea defences were enhanced from 1893-4 with the building of a low wall to the east of the gangway.

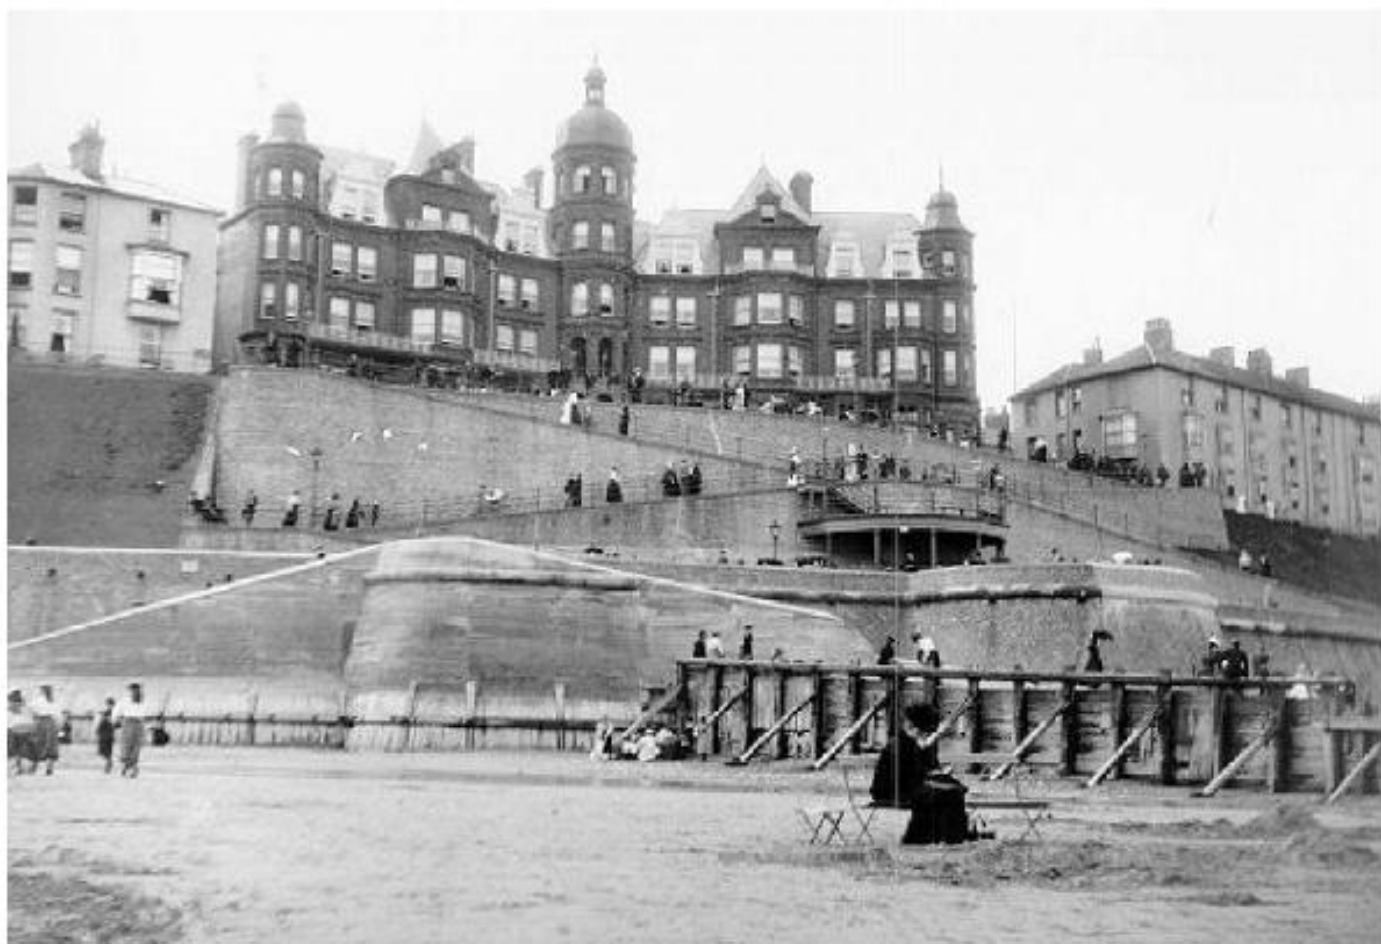
An unusual shot with no jetty or pier, 1898.
With thanks to Cromer Museum for the image.

The photo here of about 1898 shows no jetty and no pier whilst the substantial walls protect the expanding town above. The bastion on the sea wall to the right of the photo appears to have been recently repaired and the ramps are still in existence.

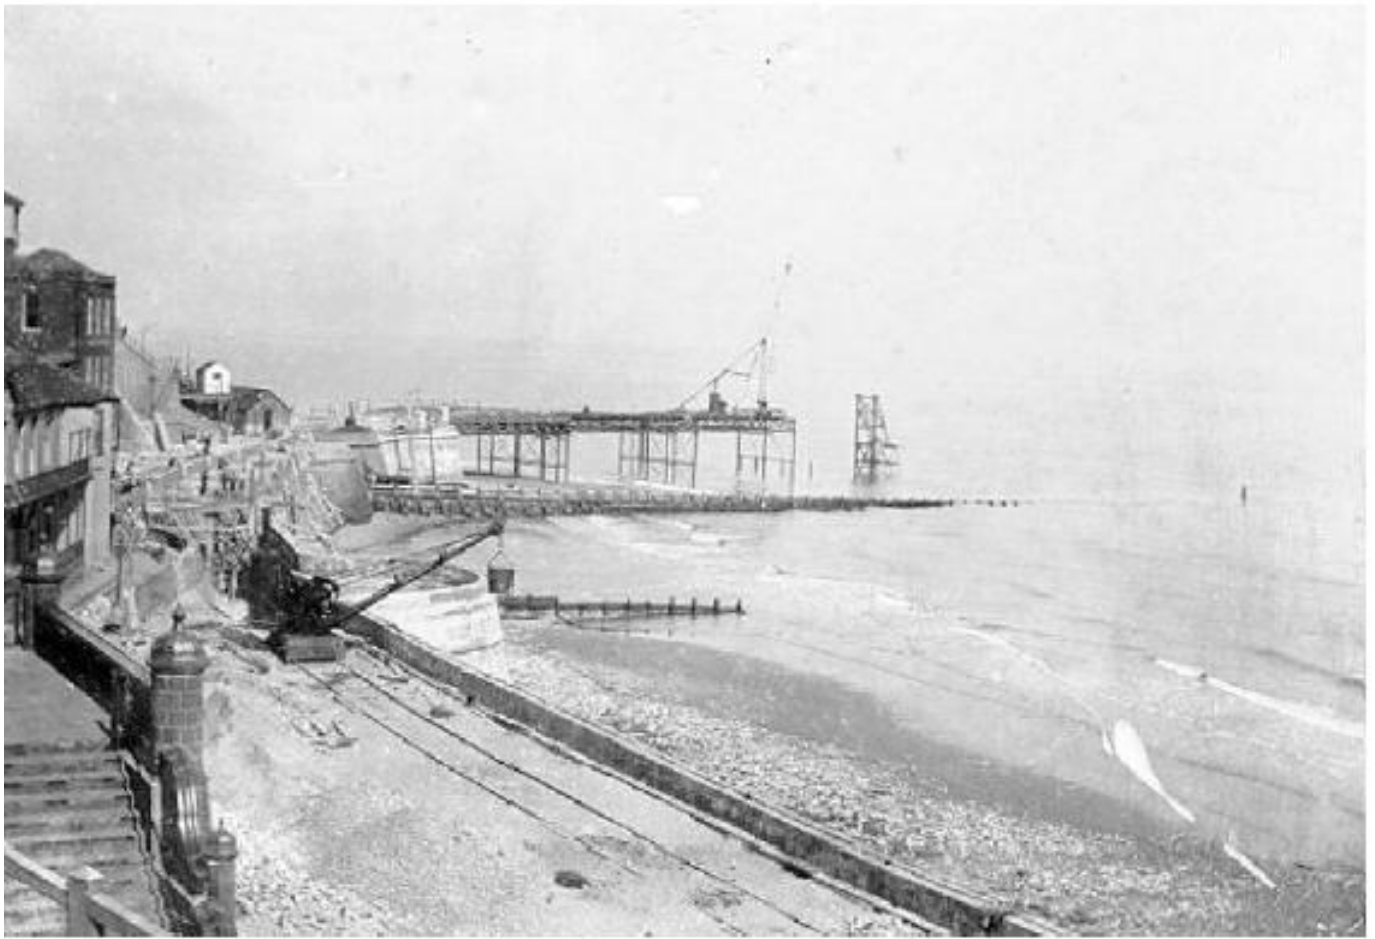
Cromer promenade and sea wall, with the pier under construction, 1900.
With thanks to Cromer Museum for the image.

Following the loss of the jetty, the pier was constructed and the central sea walls were substantially enhanced from 1899-1902. The photograph shows the pier half built with a temporary 'works' building at its landward end. A railed steam crane is moving materials for the sea wall construction. These sea walls are substantially what the promenade is based upon today.

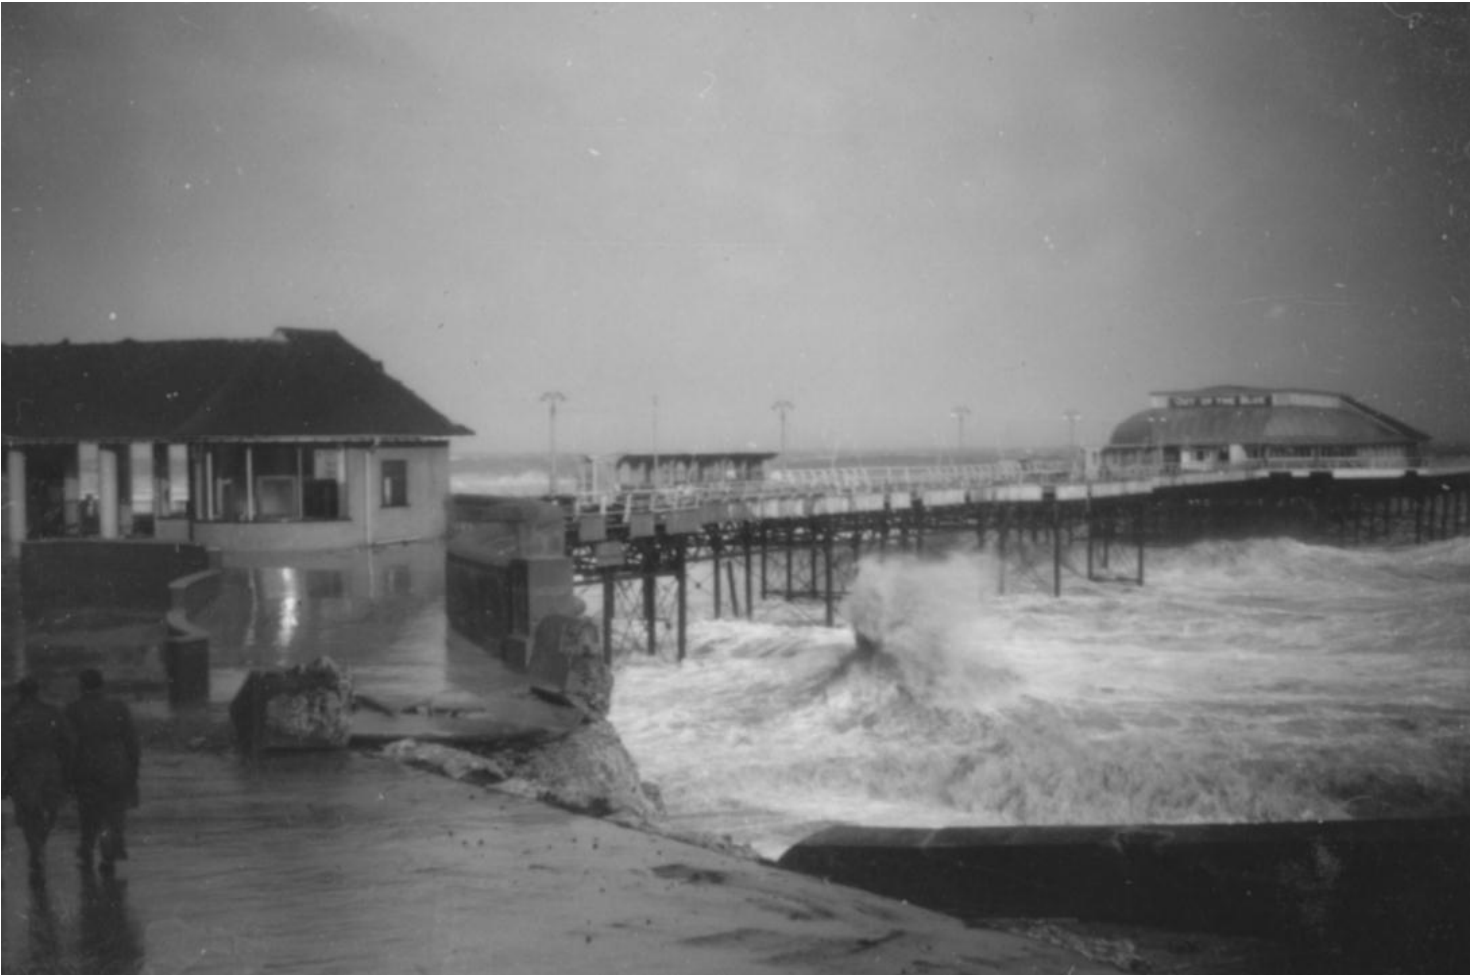
Storm Surge Damage, 1953.
With thanks to George Baker for the image.

Although it is easy to marvel at our achievements at taming nature, storms can still pose threats as experienced during the 1953 North Sea surge. There was a great deal of damaged and flooding along the East Anglian coast.

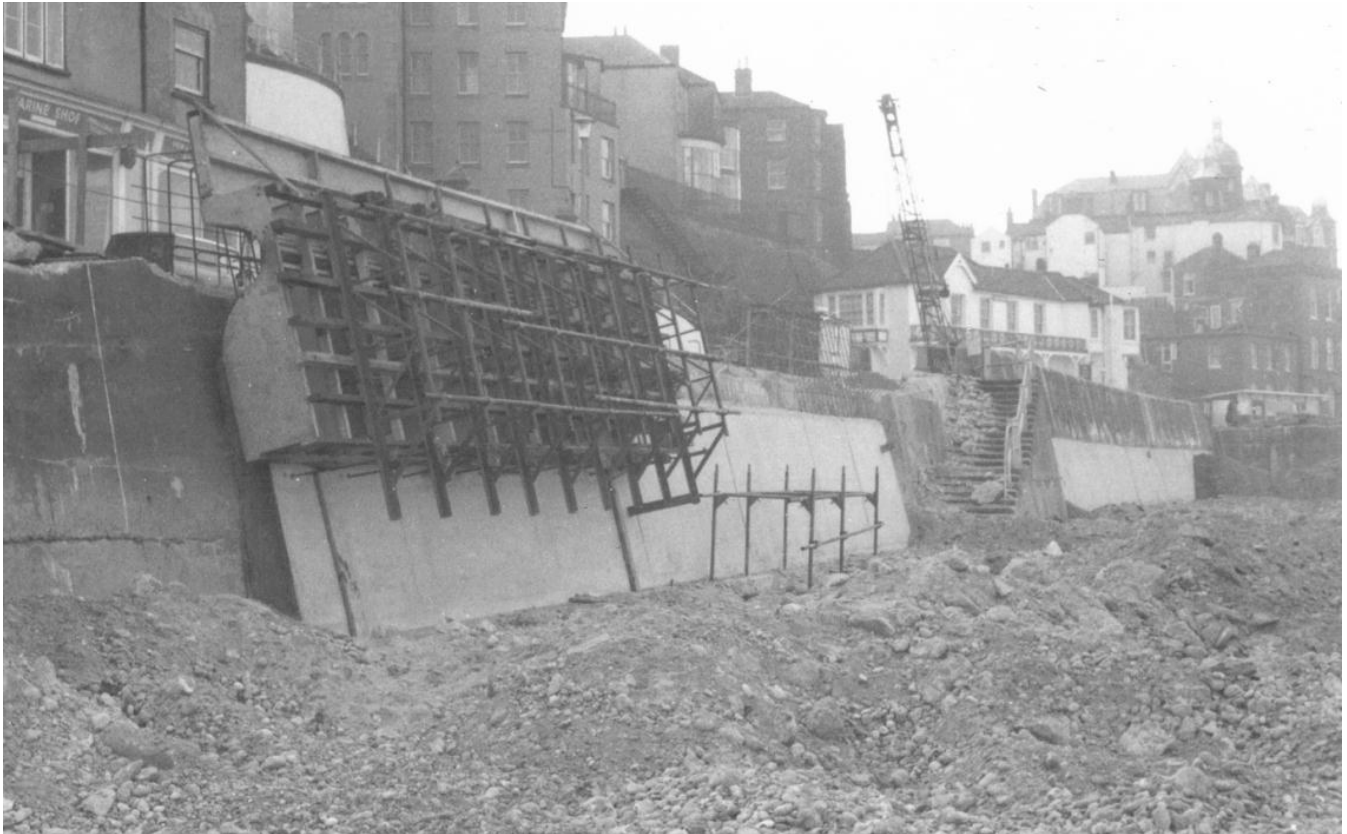
Continued investment in coastal protection following the 1953 storm, 1950's – 1960's.
With thanks to George Baker for the image.

Concrete, steel and timber are not indestructible and the sea defences require regular maintenance and rebuilding. Here a photograph of the 1950/60 depicts 'shuttering' in place ready for new concrete to be poured to shape a new face to the sea wall. This is a method still in use today.

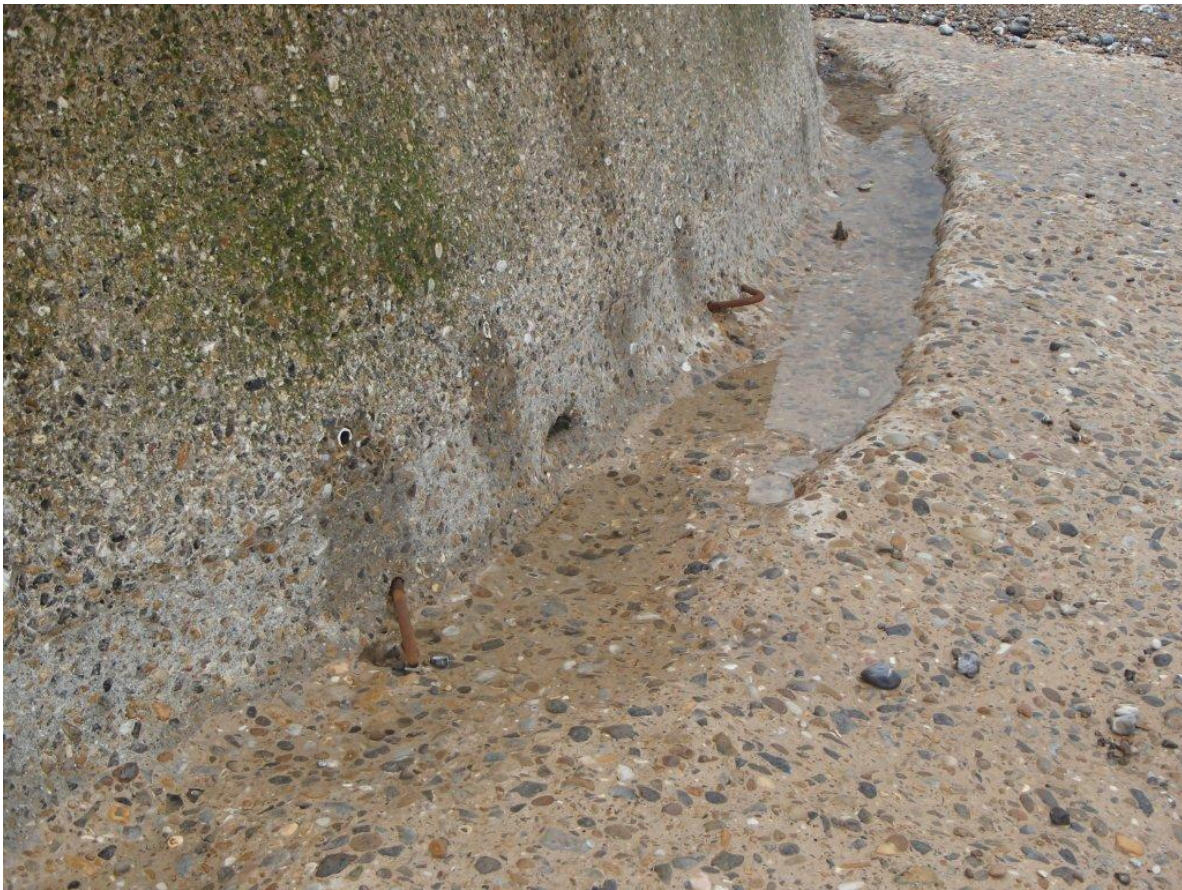
Concrete worn away by the action of the sea, 2013.
NNDC Image.

The North Sea throws stones and sand at the defences and over time the surface is worn away. The photo taken in 2013 shows reinforcing steel work exposed to the sea, when built this steel would have been encased by concrete. The new concrete at beach level is a mix which is especially hard.
