Thornage

Conservation Area Appraisal and Management Plan

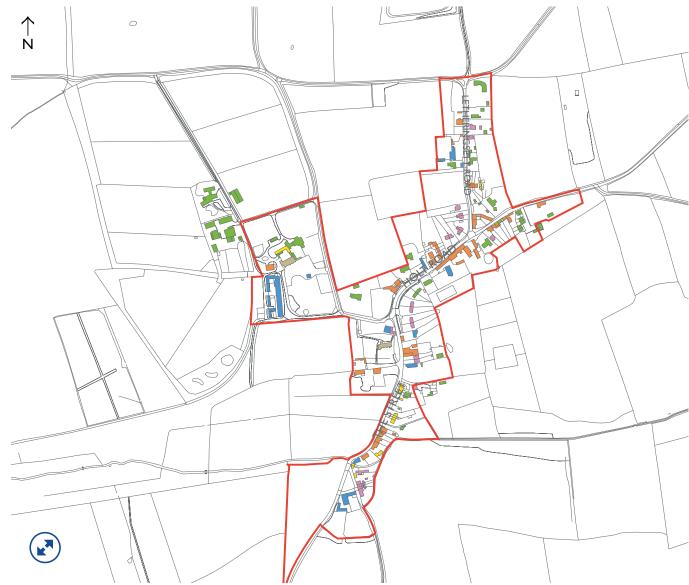
3.3 **HISTORIC DEVELOPMENT PLAN**

This plan indicates the age of the existing built fabric of the main buildings and structures in Thornage. It is mostly based on a comparison of historic maps with limited verification through viewing of the existing building from the street. Some buildings may have been constructed in phases but generally only the main phase is shown here. Some buildings may have been partially rebuilt or substantially repaired since they were first built but their footprint was unchanged and so the change is not obvious in map comparisons. Where this is the case, generally the building is coloured for the earliest date that it appears on the map.

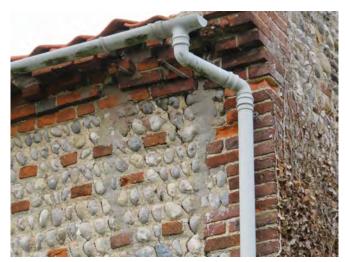
Brick delamination

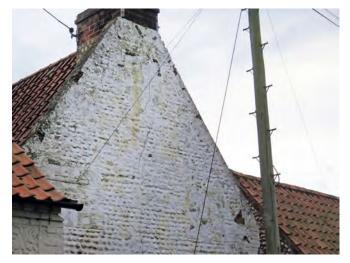
Cracks and cementitious repairs to a building

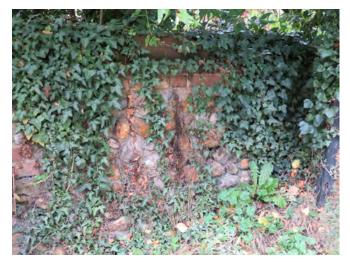
Boundary wall brick decay resulting from proximity to the road

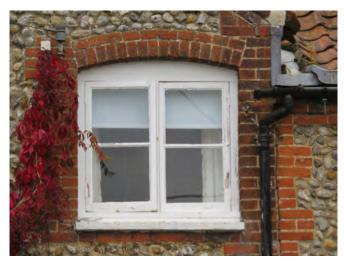
Broken gutters cause water to soak the walls, which leads to deterioration of the fabric

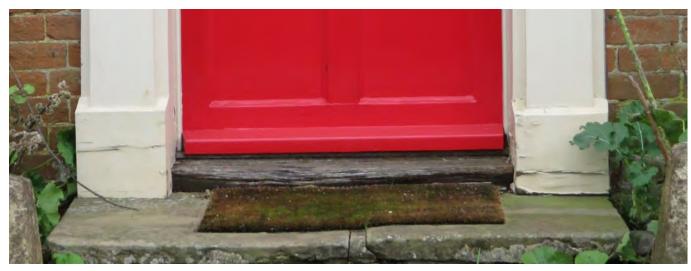
Example of external timber joinery requiring repainting

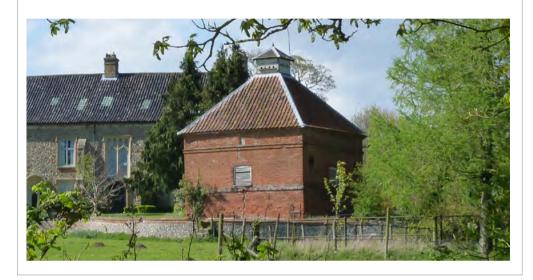
Address / Building Name	Dovecote, c30m south-east of Thornage Hall
Street-by-Street Area	Thornage Hall
Status	Grade II
List Entry Link	<u>https://historicengland.org.uk/listing/the-list/list-</u> entry/1049195
Brief History	1728
Brief Description	Dovecote. Red brick. Square hipped roof in red and black glazed pantiles terminating in square wooden glover. Moulded brick platbands and square wooden shuttered openings on each side. Stone plaque south side inscribed TA/1728. Small stone arched door to west. Internally 20 tiers of holes on all four sides.

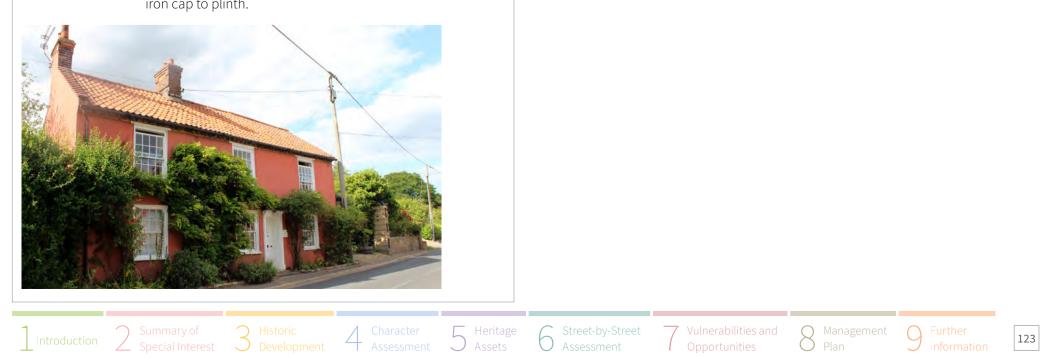
Address / Building Name	Gatepier, c5m to right of Old Foundry House
Street-by-Street Area	Holt Road
Status	Grade II
List Entry Link	<u>https://historicengland.</u> org.uk/listing/the-list/list- entry/1049154
Brief History	Nineteenth century gatepier. There was an iron and brass foundry on the site in the nineteenth century, which would explain the unusual gatepiers.
Brief Description	Gatepier in rusticated gault brick, cast iron double cap, 3 front panels with cast iron plaques showing decorative figurework and Latin inscriptions, cast iron cap to plinth.

Unique to Thornage are the Grade II listed gate piers marking the site of the former brass and iron foundry from the early 1900s. The gate piers contain casted relief panels depicting scenes such as a lion and a dogfight and a Latin inscription. Information about the foundry accompanies the figurative panels.
