Happisburgh: Assessment of Rock Bund and Beach Access

Document no: B2491800-JAC-RPT-001 [P03]

North Norfolk District Council
Coastwise- Happisburgh
8 May 2025

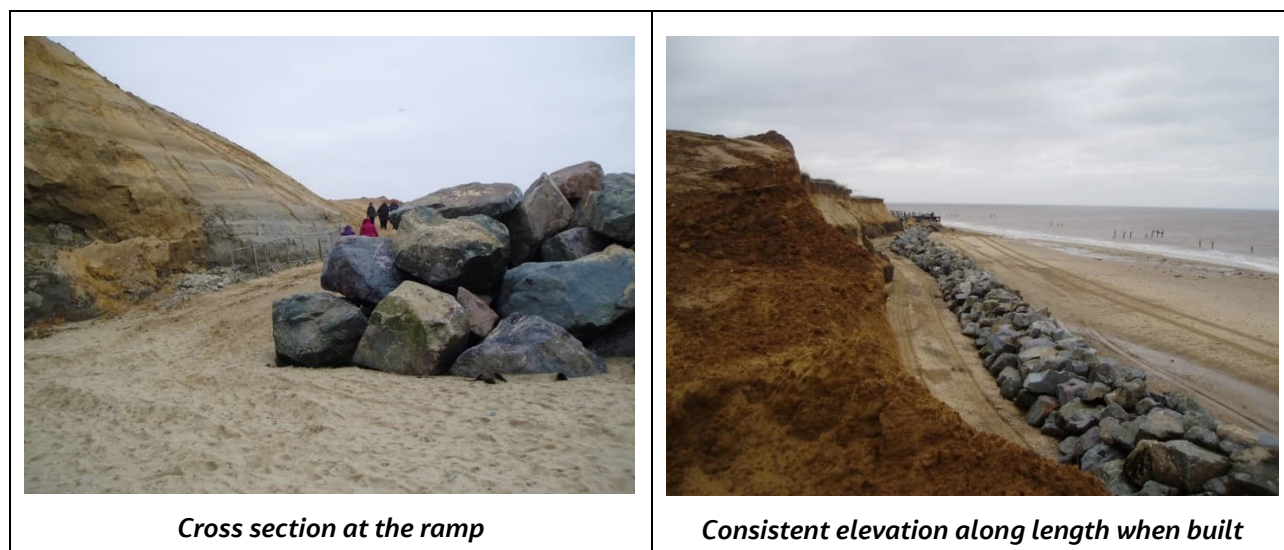
Figure 3-4. Rock Bund as constructed in early 2019

The present configuration of the rock bund was constructed at approximately 400m in length, 6 m wide and to an elevation of +4.0mOD. There are approximately 9000 tonnes of rock placed in the current structure ranging in size from approximately 3-5 tonnes. The construction, broadly based on being a trapezium shaped mound of armour rock, one layer on top of the other, as illustrated in Figure 3-3 below. This is sat on top of a fabric geotextile to help resist sinking into the substrate. The photographs below show the rock as constructed in 2019 (Figure 3-4).

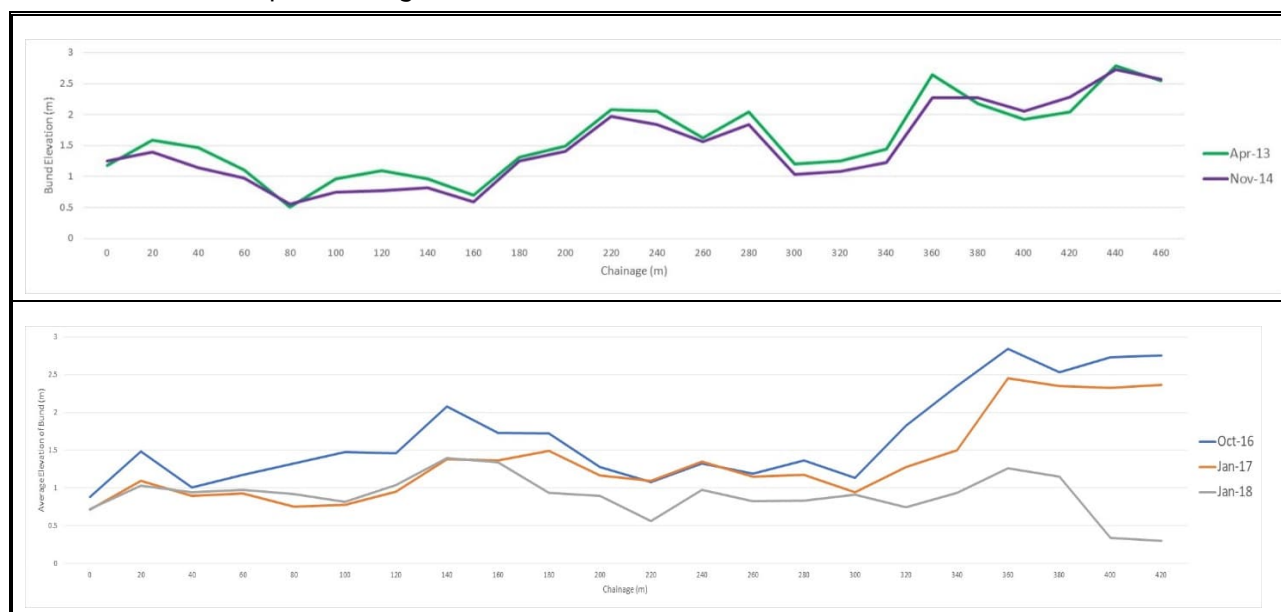
Figure 3-7. Rock Bund Crest Elevation (upper graph shows first configuration of bund post-2013, lower graph shows second configuration of bund between 2015 and 2018)

Similar reductions and variations in elevation are also seen on the previous bund configurations (2007 plus 2013 extension at the ramp, and 2015 relocation) – see Figure 3-7. These are again believed to have been constructed originally at an approximately consistent elevation along their full length (although the actual constructed level in each case is not recorded).

The reasons for this rapid lowering has been considered.

Due to the geotextile beneath the rocks, it is unlikely that the structure simply settled, as illustrated in Figure 3-8 (a) below. Indeed had that been the case then the time for that to occur to the extent shown in Figure 3-7 above would have been much slower than just a few months. What is likely is that, because the bund had to be placed on sand rather than the underlying clay, scouring of the sand at the edges has led to the structure being undermined. As the sand lowered, the edge rocks will have been displaced, leading to those above also becoming destabilised and falling away from the crest, as illustrated in Figure 3-8 (b).

The rock would be best placed directly on the wave cut clay platform (over geotextile) rather than on the unconsolidated sand veneer to restrict or at least slow the rate to which the structure lost. However, the reasons this was not done for parts of the existing (and previous) bunds is recognised. This was due to depth at which the wave cut clay platform is found, which would have therefore required excavating deeper to locate this. This would have also resulted in a lower elevation (or shorter) bund from the outset due to the finite quantities available. Placing the rock directly on the clay would have also been contrary to restrictions that exist due to archaeological/heritage interests (discussed later in Section 5.1.6).

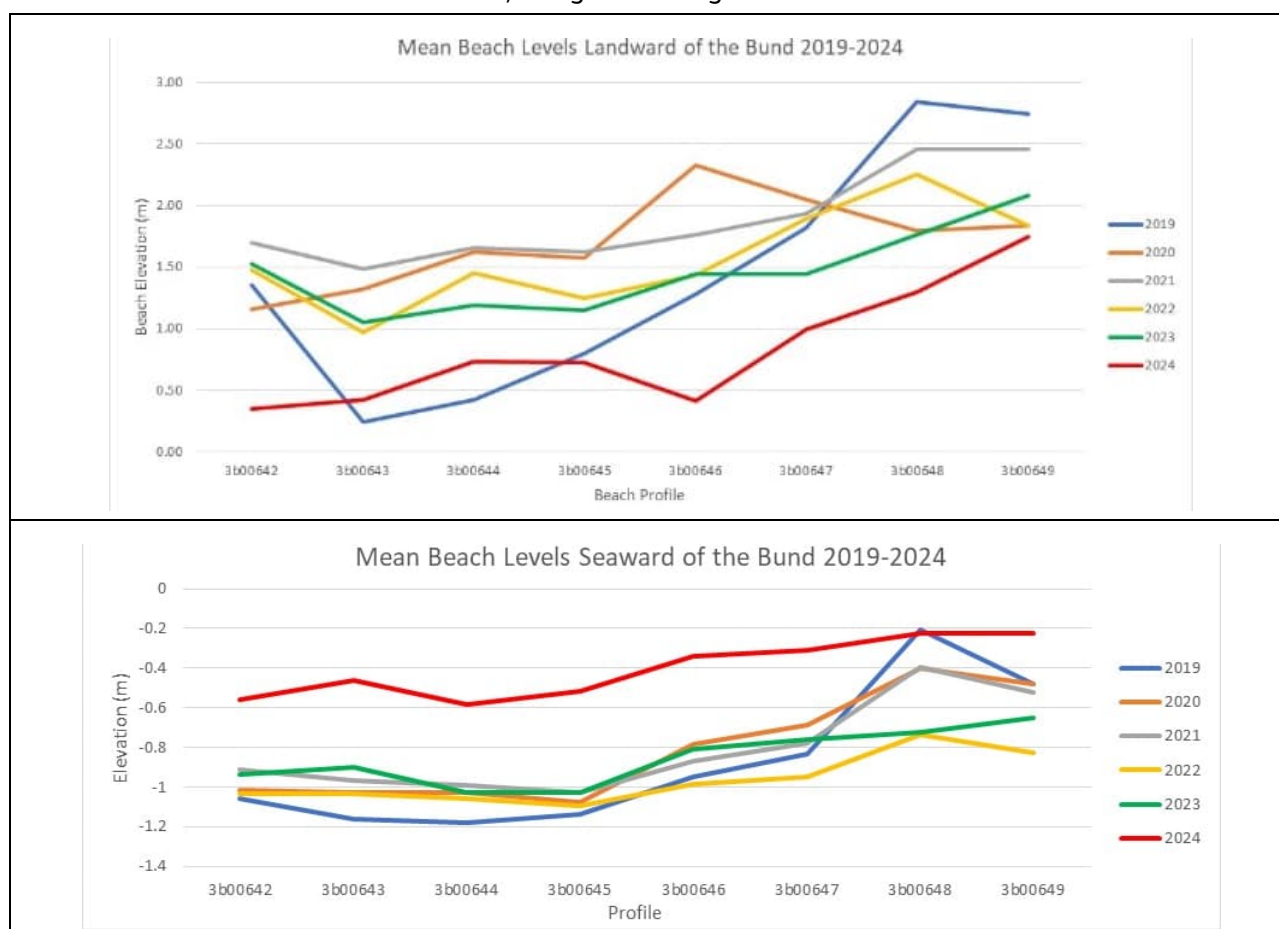
Figure 4-4. Variations in beach level along the current rock bund (taken from annual LiDAR surveys (Nov 2019, Dec 2020, Nov 2021, Apr 2022, Feb 2023, Mar 2024))

These show that the retained beach levels landward of the bund vary along its length, rising to the south, which broadly mirrors the changes in elevation of the bund itself, indicating that this is potentially having an influence in retaining sand. There is also a slight increase in the beach levels seaward of the bund too,

It may therefore be concluded that there does appear to be a direct correlation between bund elevation and beach retention on the landward side. This will have some impact upon the degree to which the cliffs are therefore exposed to day-to-day tidal, and thus wave, action.

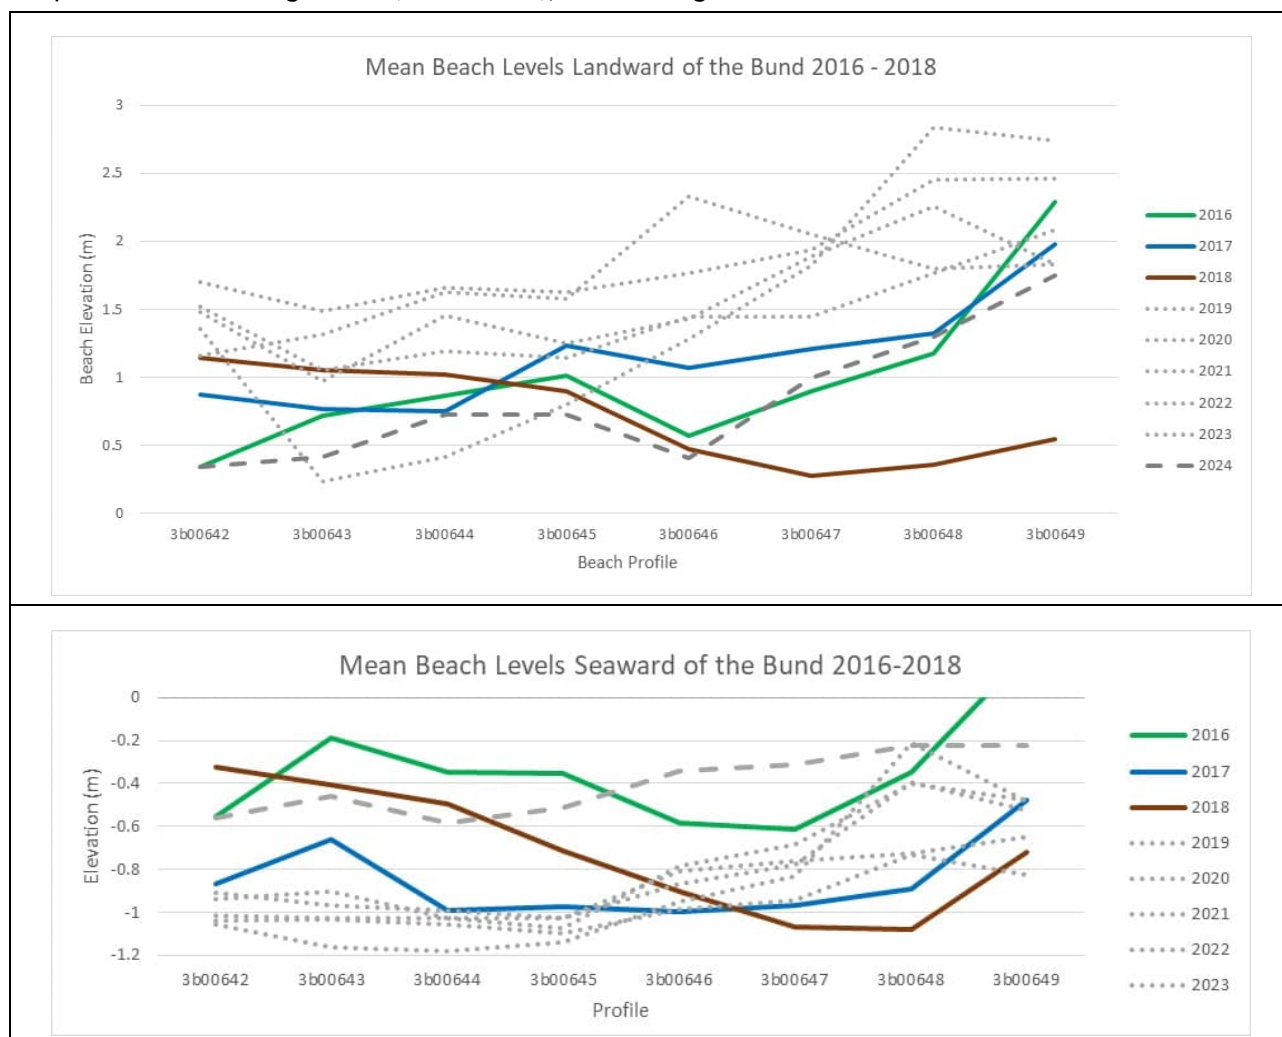
Figure 4-5. Variations in beach level along the previous rock bund

Again the landward beach level broadly follows the bund elevation, including the reduction recorded in 2018 (see Figure 3-7).

For comparative purposes, the levels for the present bund have been included as a backdrop in Figure 4-5. Generally the retained sand levels were at the lower end of what has been achieved more recently, particularly across transects 646 to 648, where the bund elevation was generally lower than in the most recent configuration. This is despite beach levels on the seaward side being higher.

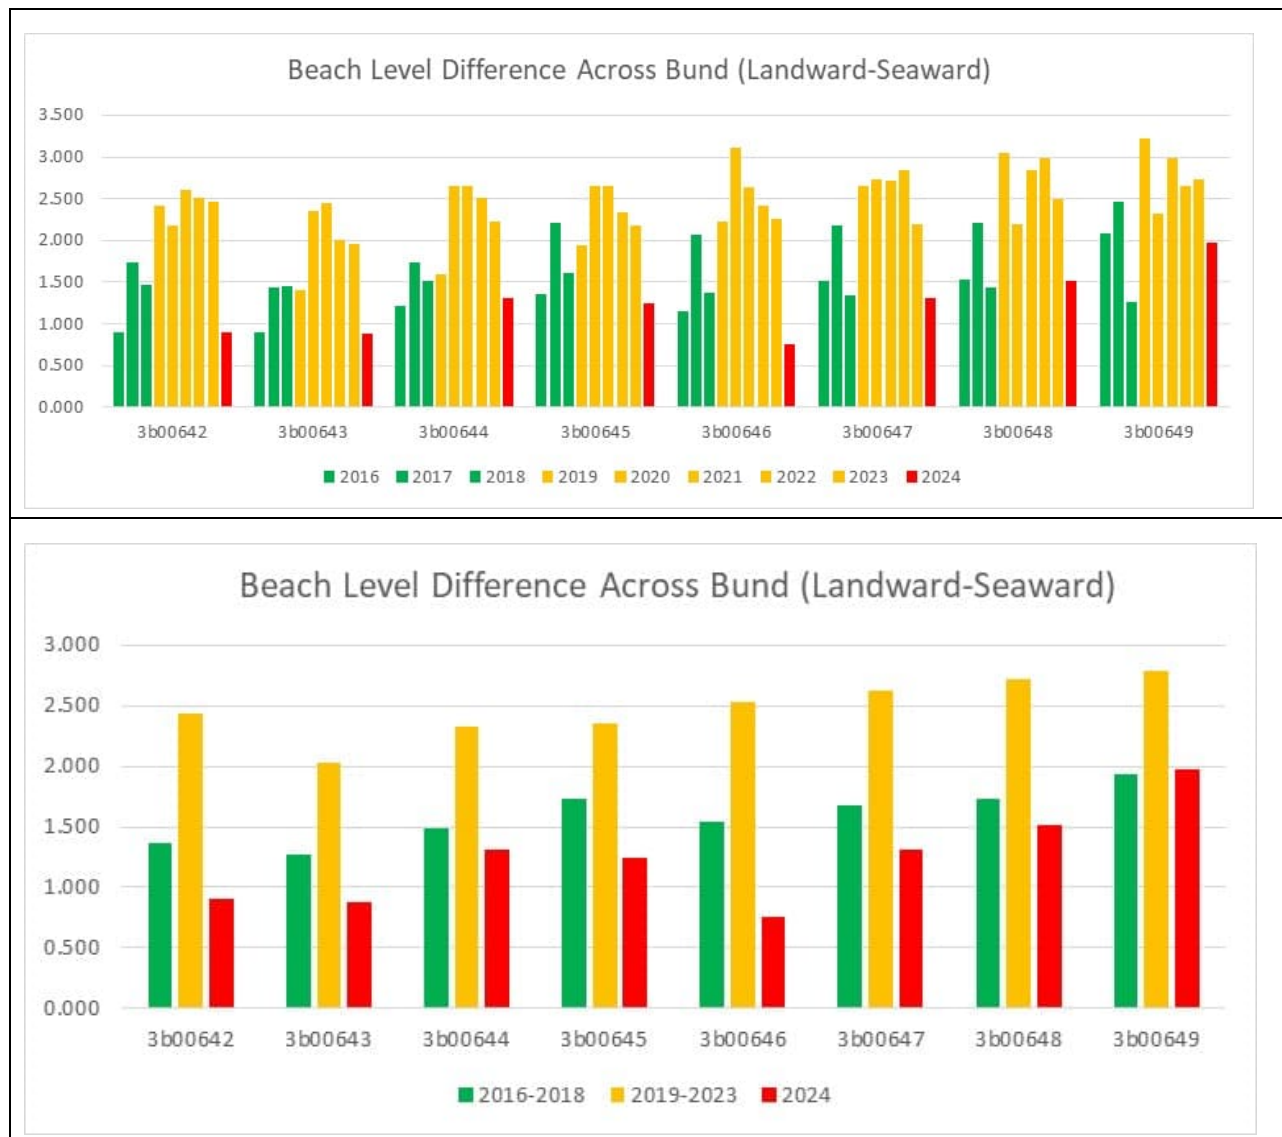
Figure 4-6. Beach Retention due to the rock bund

Despite some year-on-year variability, the effect of the bund appears to be fairly consistent between 2019 and 2023, generally resulting in a perched beach 2.0m to 2.5m higher on its landward side (or 1.0m to 1.5m when discounting the natural beach slope). Interestingly, this is having a similar effect along the entire length of the bund despite the variations in beach level (as shown in Figure 4-4) and the corresponding variations in bund elevation (as shown in Figure 3-6). This may therefore indicate that the overall size of the structure (i.e. width as well as elevation) is a primary influence, limiting transmission of waves (from seaward) and sand (from landward) passing through it – noting the construction included a similar volume of rock along its entire length.

The perching efficiency of the 2016-2018 bund appears lesser (closer to 1.5m) despite the bund being similar elevation over much of its length. However, although levels landward of that bund were towards the lower end of the envelope, this differential is also due to the foreshore levels seaward of the bund being higher than in the most recent years, as can be seen in Figure 4-5. Arguably, when accounting for natural beach slope, the perching effect is negligible. The results for 2024 are also more comparable with those seen

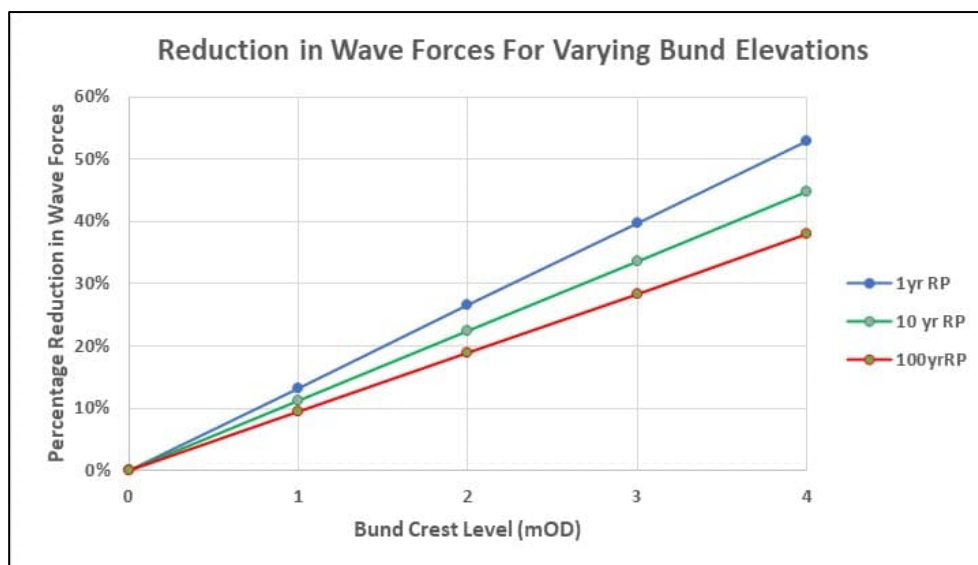
Figure 5-2. Indicative influence of rock bund elevation on waves potentially impacting the cliff face.

The results show a potential reduction in wave forces of 40-50% for a bund with elevation of +4.0mOD, compared to no bund. This reduces to having the effect of reducing the wave forces by just 20-25% for a bund at +2.0mOD.

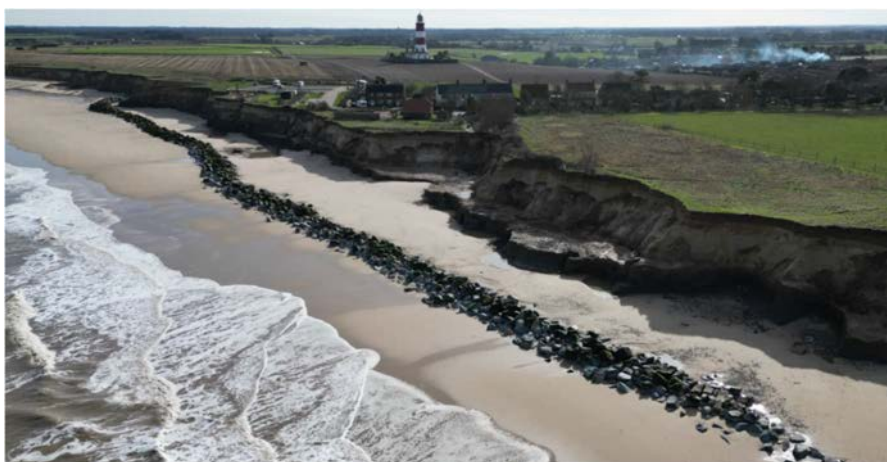
Figure 5-6. Happisburgh rock bund (North Norfolk District Council, Drone Footage from 27th Feb 2024)

The full extent of the present bund is shown in Figure 5-6. As can be seen, a considerable length of the bund is protecting what is now open land and the cliffs would need to recede some considerable distance before property landward of that is at risk from erosion. It is therefore questionable whether maximum benefit is currently being obtained from that rock being used along that whole length and it might be directed somewhere else.

If any of the above recommendations for improving the effectiveness of the bund are adopted, a shorter length of bund will have to be constructed due to the requirement for a more substantial quantity of rock per linear metre. However, a shorter bund could be targeted at the locations in need of most immediate protection.

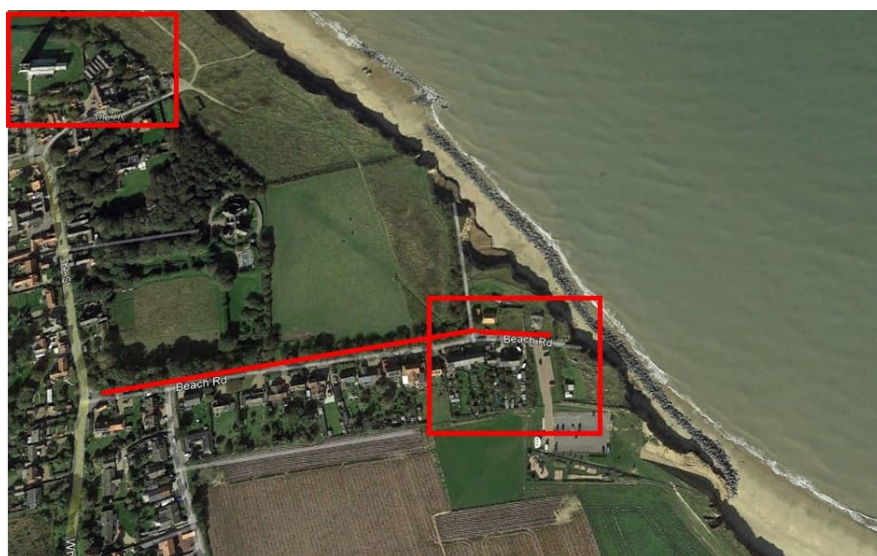
Figure 5-7. Assets closest to the cliff edge

The rock bund can be reconstructed as a continuous bund, or targeted protection at more than one location along the coastline. That decision is going to be based upon which assets are potentially at risk and over what timescales, which as indicated in Figure 5-7 are first the properties and infrastructure at the end of Beach Road, with the Church of St Mary the Virgin and surrounding properties next at some point in the future.

The most immediate risk and thus need is enhanced protection at the end of Beach Road. To enhance this as per the approaches set out in Section 5.2.2, rock could be taken from the northern end of the bund to increase the volume here. Depending upon the future plans implemented for beach access (see Section 8), it may also be possible to shorten the length of bund at the southern end too. To note, however, when reducing the length of protection, care should however be taken to not build a structure that is too short, as this can be subject to outflanking by erosion around either end. With that in mind the bund ought to extend further north than the end of Beach Road, this being the predominant direction for incoming storm waves.

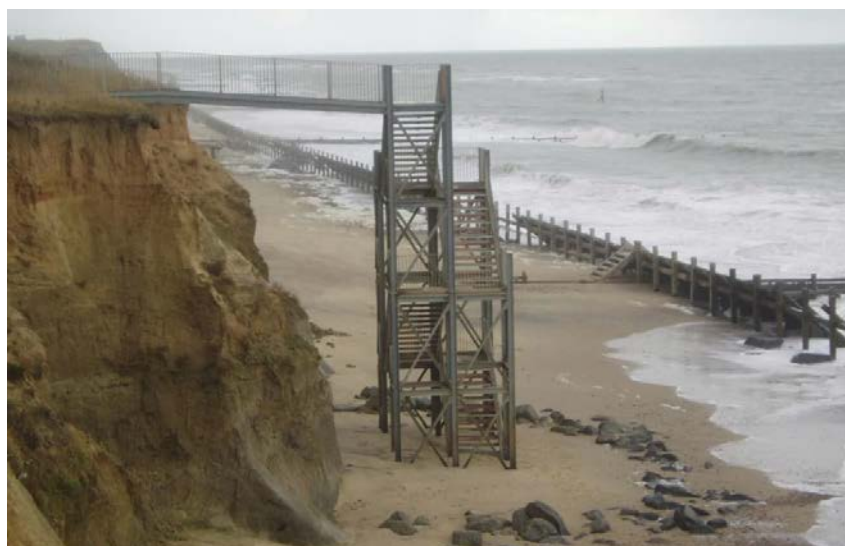
Figure 7-1 Staircase units previously used for beach access to the north of Happisburgh (September 2009)

To enable continued public access to the beach, a steel staircase was installed the following year (see Figure 8-1). However, following further cliff recession, these had to be removed in 2012 as no longer safe to use. These have since been placed in storage for potential reuse.

Assessment has been made of the potential reuse of the old steel staircase which is currently in storage and remains in visibly reasonable condition, although it would need to be thoroughly checked from a structural perspective for safety reasons before considering its installation.

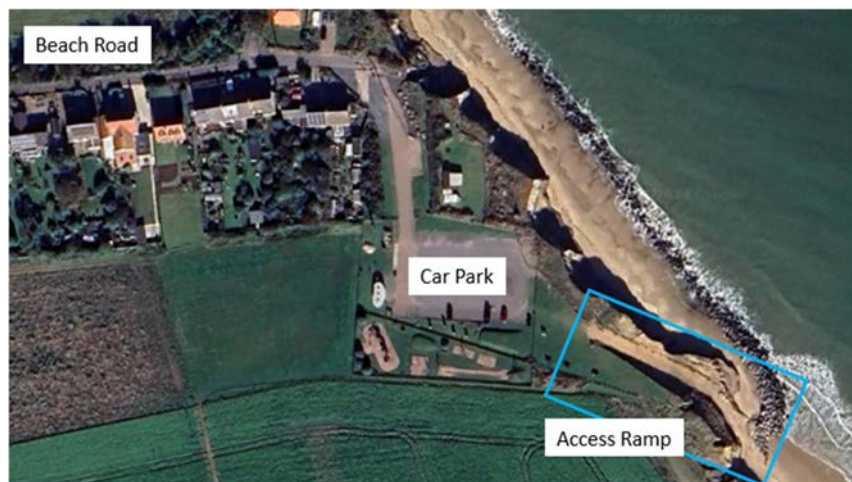
Figure 7-2 Location of the current beach access ramp at Happisburgh

With removal of the steps, an access ramp was created to the south of Beach Road near the current car park (Figure 8-2), with the rock bund extended to provide protection to that in 2013. This follows the line of the cliff face, with a side slope of 45° cut back into the cliff for stability, and the cut clay has been used as extra packing for the unsurfaced ramp slope. The current ramp is between 4m and 5m in width and now has a steep slope of between 1 in 5 and 1 in 6. As a general rule the maximum ramp slope would be 1 in 12, but this has not been possible here due to constrictions on available space and being able to maintain the ramp in the face on continued erosion.

This still exists, although the ramp has been recut and reshaped several times as erosion has occurred. More recently this recutting has been required every few months. This remains the primary route down to the beach for both pedestrians and maintenance vehicles, although in periods of low beaches and inclement weather can be closed for long periods of time.

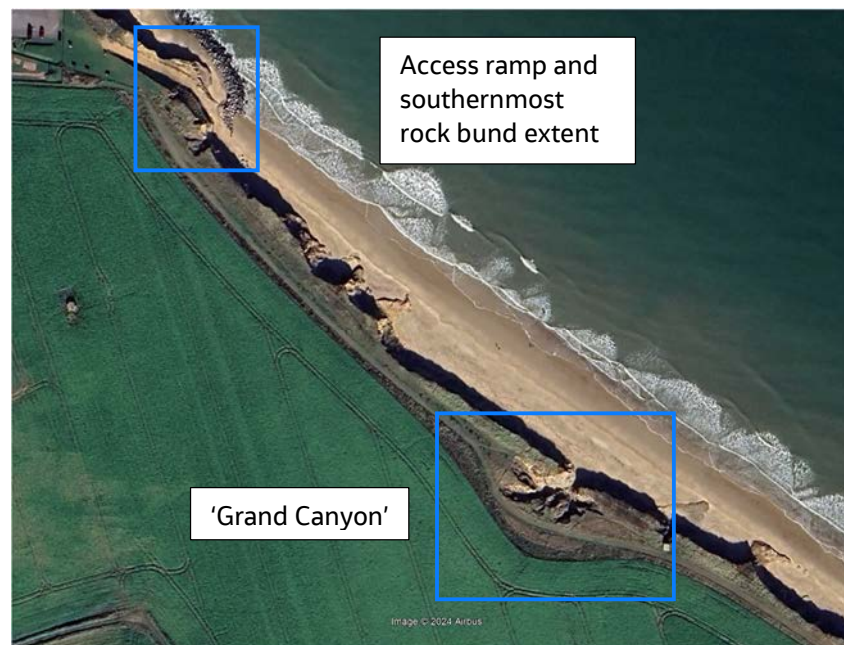
Figure 7-3 Location of 'Grand Canyon' at Happisburgh, shown on an aerial photo from 2024.

A cut in the cliffs to the south of Happisburgh village, locally known as the 'Grand Canyon' developed in early 2021. This is located approximately 250m south of the current access ramp (Figure 7-3). and has recently become an informal and unmanaged access to the beach for pedestrians.

The 'Grand Canyon' now extends approximately 40m inland from the main cliff frontage and spans approximately 50m at its widest point after just four years. It is thought that this was initially triggered by Storm Christoph in the January of 2021, and resulted from an erosion induced 'landslide' (Petley, 2021), which formed a small but ever growing 'gully' feature (Figure 7-4). Certainly surface water runoff has contributed to its development, this being a noticeable low spot in the surrounding field, and there also appears to be sub-surface groundwater running off through this location too.

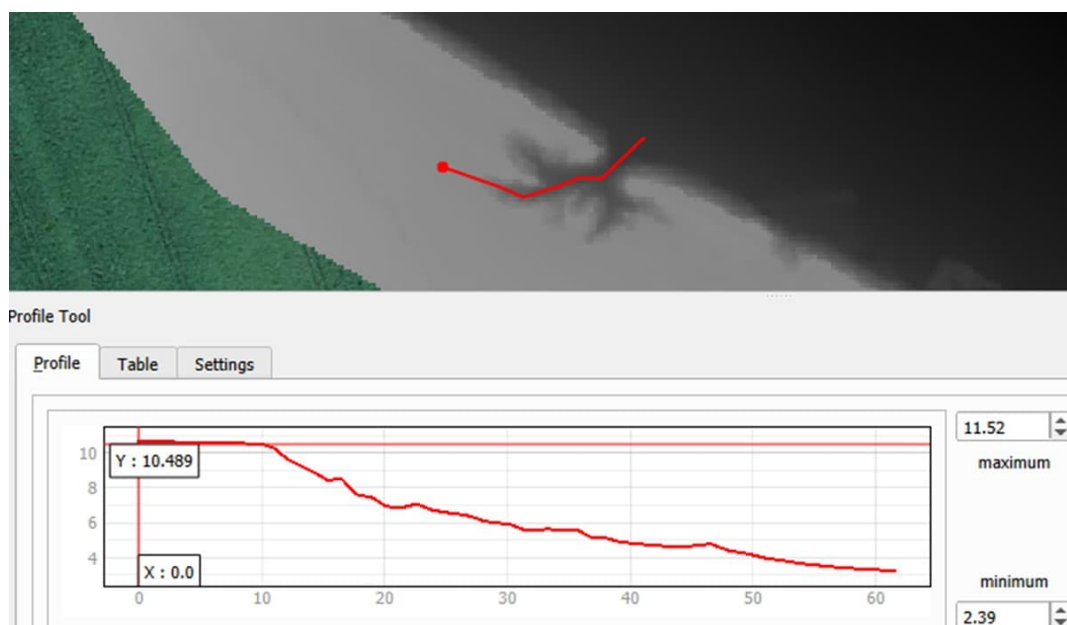
Figure 7-7 Section showing the slope through the Grand Canyon

One potential approach to improve access here is to grade the slope to make it easier to walk down, potentially also adding some surfacing material or matting that provide a better grip and make the surface less slippery. However, as can be seen in Figure 8-6, this existing slope is already steep, at approximately 1:6 (not dissimilar to the existing beach access ramp at Happisburgh). So, to achieve a slope closer to 1:12 for more suitable pedestrian use) would require cutting further back inland. Although the land is not owned by NNDC.

However, despite cutting a shallower slope, the processes that have formed this feature include surface water runoff and subsurface ground water seepage, which will continue as this evolves. So this pathway may remain slippery and unstable even with some form of surfacing. Increased pedestrian use of this pathway will also cause some further erosion through wear and tear. Consequently, if access is simply improved in this way, there will be certainty of suitable access on a continual basis and may need to be closed off at times if deemed unsafe. As such it will need ongoing monitoring and maintenance if it is to be adopted as an approved access point.

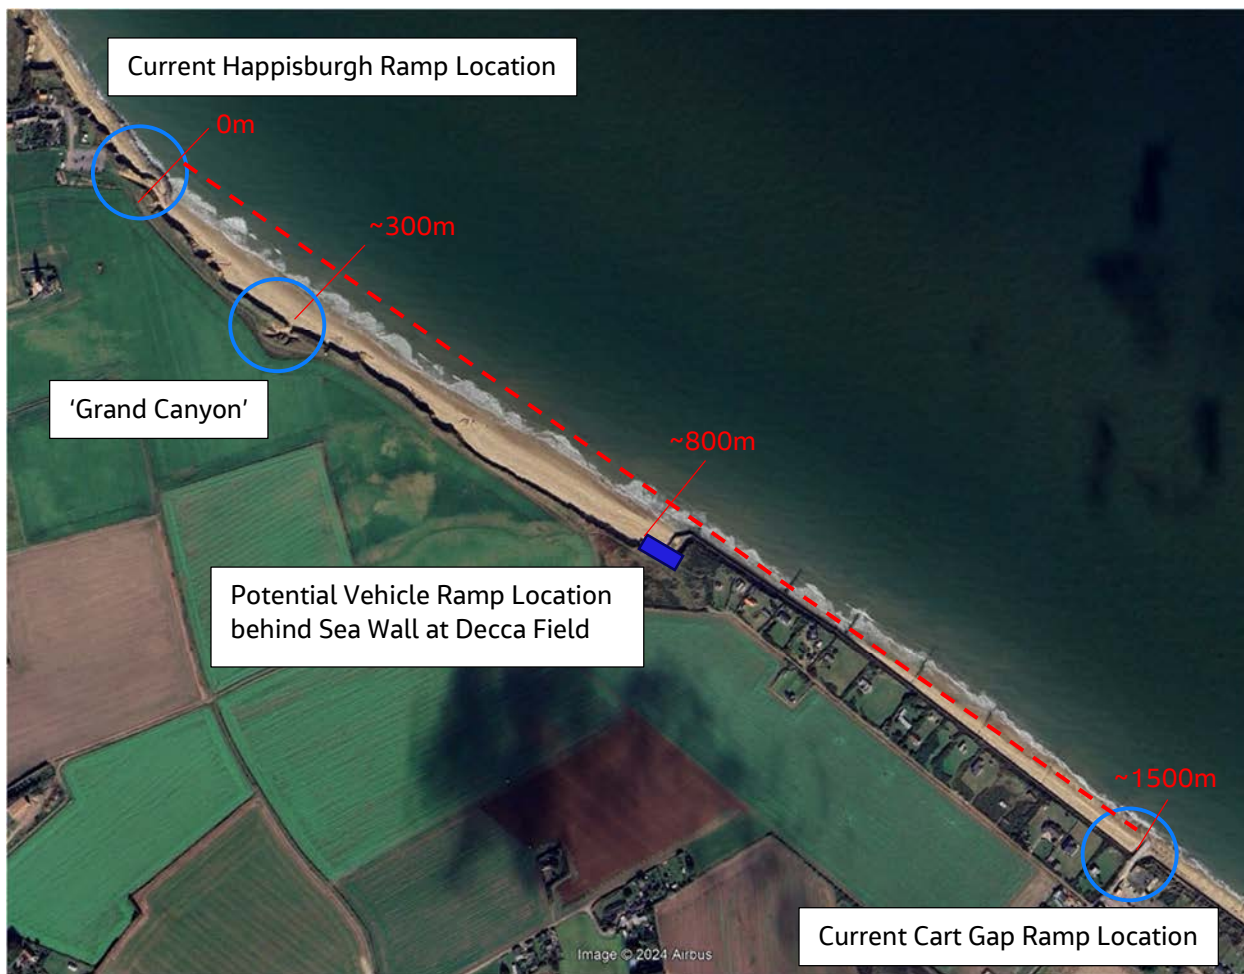
Figure 7-8 Locations of the potential Decca Field vehicle ramp and current Cart Gap ramps relative to the access ramp at Happisburgh

- Use of Cart Gap depends upon the levels of the beach at that location and in front of the wall at Bush Estate, which can be volatile. As such, there are times where it would be impossible to use this to get machinery onto the beach and track north even as far as the end of the seawall.
- There are a series of groynes along the seawall in front of Bush Estate. Unless tide levels are very low this makes the beach impassible without temporary works to go over each of those groynes.
- The time it takes to track along the beach from Cart Gap to Happisburgh reduces the working window. This is especially limiting and potentially impractical if tides are such that machinery needs to exit the beach every high tide.

Consequently, Cart Gap is not seen as a viable option for assured access by plant if required.

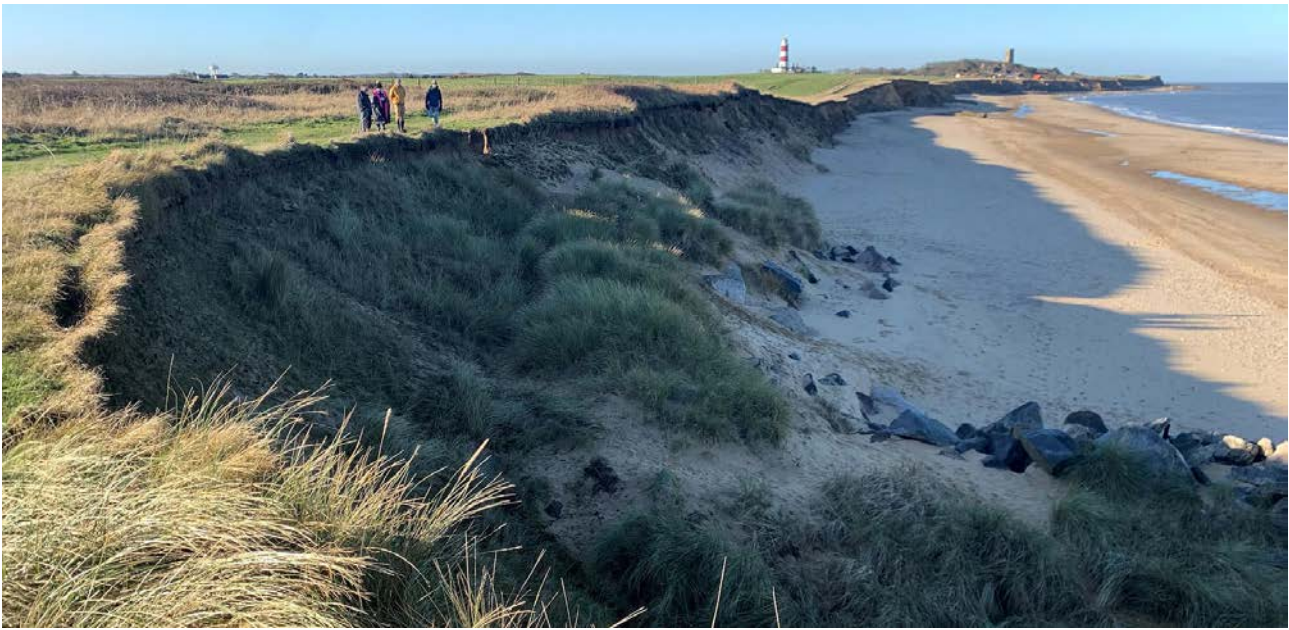
Figure 7-9 Happisburgh coastal frontage. Photo taken looking north from the potential Decca Field vehicle ramp location (November 2024)

The ramp itself could be similar to that described for Happisburgh, albeit north-facing. However, unlike those locations, the cliffs here now appear to be relatively stable and there are even signs of some dune vegetation growth on the foreshore, indicating sand deposition. Consequently, the risks of erosion to the ramp edges and to the toe of the ramp are considered to be considerably lower than at Happisburgh. In addition, there is rock already at this location which can be utilised to help reinforce and protect a ramp at this location.

This is however a considerably more favourable location than Cart Gap for maintenance vehicles, being only half the distance to travel and without the obstacles of beach structures to overcome. A longer tidal working window would also result. Although some landside work might be required to ensure access to the ramp, and noting NNDC do not currently own that land, there is already an informal access track behind properties that could be improved. Maintenance vehicles would then reach the coast from the south, rather than via Happisburgh village or any need to track along the cliffs.
