Overstrand to Walcott

Defence Condition Survey

**Interim Report
October 2003**

This report describes work commissioned by North Norfolk District Council whose representative was Mr Peter Frew. The HR Wallingford job numbers were CDR3212 and CDR3214. The work was carried out by Mr Peter Lawton of St La Haye Consulting Engineers. The HR Wallingford project manager was Mr Paul Sayers.

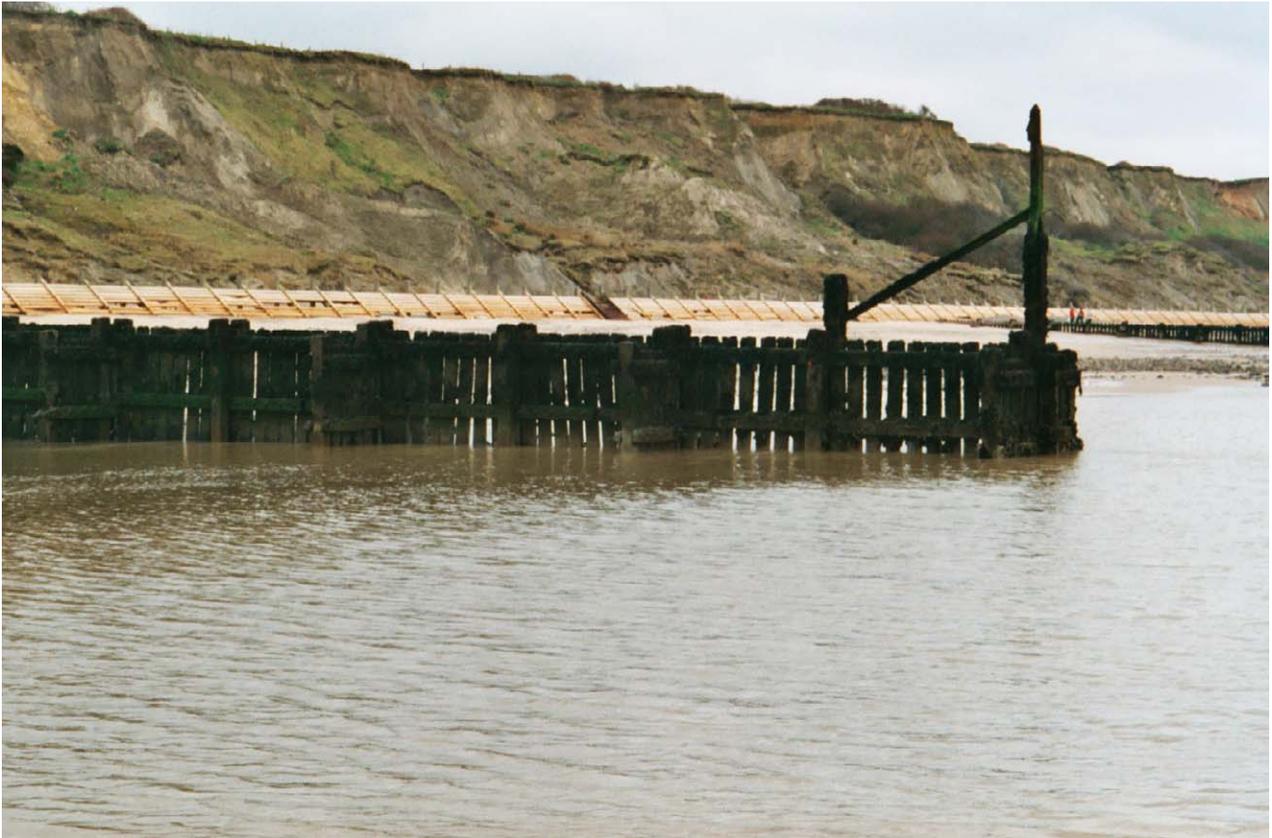
Plate 3.4 Photo OP1 East Elevation of Groyne 1

<u>Condition and Performance of Beach</u>	
<p>Normally a thin veneer of sand over gravels and clay. Highly volatile.</p> <p>Control Structures</p> <p>There is a timber groyne at the western extreme of the beach. This is in good condition with no planks missing</p>	
<u>Conditions and Performance of Backshore Defences</u>	
Type: Sea Wall	Built: 1890 Refurbished: 1998
Description: The sea wall is in good condition with no visible signs of damage or movement since it was repaired and refaced	
Defence Condition Rating: Very Good	
Updates to CPSE (1997): Unknown	
<u>Description of Hinterland and Development</u>	
<p>The town of Overstrand. Predominantly residential but having an important tourism based economy. The sewerage system serving the town is focussed on the cliff top site where a storage tank and pumping station is located at the rear of a car park.</p>	
<u>Cause and Consequence of Failure</u>	
Likely Failure Mechanism: Slip circle failure of the cliff.

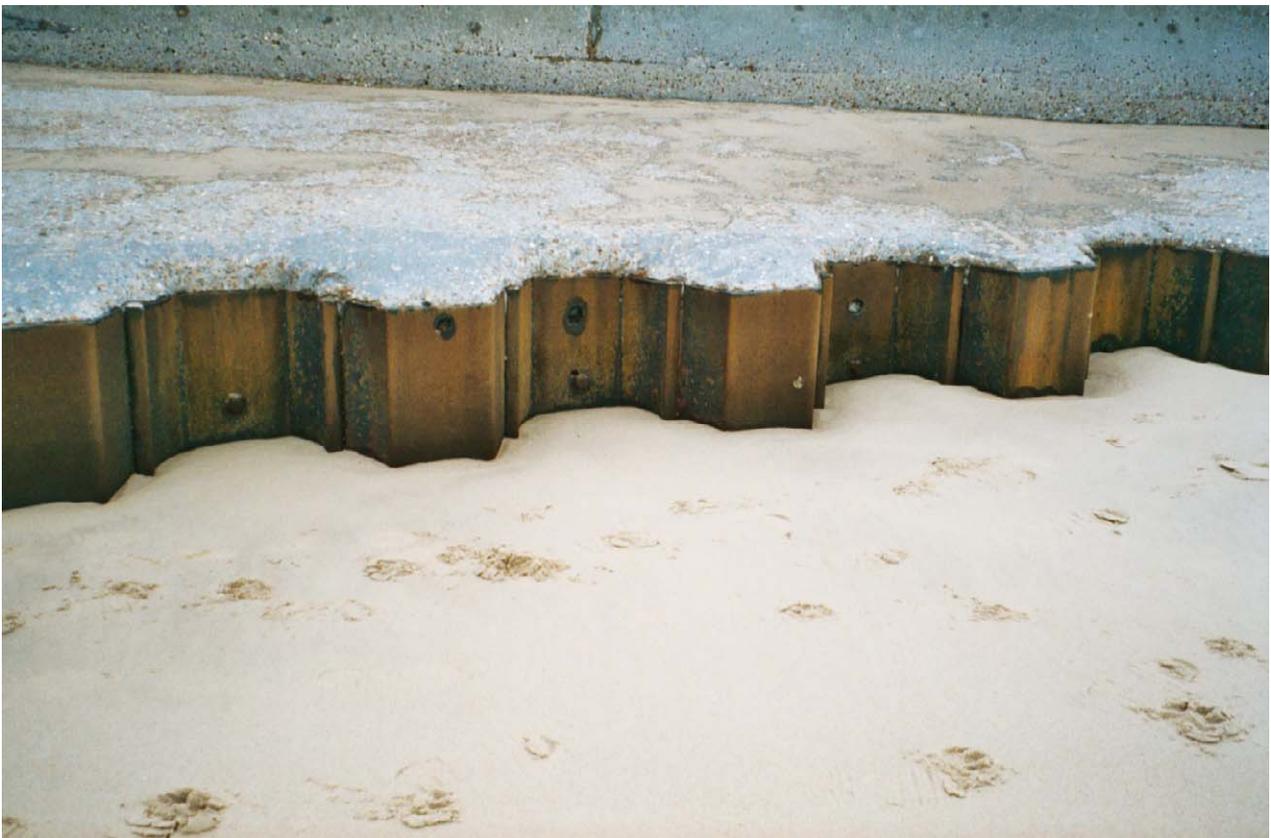
Likely Failure Mechanism: A review of the durability of the steel piles, using literature dating from when they were installed, suggests that they have reached the end of their useful life. The contemporary standard of a corrosion allowance of 0.09mm per year gives a calculated loss of 4.5mm, which is over half the original steel thickness. Imminent steel pile toe and apron failure followed quickly by failure of the seawall. This in turn leads to cliff instability.

Plate 3.7 **Photo OP8** **Steel Piling and Concrete Apron at the base of the Sea Wall**

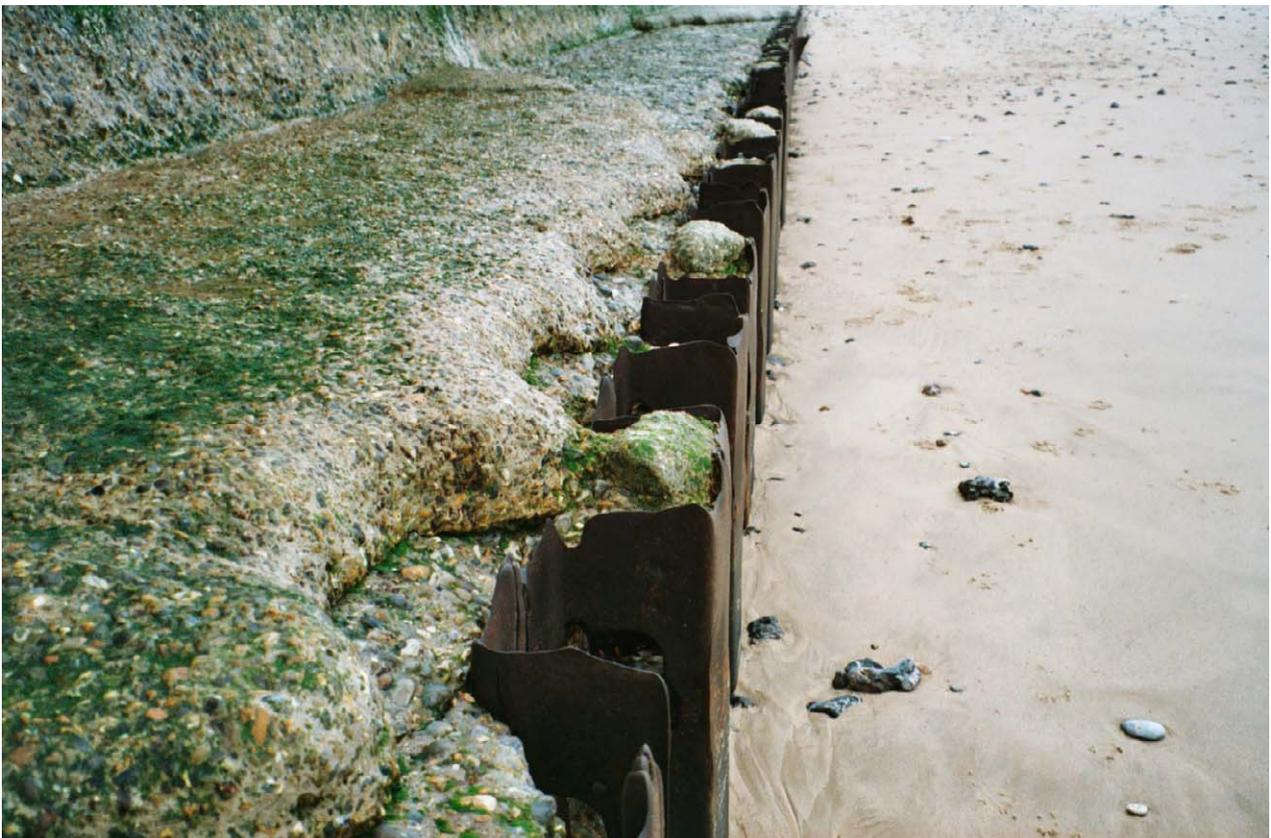
<p>The concrete apron is in poor to fair condition unlike the steel piles, which have been assessed to be in very poor condition, beyond repair. The Frodingham piles are very badly corroded and the tie rod waling fixings have failed consequently. The piles would have failed in bending under ultimate limit state conditions. Hence, on review, the condition of the apron and piles has been confirmed as very poor condition with a residual life of 0 to 3 years.</p> <p>The walls, when analysed in isolation are safe. Their stability is however entirely dependant on the serviceability of the apron and steel piles. If the piles fail the wall fails. Hence, the overall condition of the sea wall has been assessed, on review, to be very poor with a residual life of 0 to 3 years.</p>	
Defence Condition Rating:	Very Poor
Updates to CPSE (1997):	Unknown
<u>Description of Hinterland and Development</u>	
As for Defence Length 2.03.1.

Plate 3.10 Photo OP21 Close up of poor Apron

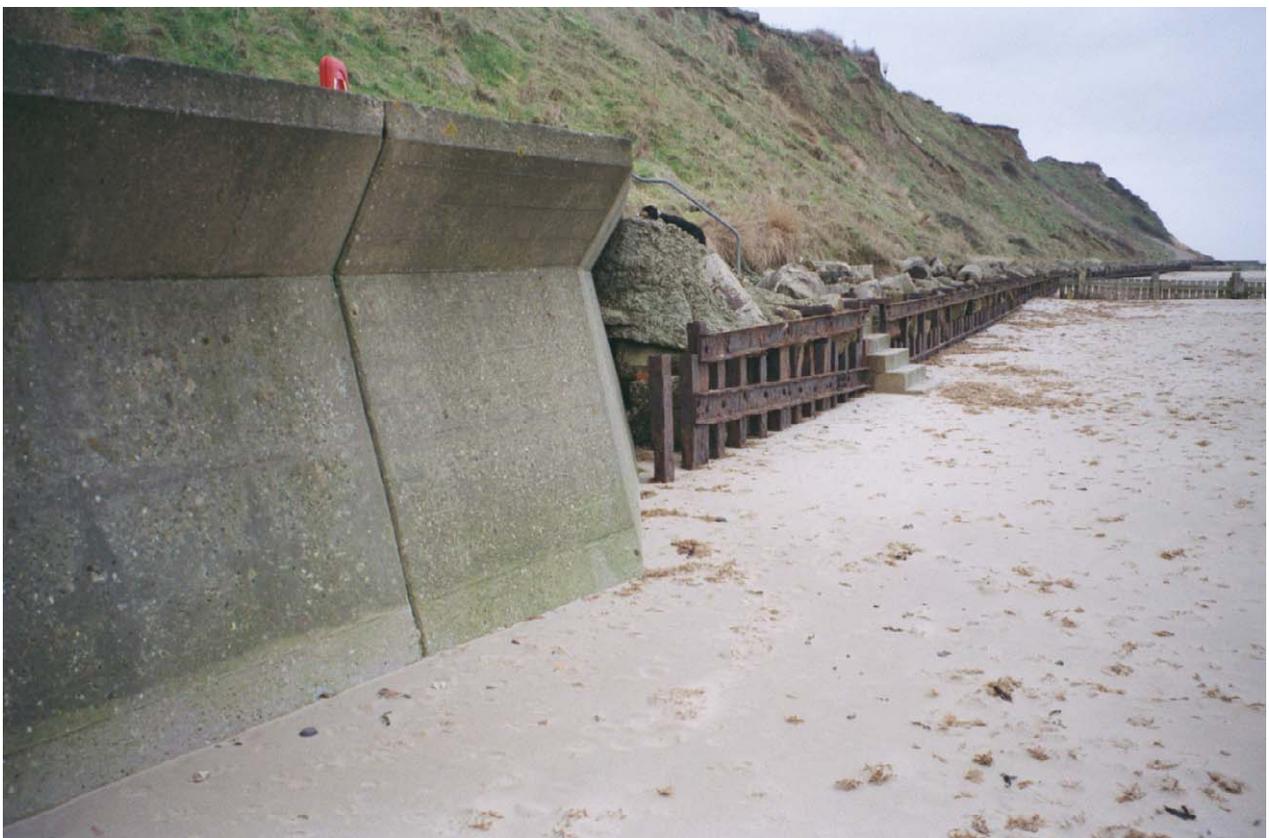
Likely Failure Mechanism: The original design life of the piles was 85 years. As most of them were placed in the fifties, the residual life of the piles is 40 years approximately. (The permissible loss of section of these piles is 6.1mm. On the basis of 0.09mm per year, the likely loss of section is 4.14mm to date.). It seems more likely that as the stem of the wall is rather slim for a mass concrete wall the most likely cause of failure is the collapse of the wall. Stability calculations show that it can resist overturning but its ability to resist sliding under serviceability limit conditions is poor.

Plate 7.4 Photo MP43 Western termination of Sea Wall

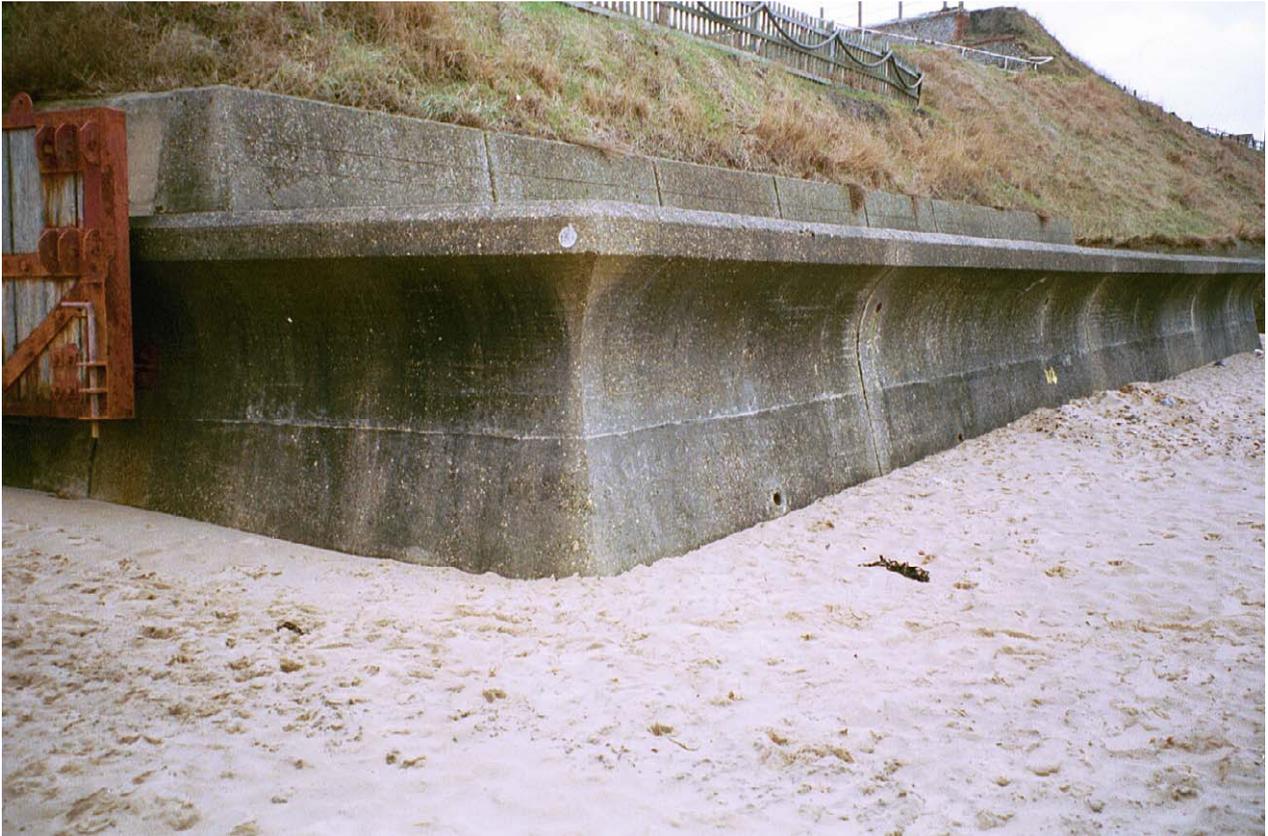
Plate 7.14 Photo MP9 Corner of Sea Wall

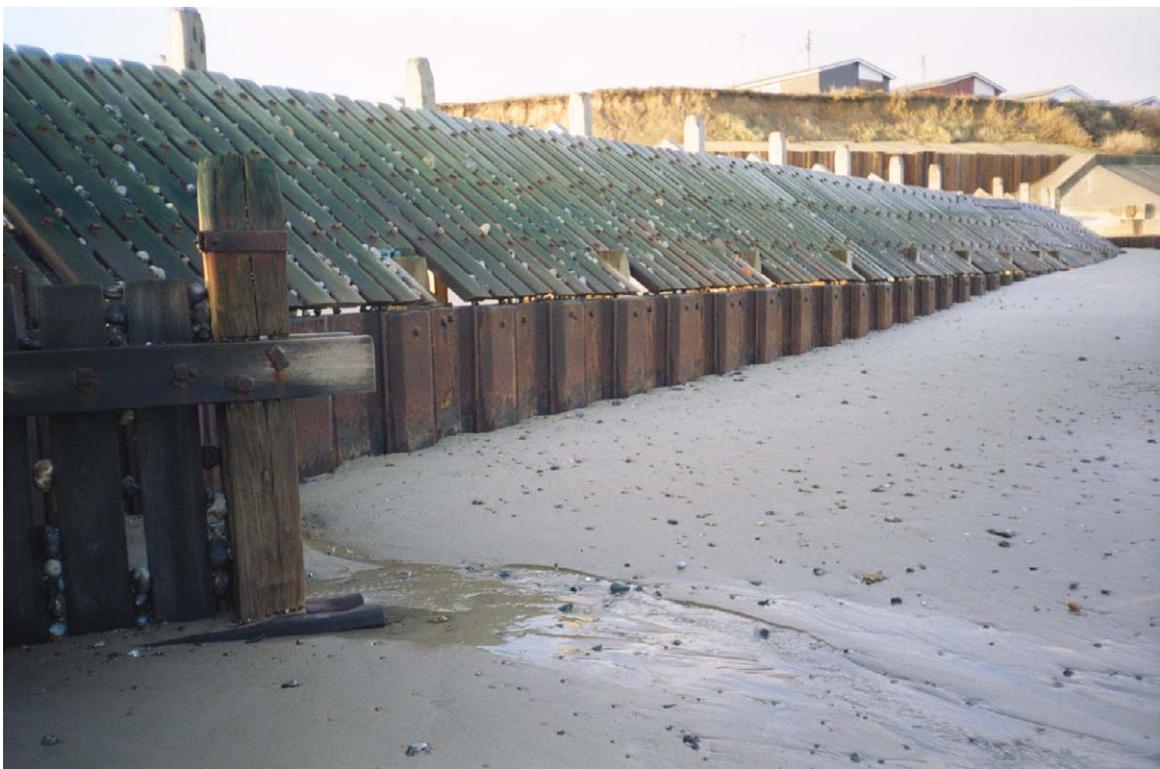
Plate 9.16 Photo WE22 Revetment, note stones clogging “permeable” structure
