# Cromer to Winterton Ness Study

Appendix A: Coastal Defence Condition Survey Update

November 2012  
North Norfolk District Council

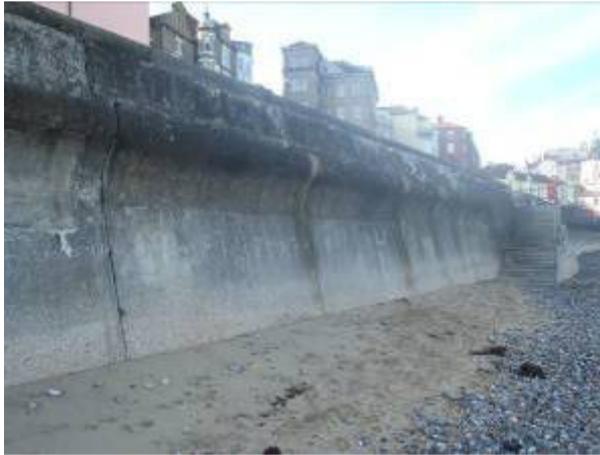
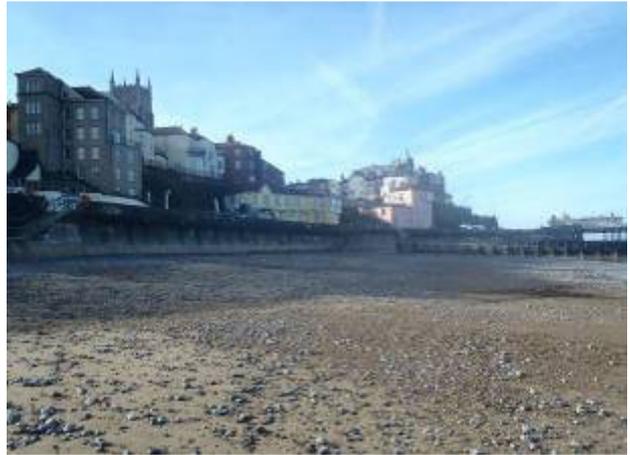
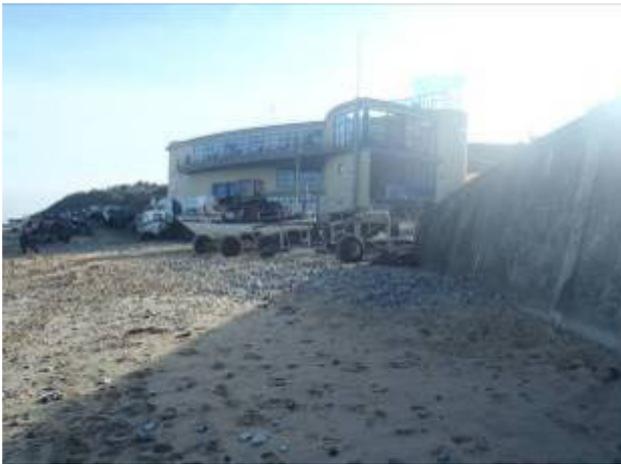
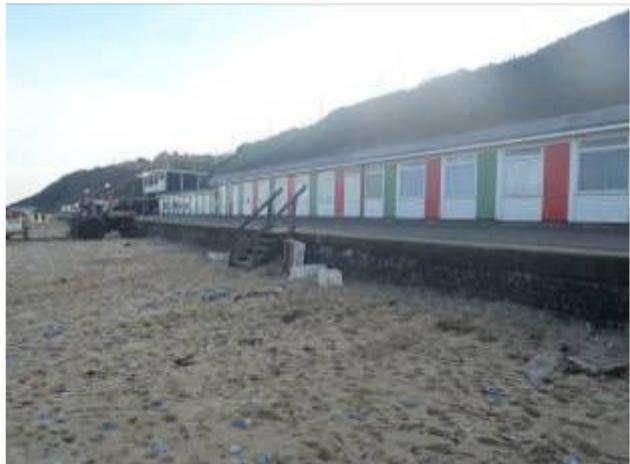
The timber groynes are in good condition and are not missing any boards or suffering from major damage. They are also retaining a fair amount beach material and the foreshore appears to be in a stable condition.

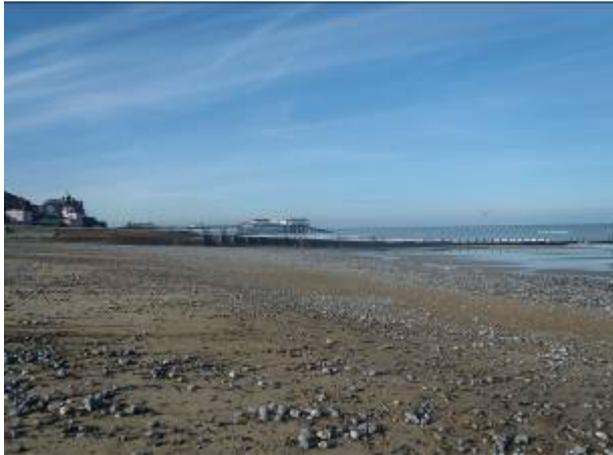
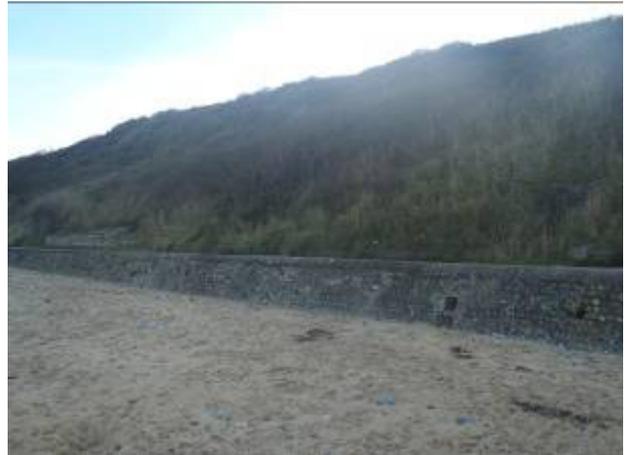
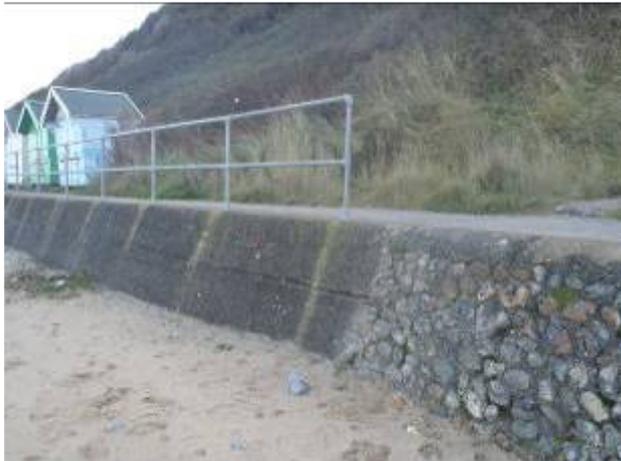
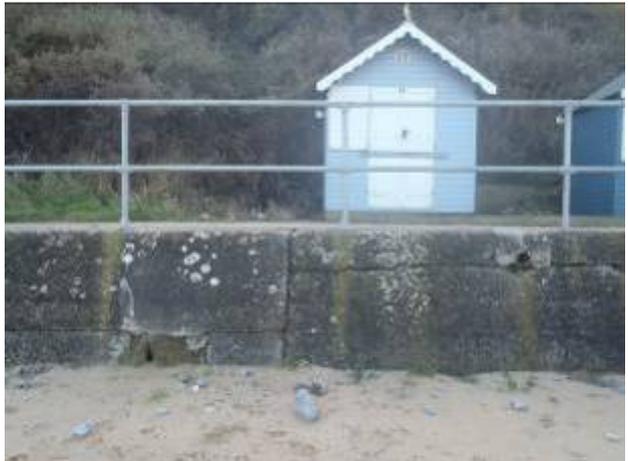
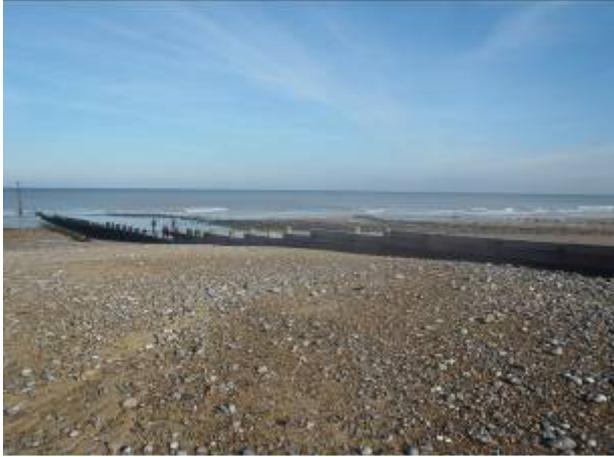
There is one timber groyne at either end of the section and these are in good condition, not missing any boards or suffering from major damage. They are also retaining a fair amount beach material and the foreshore is in a stable condition.

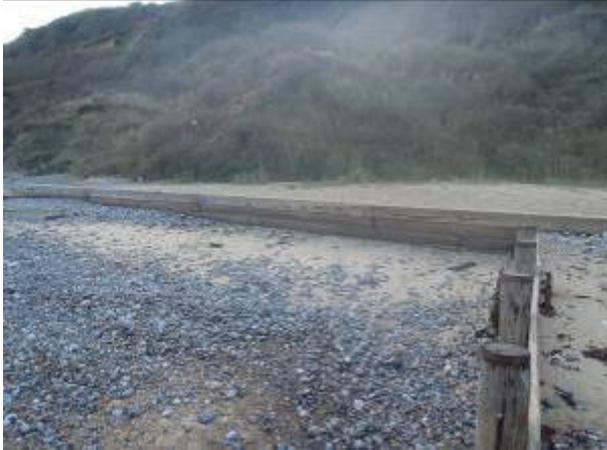
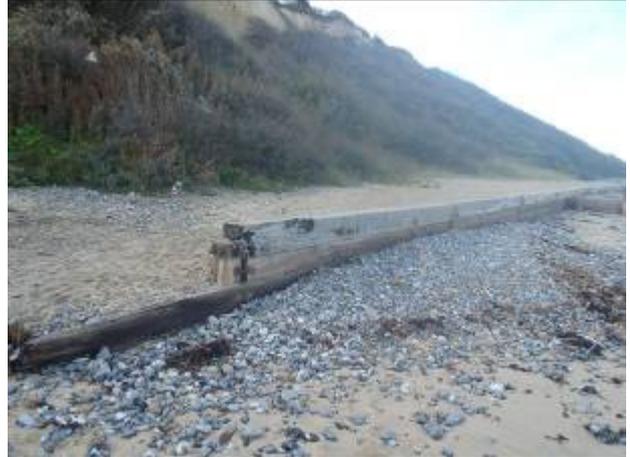
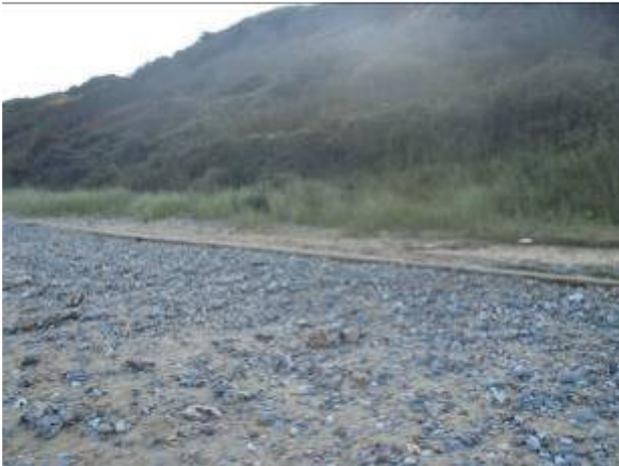
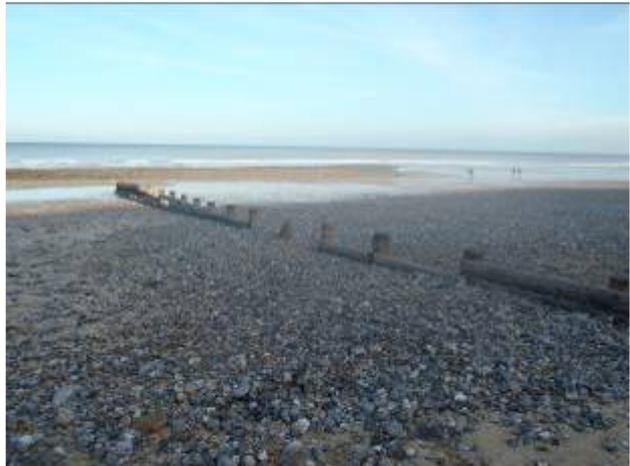
The timber groynes in the section are well worn and showing signs of damage and corrosion of the fixtures and fittings with a number of boards missing along their length. There is a fair amount of retained beach material against the cliffs though this may be the result of recent cliff falls as the beach flattens out and becomes very shallow approximately 25m from the base of the cliffs.

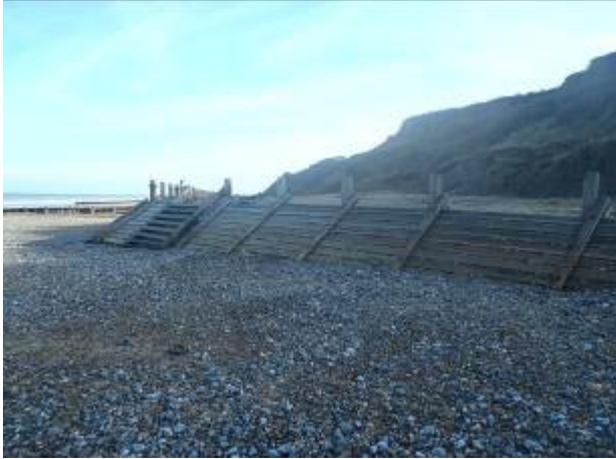
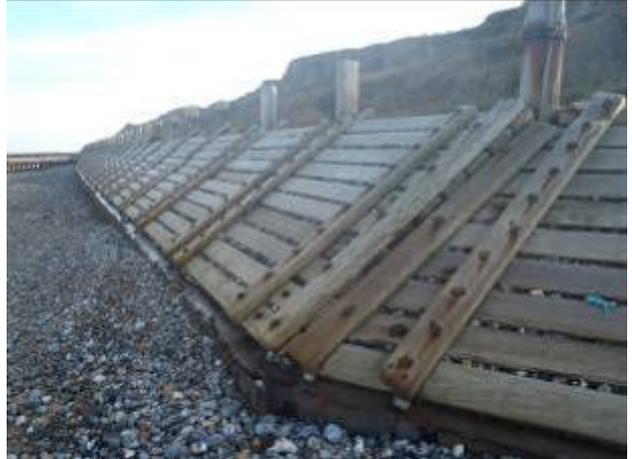
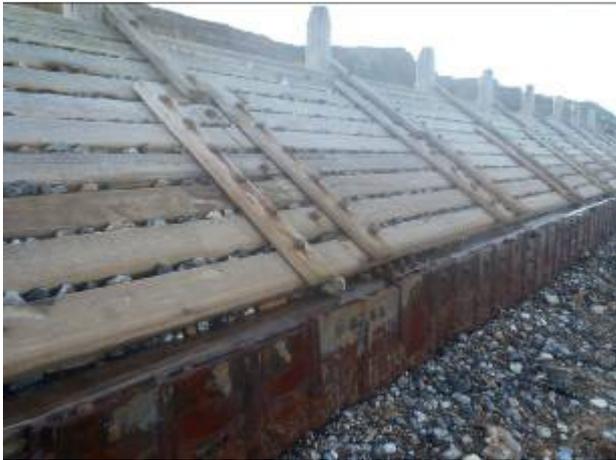
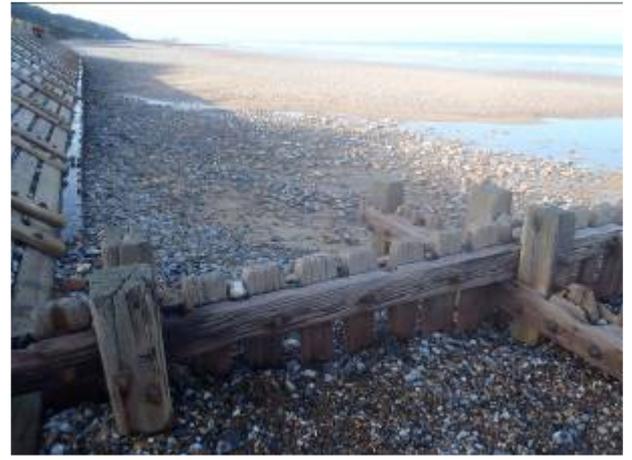
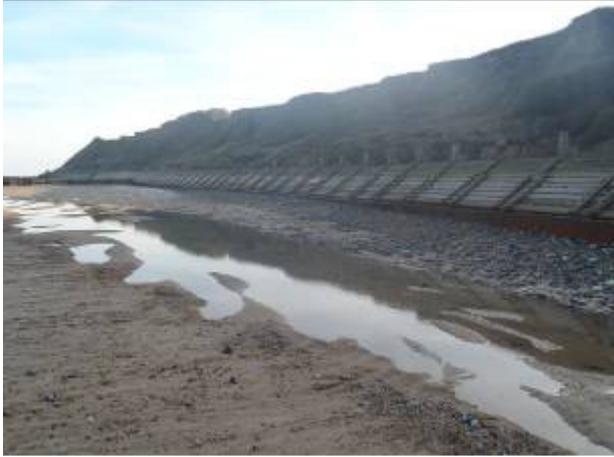
The timber groynes are in a fair condition with the timber becoming worn but not damaged and the fittings are showing some signs of corrosion. The beach appears stable but is relatively low in the area.

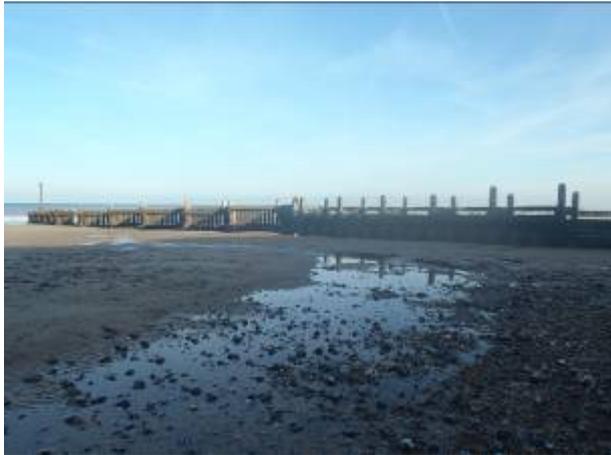
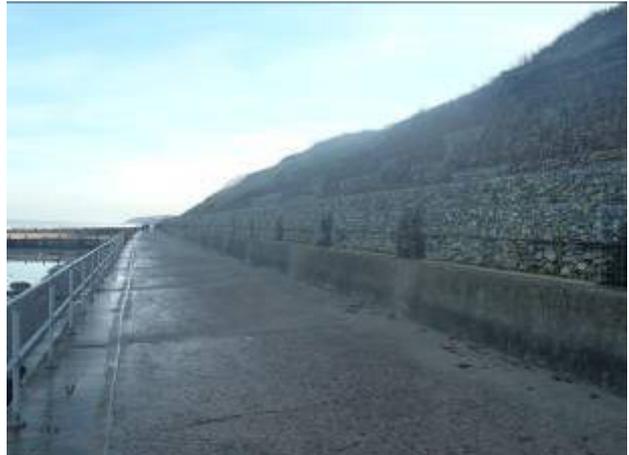
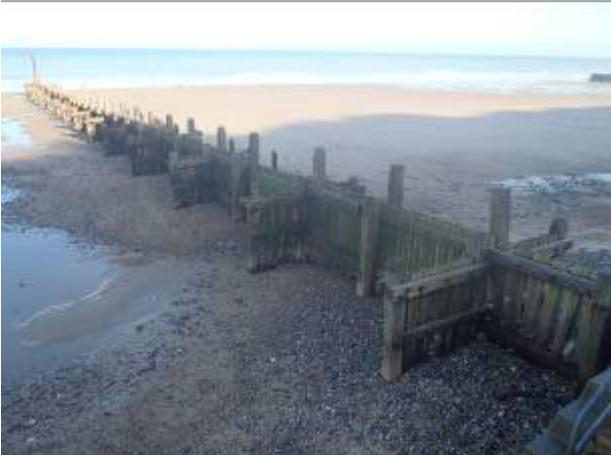
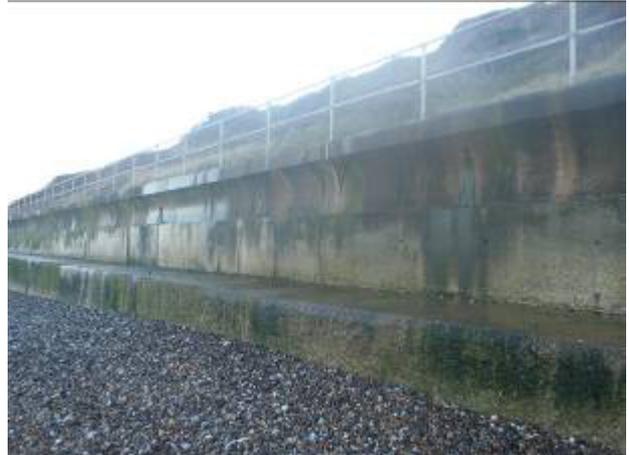
The timber revetment is missing a number of the boards and has been damaged in places whilst some of the piled foundations are exposed and becoming corroded.

The timber groynes run through the section and are in a good condition with no missing boards and minimal wear on the timber, though the fittings are starting to corrode.

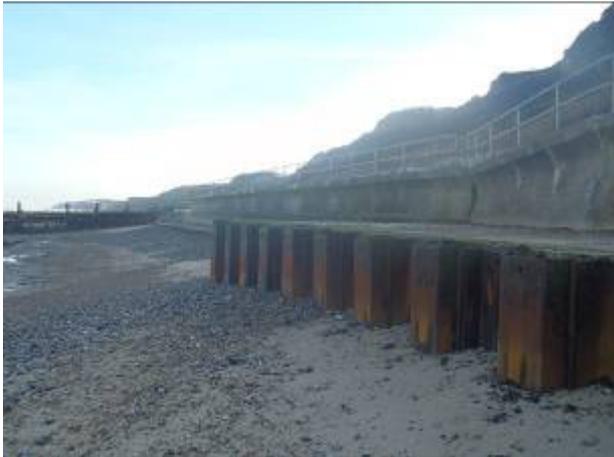
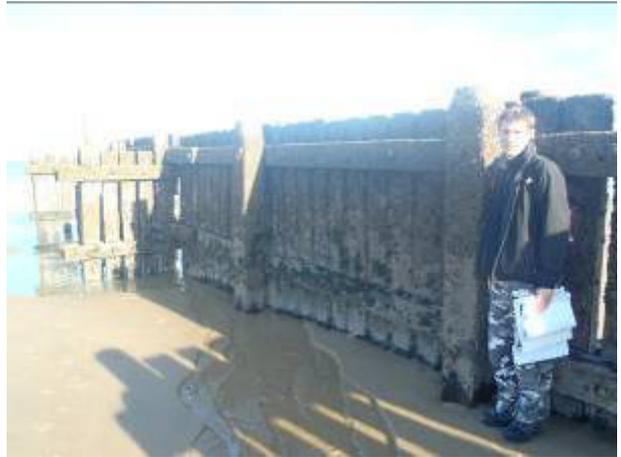
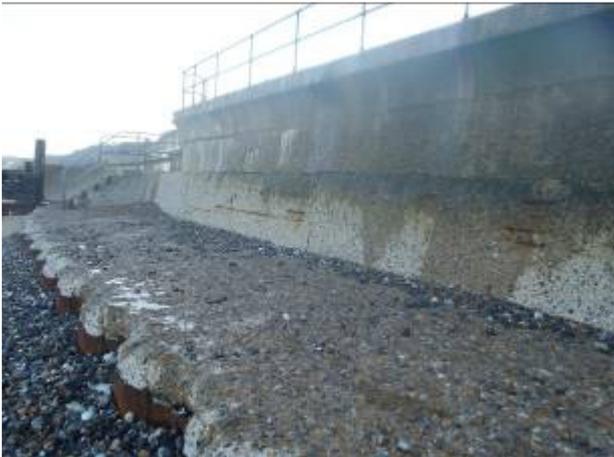
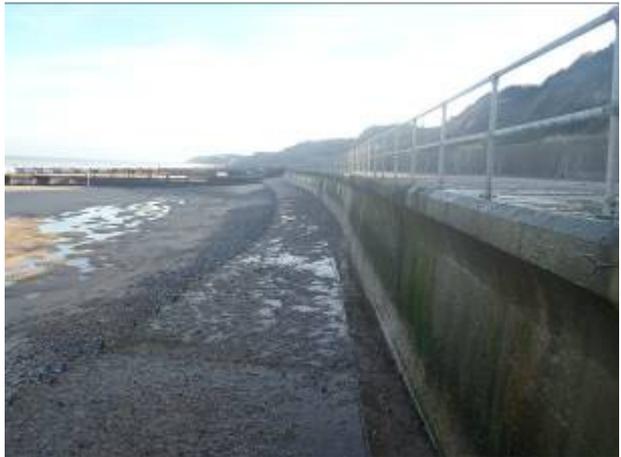
The concrete defence comprises a promenade atop a concrete recurved seawall. The wall appears to have been refurbished with an additional concrete pour to its front before a line of steel sheet piles to prevent undermining of the structure. The piles are offset from the face of the wall by a concrete capping slab. The structure is showing minimal signs of damage and the piles are buried in the beach so they are not experiencing a high degree of corrosion. There is also a concrete slipway providing access to the foreshore. The cliffs to the rear of the wall are also in places protected by a set of stepped gabion baskets which are in good condition with no obvious damage to the baskets.

The short block work section is in a poor state as the timber frame supporting the structure is corroded around the fittings and the frame is not regular with timber of varying length tied together. The blocks are held in place purely by this frame although the blocks themselves are in a reasonable condition they are very irregular and there are residual sections of steel sheet piling amongst them which constitute the previous steel frame structure.

The timber revetment is missing a number of the boards and has been damaged in places whilst some of the piled foundations are exposed and becoming corroded.

The timber groynes run through the section and are in a good condition with no missing boards and minimal wear on the timber, though the fittings are starting to corrode.

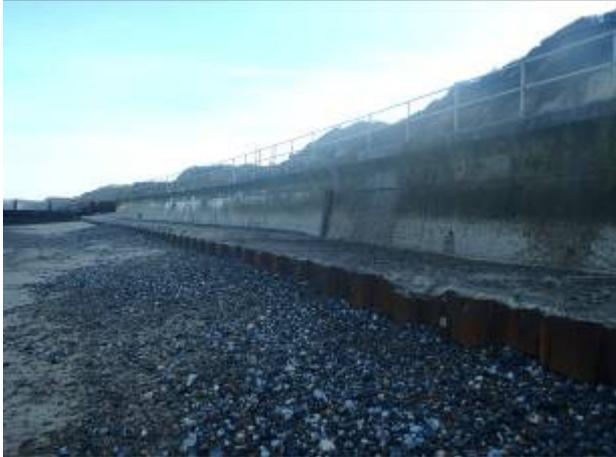
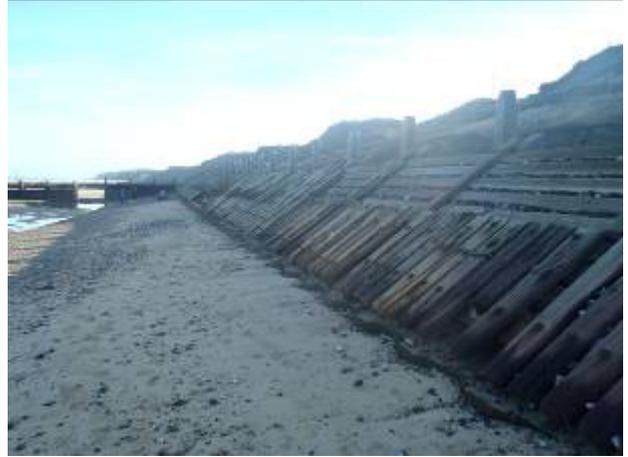
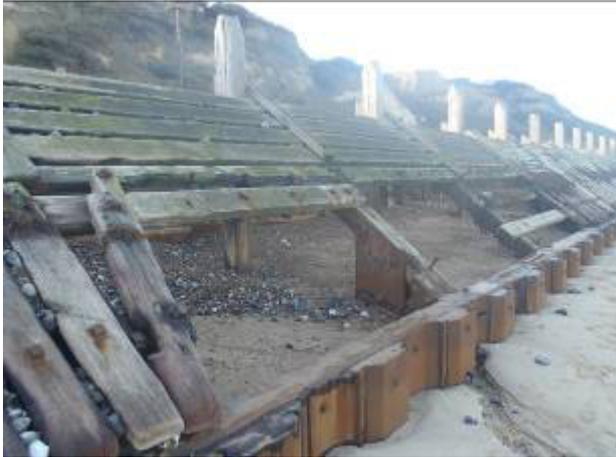
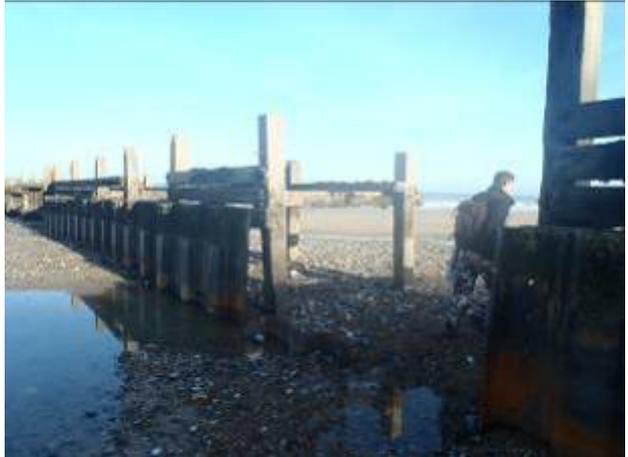
The timber revetment is in a varied condition which worsens significantly towards the western end of the section. The timber revetment starts intact with no missing boards and only minor damage to the main revetment; this may be due to the revetment being of a more permeable construction with larger gaps in the face of the structure. The steel sheet piles at its toe are also in good condition with just some corrosion visible in places.

The overall condition has been taken as poor based on the impact that the loss of the very poor section would have on the remaining revetment.

The timber groynes are not missing any boards and are just being worn down, increasing the gaps between them. The beach level appears low in this area.

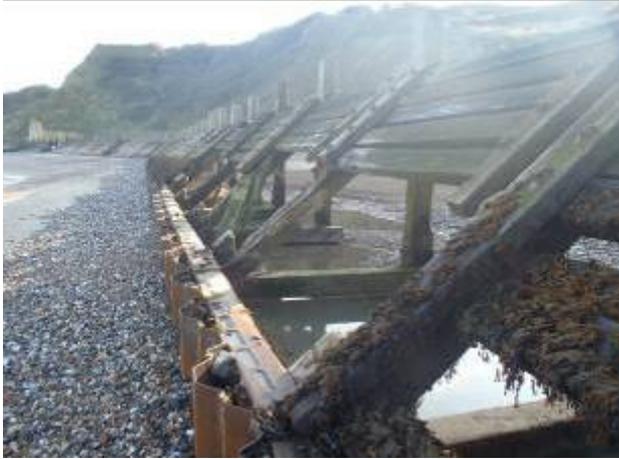
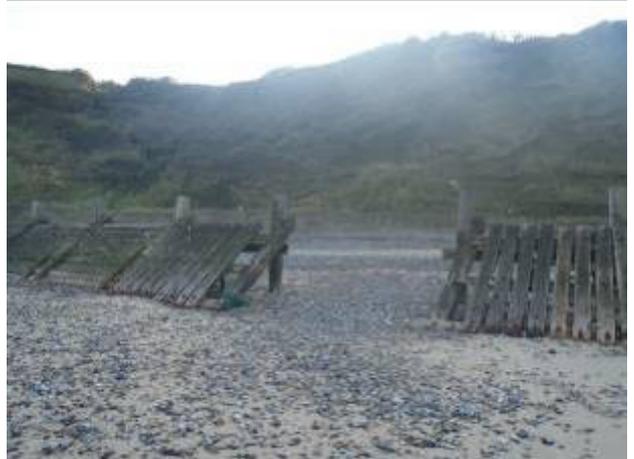
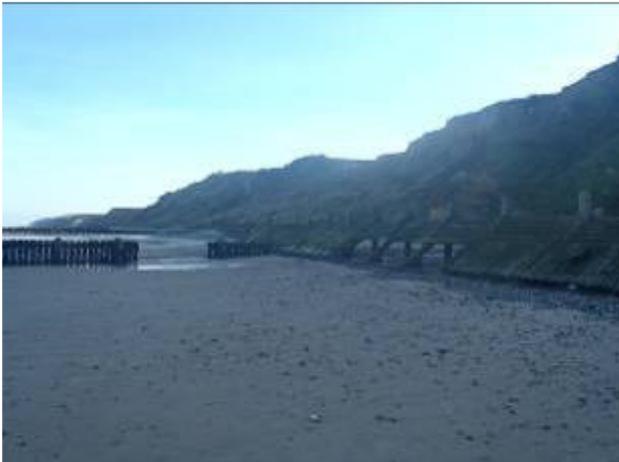
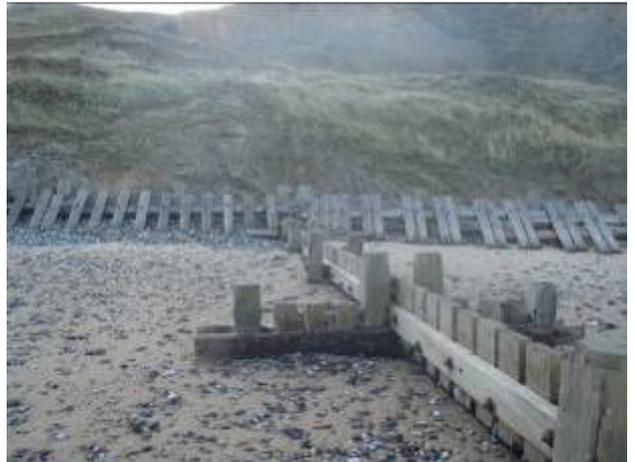
Section no. 62  
Overstrand to Mundesley (Sidestrand)

The timber revetment is in a varied condition which worsens significantly towards the eastern end of the section. The timber revetment starts with the boards on the revetment being missing and the structure is subsequently providing minimal protection to the cliff face. The bulk of the revetment is intact with no missing boards and only minor damage, the steel sheet piles at the toe of the structure are also in good condition with just some corrosion visible in places.

A final condition of poor has been taken as the damaged section is situated at the very end of the structure which could lead to progressive failure.

The timber groynes are not missing any of the boards and are just being worn down, increasing the gaps between boards. The beach level appears to be quite low in this area but stable.

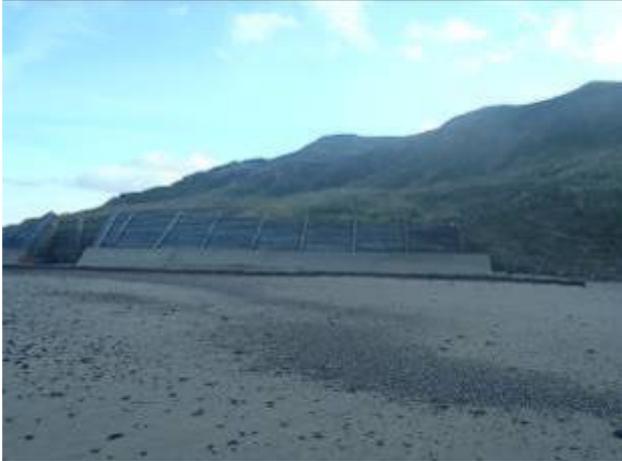
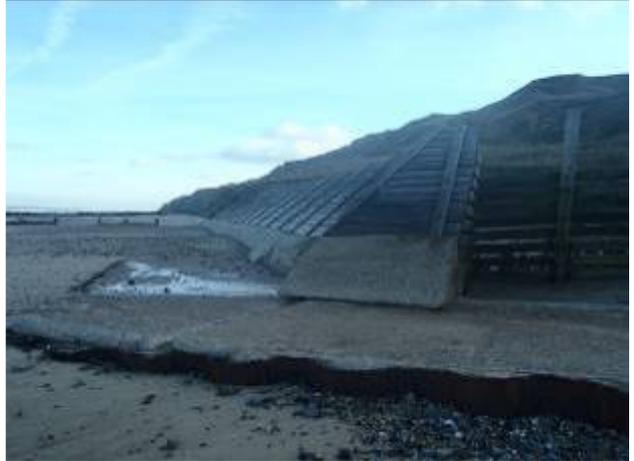
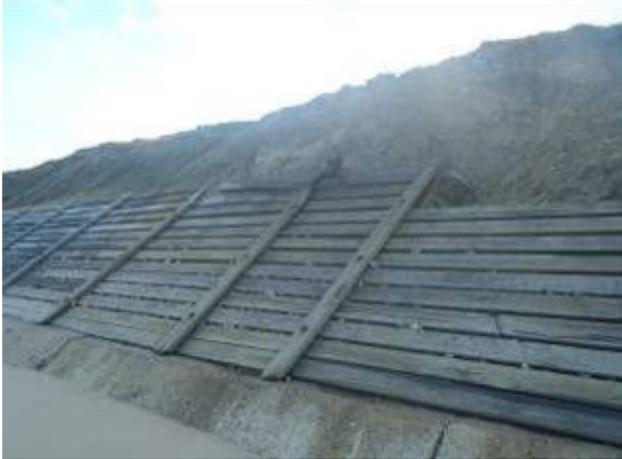
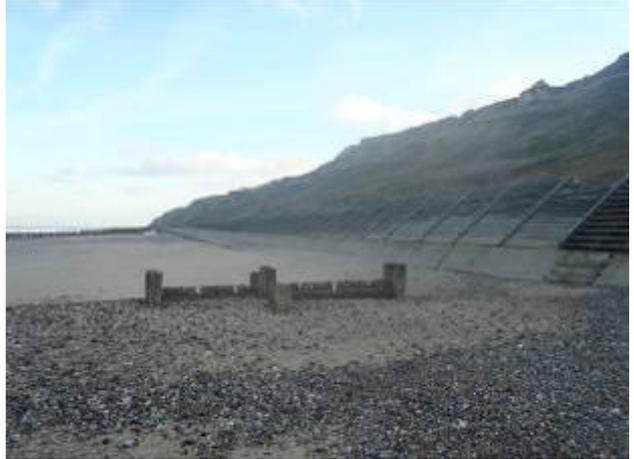
Section no. 57  
Overstrand to Mundesley (Sidestrand/Trimingham)

The timber revetment extends from the eastern end of the section to the mid point and is damaged in a number of places. Only a few boards are missing from the main structure, though a number are broken in places together with wearing of the main frame. The structure also has a steel sheet piled toe to improve stability and prevent undermining which is being corroded in places. The eastern extent of the timber revetment is in a very poor condition with many boards missing along a 50m length.

The timber groynes are also quite worn and experiencing some damage towards the seaward end of the structure. The beach level is stable and relatively high, providing some protection to the revetment piles.

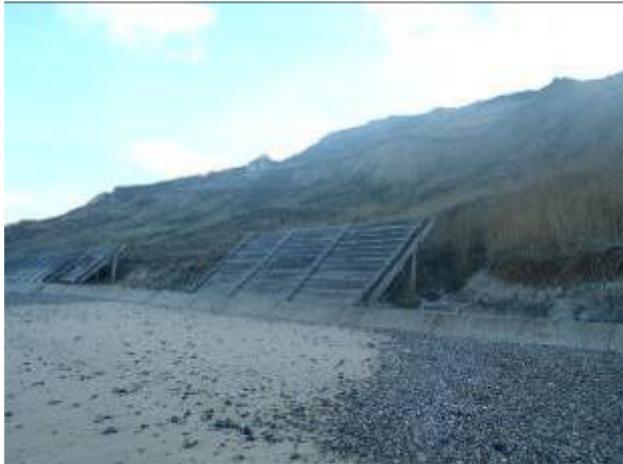
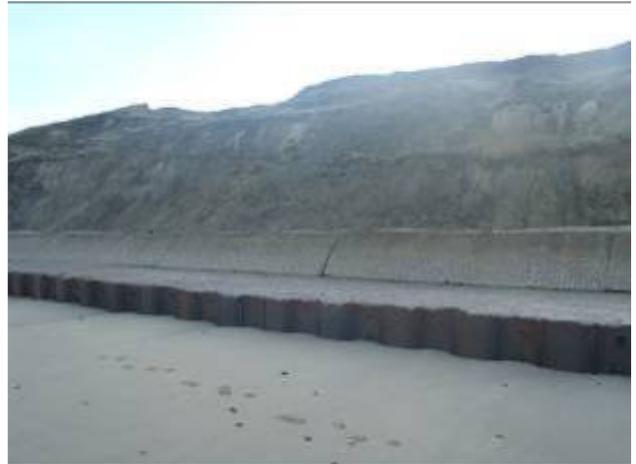
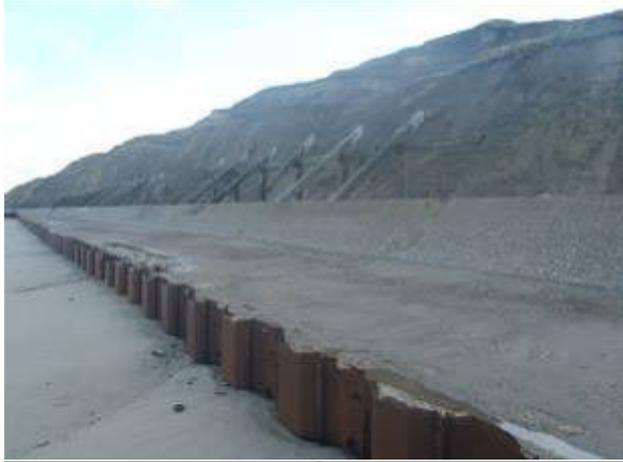
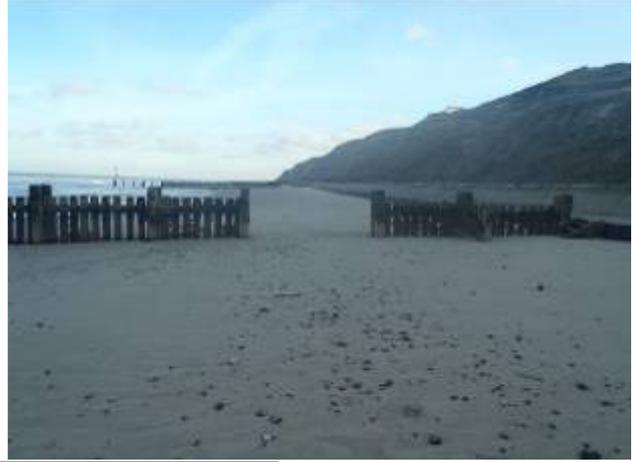
Section no. 56  
Overstrand to Mundesley (Trimingham)

The timber revetment in the first half of this section has been completely destroyed above the concrete footing, none of the timber structure remains and all that is in place is the concrete toe footing before the steel sheet piles which are offset from the concrete toe by a concrete capping slab. The piles are mainly buried in the beach material which appears stable. Through the second half of the section the timber revetment is in a very good condition with the timber experiencing minimal wear. Only a very few number of boards are missing. The toe is also completely buried in beach material to the western end of the section.

The timber groynes are damaged at the lower (seaward) end of the structure where a number of boards have been lost and the remaining timber is being badly worn. Conversely the upper sections of the groynes are in good condition and often buried. The groynes provide a good retention of beach material within the bays.

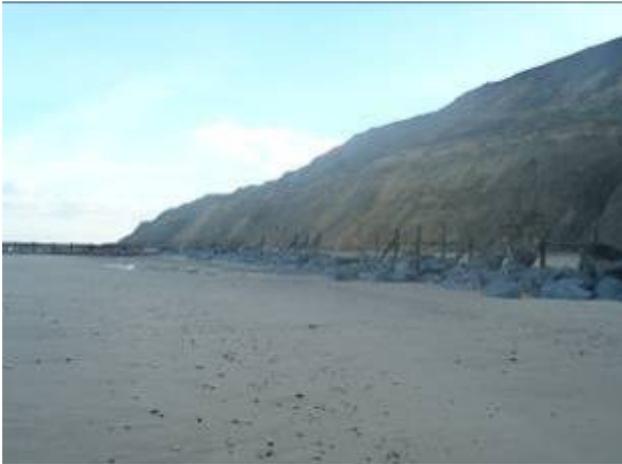
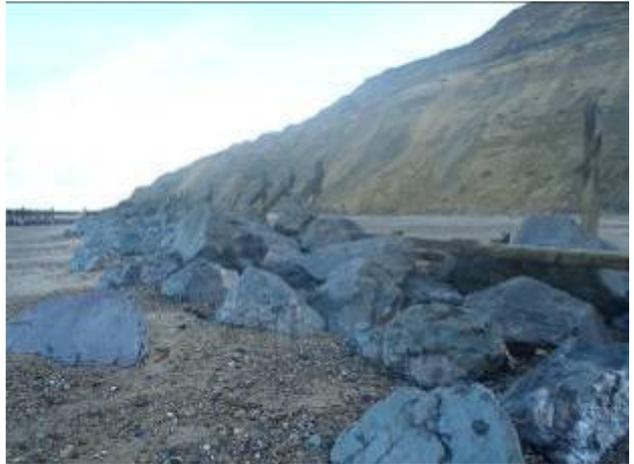
Section no. 55  
Overstrand to Mundesley (Trimingham)

The timber groynes are being damaged at the lower (seaward) end of the structure where a number of boards have been lost and the remaining timber is badly worn. Some sections have even broken off from the main body. The upper sections of the groynes are in a reasonable condition though the timber is very worn in places. The groynes are also retaining some beach material within the bays.

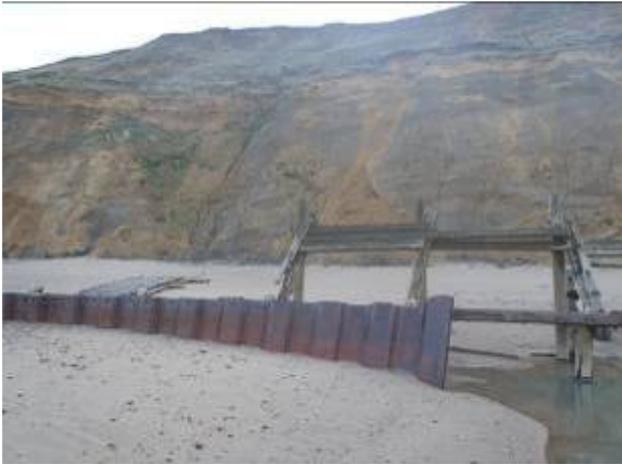
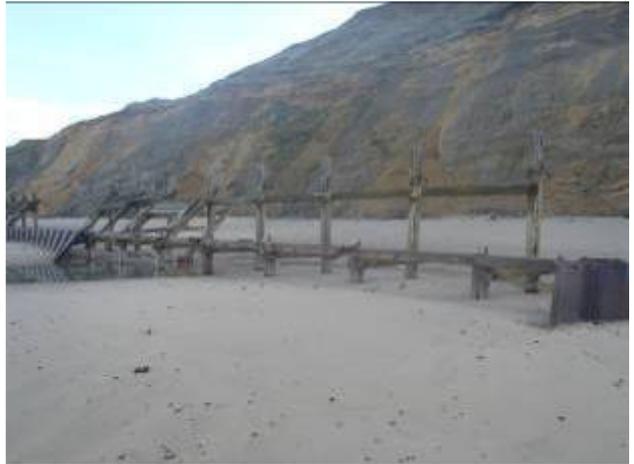
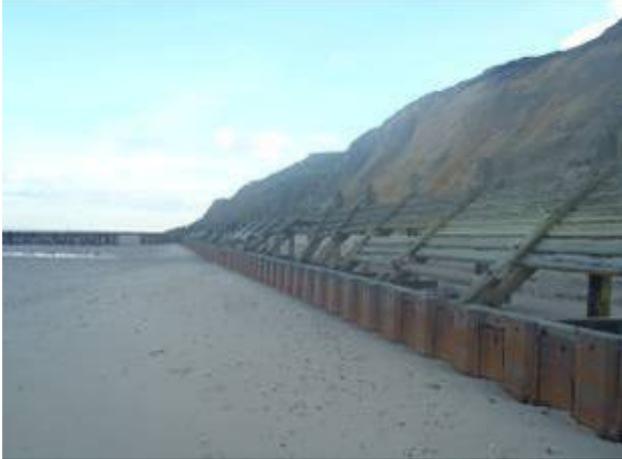
**Section no. 54**  
Overstrand to Mundesley (Trimingham)

The timber revetment in this section deteriorates from the east to the west, though there are intermittent sections that vary in condition. Initially the revetment is in very good condition with no missing boards and the timber appears to be only slightly worn with minimal colouration and only some corrosion around the fixtures. There are other sections which are missing and there are occasionally no boards in isolated areas. The piles are not overly worn and the majority of them are buried in the beach material though levels are slightly lower here than elsewhere. They comprise a timber capping beam to tie them into the structure.

The timber groynes are in a good condition with the boards becoming worn and creating larger gaps over the length of the groyne though mainly toward the seaward end. The beach appears quite stable.

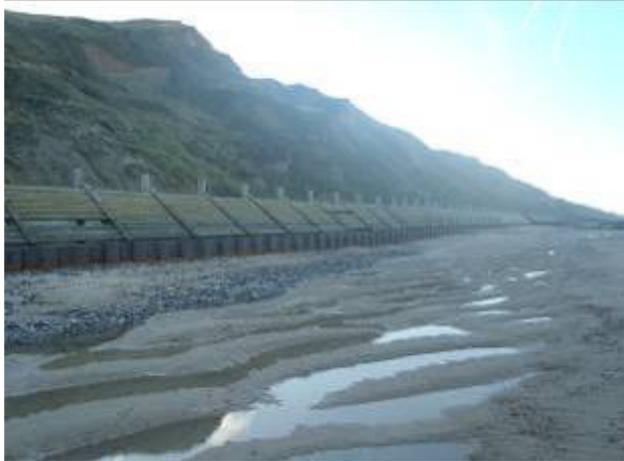
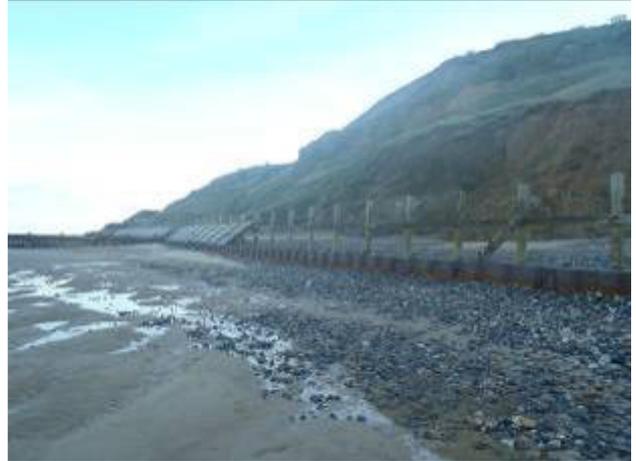
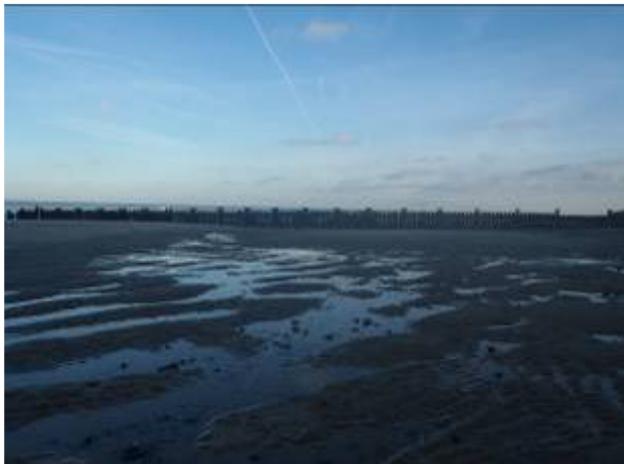
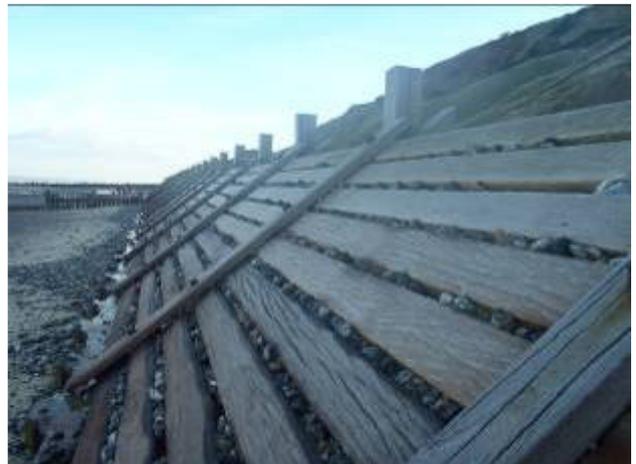
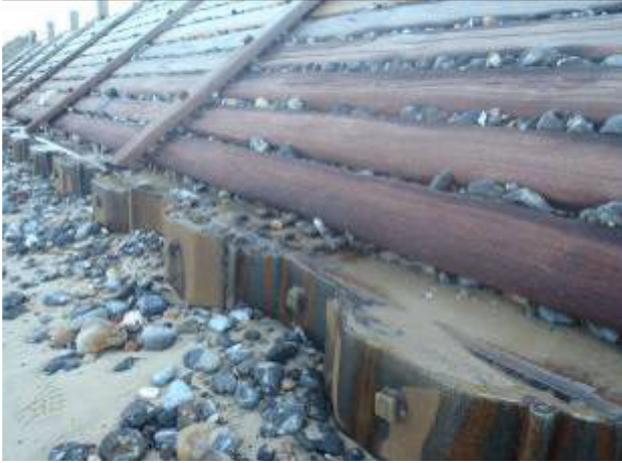
Section no. 53  
Overstrand to Mundesley (Trimingham)

The timber revetment in this section is in a good condition with no missing boards and the timber appears to be only slightly worn with minimal colouration and only some corrosion around the fixtures. The piles are not overly worn and the majority of them are buried in the beach material though levels are slightly lower here than elsewhere. They comprise a timber capping beam to tie them into the structure.

The timber groynes are in a good condition with the boards becoming worn and creating larger gaps over the length of the groyne though mainly toward the seaward end. The beach appears quite stable.

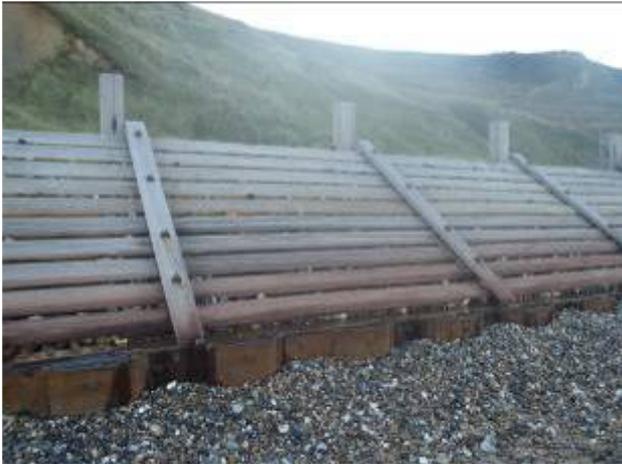
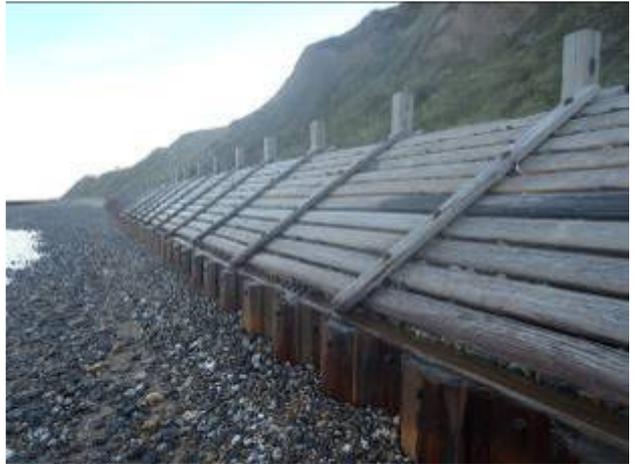
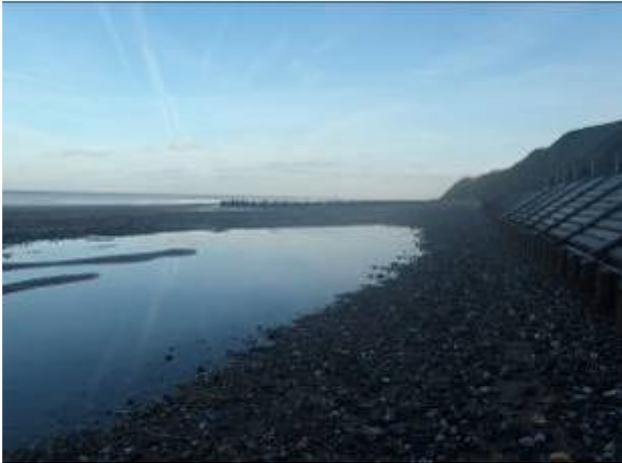
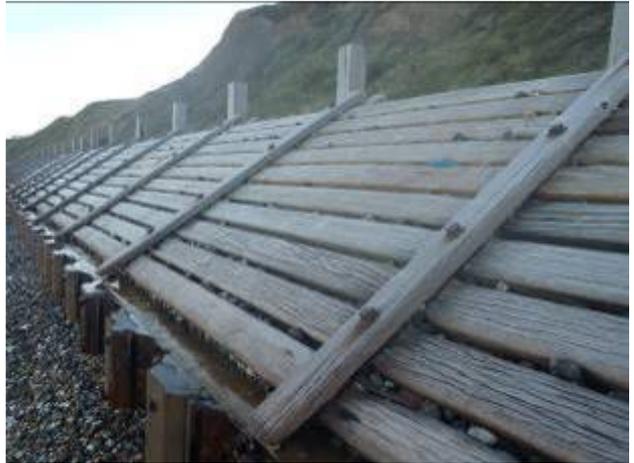
Section no. 52  
Overstrand to Mundesley (Vale Road)

The timber revetment in this section is in a good condition with no missing boards and the timber appears to be only slightly worn with minimal colouration and only some corrosion around the fixtures. The piles are not overly worn and the majority of them are buried in the beach material though levels are slightly lower here than elsewhere. They comprise a timber capping beam to tie them into the structure.

The timber groynes are in a good condition with the boards becoming worn and creating larger gaps over the length of the groyne though mainly toward the seaward end. The beach appears quite stable.

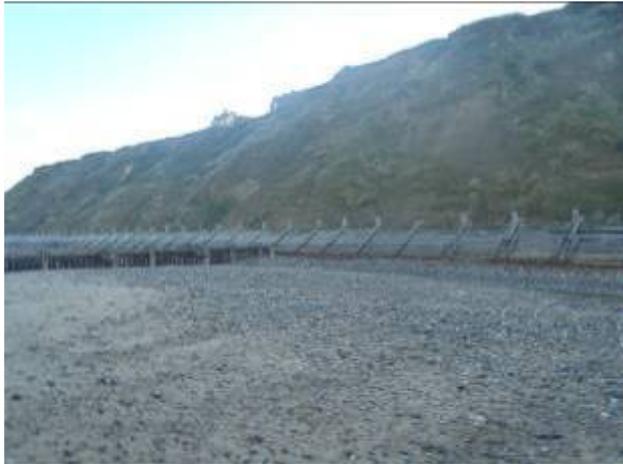
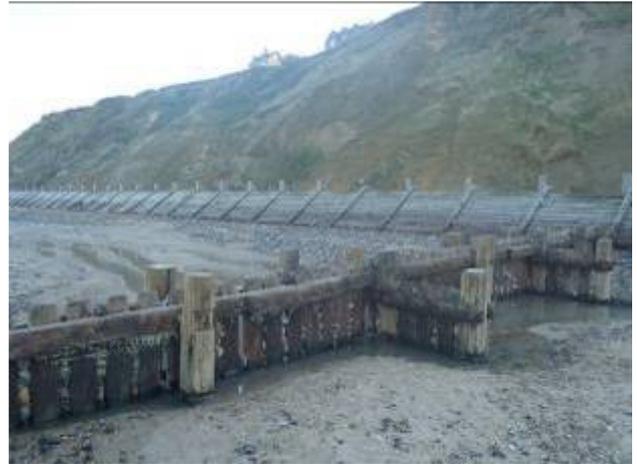
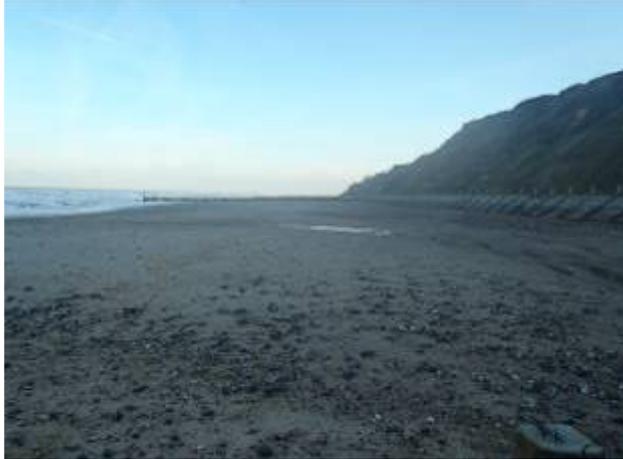
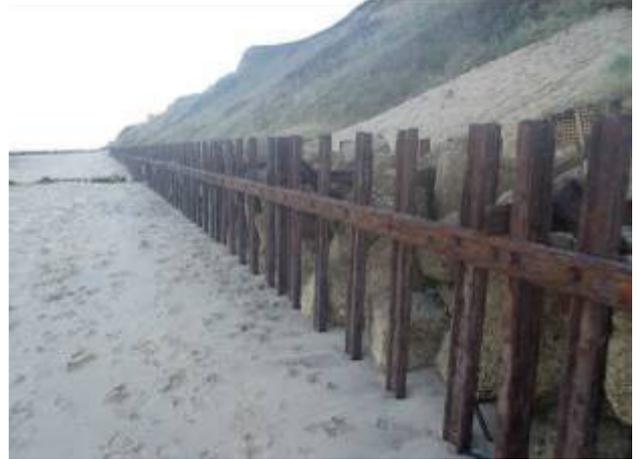
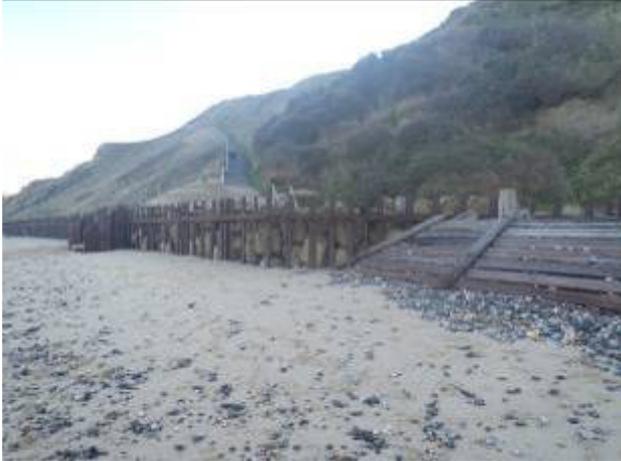
The timber revetment in this section is in a good condition with no missing boards and the timber appears to be only slightly worn with minimal colouration and only some corrosion around the fixtures. The piles are not overly worn and the majority of them are buried in the beach material though levels are slightly lower here than elsewhere. They comprise a timber capping beam to tie them into the structure.

The timber groynes are in a good condition with the boards becoming worn and creating larger gaps over the length of the groyne though mainly toward the seaward end. The beach appears quite stable.

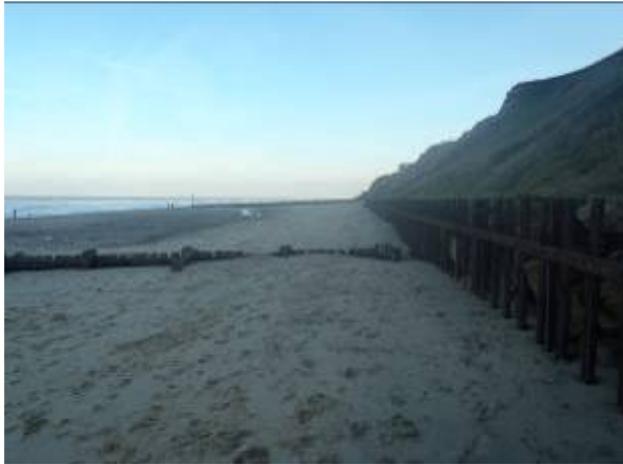
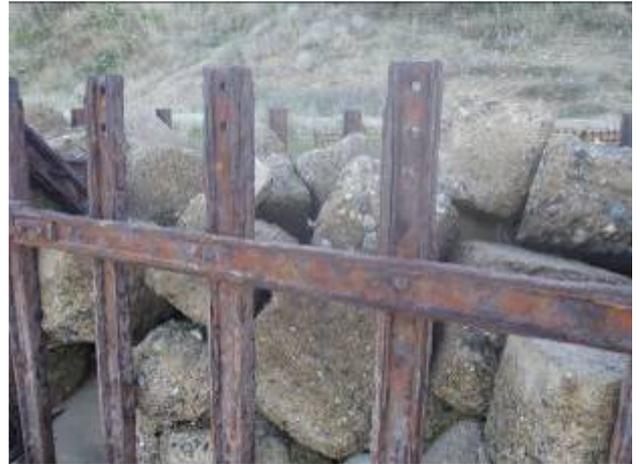
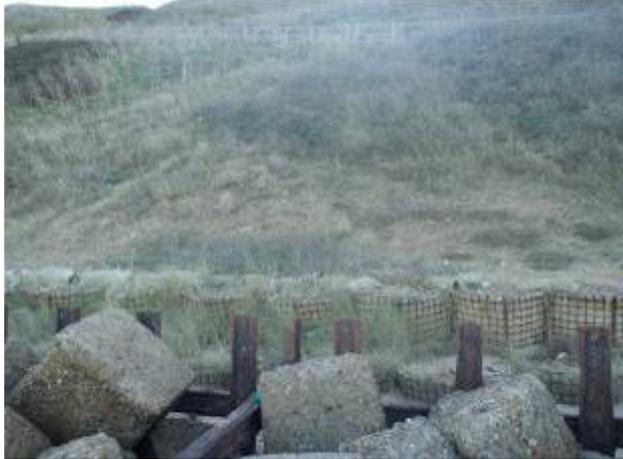
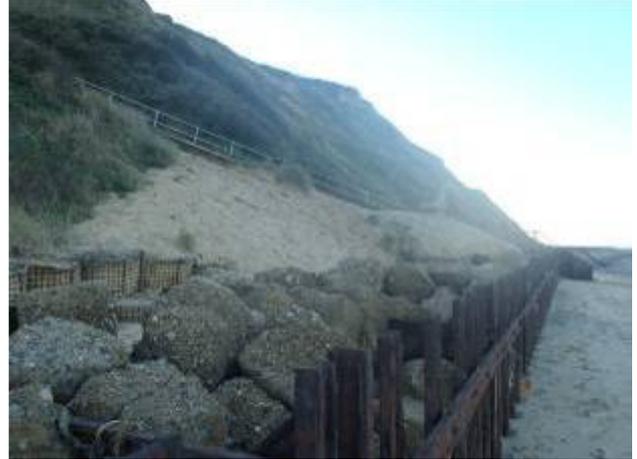
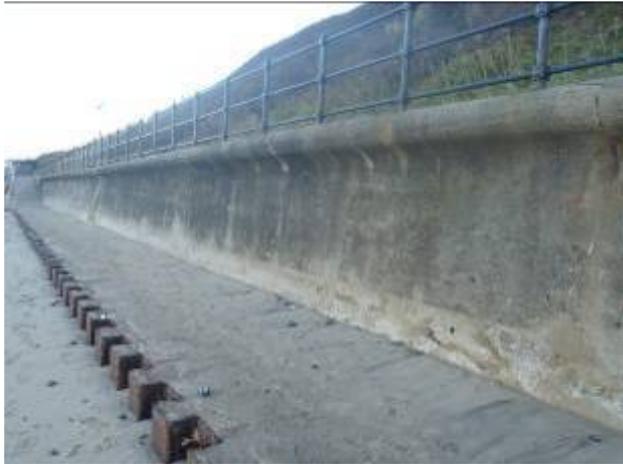
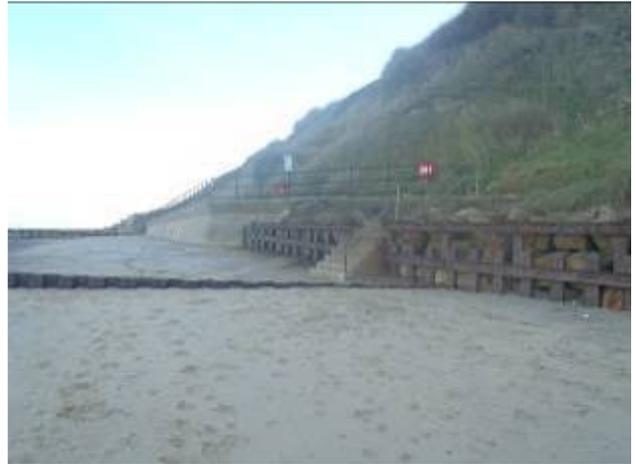
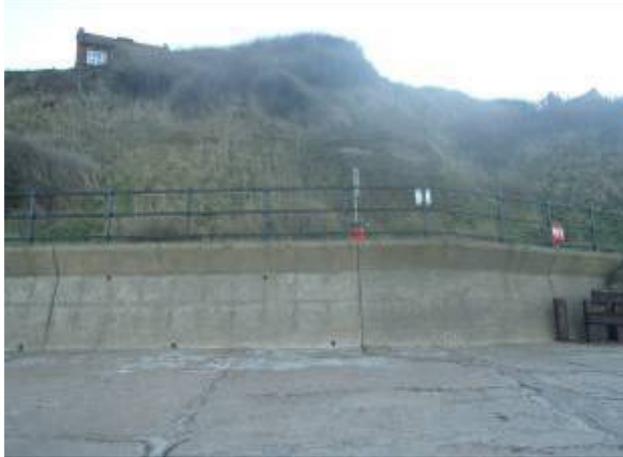
The timber groynes are retaining a reasonable amount of beach material and the foreshore begins to extend out further in this location than that fronting the timber revetment to the west. The groynes are partially buried toward the landward end and generally intact with only minimal damage toward the seaward section where the timber is worn and larger gaps are forming in the structure.
