# Cromer to Winterton Ness Study

Appendix A: Coastal Defence Condition Survey Update

November 2012  
North Norfolk District Council

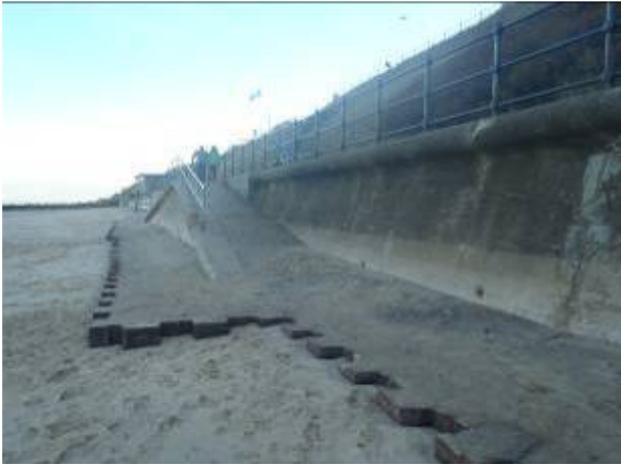
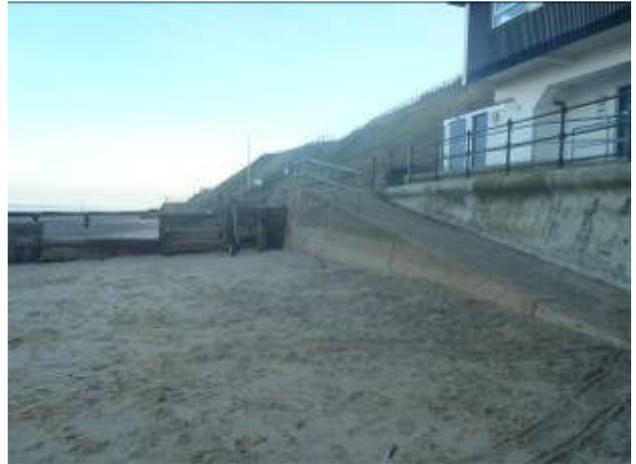
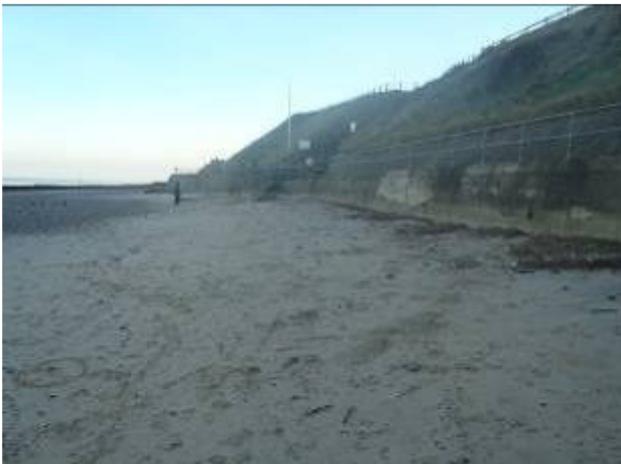
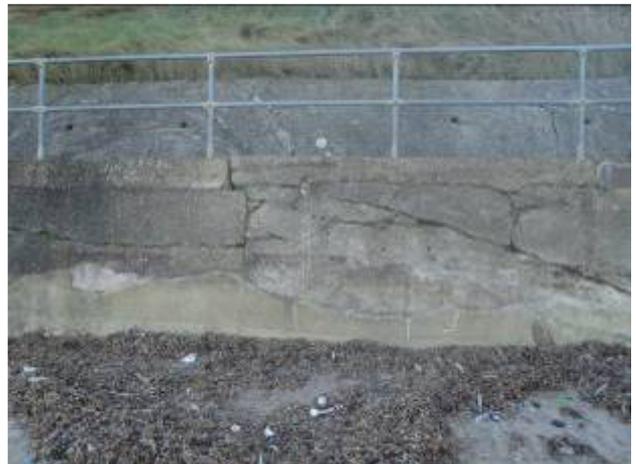
Some sections of wall around the slipways are experiencing cracking and concrete spalling and do not include a recurved structure at its crest.

The timber groynes are retaining a significant amount of beach material in the area and are partially buried toward the landward end. The structures are in good condition with only general wear to the timber and corrosion of the fixtures and fittings.

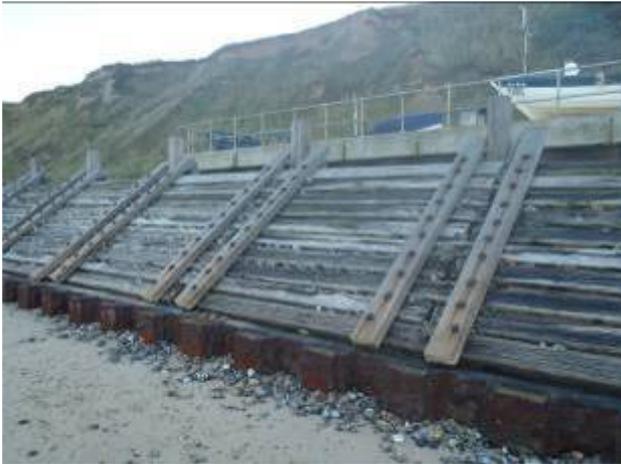
A

The concrete structure through this section comprises a seawall with wave return at its crest, there is also a hand railing atop the structure as the wall forms the front of a concrete promenade. At the base of the toe is a stepped concrete apron before a capping slab that is fronted by steel sheet piles. The piles are buried with beach material. The seawall is in good condition with only minor damage in some areas and very little abrasion or cracking. Near the access ramps there is some evidence of steel corrosion in the base of the wall which can be seen through the face of the structure.

The main defence is the timber revetment which is in a good condition with no missing boards and additional bracing on the face of the structure. The timber is in good condition with some corrosion to the fixtures and fittings. The steel sheet piles at the toe are quite corroded but the beach level appears high and only the tops of the piles are visible.

The timber groynes are retaining a significant amount of beach material in the area and are partially buried toward the landward end. The structures are in a good condition with general and expected wear to the timber and corrosion of the fixtures and fittings. There are a limited number of boards missing towards the seaward end of the structures.

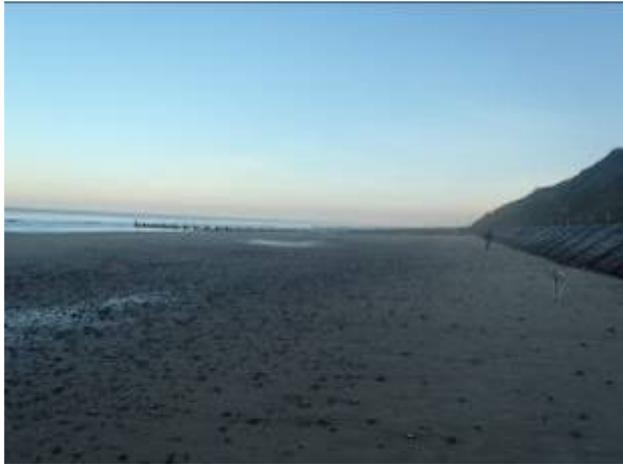
A

The main defence is the timber revetment which is in a good condition with no missing boards and additional bracing on the face of the structure. The timber is in good condition with some corrosion to the fixtures and fittings. The steel sheet piles at the toe are buried due to high beach levels and occasionally only the tops of the piles are visible.

In places the steel pile toe of the structure has been replaced with some timber bracing, it is not clear if the piles exist further down due to the level of beach material, though the timber bracing appears to be in a good condition.

The timber groynes are retaining a significant amount of beach material in the area and are partially buried toward the landward end. The structures are in a good condition with general and expected wear to the timber and corrosion of the fixtures and fittings.

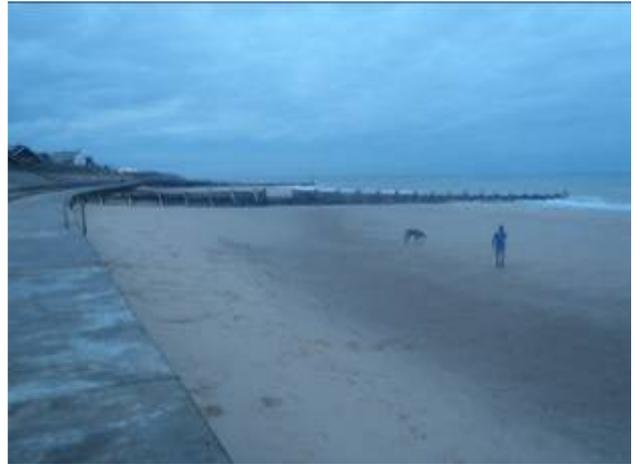
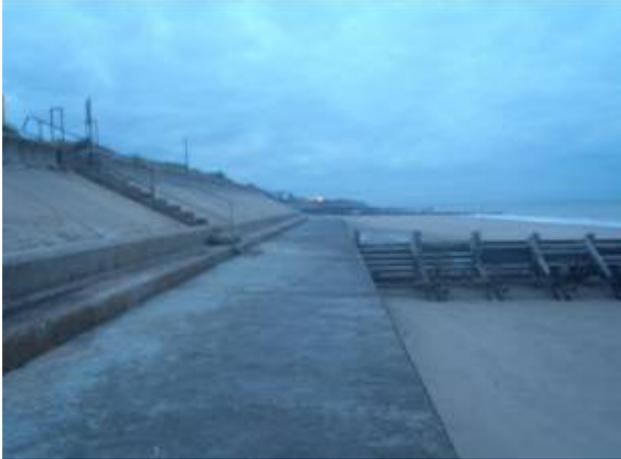
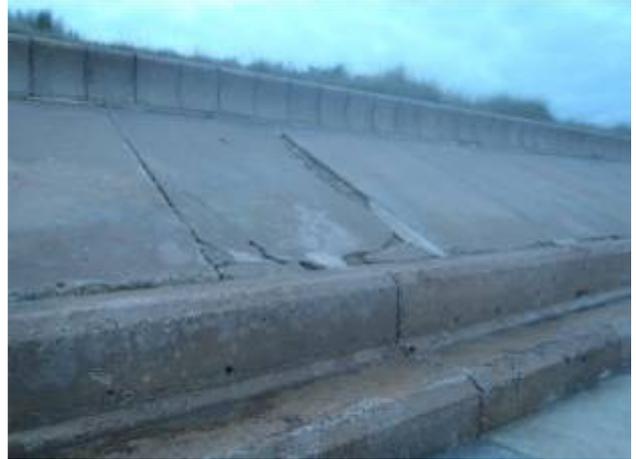
**Section no. 40**  
Bacton, Walcott and Ostend (Bacton)

The concrete wall comprises a small seawall to the rear of a concrete revetment, this sits atop the main concrete seawall with wave recurve at its crest. This then has a stepped concrete apron at its toe before turning into a concrete promenade with access point down the revetment for members of the public. There is concrete spalling along the face of the upper revetment and some other areas of minor damage to the structure. The promenade has been recently recapped with an additional concrete slab providing a more robust promenade and also providing some additional protection to the tops of the steel piles.

The beach levels in this section appear to have increased slightly providing some additional protection to the steel piles though the additional damage experienced on the structure has kept the overall condition grading as 'Fair'.

The timber groynes are in a reasonable condition and are retaining more beach material. The structures are quite intact with minimal damage other than general wear from being situated in the intertidal zone.

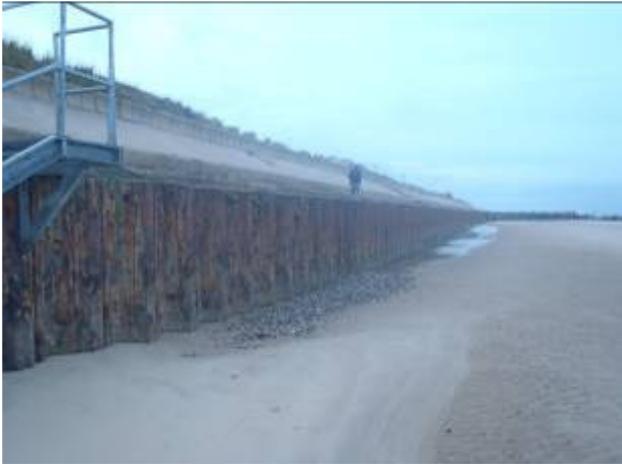
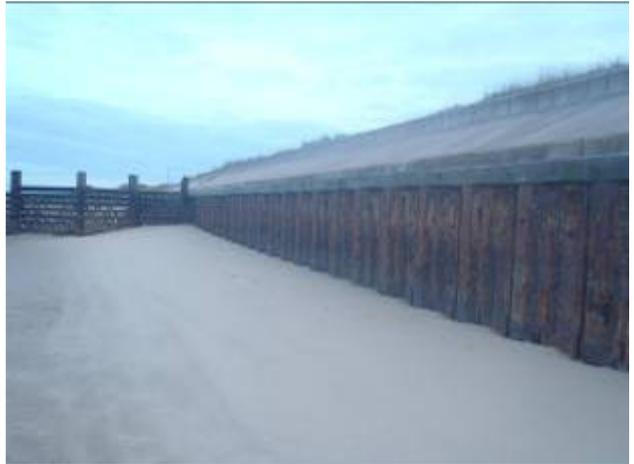
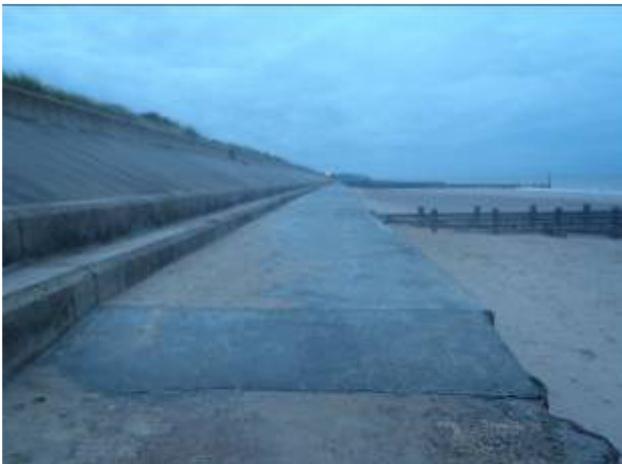
**Section no. 39**  
Bacton, Walcott and Ostend (Bacton)

The beach levels in this section appear to have reduced which is exposing more of the steel sheet piles resulting in further corrosion. The beach levels begin to lower again towards the western end of the section.

The timber groynes are in a reasonable condition and are retaining more beach material. The structures are quite intact with minimal damage other than general wear from being situated in the intertidal zone.

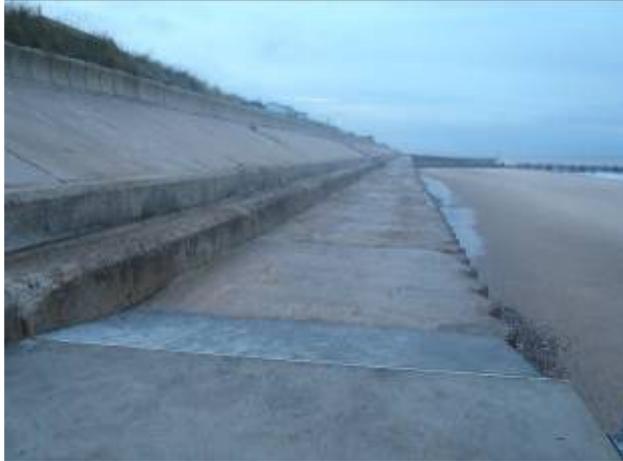
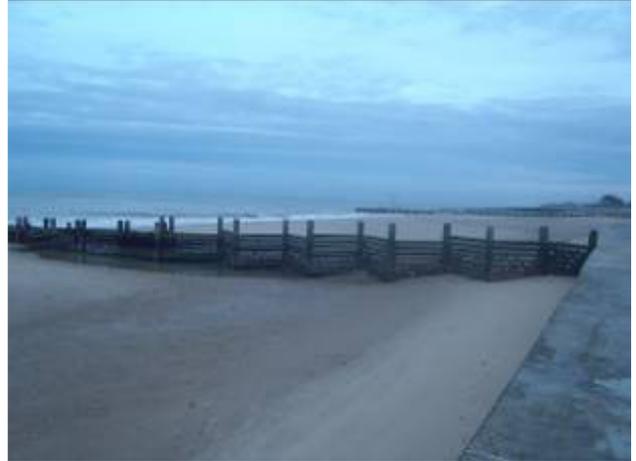
**Section no. 38**  
Bacton, Walcott and Ostend (Bacton)

The beach levels in this section appear higher providing some additional protection to the toe of the promenade which is constructed from steel sheet piles, the tops of which are heavily corroded. The beach levels begin to lower again towards the western end of the section.

The timber groynes are in a reasonable condition and are retaining more beach material. The structures are quite intact with minimal damage other than general wear from being situated in the intertidal zone.

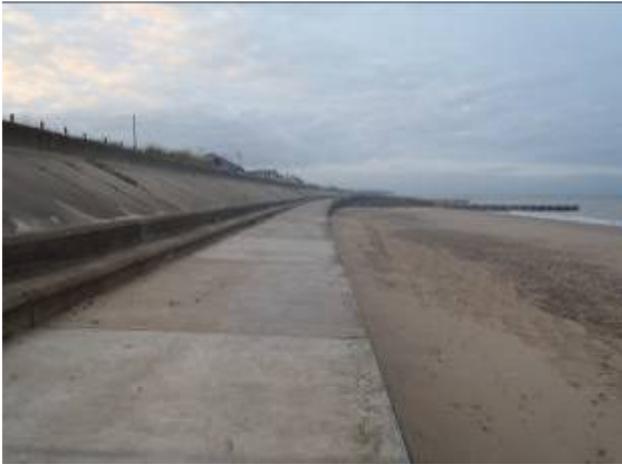
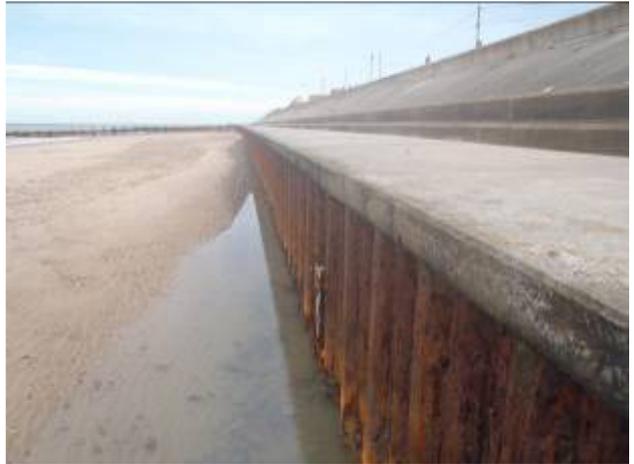
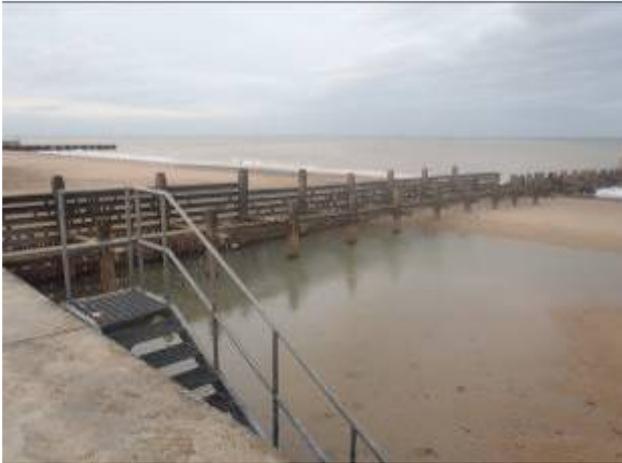
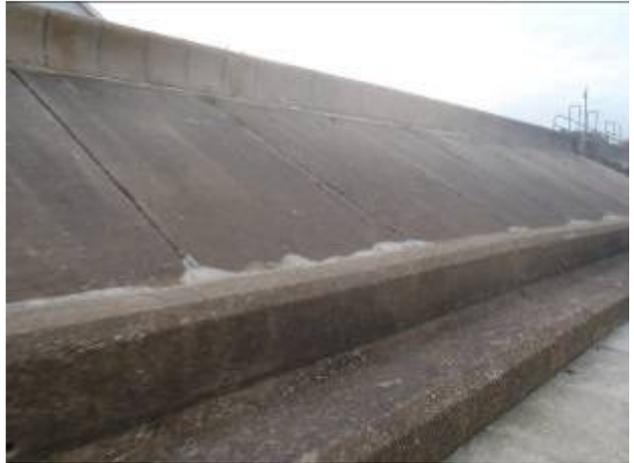
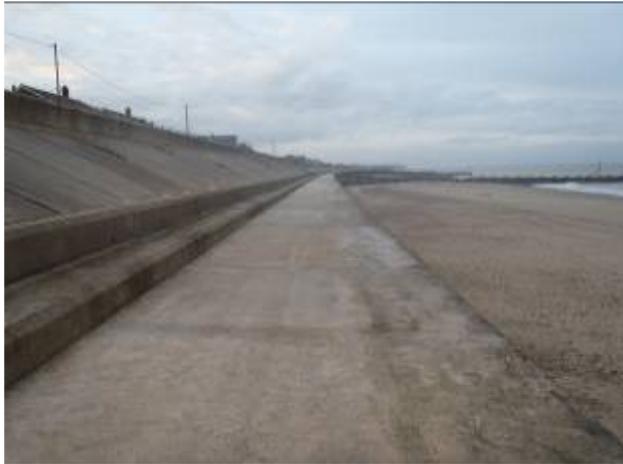
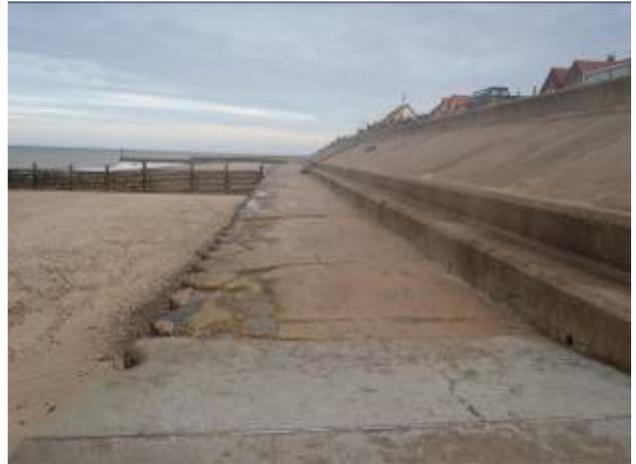
Section no. 36  
Bacton, Walcott and Ostend (Walcott)

The beach levels in this section appear to be quite low and expose the toe of the promenade which is constructed from steel sheet piles which are heavily corroded due to the lack of beach material in the bays.

The timber groynes are not retaining much beach material and the seaward end is in a poor state of repair with the timber being quite worn and the fixtures and fittings being corroded.

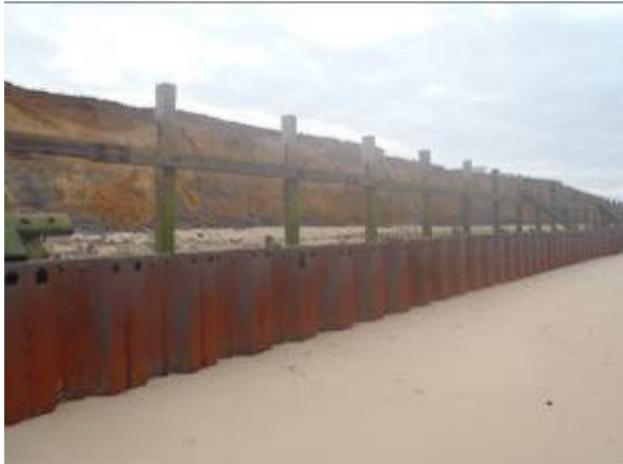
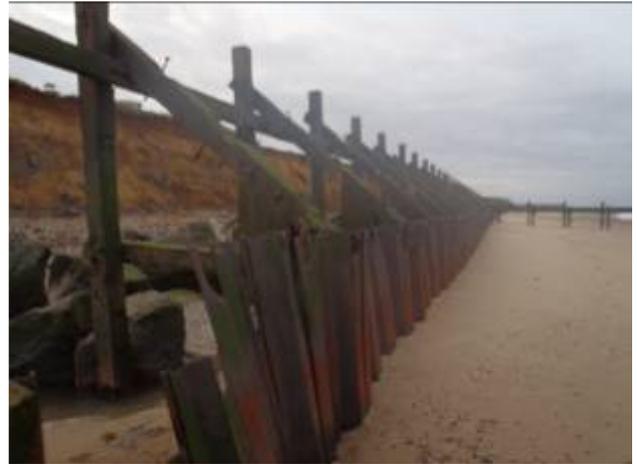
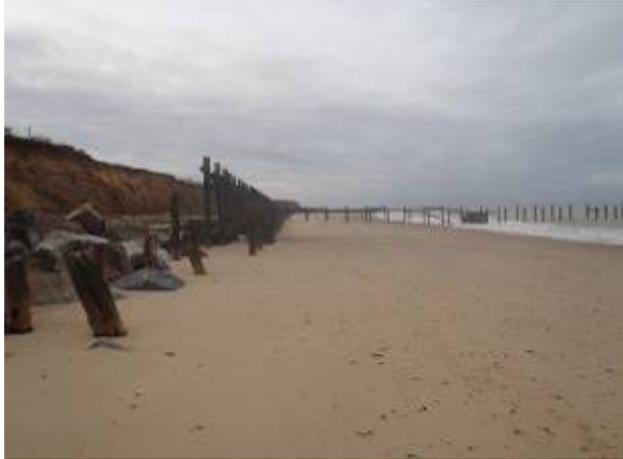
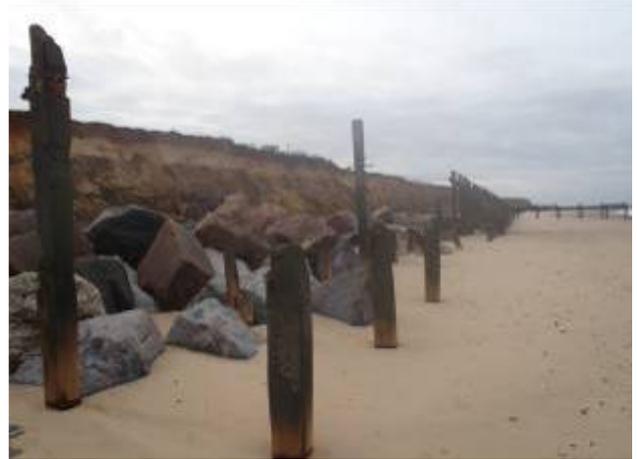
**Section no. 31**  
Ostend to Eccles (Happisburgh North)

A timber revetment spans the whole section but is missing all the facing horizontal boards and only the timber frame remains offering no protection to the coastline.

Residual timber groynes span the section but only a few boards remain at the landward ends; they subsequently fail to retain beach material.

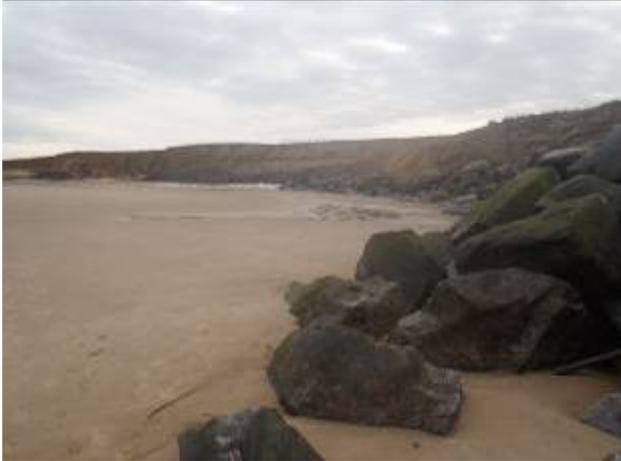
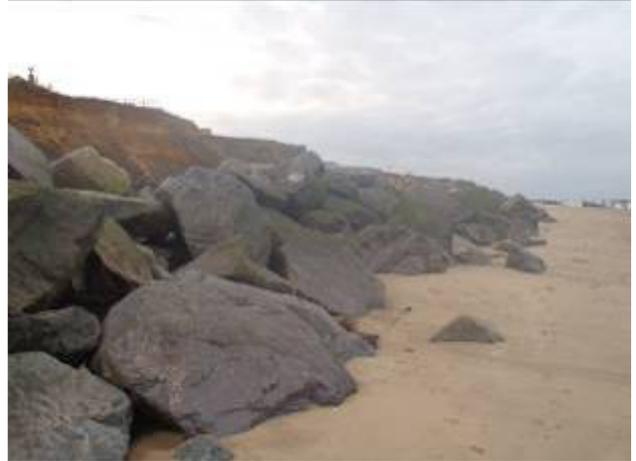
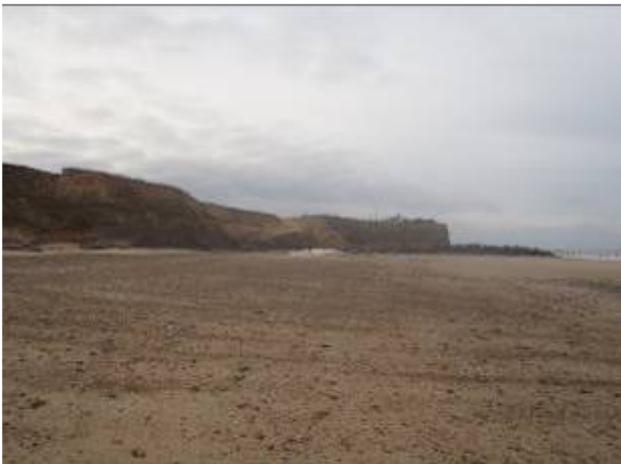
**Section no. 30**  
Ostend to Eccles (Happisburgh South)

A rock armour revetment has been placed along half the length of this section, although it is inter-mixed with debris from the foreshore where steel piles have corroded and broken including residual structures such as a base of an access stairway. The redundant revetment frames toward the north west of the section have very little effect on dissipating wave energy.

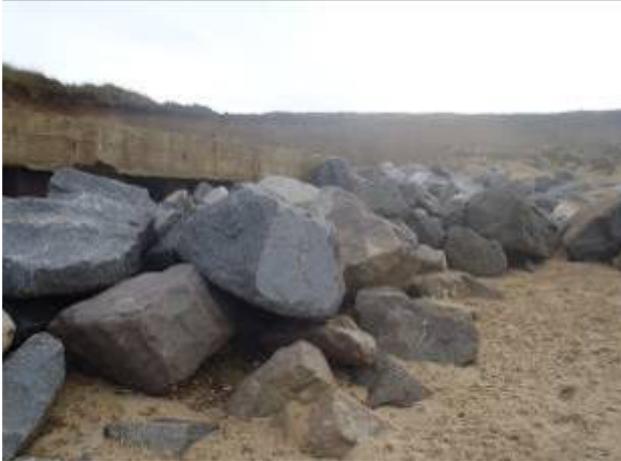
A

The structure comprises a concrete wave return seawall with a stepped concrete apron, with the apron fronted by steel sheet piles to prevent undermining. Above the seawall crest is a revetment formed of a concrete mattress grid. The beach has narrowed in this section most likely as a result of the poor condition of the timber groynes.

The timber groynes are in a deteriorating state with large sections missing or damaged. The remaining timber is bent and bowed in places and does not retain beach material.

Towards the western end of the section the seawall ties into some steel piles with a concrete cap before becoming a rock armour revetment, the purpose of which is to prevent the concrete seawall from being outflanked. The rock armour is in a very good condition. However, the steel piles are corroded and have low beach levels at their face. The western most 50m of the section are undefended.

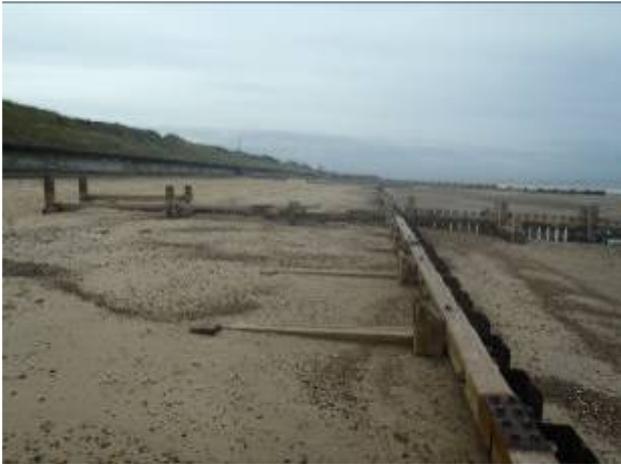
The defences comprise a concrete wave return seawall with a stepped concrete apron, with the apron fronted by steel sheet piles to prevent undermining. Rock armour has been placed in front of the steel piles as they are corroding and this will extend the life of the structure. The width of beach has also reduced throughout this section although the beach appears stable. The rock is in a very good condition but the overall assessment is good to fair based on the level of beach material and corroded nature of the piles. A slipway has been constructed in this section which is in a good condition. The slipway marks the end of the rock armour fronting the seawall, the revetment on the crest changes to a grid form from a solid concrete mattress.

The composite groynes are in a fair condition with the timber sections fitted to steel support piles, the steel is corroding and the timber is wearing. The seaward sections of the groynes are constructed with rock armour units which are in a very good condition.

The timber groynes are in a deteriorating state worsening towards the west. They have suffered a lot of wave damage and the timber is well worn with the fixtures and fittings heavily corroded. The groyne fields fail to effectively retain beach material.

There are remains of a timber revetment fronting the seawall but this has been destroyed beyond any form of repair and has been left redundant on the foreshore.

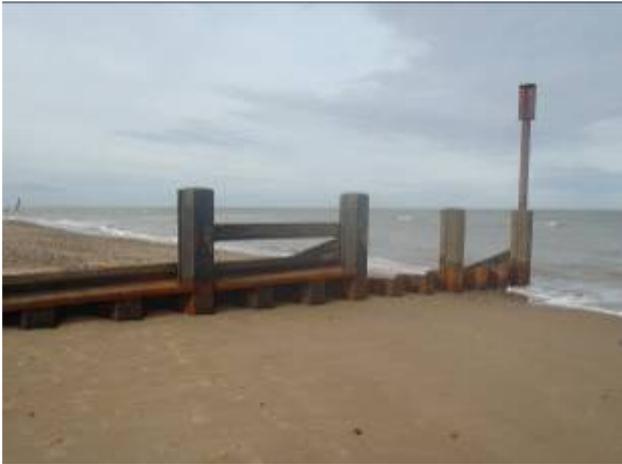
A

The defences comprise a concrete wave return seawall with a stepped concrete apron, with the apron fronted by steel sheet piles to prevent undermining. Rock armour has been placed in front of the steel piles as they are corroding and this will extend the life of the structure. The width of beach has also reduced throughout this section although it appears stable. The rock is in very good condition but the overall assessment is good to fair based on the level of beach material and corroded nature of the piles.

The groynes are in fair condition with the timber sections fitted to steel support piles, the steel is corroding and the timber is wearing. The seaward sections of the groynes are constructed with rock armour units which are in very good condition. However, the groyne field fail to effectively retain beach material.

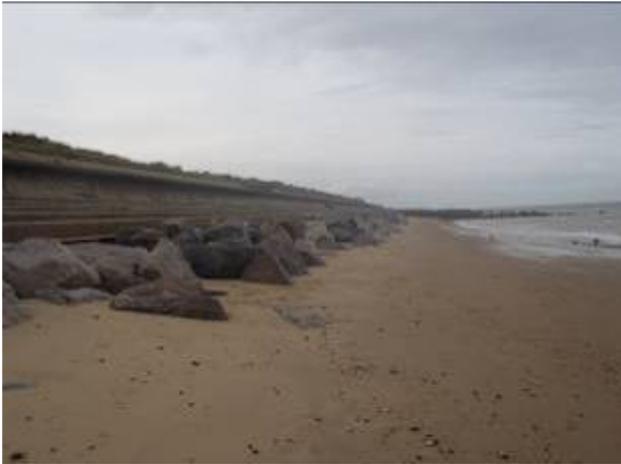
A

The structure comprises a concrete wave return seawall with a stepped concrete apron, with the apron fronted by steel sheet piles to prevent undermining. Rock armour has been placed in front of the steel piles as they are corroding and this will extend the life of the structure. The width of beach has also reduced throughout this section though it is stable. The rock is in a very good condition but the overall assessment is good to fair based on the level of beach material and corroded nature of the piles.

The groynes are in fair condition with the timber sections fitted to steel support piles, the steel is corroding and the timber is wearing. The seaward sections of the groynes are constructed with rock armour units which are in very good condition, though the groyne field fails to retain beach material.

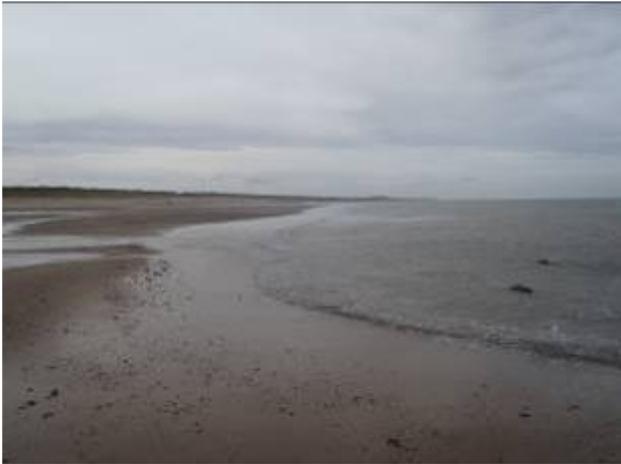
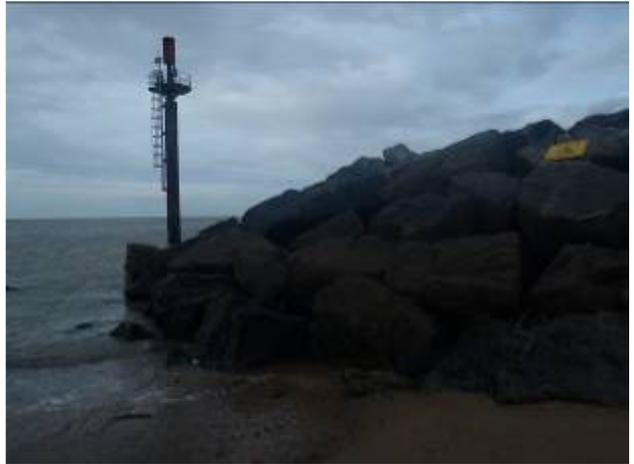
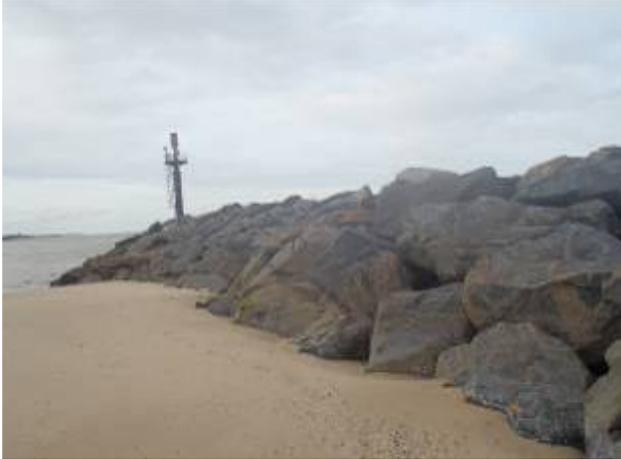
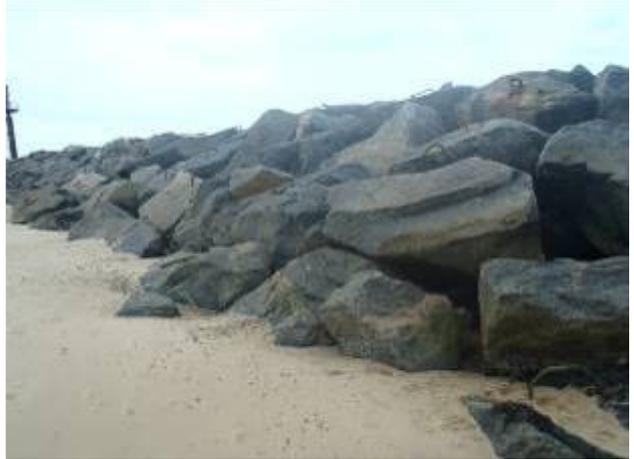
The entire defence structure has been buried within the natural dune system and accretion to the rear of the western most offshore breakwater. The structure most likely comprises a concrete wave return seawall with a stepped concrete apron, with the apron fronted by steel sheet piles to prevent undermining similar to that exposed in section 21. It is assumed that the condition will be good as the sand will provide protection to the structure and it is not under direct wave impact.

There is one offshore breakwater of rock armour construction forming the western most of the series of nine breakwaters along the coastline. The rock appears stable with minimal movement of units. This structure was fully exposed at the time of inspection; sediment had built up to the rear of the structure joining it to the shoreline at low tide and the largest build up of accretion occurs at this location. The toe of the structure was also intact and in very good condition with no movement of the armour units.

The beach level appears stable and the foreshore extends to twice the width of the beach to the west.

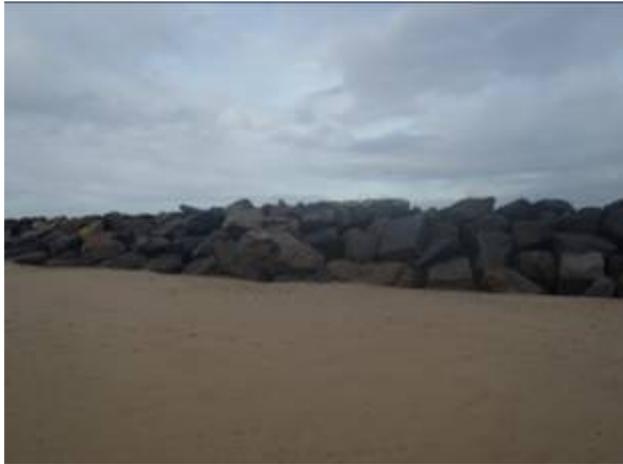
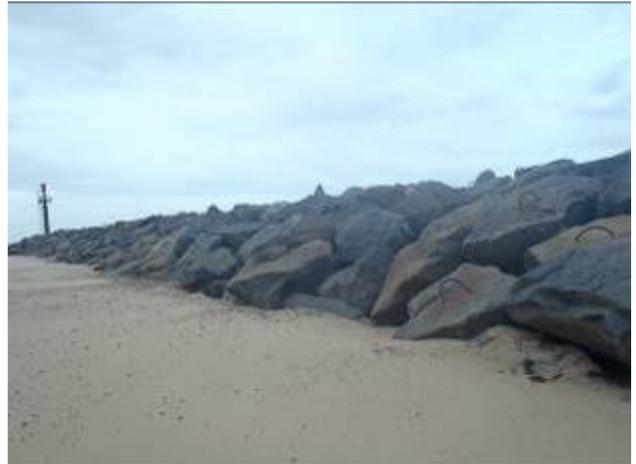
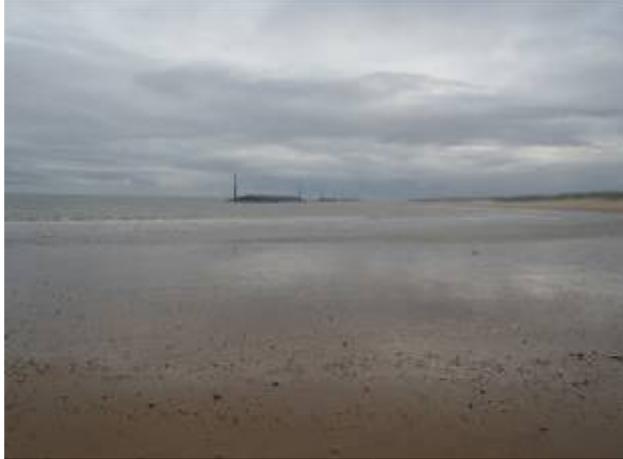
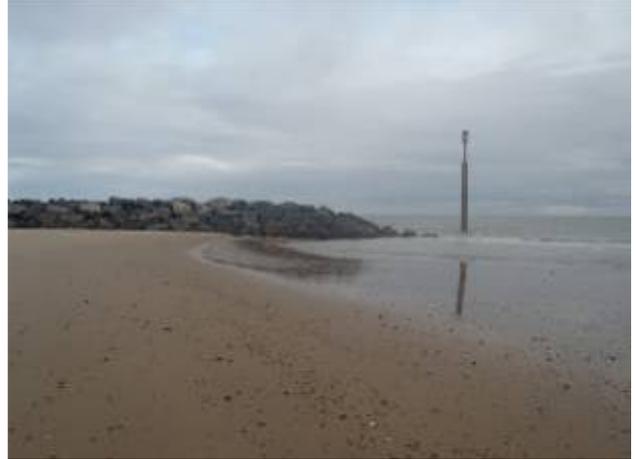
The concrete seawall has been uncovered from within the natural dune system and comprises a concrete wave return seawall with a stepped concrete apron. The apron is then fronted by steep sheet piles to prevent undermining. The piles have become corroded in the tidal environment and also as a result of the lowered beach level in this location a layer of rock armour has been placed at the toe of the structure to prolong its life. However an additional layer of rock armour has also been placed 10m in front of the initial layer to further breakup the approaching waves. The main body of the structure is in good condition with a slightly higher max residual life based on the evidence that the offshore breakwaters will increase accretion in the section.

There is one offshore breakwater of rock armour construction forming part of the series of nine along the coastline. The rock appears stable with minimal movement of units. The structures are decreasing in depth heading west and this one was fully exposed at the time of inspection, sediment had built up to the rear of the structure joining it to the shoreline at low tide. The toe of the structure was also intact and in very good condition with no movement of the armour units.

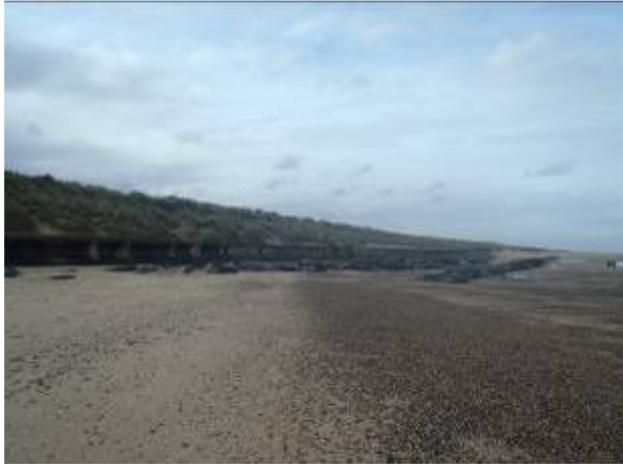
A

The concrete seawall has been uncovered from within the natural dune system and comprises a concrete wave return seawall with a stepped concrete apron. The apron is then fronted by steel sheet piles to prevent undermining. The piles have become corroded in the tidal environment and also as a result of the lowered beach level in this location a layer of rock armour has been placed at the toe of the structure to prolong its life. However an additional layer of rock armour has also been placed 10m in front of the initial layer to further breakup the approaching waves. The main body of the structure is in good condition with a slightly higher maximum residual life based on the evidence that the offshore breakwaters will increase accretion in the section.

There is one offshore breakwater of rock armour construction forming part of the series of nine along the coastline. The rock appears stable with minimal movement of units. The structures are decreasing in depth heading west and this one was partially submerged at the time of inspection, but sediment was gradually building up to the rear of the structure creating a spit out to sea.

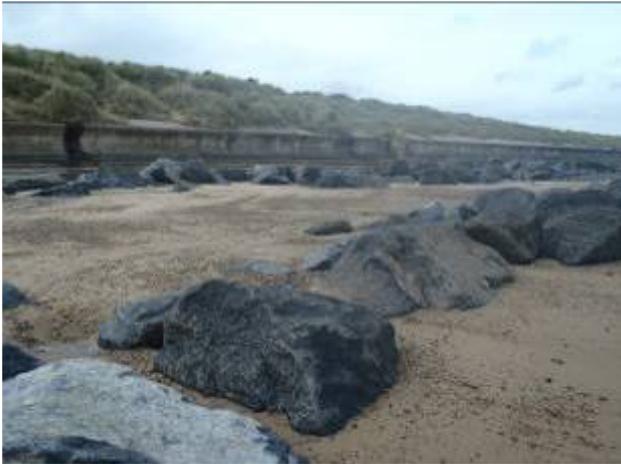
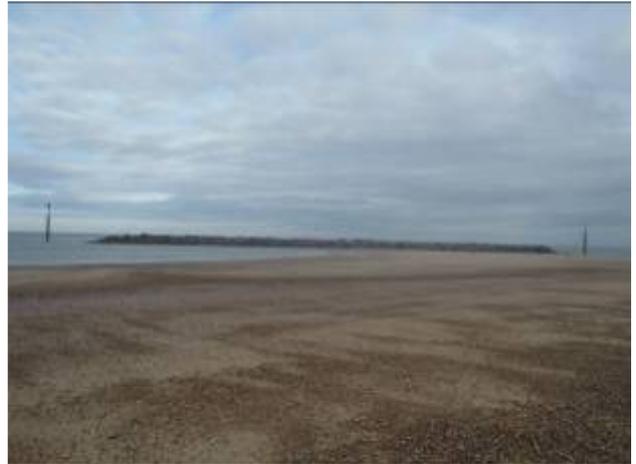
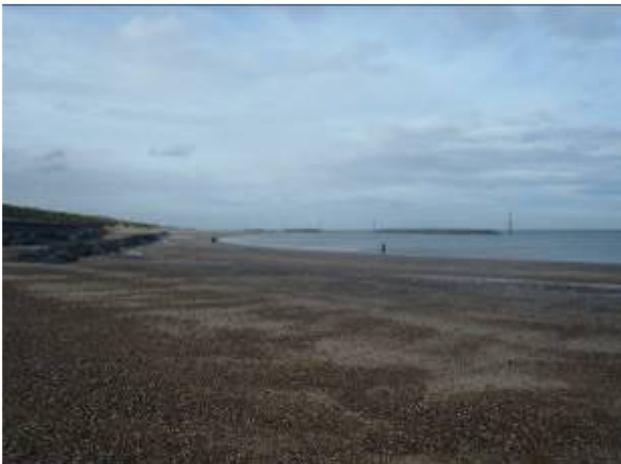
The eastern half of the concrete seawall has been uncovered from within the natural dune system and comprises a concrete wave return seawall with a stepped concrete apron. The apron is then fronted by steel sheet piles to prevent undermining. The western half of the defence was buried under the natural sand dunes formed at the rear of the structure. The main body of the structure is in good condition.

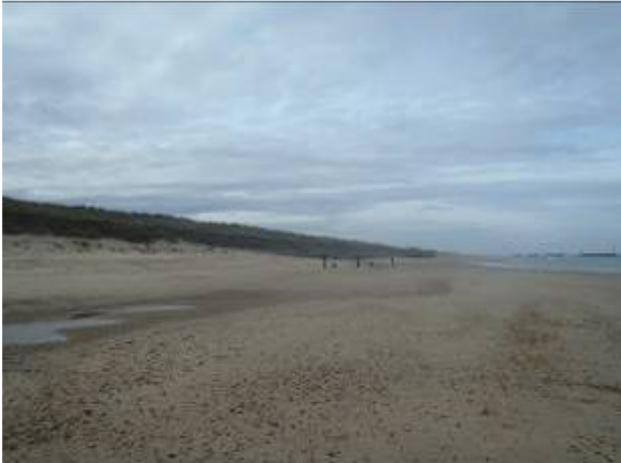
A

The concrete seawall has been uncovered from within the natural dune system and comprises a concrete wave return seawall with a stepped concrete apron. The apron is then fronted by steel sheet piles to prevent undermining. The piles have become corroded in the tidal environment and also as a result of the lowered beach level in this location a layer of rock armour has been placed at the toe of the structure to prolong its life. The main body of the structure is in good condition with a slightly higher max residual life based on the evidence that the offshore breakwaters will increase accretion in the section.

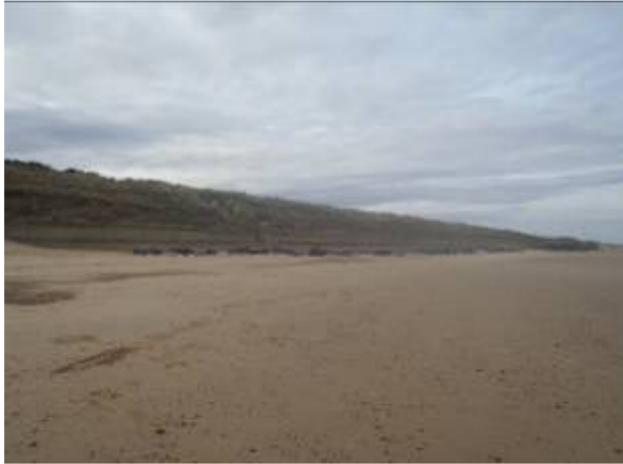
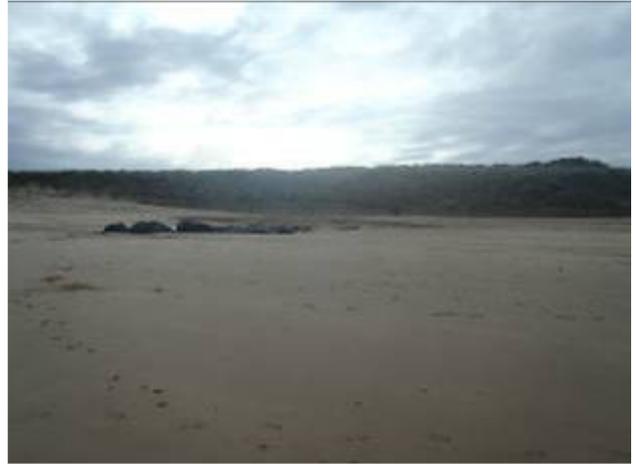
The single groyne was situated in the centre of the section and was in very good condition partially covered in sand as the beach appears to be in a stable condition.

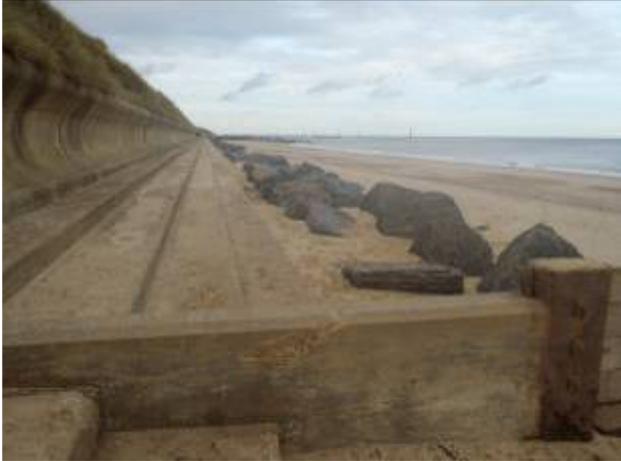
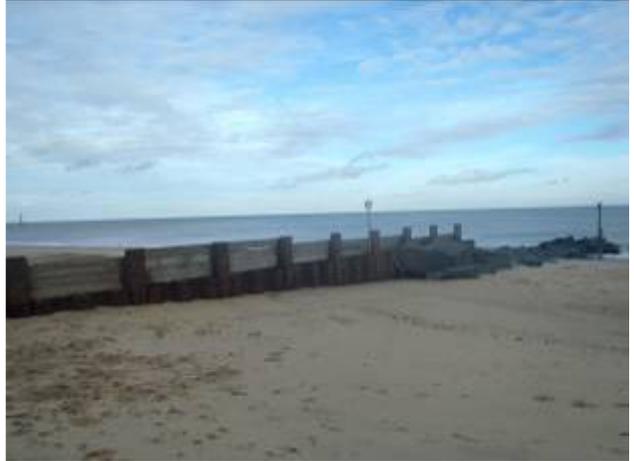
The defences comprise a concrete wave return seawall with a stepped concrete apron. The apron is then fronted by steel sheet piles to prevent undermining. However the piles are corroding and additional rock armour has been placed in front of these to extend the life of the structure which extends throughout this section.

The composite groynes are timber fixed to steel supports along the landward section of the groyne, before becoming rock armour construction for the seaward section. The timber and steel sections are worn and corroding whilst the rock armour is in a very good condition.

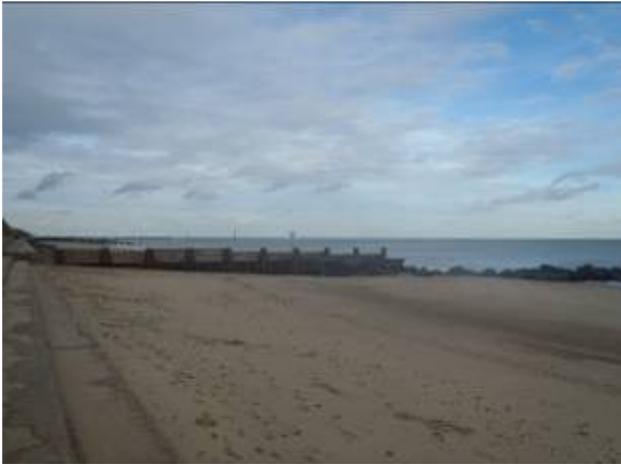
A

The seawall comprised a concrete wave return wall with stepped concrete apron at its toe. The apron was fronted by steel sheet piles to prevent undermining of the structure. The piles are corroding and rock armour has been placed in front of the piles to extend the overall residual life of the structure for the majority of the section. The piles become buried in sand towards the western end of the section.

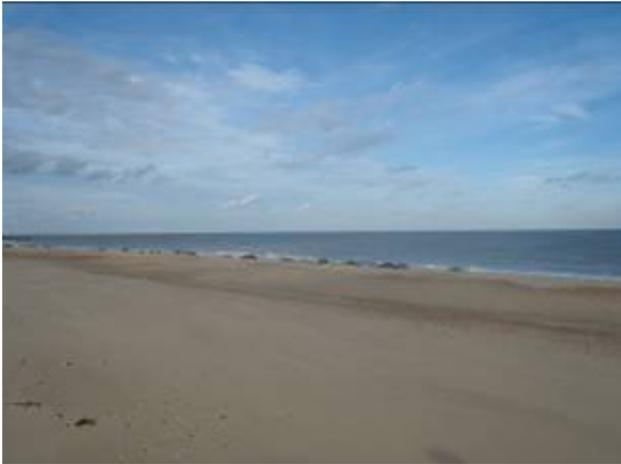
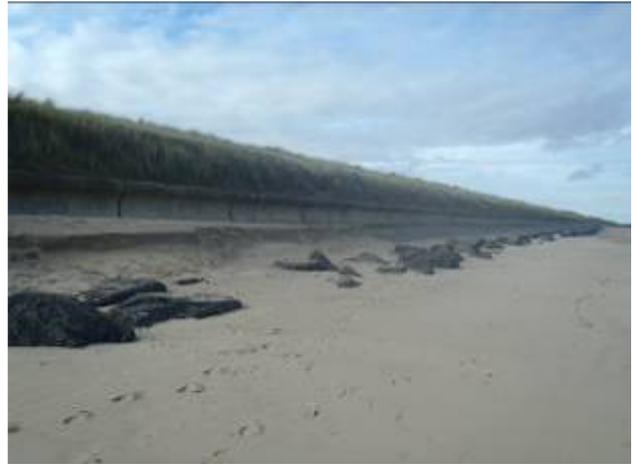
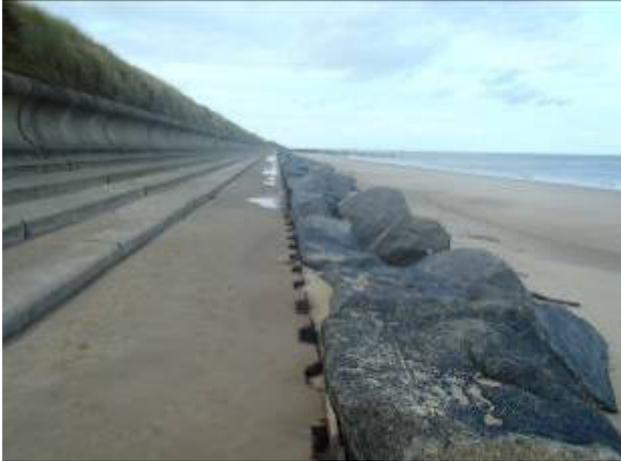
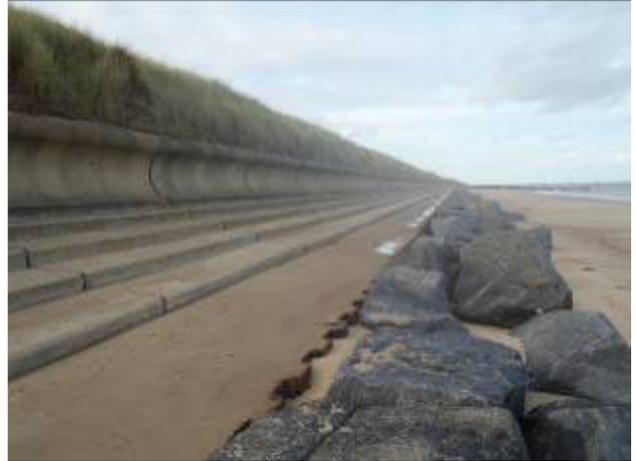
Section no. 13  
Eccles to Winterton Beach Road

The concrete seawall is engulfed by the sand dunes to the rear of the structure through sedimentation and the condition grade is assumed to be similar to that of section 6 as the dunes will provide protection to the structure and it is not subject to direct wave impact.

The groyne field was constructed with timber fixed to steel piled posts. The beach condition was stable with high levels of sand throughout often burying the upper parts of the groynes. The upper boards of the buried sections appeared in good condition where as the lower sections exposed to tidal conditions were worn and the steel supports were corroding.

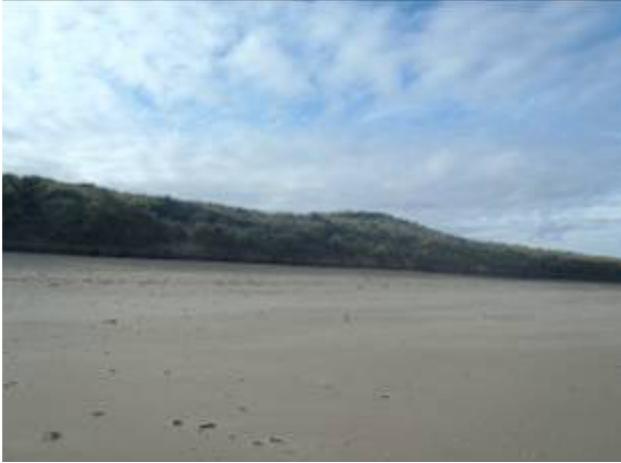
A

The majority of the concrete seawall is engulfed by the sand dunes to the rear of the structure through sedimentation. At the section centre beach levels are reduced in a scoured dip to the rear of the beach uncovering the seawall, apron and top of the piled toe. Based on the condition of the uncovered section the buried seawall has been taken as good as the dunes will provide protection to the structure and it is not subject to direct wave impact.

The groyne field was constructed with timber fixed to steel piled posts. The beach condition was stable with high levels of sand throughout often burying the upper parts of the groynes. The upper boards of the buried sections appeared in good condition where as the lower sections exposed to tidal conditions were worn and the steel supports were corroding.

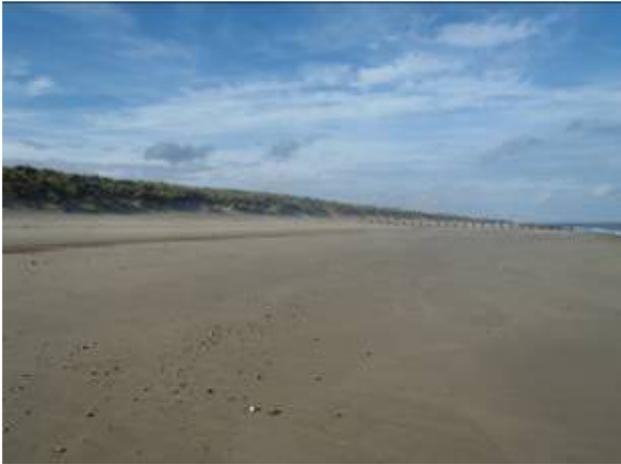
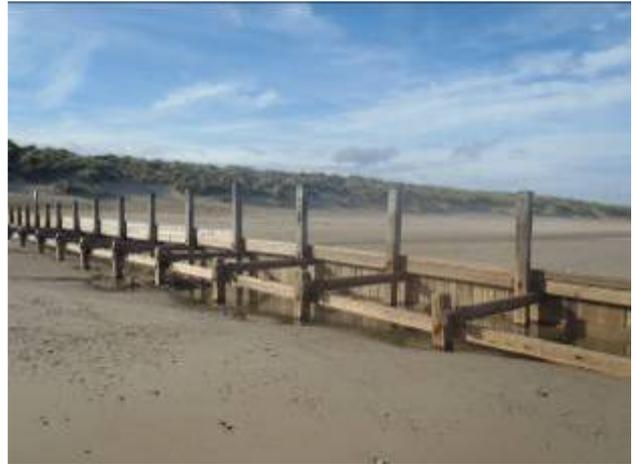
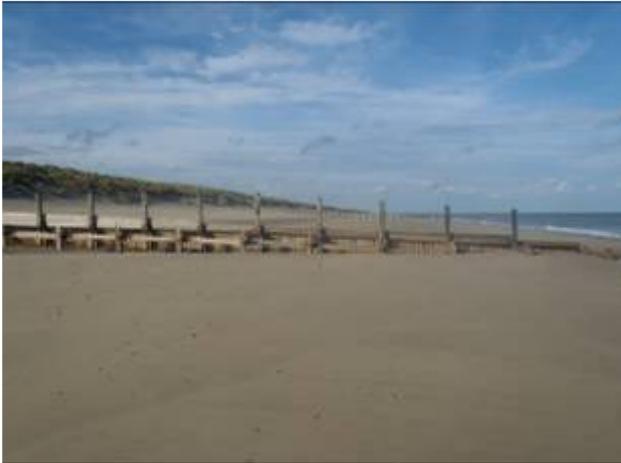
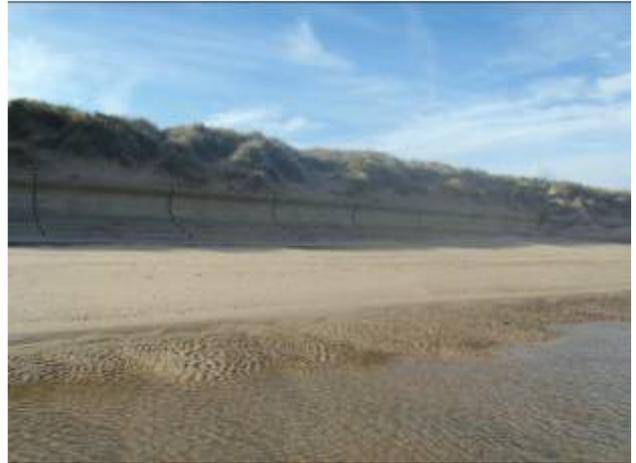
Section no. 11  
Eccles to Winterton Beach Road

The concrete seawall is engulfed by the sand dunes to the rear of the structure through sedimentation and the condition grade is assumed to be similar to that of section 6 as the dunes will provide protection to the structure and it is not subject to direct wave impact.

The groyne field was constructed with timber fixed to steel piled posts. The beach condition was stable with high levels of sand throughout often burying the upper parts of the groynes. The upper boards of the buried sections appeared in good condition where as the lower sections exposed to tidal conditions were worn and the steel supports were corroding.
