# Cromer to Winterton Ness Study

Appendix A: Coastal Defence Condition Survey Update

November 2012  
North Norfolk District Council

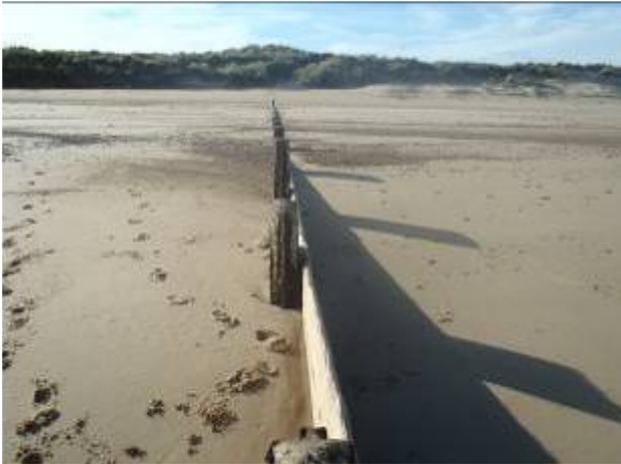
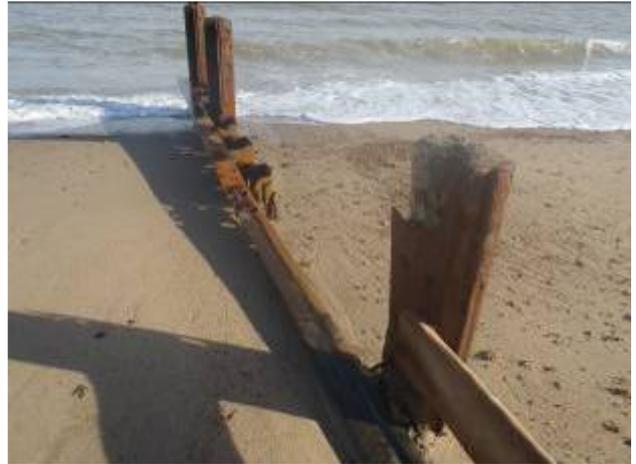
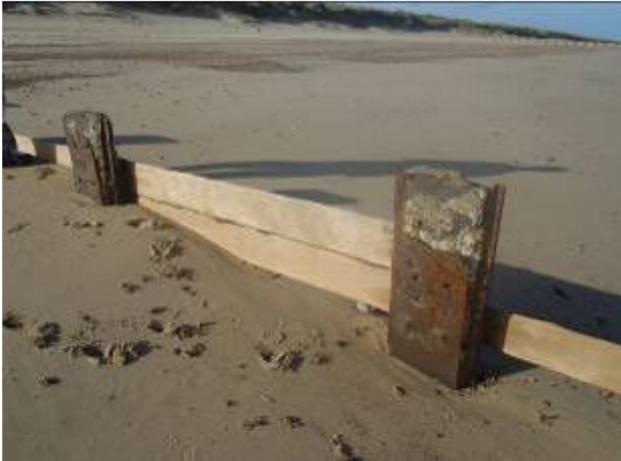
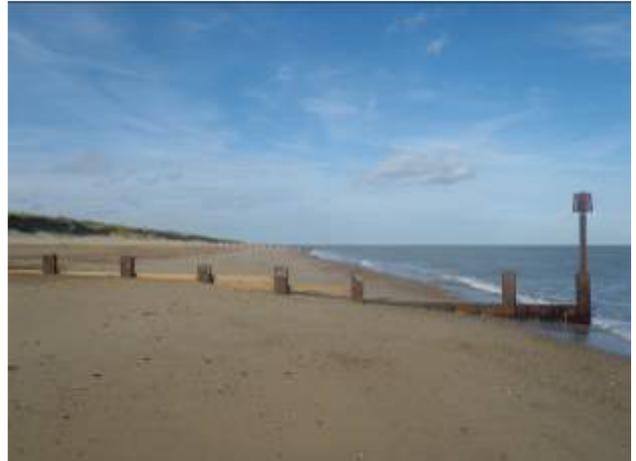
Section no. 8  
Eccles to Winterton Beach Road

The concrete seawall is engulfed by the sand dunes to the rear of the structure through sedimentation and the condition grade is assumed to be similar to that of section 6 as the dunes will provide protection to the structure and it is not subject to direct wave impact.

The groyne field was constructed with rock groynes which showed no signs of damage, effectively building up beach material along the foreshore. The beach condition was stable with high levels of sand throughout.

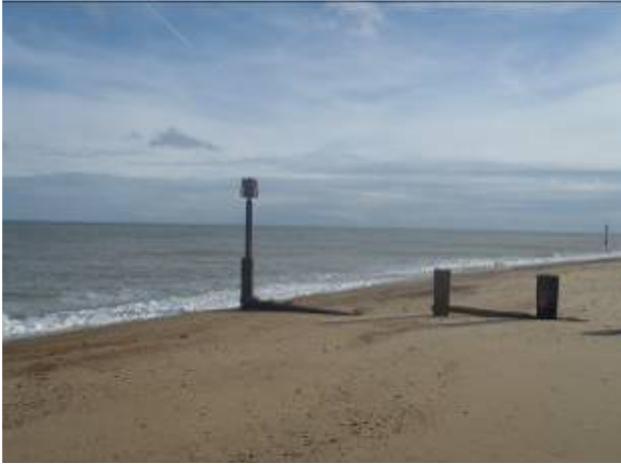
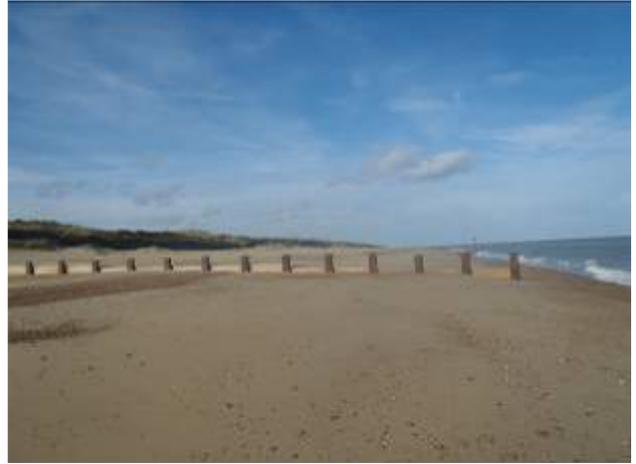
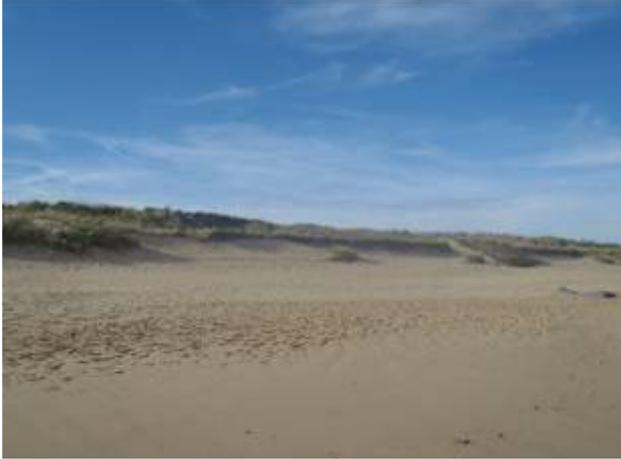
**Section no. 7**  
Eccles to Winterton Beach Road

The concrete seawall is engulfed by the sand dunes to the rear of the structure through sedimentation and the condition grade is assumed to be similar to that of section 6 as the dunes will provide protection to the structure and it is not subject to direct wave impact.

An additional overtopping wall and sloped concrete revetment was fitted above the crest of the main wall. Some of the seawall crest is visible at points through the dunes. An access point through the seawall comprising concrete revetments / wing walls was also present within this section. Some cracking was evident here at the rear of the wave return wall.

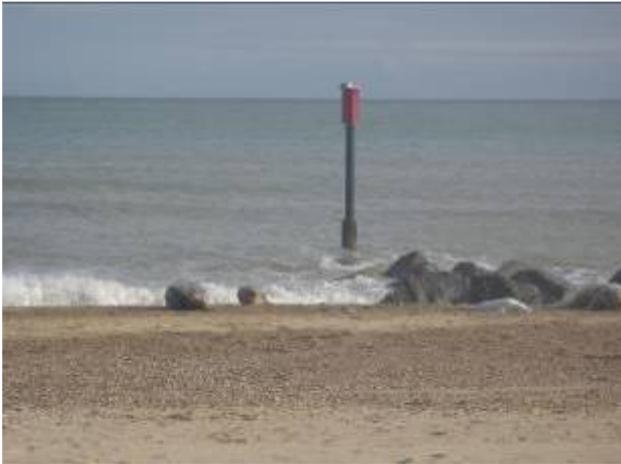
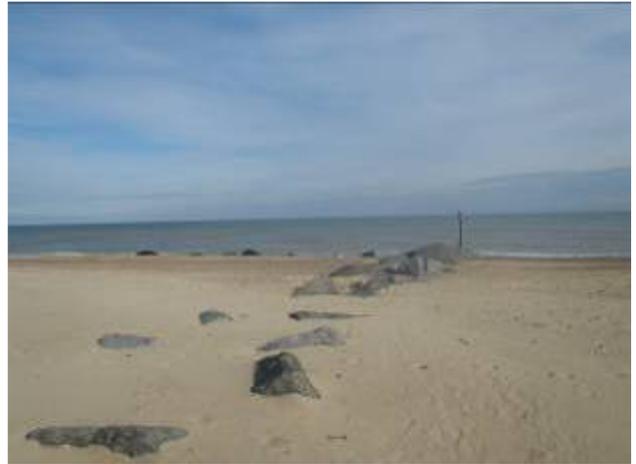
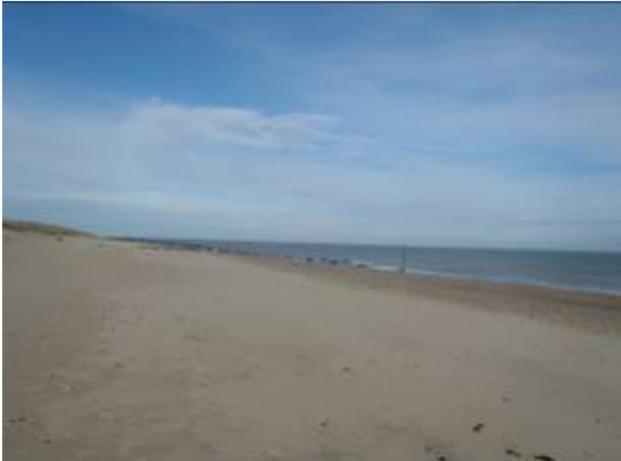
**Section no. 6**  
Eccles to Winterton Beach Road

Minimal damage was evident on the structure, though the last 100m was engulfed by the sand dunes to the rear of the structure through sedimentation.

The groyne field was constructed with rock groynes which showed no signs of damage, effectively building up beach material along the foreshore. The beach condition was stable with high levels of sand throughout.

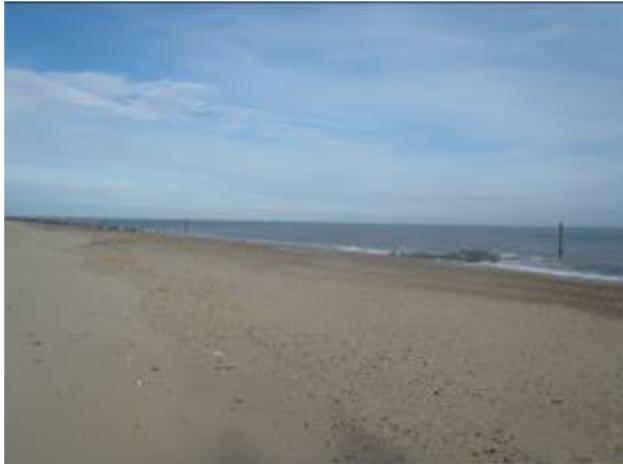
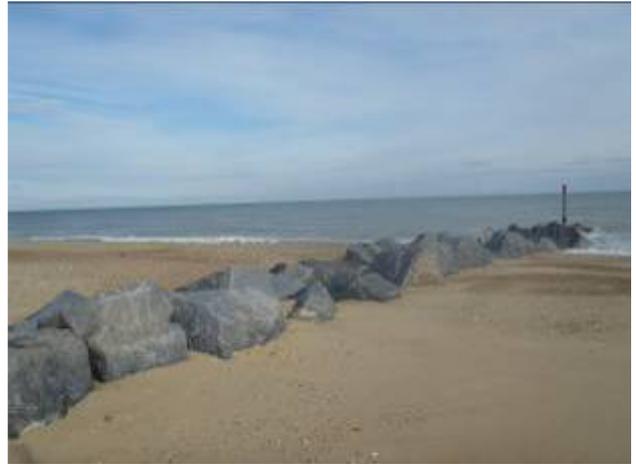
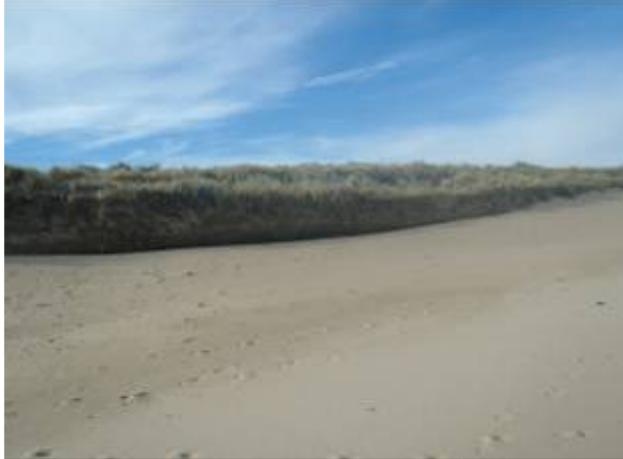
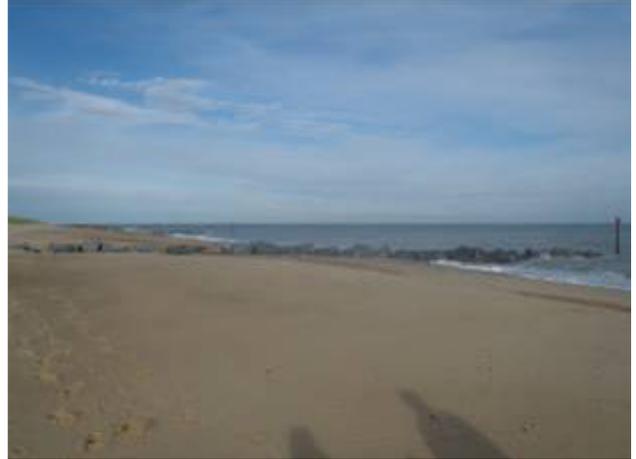
**Section no. 5**  
Eccles to Winterton Beach Road

Minimal damage was evident on the structure.

The groyne field was constructed with timber groynes experiencing some wear throughout the structure.

The beach condition was stable with very high levels of sand throughout.

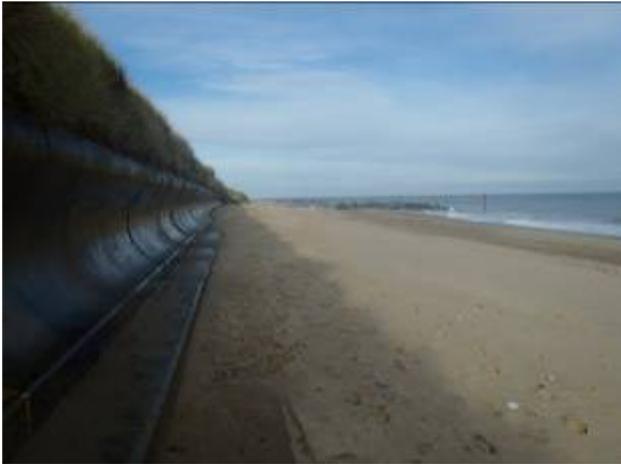
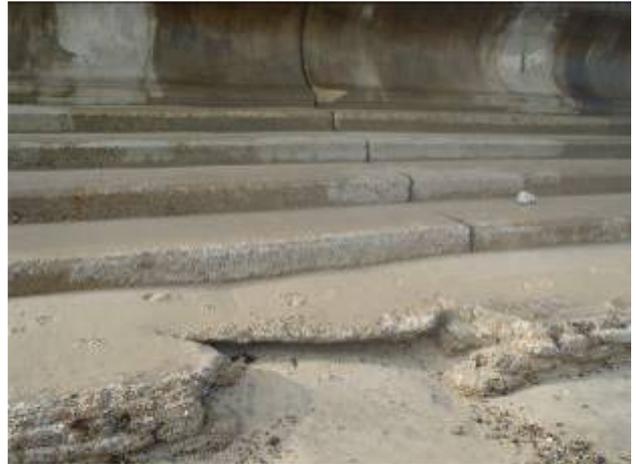
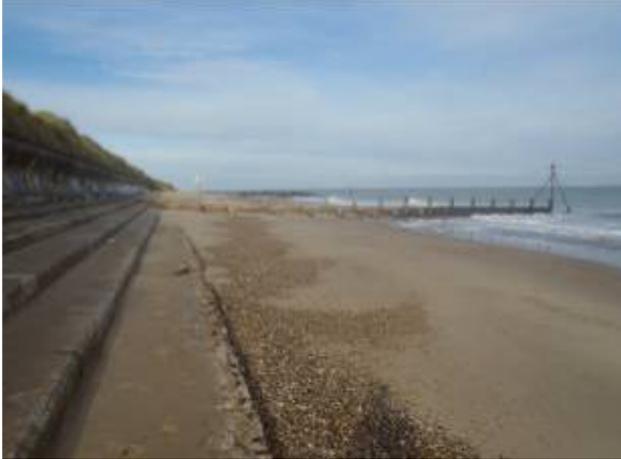
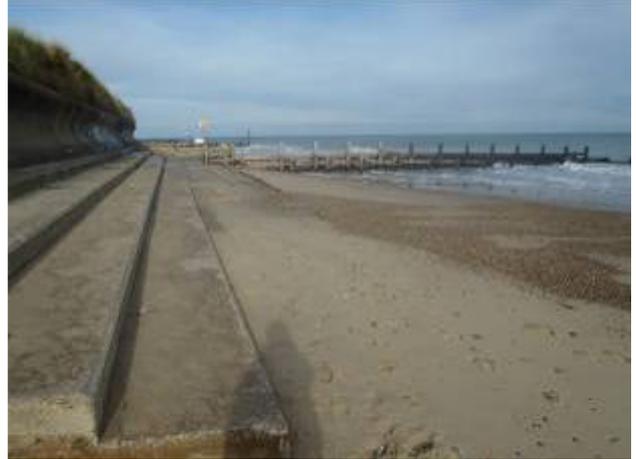
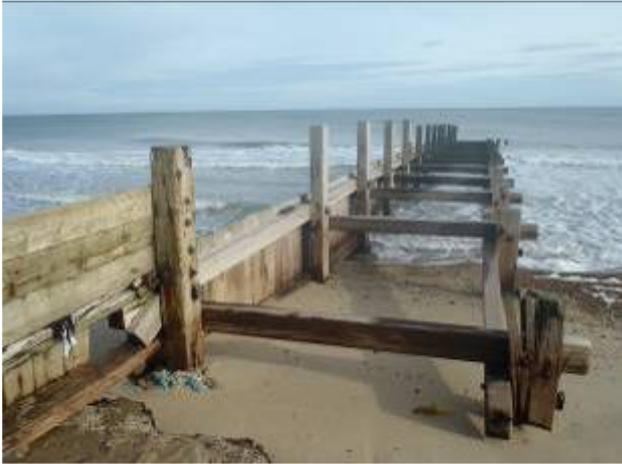
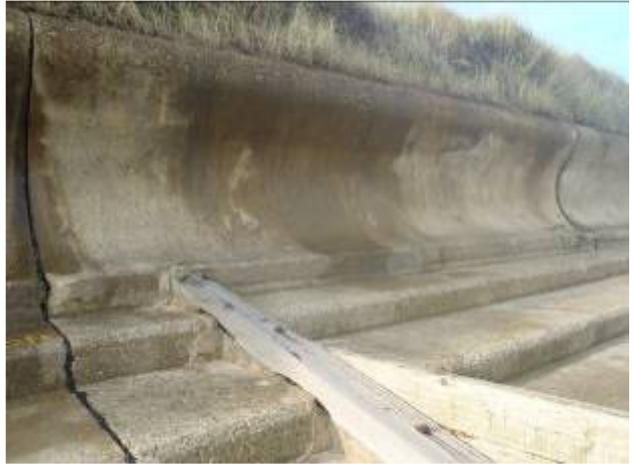
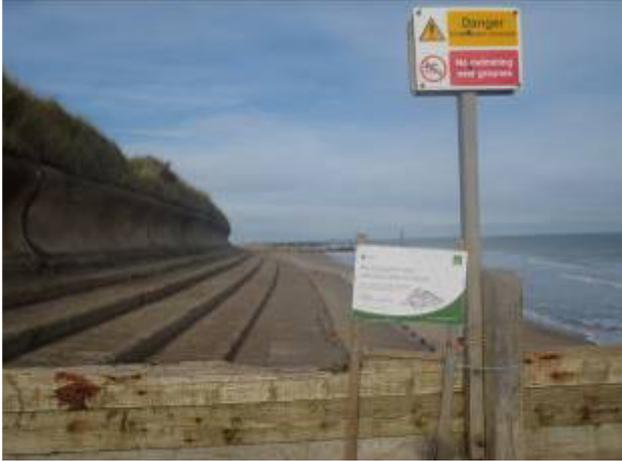
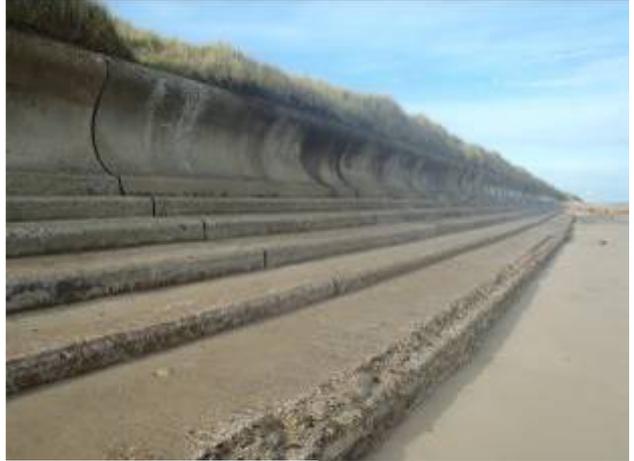
**Section no. 4**  
Eccles to Winterton Beach Road

Minimal damage was evident on the structure.

The groyne field was constructed with timber groynes experiencing some wear throughout the structure.

The beach condition was variable but high levels of sand were present throughout.

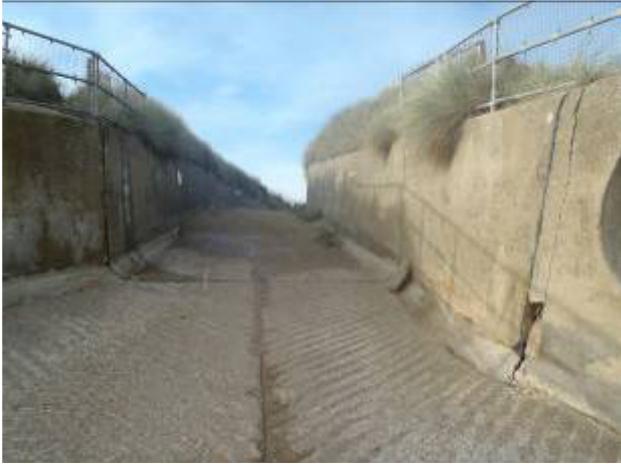
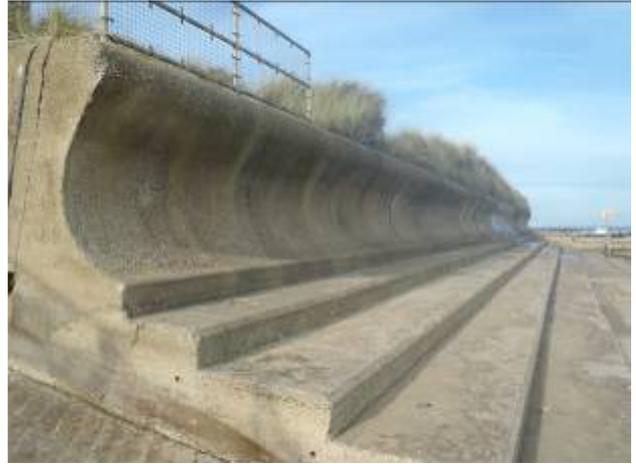
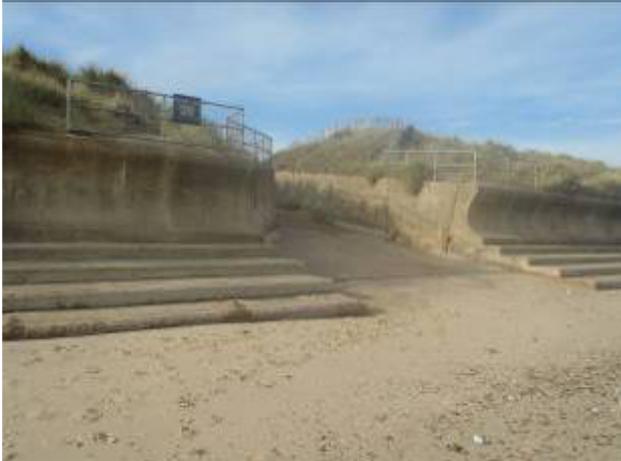
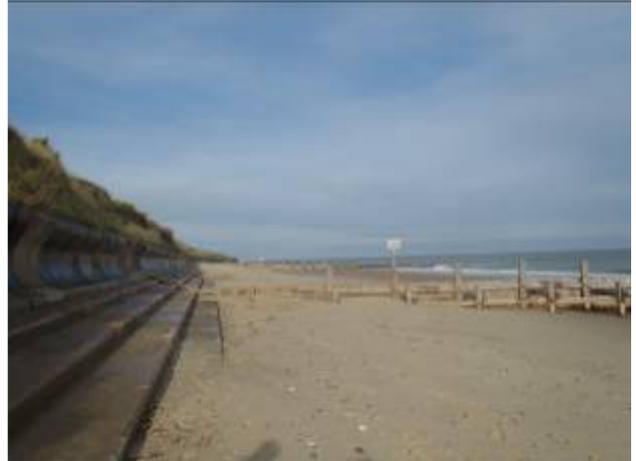
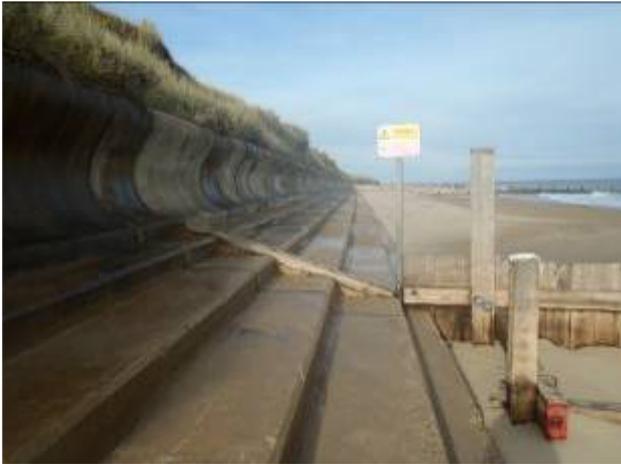
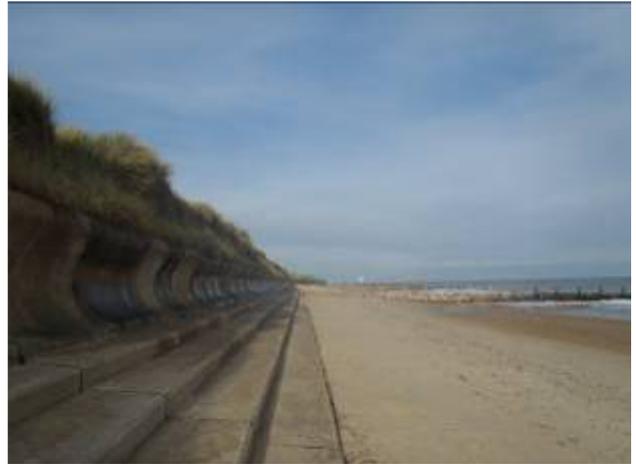
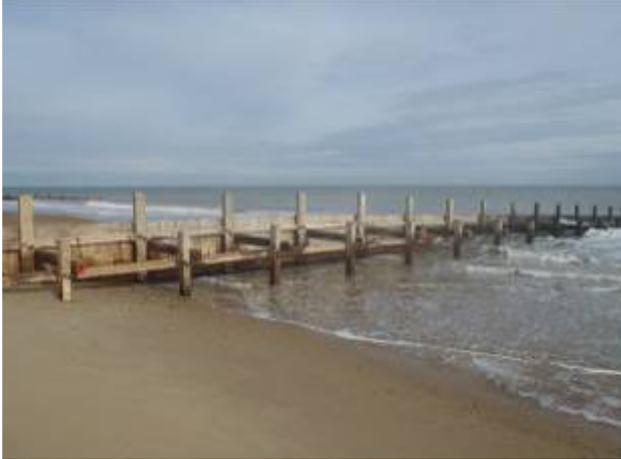
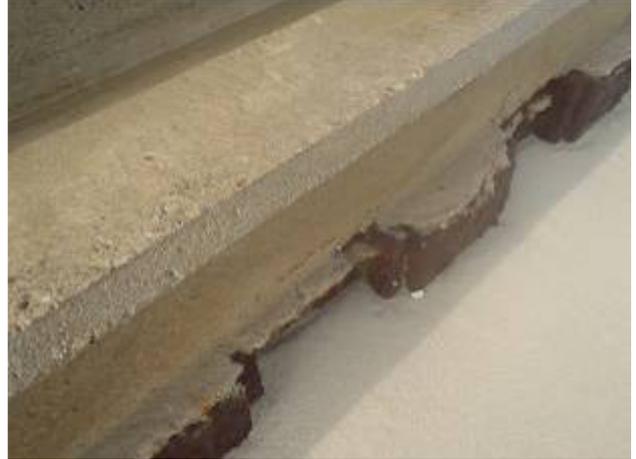
**Section no. 3**  
Eccles to Winterton Beach Road

Minimal damage is evident on the structure. An access point through the seawall comprising concrete revetments / wing walls is also present within this section. Some cracking was evident here at the rear of the wave return wall.

The groyne field was constructed with timber groynes experiencing some damage throughout the structure.

The beach condition was variable with some shingle present towards the eastern end.

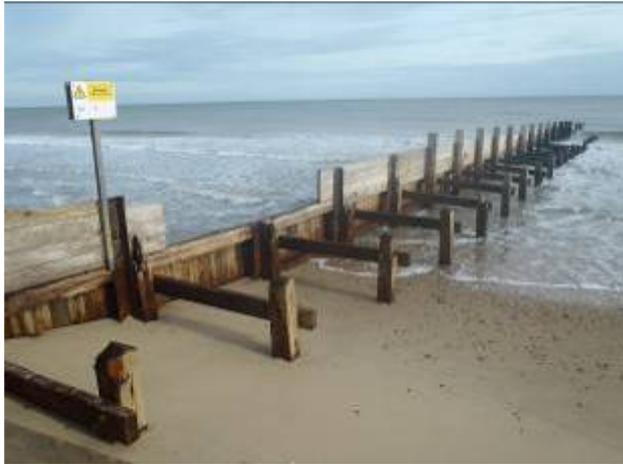
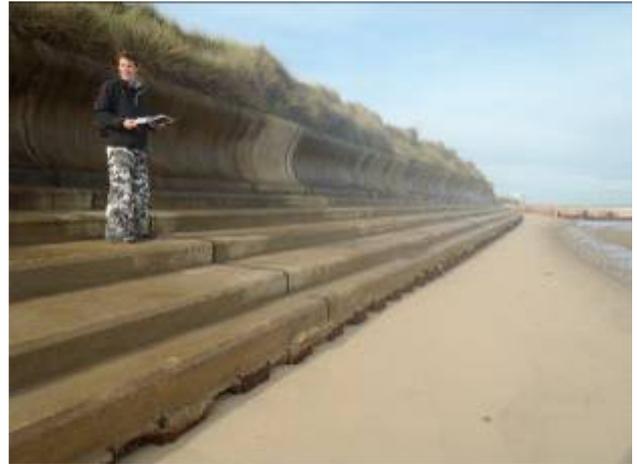
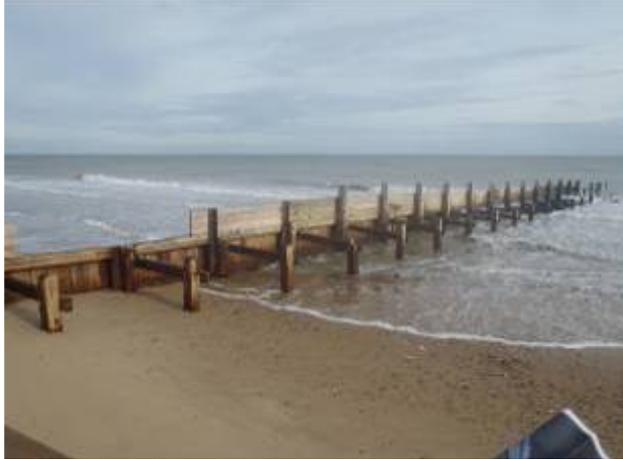
Section no. 2  
Eccles to Winterton Beach Road

There are some manmade repairs within the dunes comprising concrete support structures to prevent breach points occurring.

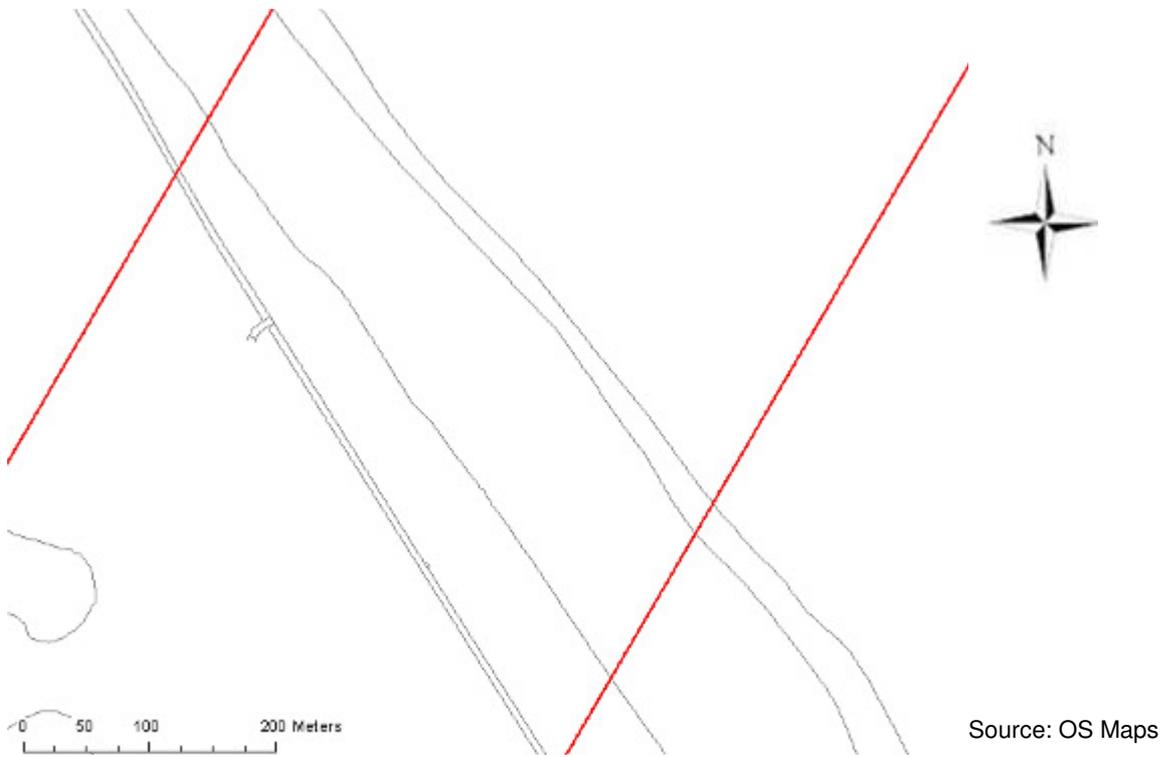
**Section no. 1**  
Eccles to Winterton Beach Road

There are some manmade repairs within the dunes comprising concrete support structures to prevent breach points occurring, most likely caused by public access over the dunes.
