# Baconsthorpe

August 2021

Conservation Area Appraisal and Management Plan

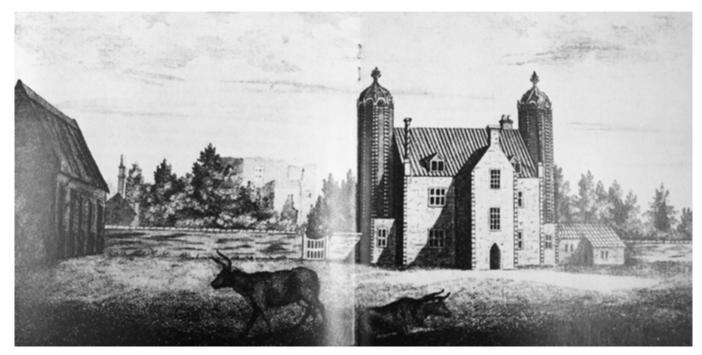
The following print dating shows the outer gatehouse of the castle in 1781, which following the dismantling of the castle had been converted to a dwelling house. The engraving shows a three-storey porch, which replaced a front gate-arch during the conversion (this was in turn removed in the nineteenth century and replaced with the current Jacobean-Gothic style front door).

The outer gatehouse, Baconsthorpe Castle, J. Page, 1781 (Norfolk Heritage Centre)

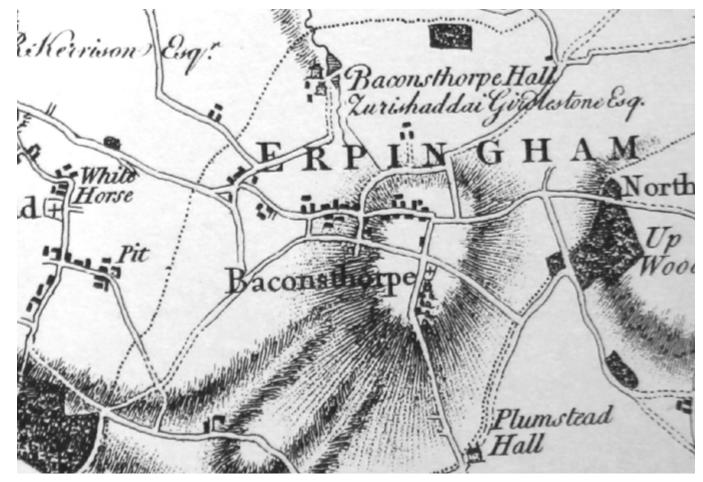
One of the earliest maps of Norfolk by William Faden, dating to 1797, shows a settlement at Baconsthorpe sitting within the hundred of Erpingham. The main development, in the form of detached buildings and farms, lines The Street. There is also a small cluster of development near the church (St. Mary's) on Church Lane, which lies roughly parallel to The Street. Baconsthorpe Hall lies out on a limb to the north of the main settlement; its importance is indicated by the representation of a house and the inscriptions bearing the name of the house and the owner, Zurishaddai Girdlestone Esquire. This Girdlestone was named after his godfather John Lang's father Dr. Zurishaddai Lang who had bought the estate in the late-seventeenth century.

Faden's Map of Norfolk, 1797 (Norwich Heritage Centre)

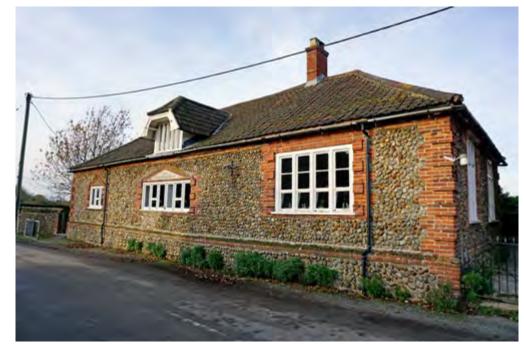
The former school building

The pebble, flint and brick former school was built in 1816 for the children of Baconsthorpe and Hempstead; the building, which sits on Church Lane at its junction with Plumstead Road, was funded by public subscription.

The former National School on School Lane is now the village hall. It is a single storey building of flint cobbles with red brick dressings. There are interesting pediment details above two of the windows facing the street, one of which has a plaque stating '1816 National School'. There is also a distinctive dormer above the central window. Timber casement windows are used and these may be later replacements. The list description notes that the plan of the school has remained unaltered since before 1867.

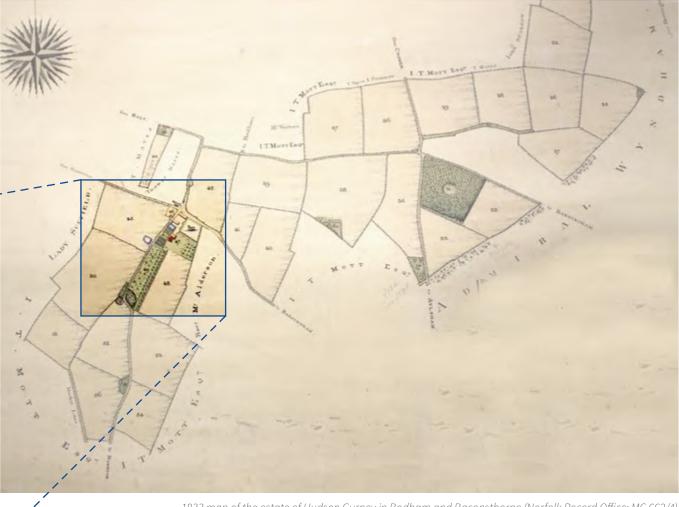
An estate map dating to 1833 shows the estate of Hudson Gurney in Bodham and Baconsthorpe. The Gurney's, who owned the neighbouring Hempstead Estate, had acquired Baconsthorpe Hall in 1801 and owned land across the east side of Baconsthorpe, namely the area around the church including the Manor House, and the fields and plantations to the north-east towards Bodham, which is shown on this map. The various fields and plantations are named, and their acreage recorded.

1833 map of the estate of Hudson Gurney in Bodham and Baconsthorpe (Norfolk Record Office: MC 662/4)

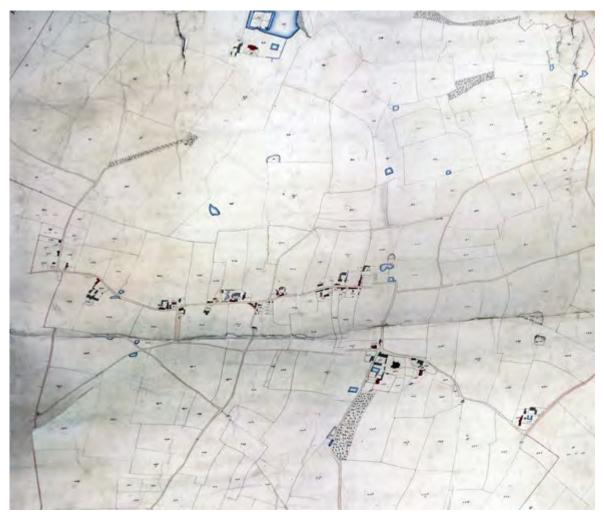
The Tithe Map of Baconsthorpe Parish, dating to 1839, provides a more detailed representation of the layout and land ownership across the whole of Baconsthorpe. The Street comprised a number of farmhouses with outbuildings arranged around yards; several of these farm buildings had been added since the lateeighteenth century. The small population of buildings around the church at the junction between Plumstead Road and Church Lane had also grown; the Rectory had been built to the east of the church, for example. Baconsthorpe Hall was shown in further detail with a carriageway sweep, a formal garden, an ancillary (probably stable) range and an orchard. The major landowners were J. Thruston Mott of Barningham Hall and Hudson Gurney, who owned Baconsthorpe Hall. The former had an estate at Bodham, Baconsthorpe, Hempstead, Sheringham and Beckham from the earlynineteenth century. Smaller landowners included Mayor Thomas and Lady Suffield.

Tithe Map, Parish of Baconsthorpe, 1839 (Norfolk Record Office: DN/TA 516)

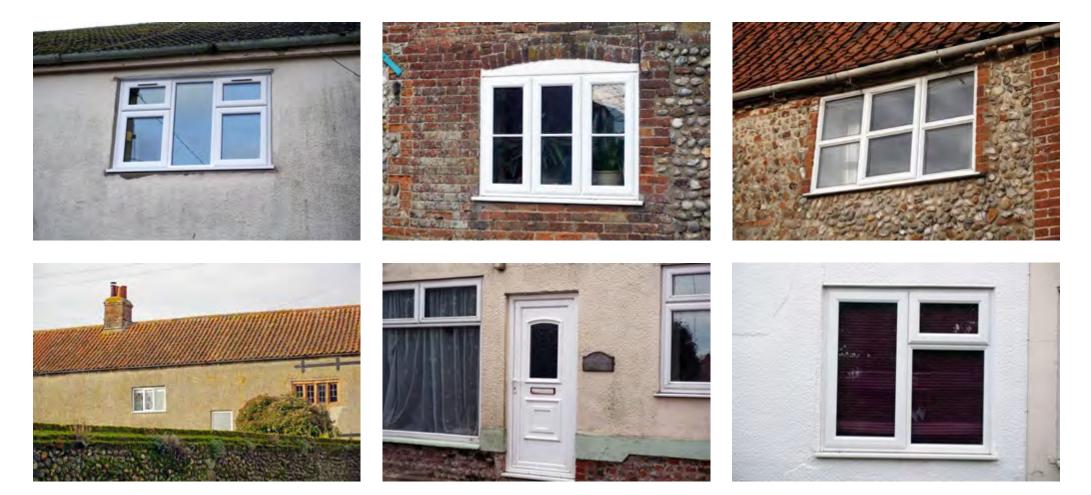
### Inappropriate uPVC Windows and Doors

Windows are traditionally painted timber, in casement form. There are several examples of inappropriate uPVC windows (see <u>Section 7.2</u> for more details). Doors are also typically painted timber but again there have been some inappropriate uPVC replacements.

- When uPVC windows are at the end of their lives and require replacement, it is preferable that this should be done with painted timber windows. If this is impossible, any new uPVC window should be of high quality, closely imitate timber windows and which, where the requisite information is available, has been designed to match the window that existed historically in that particular location in that specific building.
- Remove inappropriate cementitious render and, if necessary to re-render, use a lime based render.
- Consider planting to screen modern agricultural barns.

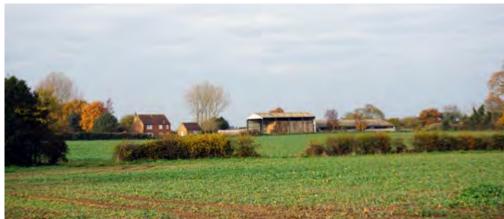
Modern barns seen from The Street

Modern barn seen from The Street

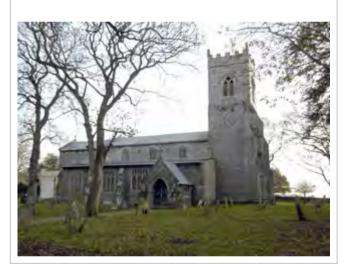
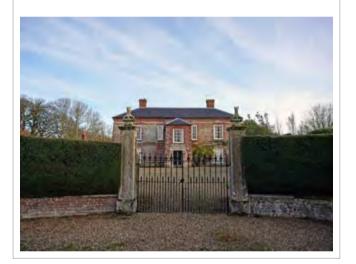
Address / Building Name	Left and Right Gate piers and attached to Splayed Garden wall
Street-by-Street Area	Church Lane/Plumstead Road
Status	Grade II
List Entry Link	https://historicengland. org.uk/listing/the-list/list- entry/1373488 and https://historicengland. org.uk/listing/the-list/list- entry/1049849
Brief History	Eighteenth century gate piers at entrance of Manor House.
Brief Description	Square, in rendered brick having recessed semi-circular headed panels to faces; square stone cap with cyma recta of classical leaf moulding, pier surmounted by stone griffin's head erased (the crest of the Newman family who held the manor late seventeenth/ early eighteenth century). Low curved brick wall with stone cap attached to right.

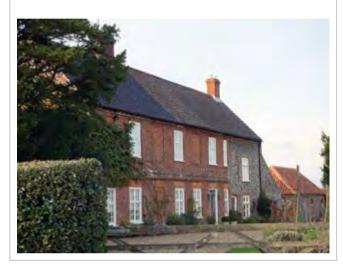
Address / Building Name	Manor House Farmhouse
Street-by-Street Area	Church Lane/Plumstead Road
Status	Grade II
List Entry Link	<u>https://historicengland.</u> org.uk/listing/the-list/list- entry/1373487
Brief History	Eighteenth century façade on earlier core dated 1635.
Brief Description	Brick, black glazed pantiles and pantiles. Two phases now under a continuous roof. Two storeys plus attic. Nineteenth century door and windows.

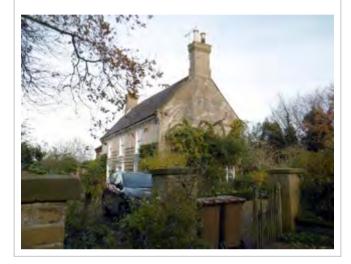
Address / Building Name	The White House
Street-by-Street Area	The Street (2)
Status	Grade II
List Entry Link	<u>https://historicengland.</u> org.uk/listing/the-list/list- entry/1373489
Brief History	Eighteenth century house at right angles to the street.
Brief Description	Rendered, black glazed pantiles, unglazed to right. Three bays, two storeys. Gable parapets on shaped kneelers, end internal stacks in gault brick each with projecting base and oversailing cap having two yellow chimney pots with hexagonal cups.

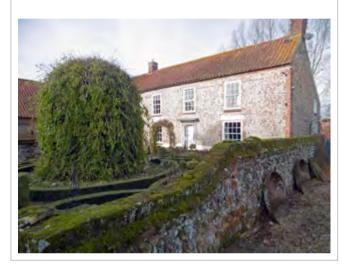
Address / Building Name	Ash Tree Farm
Street-by-Street Area	The Street
Status	Proposed Locally Listed
List Entry Link	N/A
Brief History	Pre-eighteenth century.
Brief Description	Red brick house with red brick dressings and pantile roof. Proposed for local listing because of its elegant symmetrical façade, good quality doors and windows, and as one of the larger and better quality farmhouses within the village.
